Ocean Park Master Redevelopment Project

Monthly EM&A Report – June 2012

Environmental Permit No. EP-249/2006/B - Condition 3.4

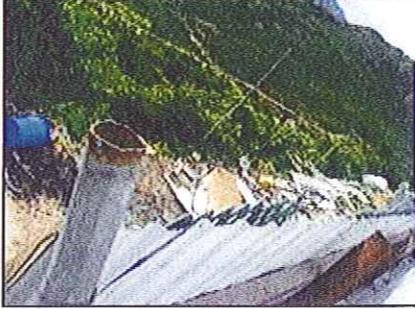
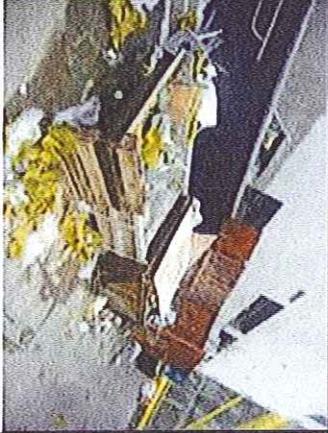
<p>P1150621: General refuse and construction waste were scattered around the site. The Contractor was reminded to clear and dispose them more frequently.</p>	<p>P1150971: General refuse and construction waste were scattered around the site. The Contractor was reminded to clear and dispose them more frequently.</p>

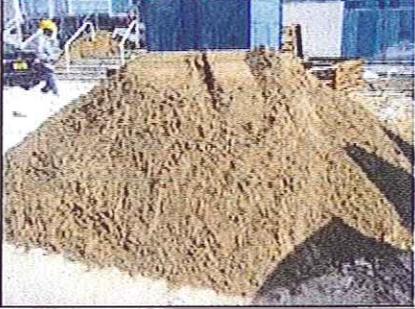
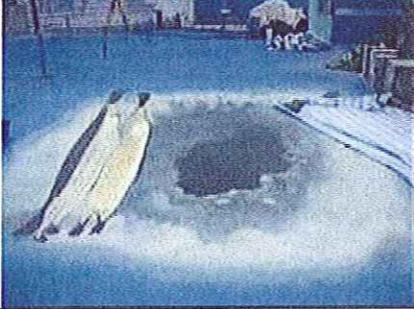
<p>P1150627: Stockpiles of dusty construction materials were not covered with tarpaulin sheets or other means. The Contractor was reminded to cover them to suppress dust and backfill them as soon as possible.</p>	<p>Closed – Stockpiles of dusty construction materials were no longer observed on site.</p>

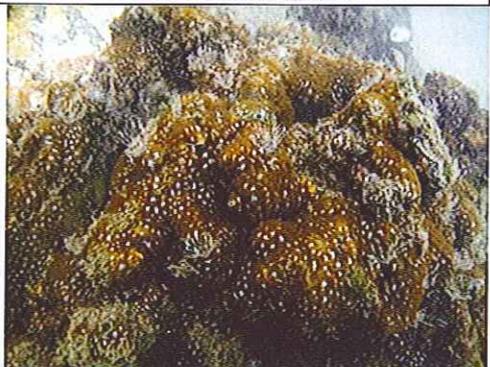
A04 *Leptastrea purpurea*

3.1.3 When compared with baseline data collected in November 2009, increased sedimentation was recorded on two colonies (A4 and A9R), by 2 to 6%. No bleaching was recorded. All tagged corals were in good condition with low percentages of sedimentation (1 – 10%) and no bleaching (0%). Small percentage of partial mortality (2 - 5%) in three colonies A2, A7 and A10R, recorded in the baseline surveys, remained unchanged (Table 3.2). (Table 3.2).

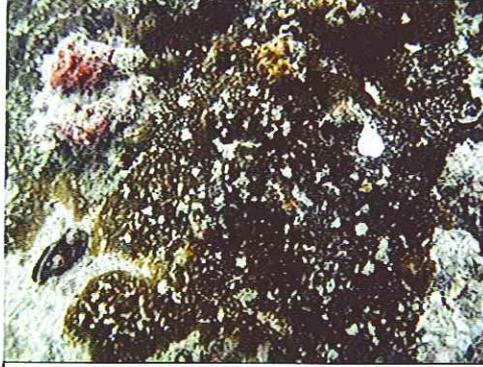
C01 *Porites* sp.

- 3.1.5 When compared with baseline data in November 2009, sedimentation increased in five colonies (C1, C2, C5, C6 and C8) by 2 to 4%. All tagged corals were in good condition, no bleaching was recorded. Partial mortality found in four colonies (C1, C2, C3, and C5) in baseline survey remained unchanged (Table 3.2).

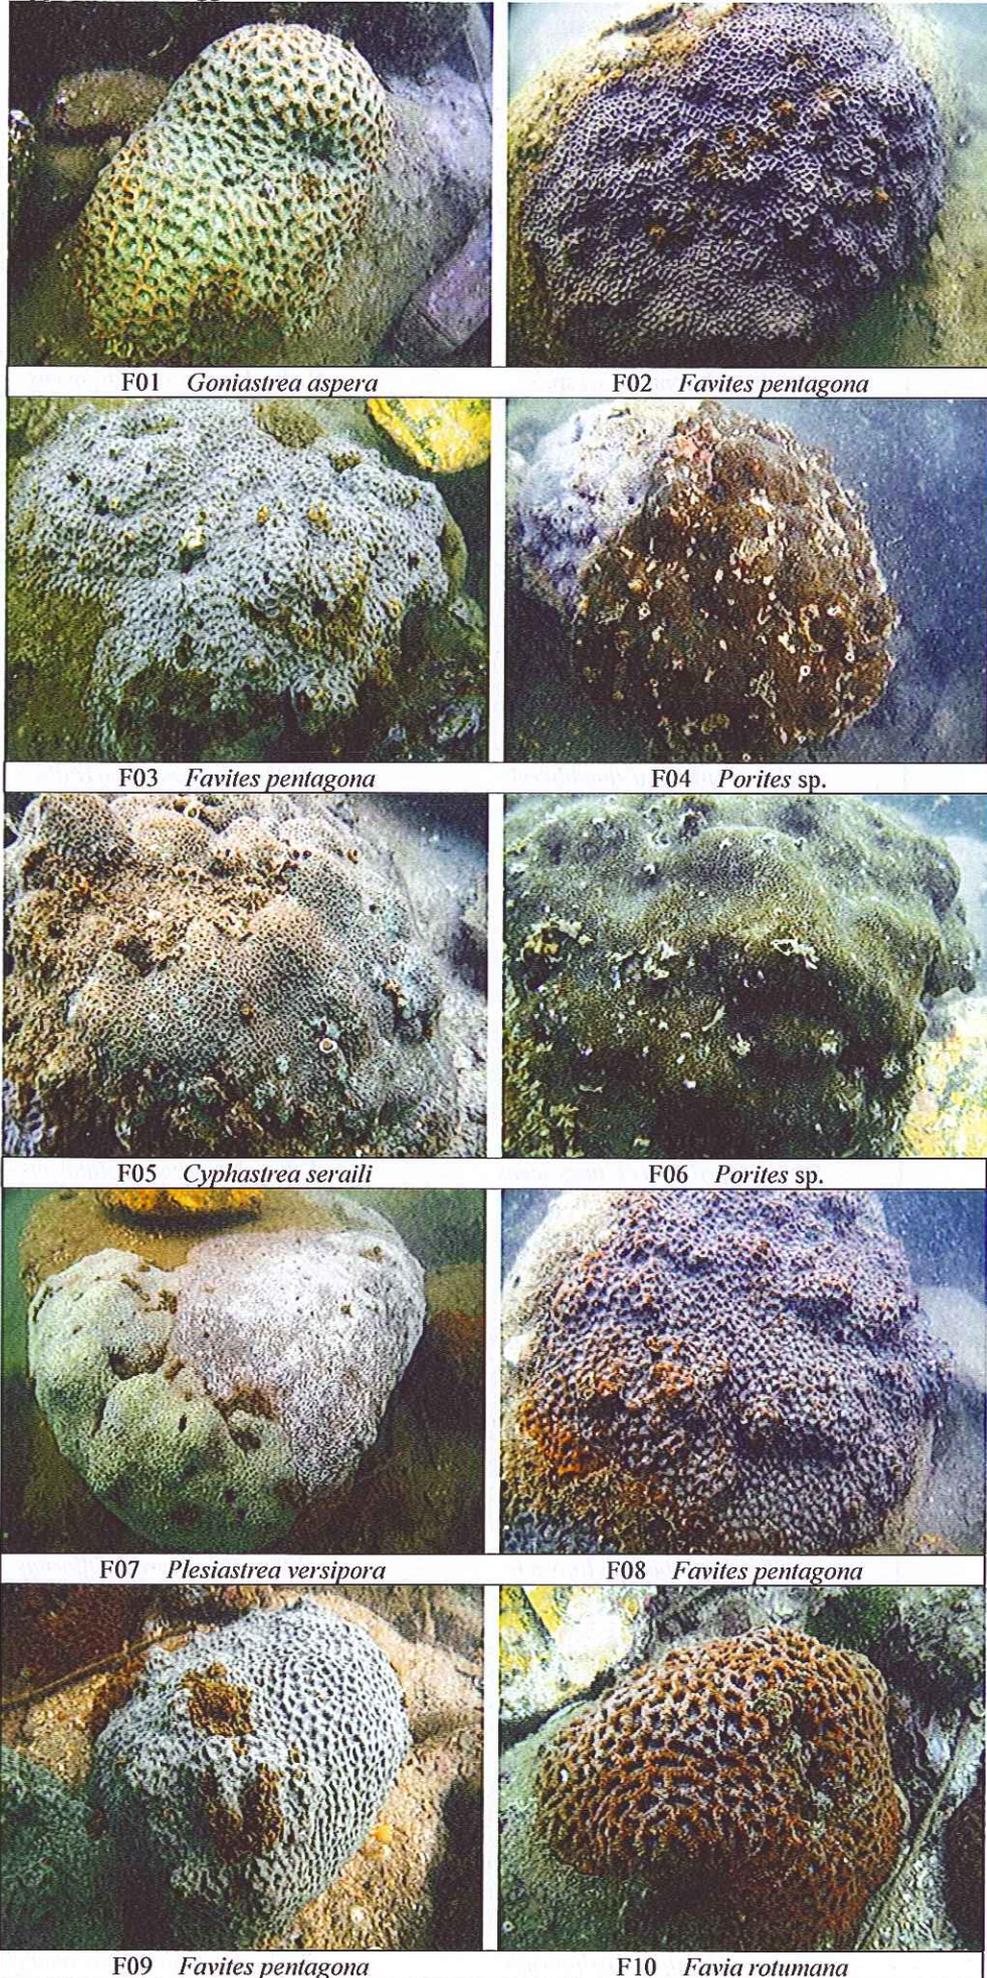
Appendix If Tagged Coral Colonies at Control Site C.

- 3.1.8 When compared with baseline data in November 2009, four colonies (F3, F4, F5 and F9) showed increase in sedimentation by 3 to 10 %. All tagged corals were in good condition, no bleaching was recorded. Partial mortality found in 3 colonies (F2, F3 and F6) in baseline survey remained unchanged (Table 3.2).
