West Island Line Project

Final Environmental Monitoring and Audit Report for Works Area MA (Rev A)

<u>Appendix E</u> Certified Arborist Final Report for Magazine Site

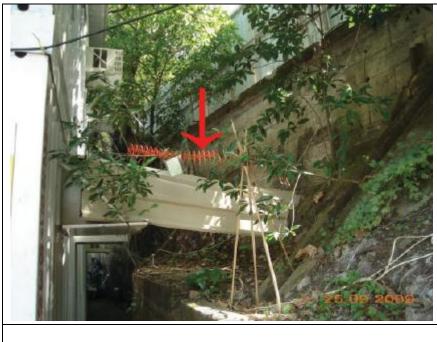
Condition of AT260 in September 2009

This plant was found inclined horizontally in the initial survey in July 2009. The Tree Protection Plan for AT260 submitted to AFCD in September 2009 proposed to adjust this plant to a less inclining angle. The photo taken in November 2009 shows that this plant has been straightened up since then.

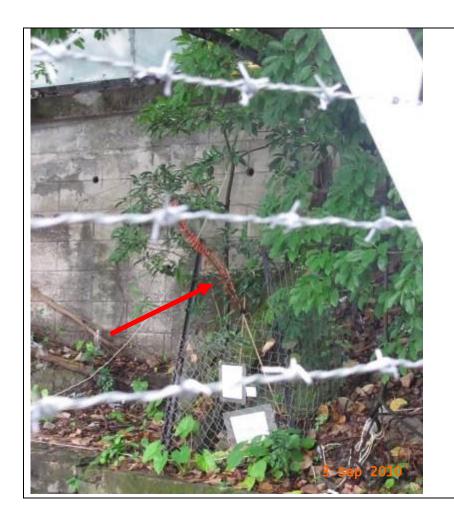
Condition of AT260 in September 2010

As observed on September 2010, the tree was retained tree being fenced off from the magazine site. Foliage density, color and size of AT260 were normal. No sign of infection was observed or recorded. No damage was recorded during the construction phase. Though this plant is outside the security fence from the magazine site, it was retained fenced off. The tree was in good health.

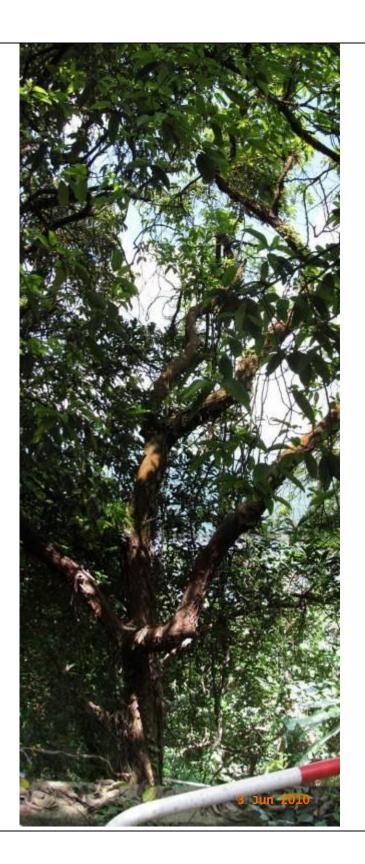
Condition of AT261 in June 2010

As observed in September 2010, the tree was in good health with dense foliage. Climbers recorded in the initial survey had been removed in the construction stage. Abundant fruits were recorded in the summer with good new shoots growth reflecting the tree was in good vigor. No sign of pest infection was observed.

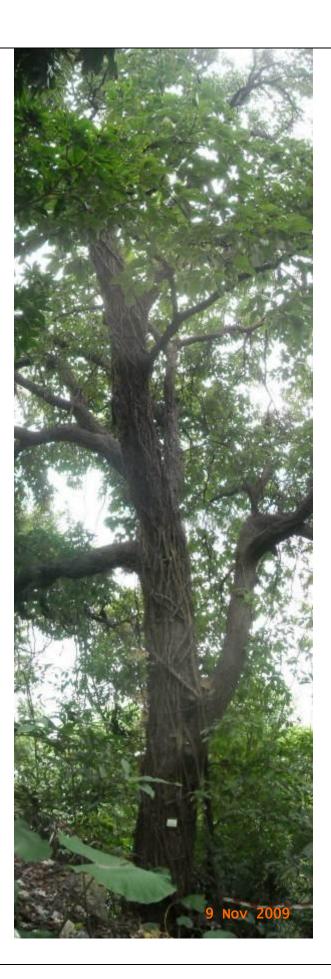
Condition of AT261 in November 2009

As observed in September 2010, the tree was in good health with dense foliage. Climbers recorded in the initial survey had been removed during the construction stage. Abundant fruits were recorded in the summer with good new shoots growth reflecting the tree was in good vigor. No sign of pest infection was observed.

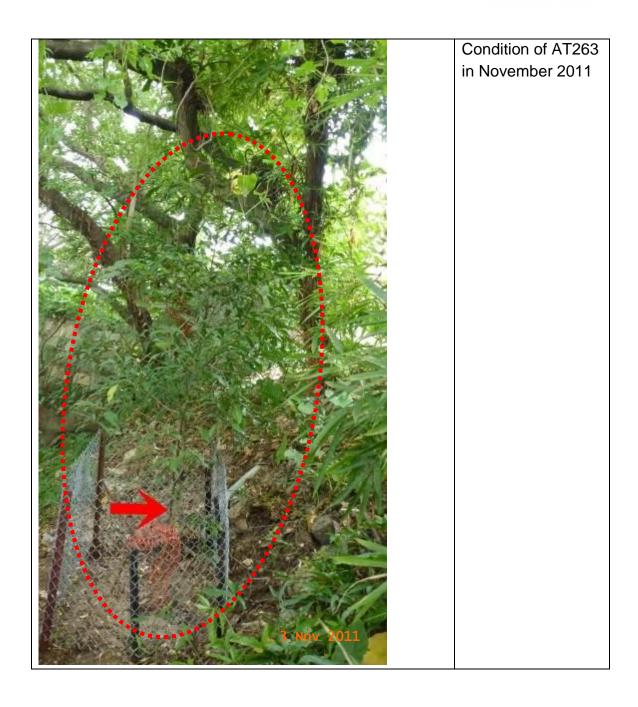
This plant was transplanted in the end of August 2009 and remained in good health. The transplantation shock was minimal to the plant as reflected by its dense foliage and good vigor in November 2009. Flower blooms were recorded in March 2010. No sign of pest infection was observed.

The tree has no change in health condition as observed in the last inspection in November 2011.
