West Island Line

Audit Report for Compensatory Trees – supplementary paper

This supplementary paper presents the findings of the audit inspection for the compensatory trees in David Lane Sitting Out Area, this area falls within the works area of WIL. The re-provisioning of this area was completed in mid 2019 and handed over to Leisure and Cultural Services Departments (LCSD) in October 2019.

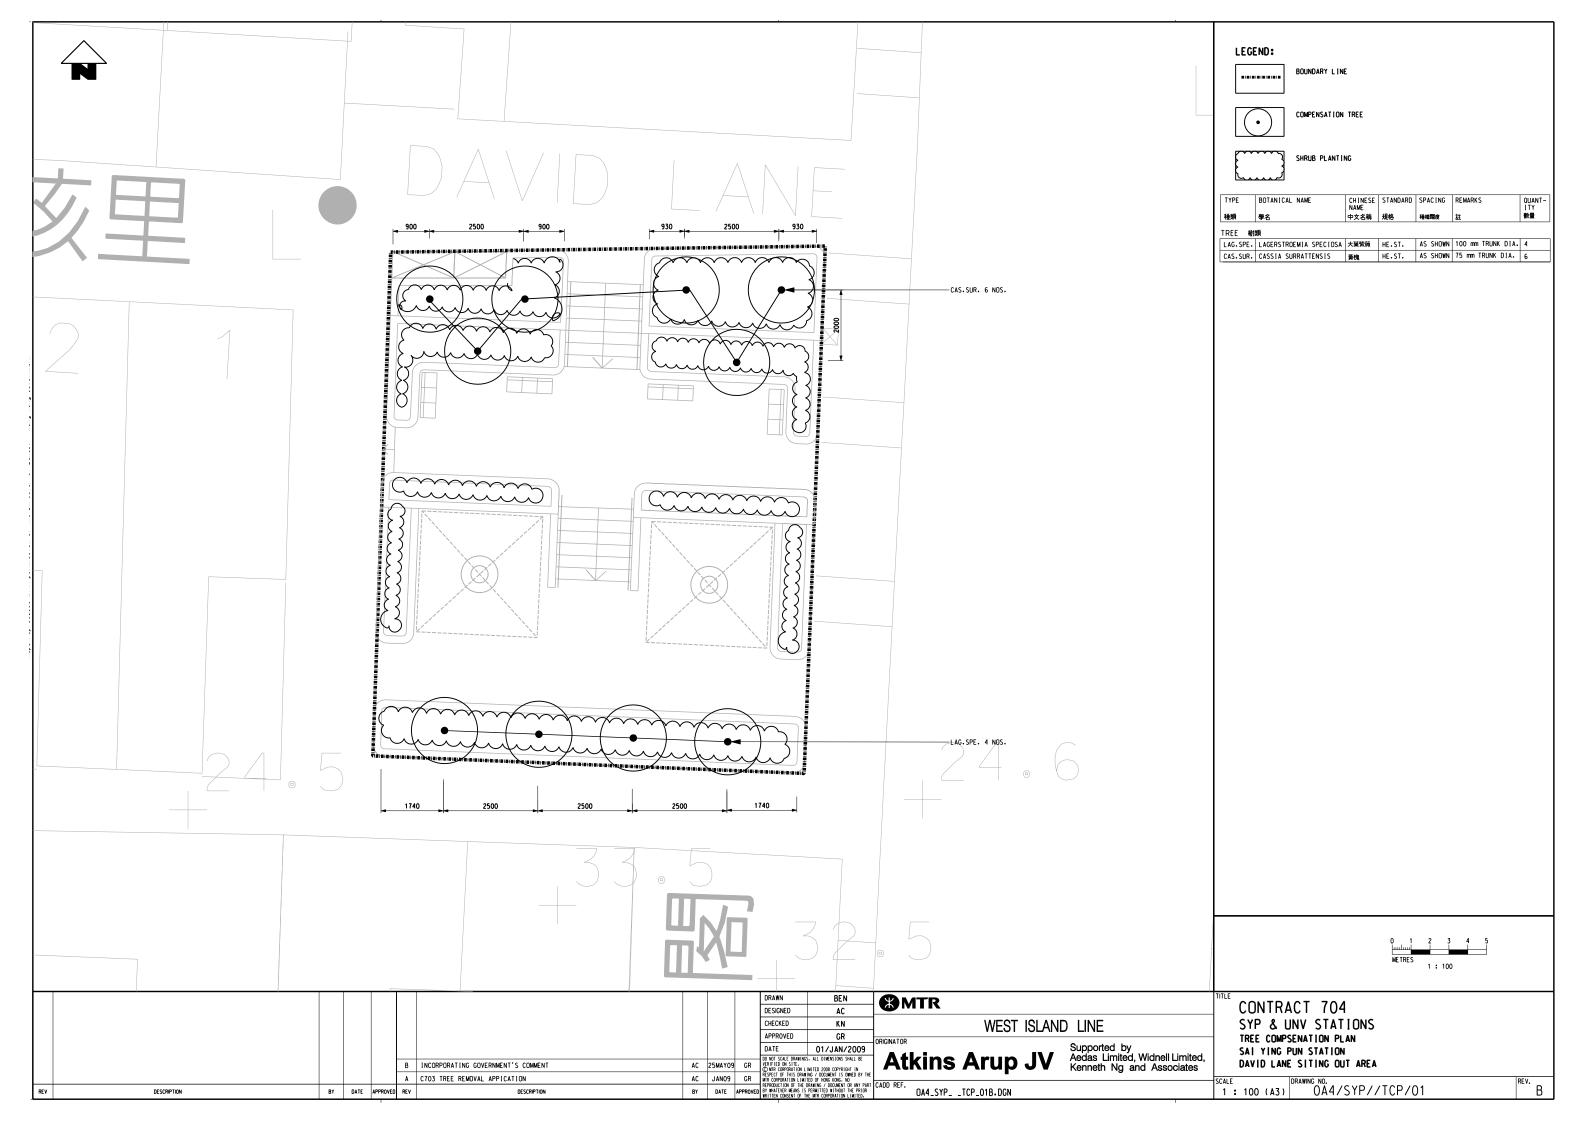
Compensatory Tree Proposal of David Lane Sitting Out Area in TPP (Rev. F)

According to the Tree Protection Plan (TPP) (Rev.F) in **Appendix A**, ten numbers of compensatory trees was proposed to be planted in David Lane Sitting Out Area, the proposed planting species in the compensatory planting proposal are listed in **Table 1.1**.

Species Name	Size	Quantity
Cassia Surattensis 黃槐	Heavy standard*	4 nos.
Lagerstroemia speciose 大花紫薇	Heavy standard	6 nos.

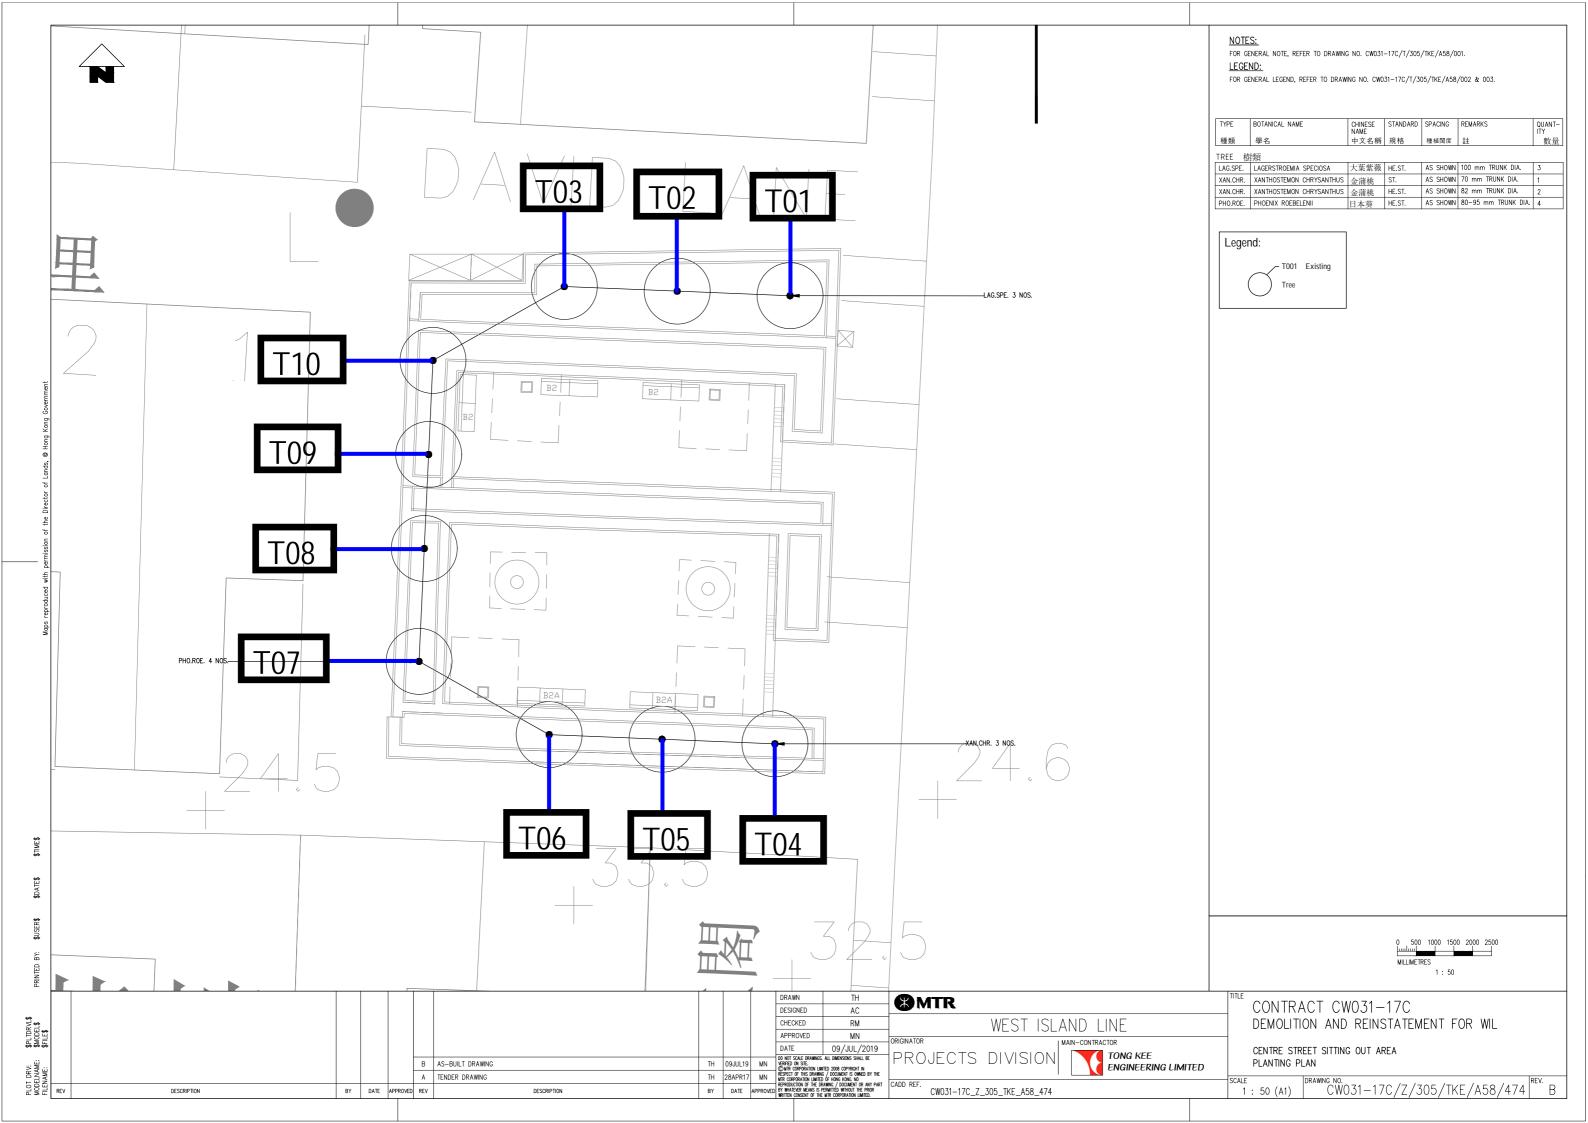
Landscape As-built Drawing of Compensatory Trees in David Lane Sitting Out Area

Refer to the Landscape as-built drawing in **Appendix B** and photo records in **Appendix C**, the key changes are as follows:

- 1) Cassia surattensis has been deleted.
- 2) The quantity of Lagerstromia speciose has been changed from 6 to 3.
- 3) 2 new species *Xanthostemon chrysanthus* and *Phoenix roebelenii* are proposed in the updated scheme.

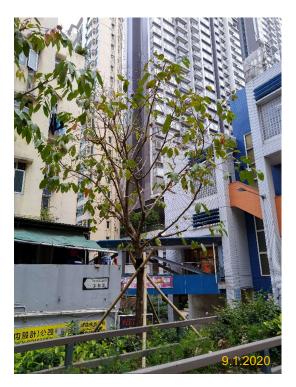
T01 T02

Size of the trees are measured during the inspection, all planted trees are the heavy standard size as proposed in TPP (Rev.F). Overall tree health and tree form are in good condition, except for T01 and T04 are in fair condition.
