**PROVISION OF CREMATORS AT  
WO HOP SHEK CREMATORIUM**

**ENVIRONMENTAL MONITORING &  
AUDIT REPORT (DECEMBER 2009)**

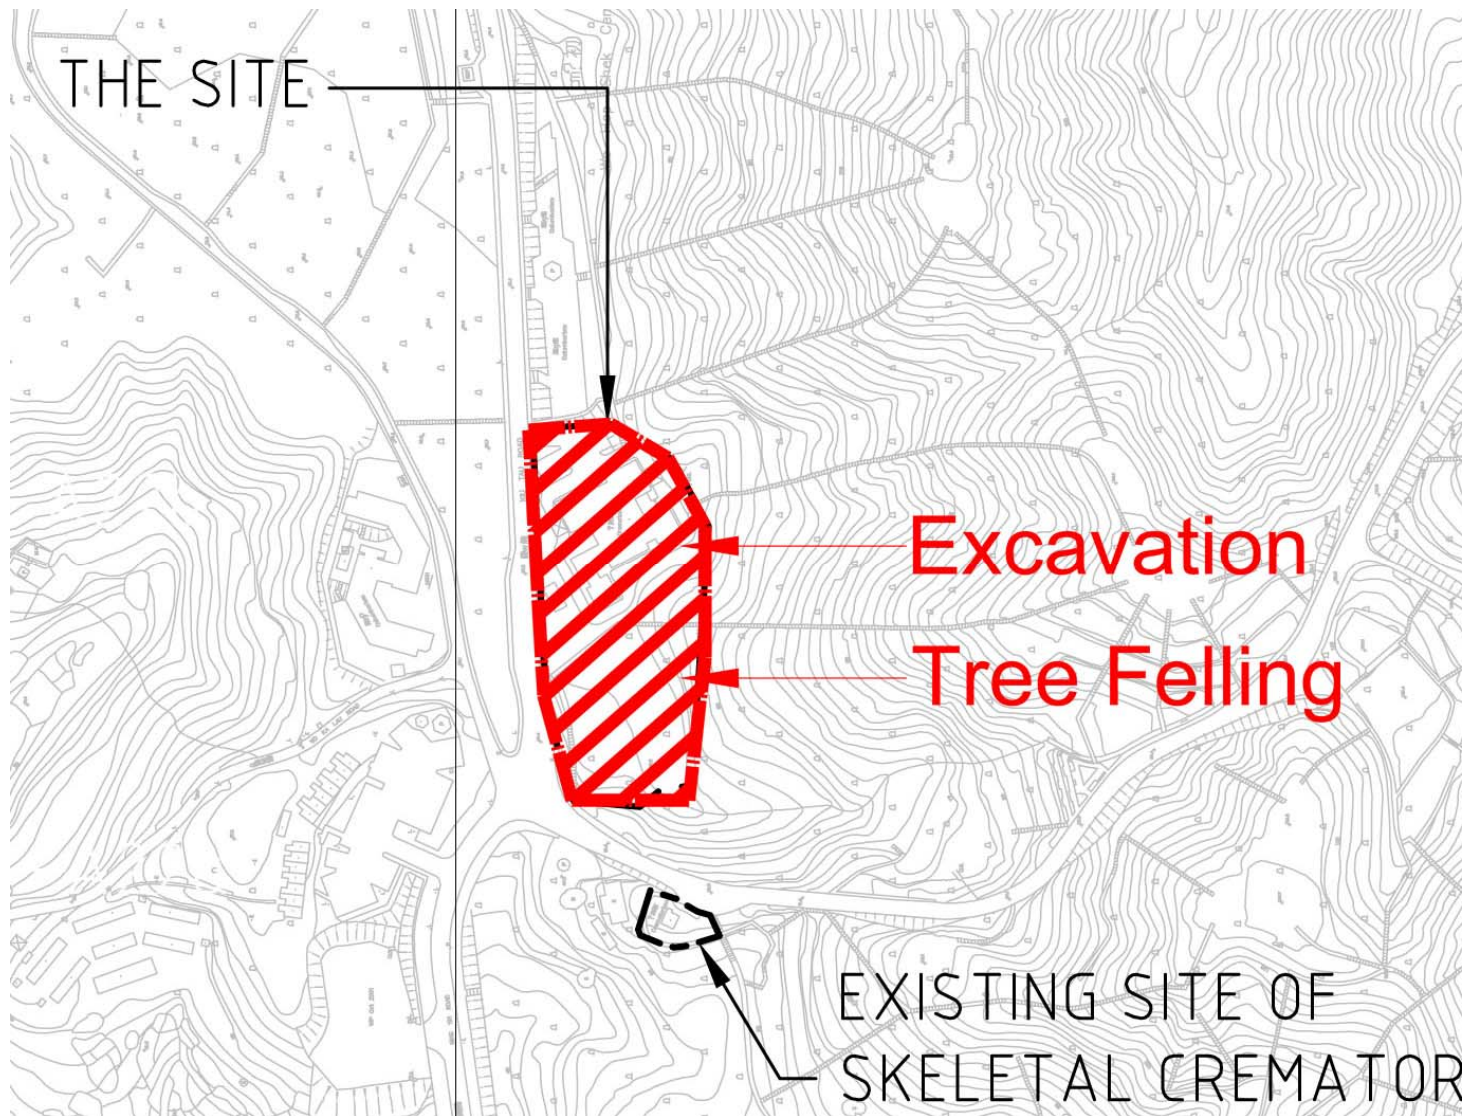
| Figure No. | 2 | Rev.: | 0 |

**PROVISION OF CREMATORS AT WO HOP SHEK CREMATORIUM AT KIU TAU ROAD**  
**CONSTRUCTION WORKS UNDERTAKEN DURING THE MONITORING MONTH**

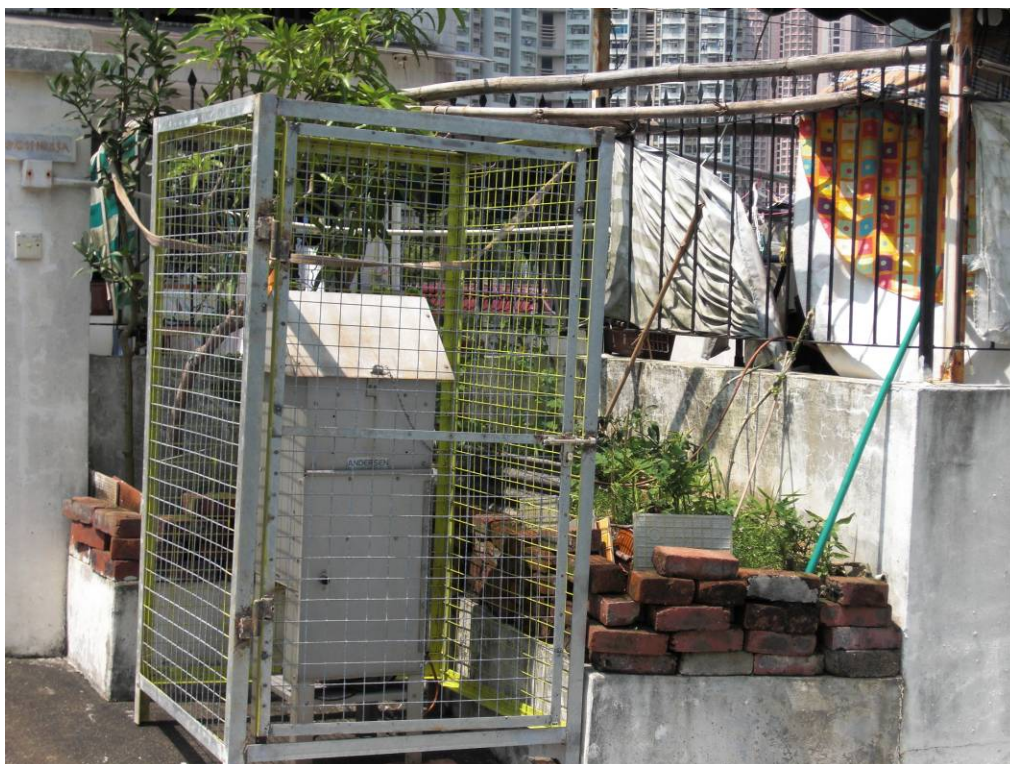
Ground floor within the front gate of 83 Wo Ka Lau Road

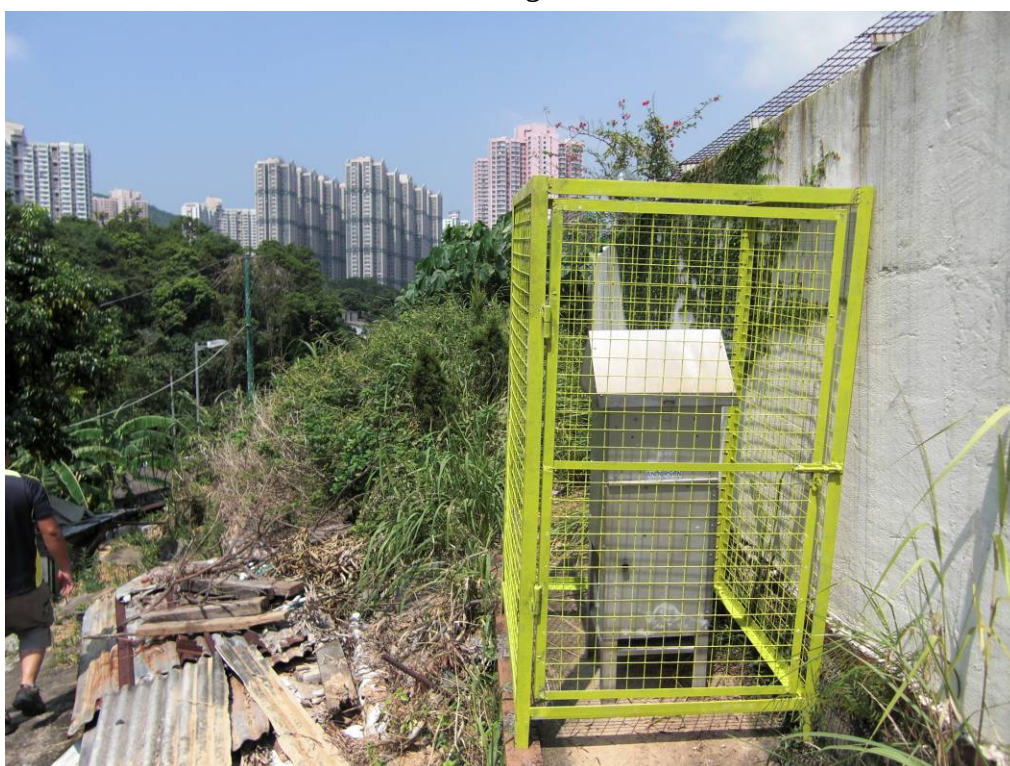
Ground floor boundary wall of house 51D of Wo Hop Shek San Tsuen

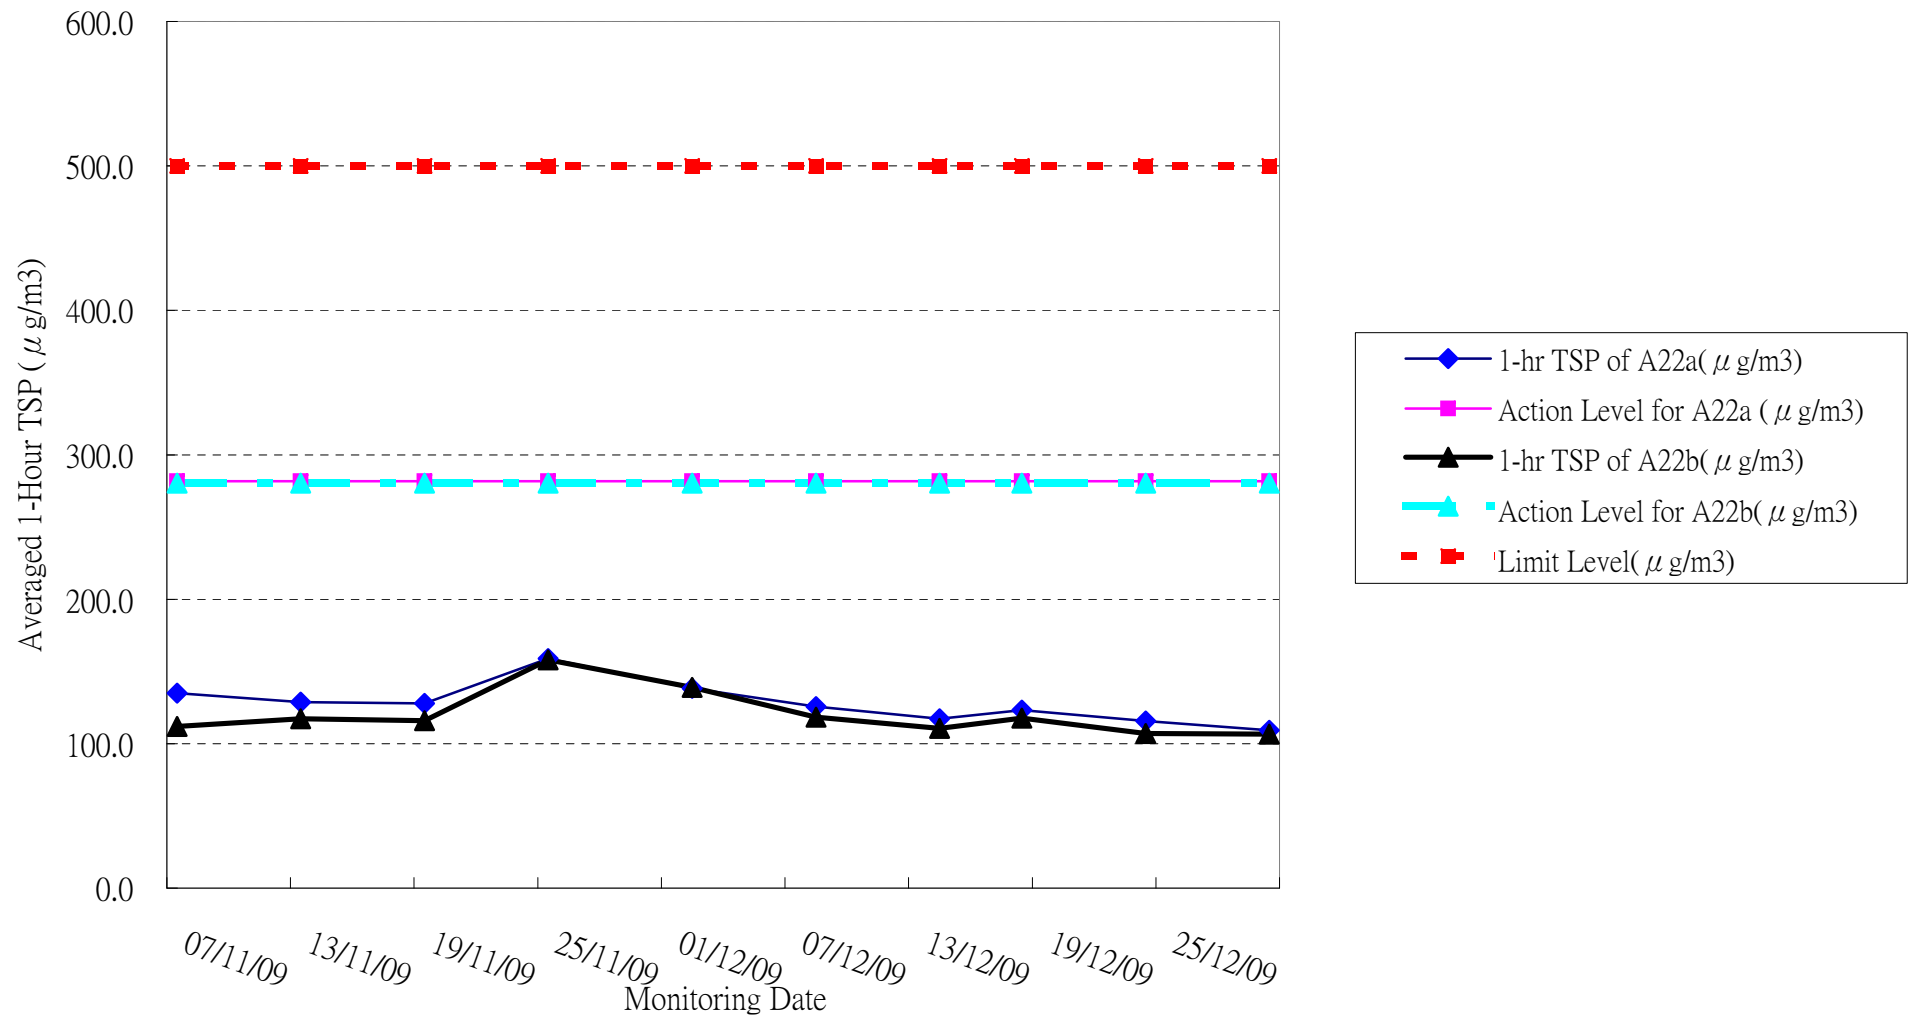
1-Hour TSP air quality monitoring data plot recorded at the designated monitoring points

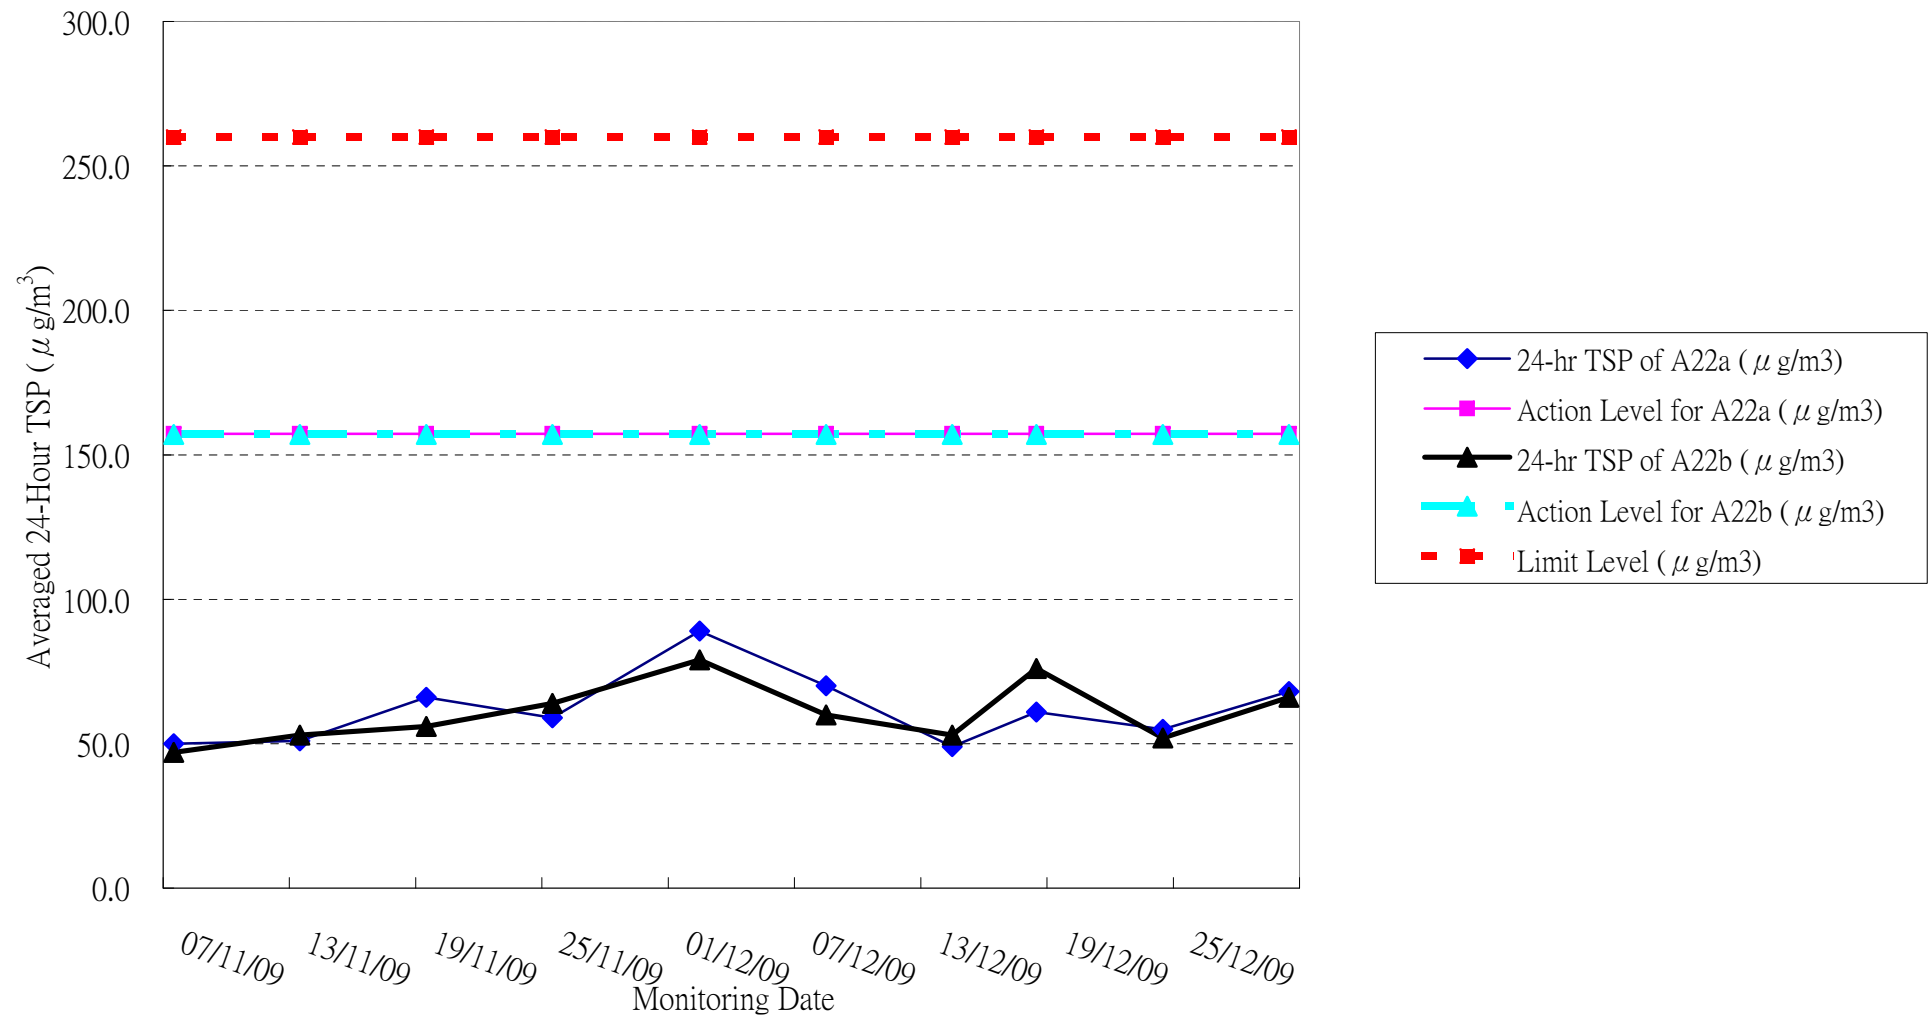
24-Hour TSP air quality monitoring data plot recorded at the designated monitoring points

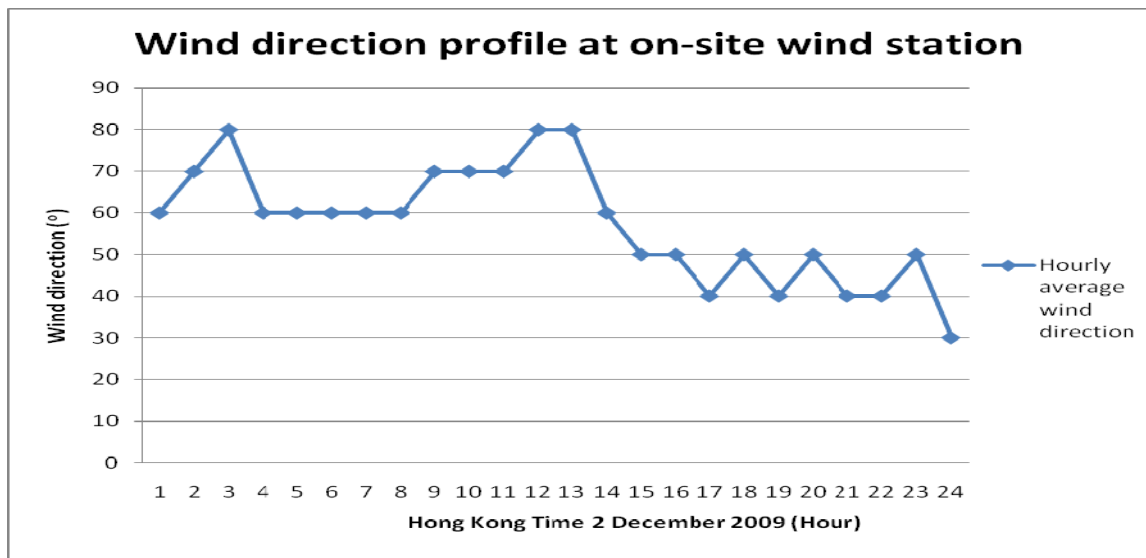
2/12/2009

## Wind Direction at On-site Wind Station

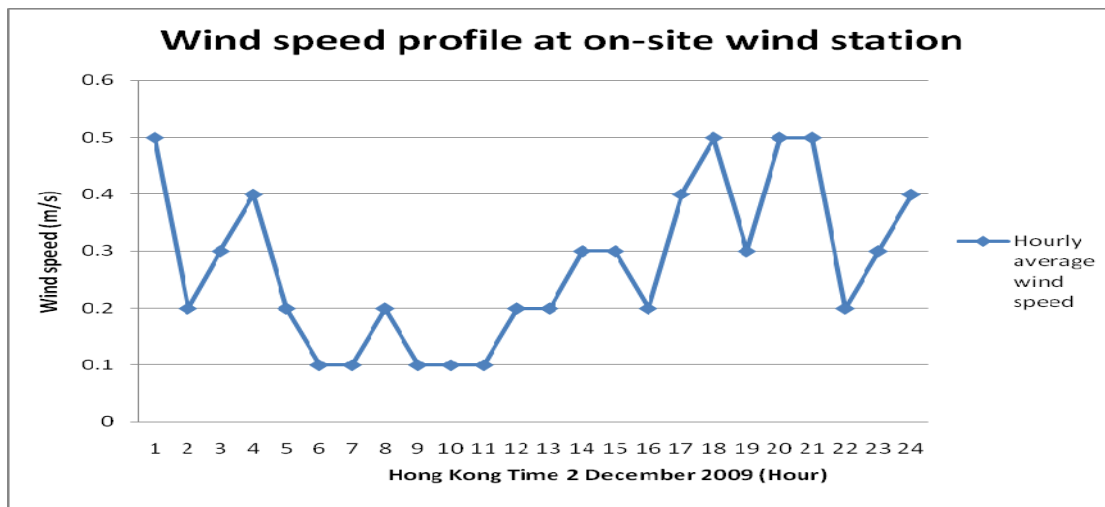
2/12/2009

## Wind Speed at On-site Wind Station

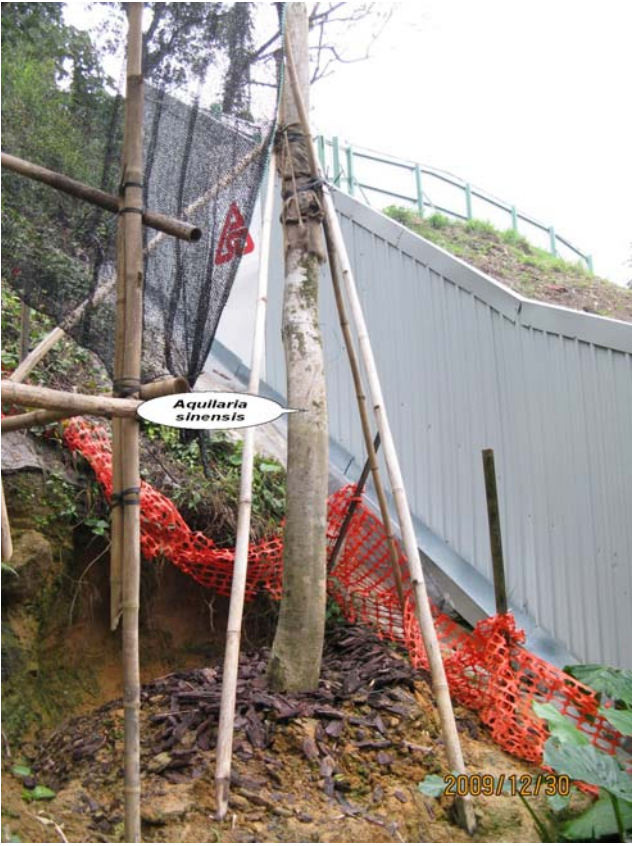
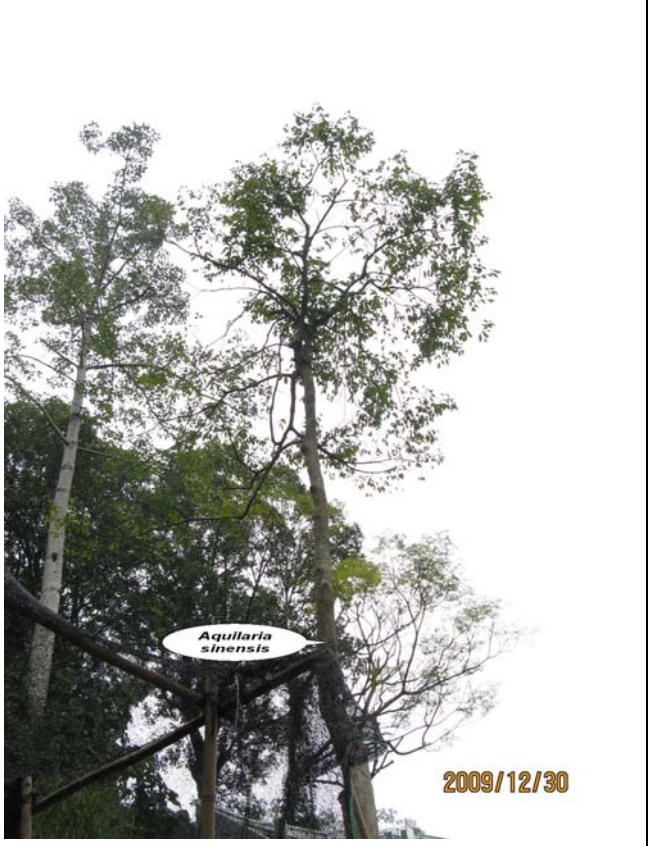
| Species | Height<br>(m) | Diameter<br>(m) | Spread<br>(m) | Remark | | | |
|---|---|---|---|---|---|---|---|
| <i>Aquilaria sinensis</i> | 8 | 0.2 | 4 | Fair condition | Fair condition | Fair condition | Fair condition |

| <p>A photograph showing the lower section of an <i>Aquilaria sinensis</i> tree. The tree trunk is supported by a bamboo frame. A black mesh net is draped over the frame, and orange safety netting is visible in the background. A white label with the text "Aquilaria sinensis" is attached to the frame. A date stamp "2009/12/30" is in the bottom right corner.</p> | <p>A photograph showing the upper section of an <i>Aquilaria sinensis</i> tree. The canopy is visible against a bright sky. A white label with the text "Aquilaria sinensis" is attached to the frame. A date stamp "2009/12/30" is in the bottom right corner.</p> |

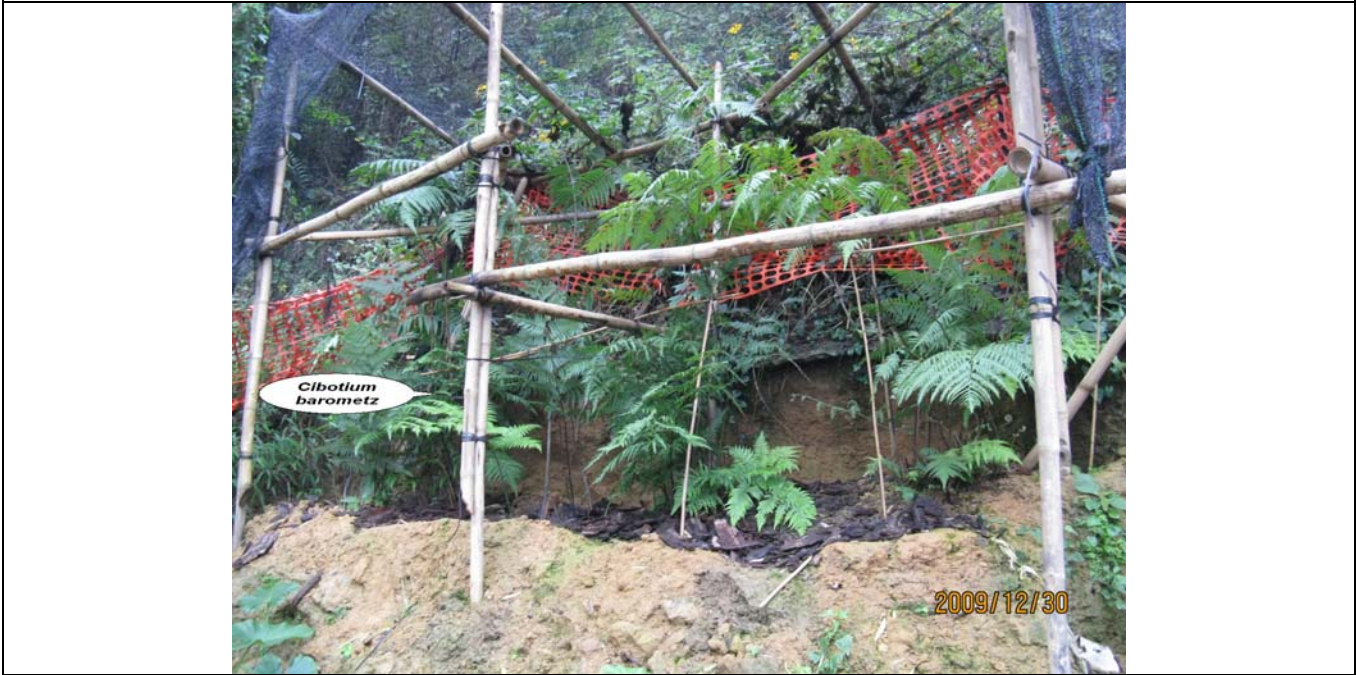
| Species | Height<br>(m) | Diameter<br>(m) | Spread<br>(m) | Remark | | | |
|---|---|---|---|---|---|---|---|
| <i>Cibotium barometz</i> | 1 | -- | -- | Fair condition | Fair condition, New<br>foliation was recorded | Fair condition, New<br>foliation was recorded | Fair condition |

| <p>A photograph showing a dense cluster of <i>Cibotium barometz</i> ferns. The ferns are supported by a bamboo frame. A white label with the text "Cibotium barometz" is attached to the frame. A date stamp "2009/12/30" is in the bottom right corner.</p> | |

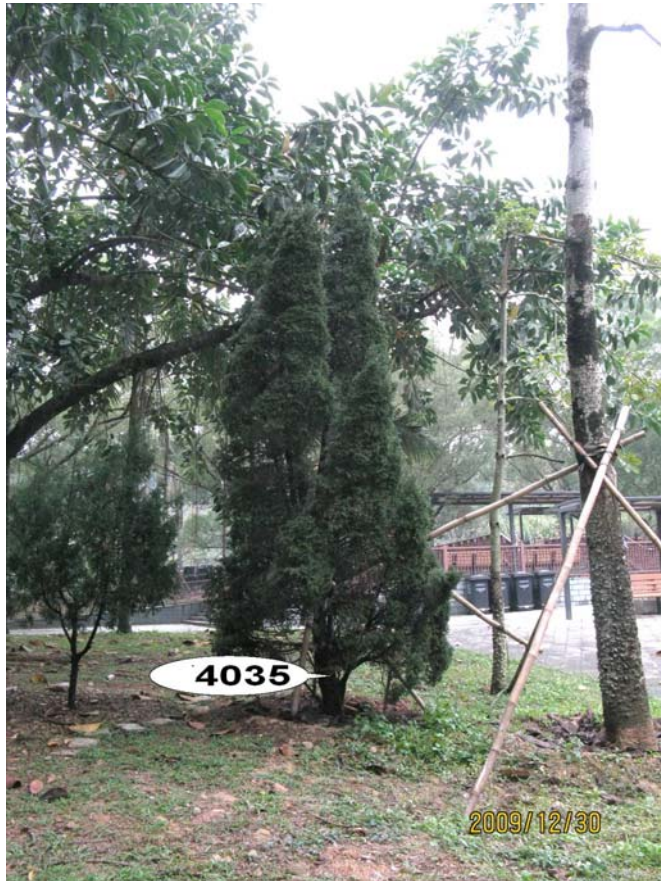
Tree No: 4035

| Tree Number | Species | Chinese name | Height (m) | Diameter (m) | Spread (m) | Remark | | | |
|---|---|---|---|---|---|---|---|---|---|
| 4035 | <i>Juniperus chinensis var.kaizuca</i> | 龍柏 | 4 | 0.16 | 2 | Fair condition | Fair condition | Fair condition | Fair condition |

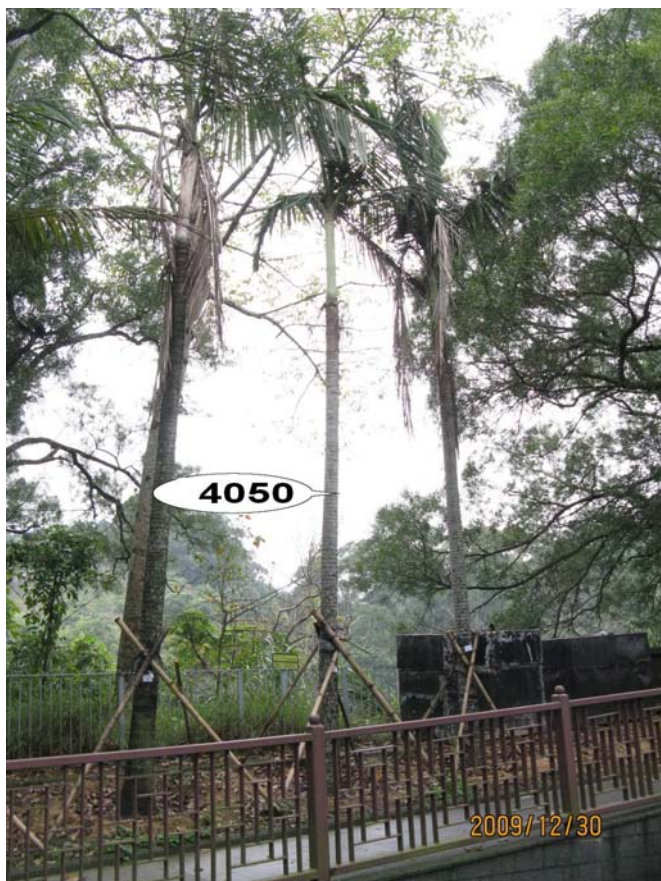
Tree No: 4050

| Tree Number | Species | Chinese name | Height (m) | Diameter (m) | Spread (m) | Remark | | | |
|---|---|---|---|---|---|---|---|---|---|
| 4050 | <i>Archontophoenix alexandrae</i> | 假檳榔 | 5 | 0.16 | 4 | Fair condition, Yellow leave | Fair condition, Yellow leave | Fair condition, Yellow leave | Fair condition, Yellow leave |

- 5.1 As the transplanted trees were not recovered from root systems injury caused during transplantation operation, and the new roots are not regenerated yet. The trees are still under environmental stress at the reception sites. It is important to watering regularly, at least twice a week, during the current dry season. Close monitoring of the trees needs to be continued and relevant mitigation measures will be proposed when necessary.
- 5.2 Organic soil or composite organic enriched soil should be applied to each transplanted tree, approx. 20kg to 40kg per tree is recommended. On top of organic soil should covered with tree barks and 5kg to 20kg tree bark is recommended according to tree size.

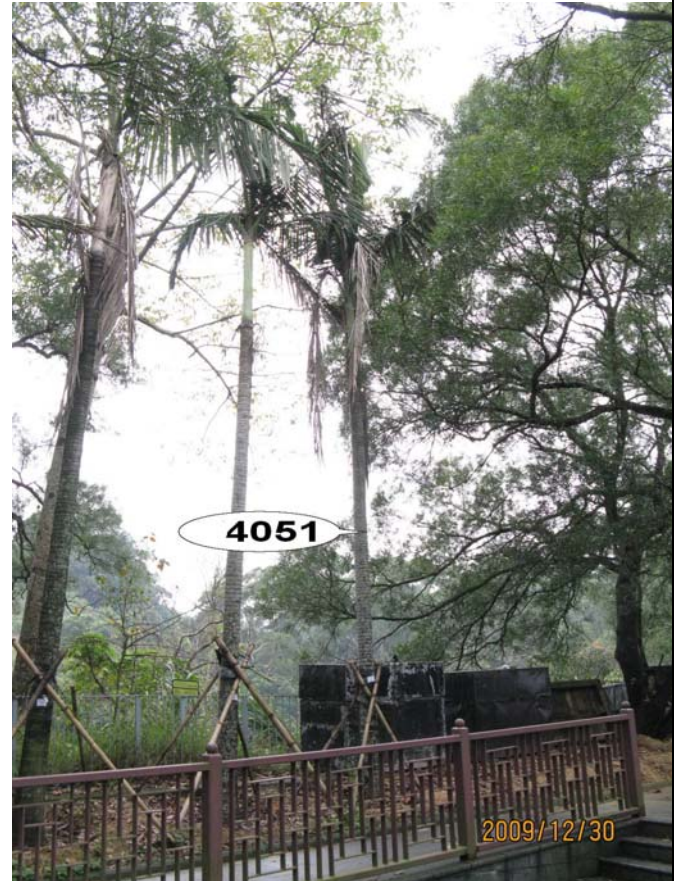
Tree No: 4051

| Tree Number | Species | Chinese name | Height (m) | Diameter (m) | Spread (m) | Remark | | | |
|---|---|---|---|---|---|---|---|---|---|
| 4051 | <i>Archontophoenix alexandrae</i> | 假檳榔 | 5 | 0.18 | 3 | Fair condition, Yellow leave | Fair condition, Yellow leave | Fair condition, Yellow leave | Fair condition, Yellow leave |

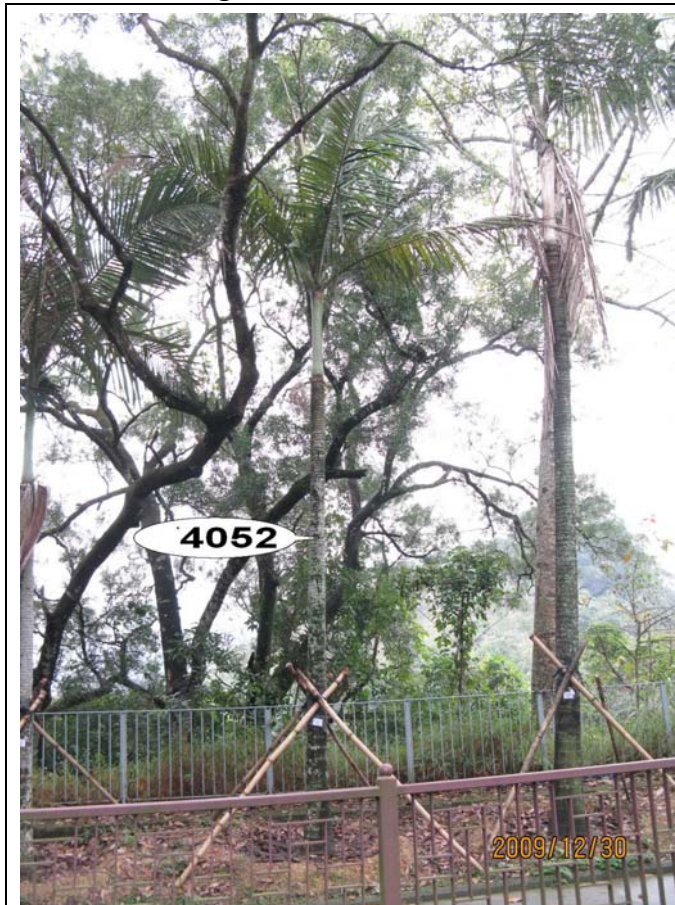
Tree No: 4052

| Tree Number | Species | Chinese name | Height (m) | Diameter (m) | Spread (m) | Remark | | | |
|---|---|---|---|---|---|---|---|---|---|
| 4052 | <i>Archontophoenix alexandrae</i> | 假檳榔 | 5 | 0.17 | 3 | Fair condition, Yellow leave | Fair condition, Yellow leave | Fair condition, Yellow leave | Fair condition, Yellow leave |

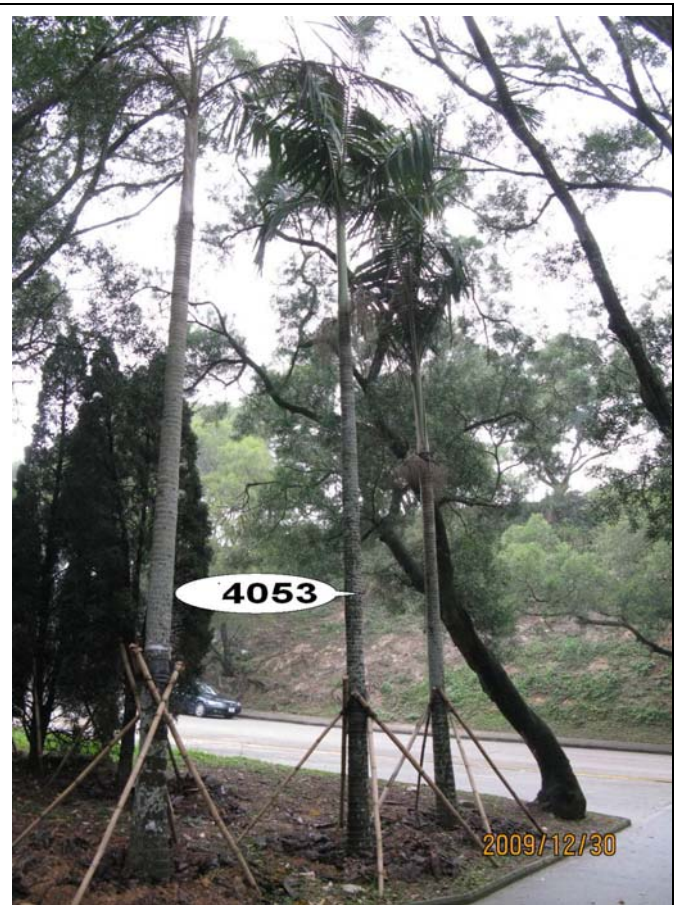
Tree No: 4053

| Tree Number | Species | Chinese name | Height (m) | Diameter (m) | Spread (m) | Remark | | | |
|---|---|---|---|---|---|---|---|---|---|
| 4053 | <i>Archontophoenix alexandrae</i> | 假檳榔 | 4 | 0.2 | 3 | Fair condition, Yellow leave | Fair condition, Yellow leave | Fair condition, Yellow leave | Fair condition, Yellow leave |

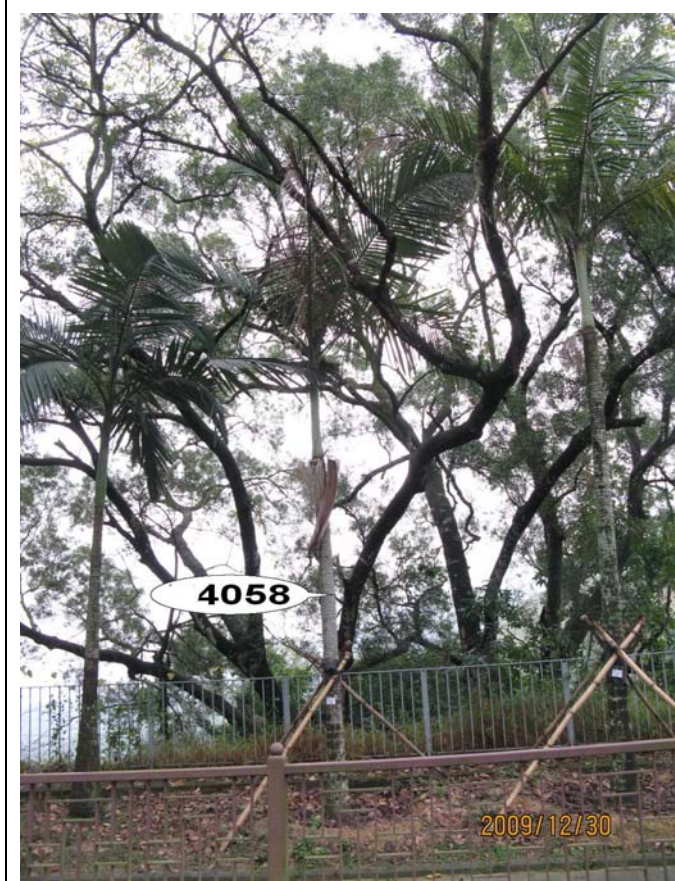
Tree No: 4058

| Tree Number | Species | Chinese name | Height (m) | Diameter (m) | Spread (m) | Remark | | | |
|---|---|---|---|---|---|---|---|---|---|
| 4058 | <i>Archontophoenix alexandrae</i> | 假檳榔 | 4 | 0.15 | 3 | Fair condition, Yellow leave | Fair condition, Yellow leave | Fair condition, Yellow leave | Fair condition, Yellow leave |

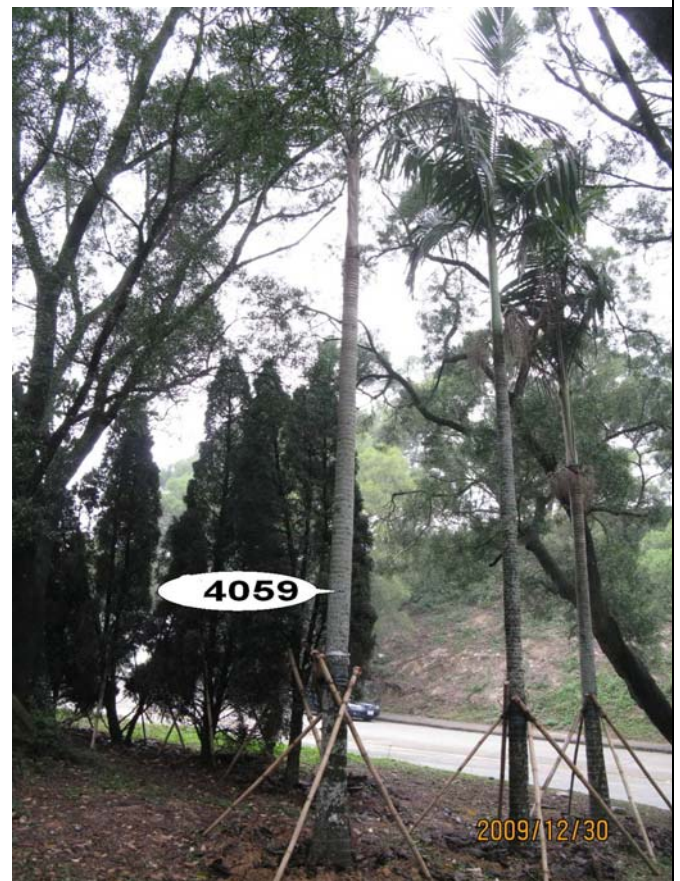
Tree No: 4059

| Tree Number | Species | Chinese name | Height (m) | Diameter (m) | Spread (m) | Remark | | | |
|---|---|---|---|---|---|---|---|---|---|
| 4059 | <i>Archontophoenix alexandrae</i> | 假檳榔 | 6 | 0.23 | 4 | Fair condition, Yellow leave | Fair condition, Yellow leave | Fair condition, Yellow leave | Fair condition, Yellow leave |

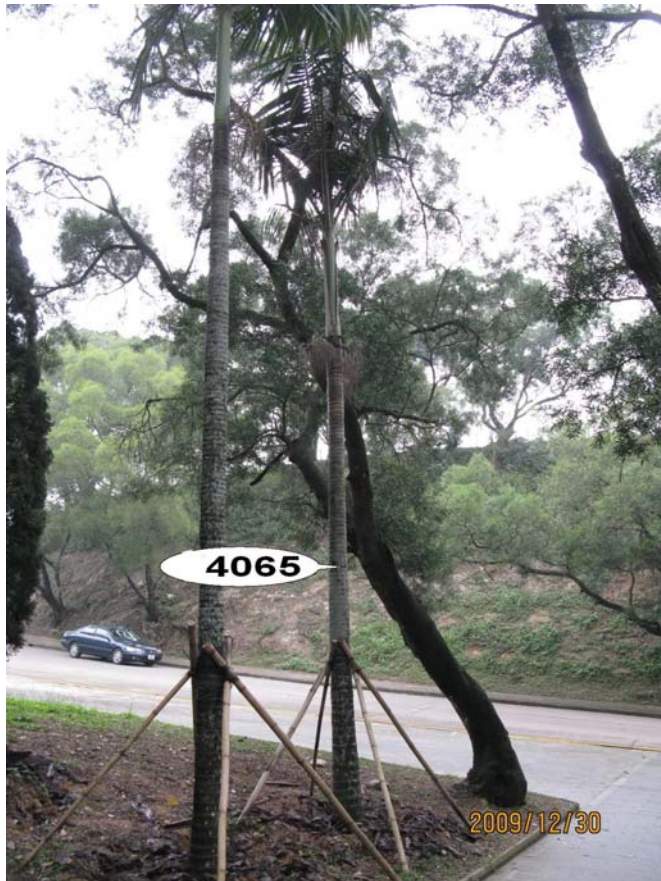
Tree No: 4065

| Tree Number | Species | Chinese name | Height (m) | Diameter (m) | Spread (m) | Remark | | | |
|---|---|---|---|---|---|---|---|---|---|
| 4065 | <i>Archontophoenix alexandrae</i> | 假檳榔 | 7 | 0.21 | 4 | Fair condition, Yellow leave | Fair condition, Yellow leave | Fair condition, Yellow leave | Fair condition, Yellow leave |

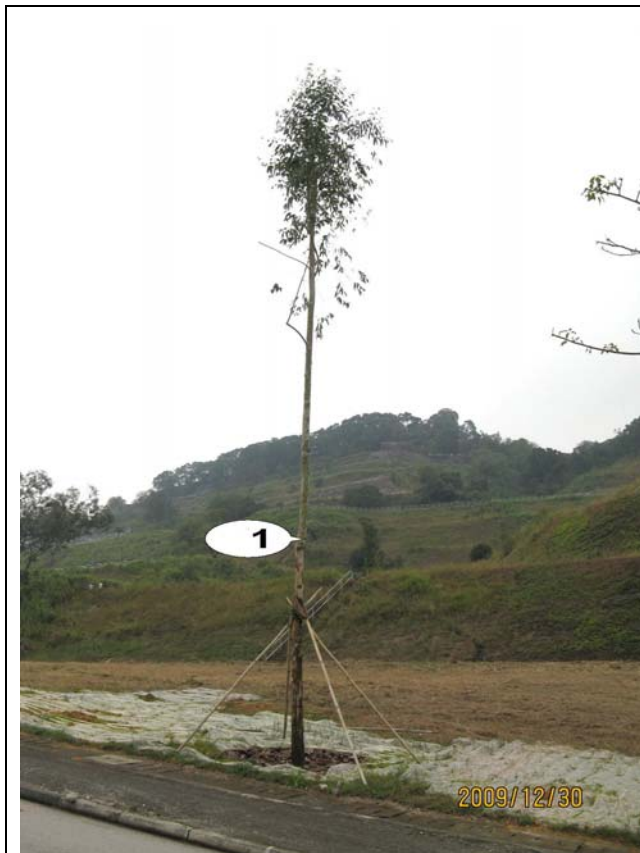
Tree No: 1

| Tree Number | Species | Chinese name | Height (m) | Diameter (m) | Spread (m) | Remark | | | |
|---|---|---|---|---|---|---|---|---|---|
| 1 | <i>Eucalyptus citriodora</i> | 檸檬桉 | 6 | 0.2 | 1.5 | Not found on site | Fair condition | Fair condition | Fair condition |

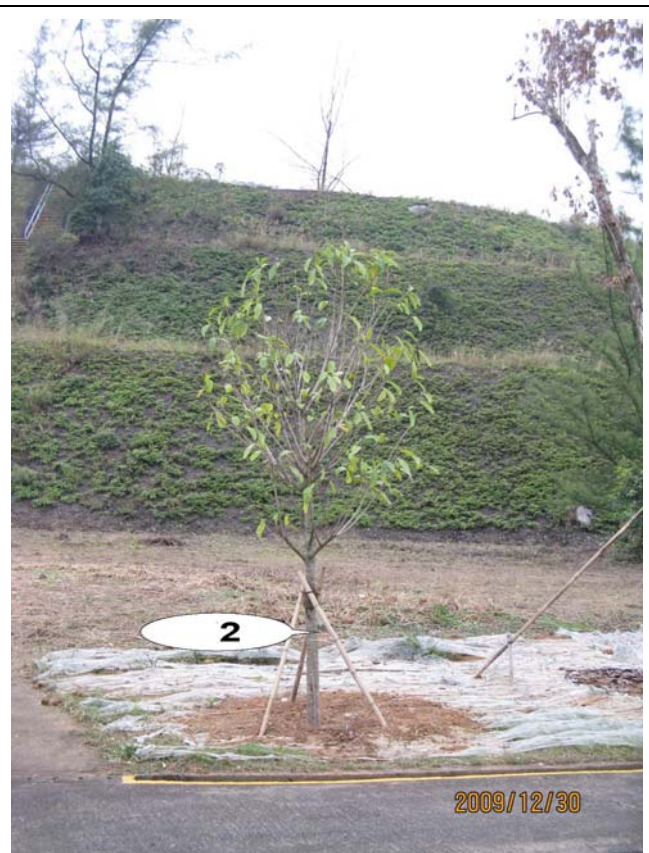
Tree No: 2

| Tree Number | Species | Chinese name | Height (m) | Diameter (m) | Spread (m) | Remark | | | |
|---|---|---|---|---|---|---|---|---|---|
| 2 | <i>Ficus hispida</i> | 對葉榕 | 2 | 0.1 | 1.5 | Not found on site | Not found on site | Not found on site | Fair condition |

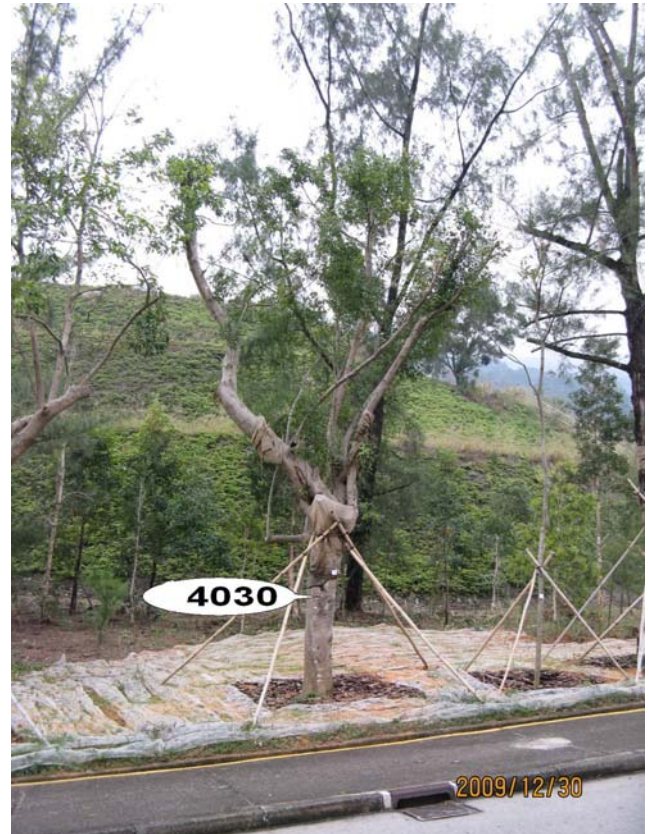
Tree No: 4030

| Tree Number | Species | Chinese name | Height (m) | Diameter (m) | Spread (m) | Remark | | | |
|---|---|---|---|---|---|---|---|---|---|
| 4030 | <i>Cinnamomum burmannii</i> | 陰香 | 5.5 | 0.16 | 4 | Poor condition, Fork, Pruned | Poor condition, Fork, Pruned | Poor condition, Fork, Pruned, Decay | Poor condition, Fork, Pruned, Decay |

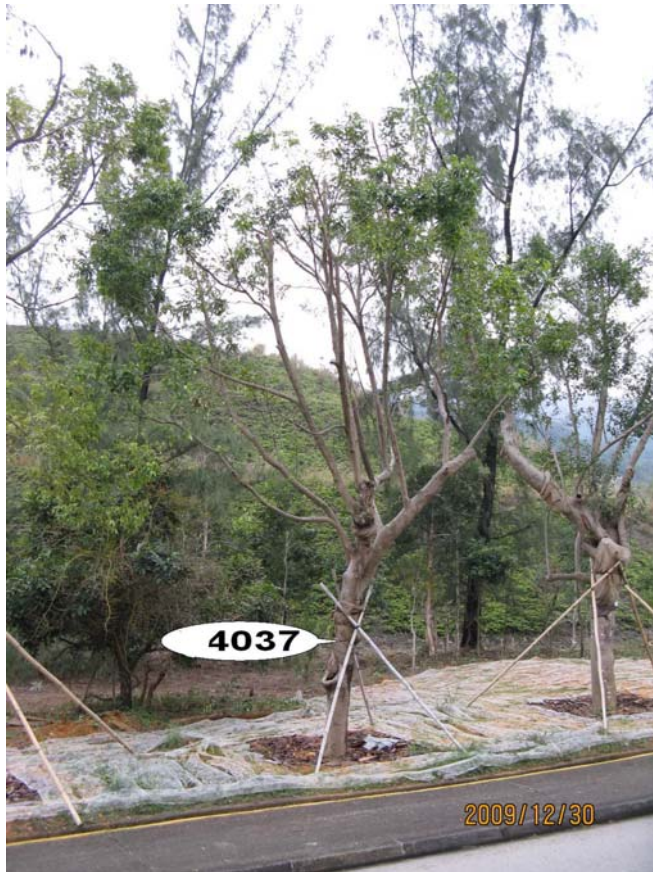
Tree No: 4037

| Tree Number | Species | Chinese name | Height (m) | Diameter (m) | Spread (m) | Remark | | | |
|---|---|---|---|---|---|---|---|---|---|
| 4037 | <i>Cinnamomum burmannii</i> | 陰香 | 6 | 0.25 | 4 | Fair condition, Fork, Pruned | Fair condition, Fork, Pruned | Fair condition, Fork, Pruned | Fair condition, Fork, Pruned, Cavity |

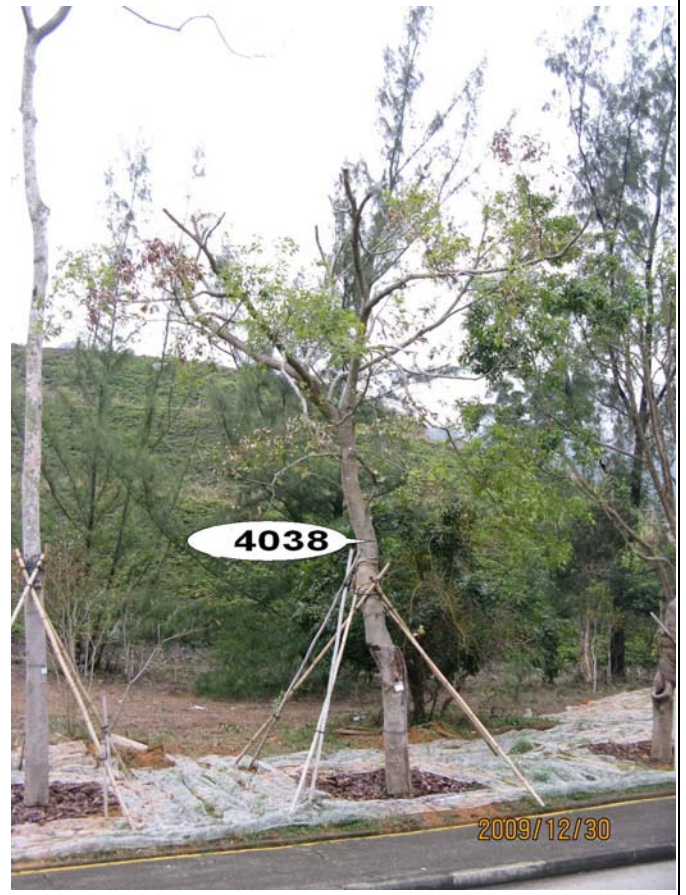
Tree No: 4038

| Tree Number | Species | Chinese name | Height (m) | Diameter (m) | Spread (m) | Remark | | | |
|---|---|---|---|---|---|---|---|---|---|
| 4038 | <i>Cinnamomum burmannii</i> | 陰香 | 6 | 0.25 | 4 | Poor condition, Bark damage | Poor condition, Bark damage, leave generating | Poor condition, Bark damage, leave generating | Poor condition, Bark damage, leave generating, Heavy sparse crown |

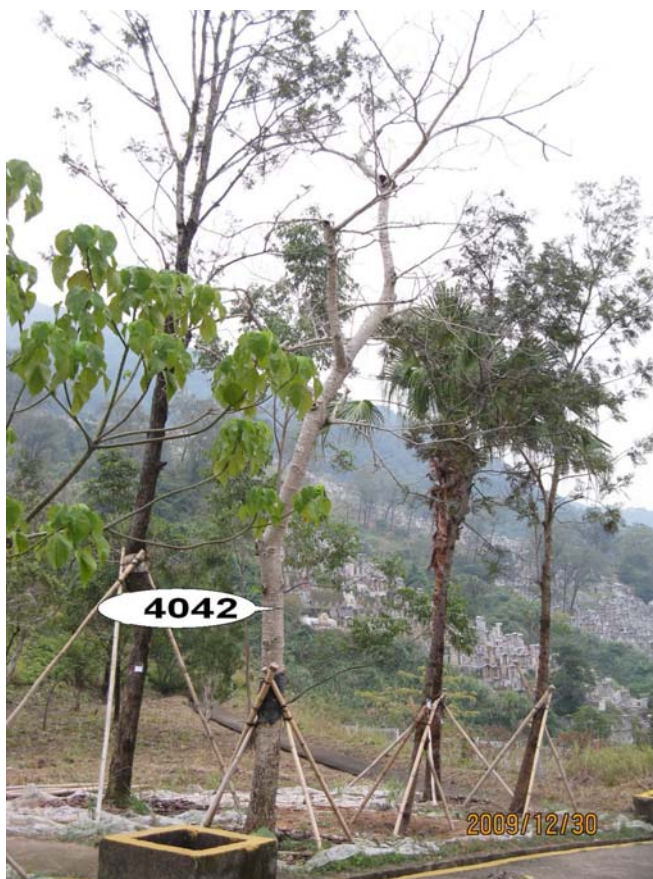
Tree No: 4042

| Tree Number | Species | Chinese name | Height (m) | Diameter (m) | Spread (m) | Remark | | | |
|---|---|---|---|---|---|---|---|---|---|
| 4042 | <i>Albizia lebbek</i> | 大葉合歡 | 8 | 0.16 | 4 | Poor condition, No leave | Poor condition, No leave | Poor condition, No leave | Poor condition, No leave |

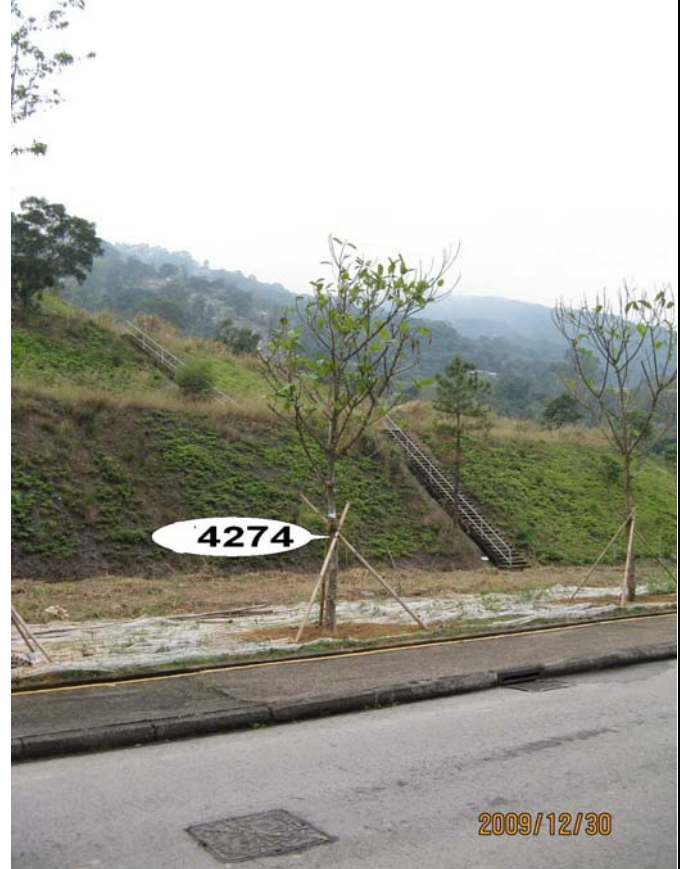
Tree No: 4274

| Tree Number | Species | Chinese name | Height (m) | Diameter (m) | Spread (m) | Remark | | | |
|---|---|---|---|---|---|---|---|---|---|
| 4274 | <i>Ficus hispida</i> | 對葉榕 | 6 | 0.18 | 4 | Poor condition, Fork, Heavy sparse crown | Missing from monitoring site | Missing from monitoring site | Fair condition |

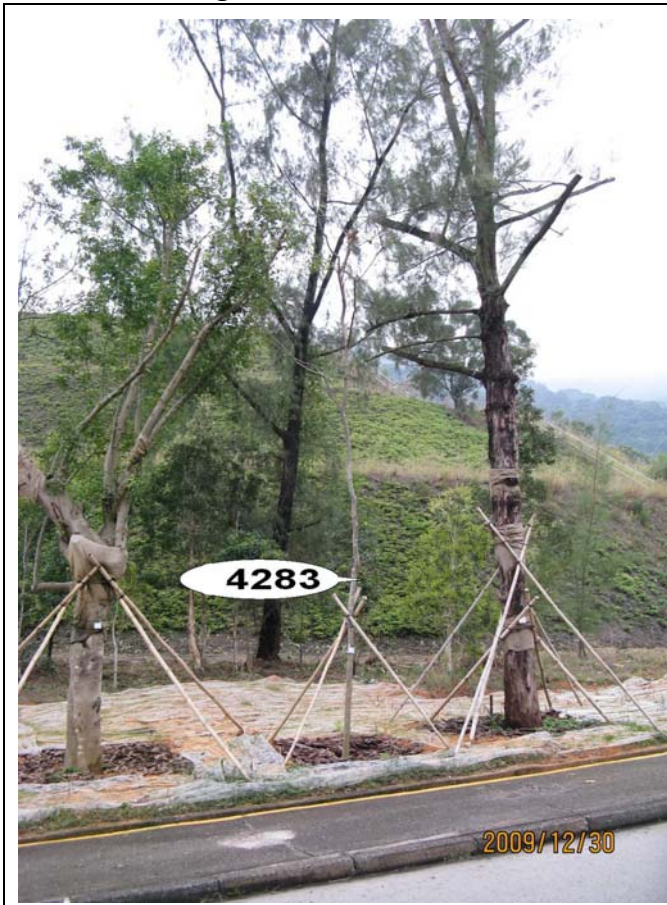
Tree No: 4283

| Tree Number | Species | Chinese name | Height (m) | Diameter (m) | Spread (m) | Remark | | | |
|---|---|---|---|---|---|---|---|---|---|
| 4283 | <i>Schefflera heptaphylla</i> | 鴨腳木 | 6 | 0.17 | 7 | Poor condition, No leave | Poor condition, Heavy sparse crown. | Poor condition, Heavy sparse crown. | Poor condition, Heavy sparse crown. |

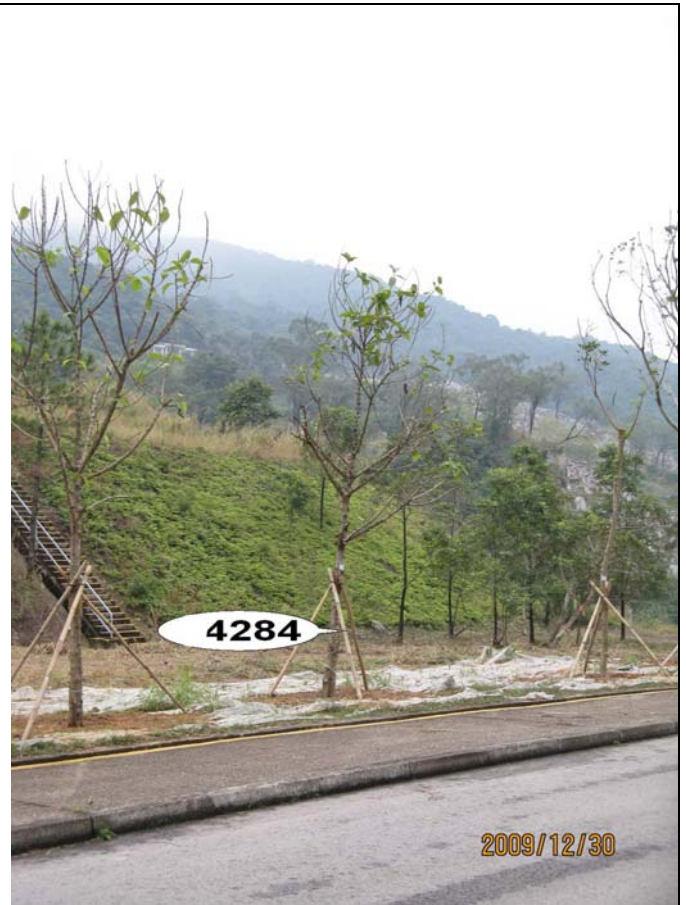
Tree No: 4284

| Tree Number | Species | Chinese name | Height (m) | Diameter (m) | Spread (m) | Remark | | | |
|---|---|---|---|---|---|---|---|---|---|
| 4284 | <i>Ficus hispida</i> | 對葉榕 | 10 | 0.23 | 5 | Poor condition, Fork, Heavy sparse crown | Missing from monitoring site | Missing from monitoring site | Poor condition, Sparse crown |
