**PROVISION OF CREMATORS AT  
WO HOP SHEK CREMATORIUM**

**ENVIRONMENTAL MONITORING &  
AUDIT REPORT (DECEMBER 2009)**

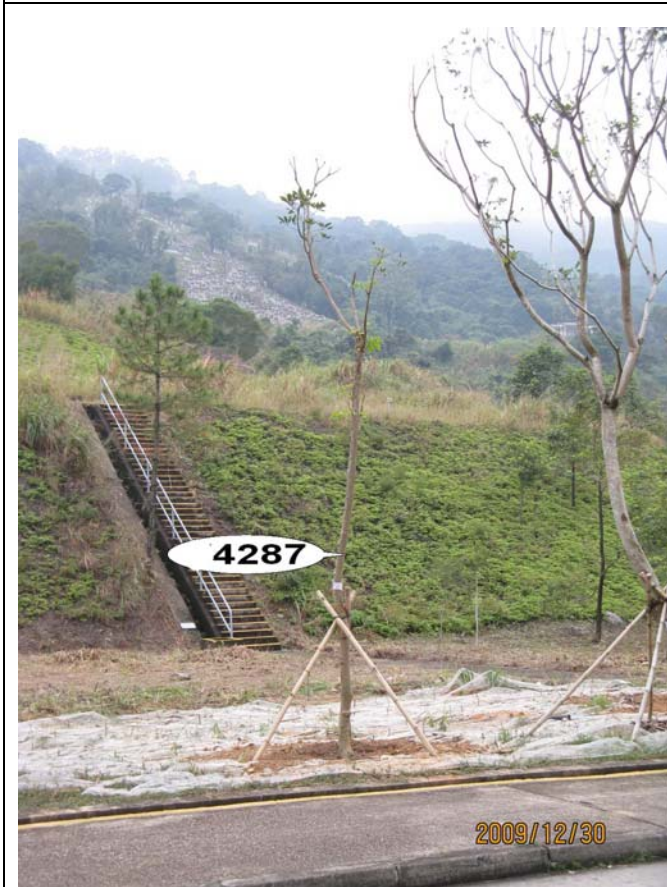
Tree No: 4287

| Tree Number | Species | Chinese name | Height (m) | Diameter (m) | Spread (m) | Remark | | | |
|---|---|---|---|---|---|---|---|---|---|
| 4287 | <i>Schefflera heptaphylla</i> | 鴨腳木 | 8 | 0.15 | 4 | Poor condition, No leave | Missing from monitoring site | Missing from monitoring site | Fair condition, Leave regeneration |

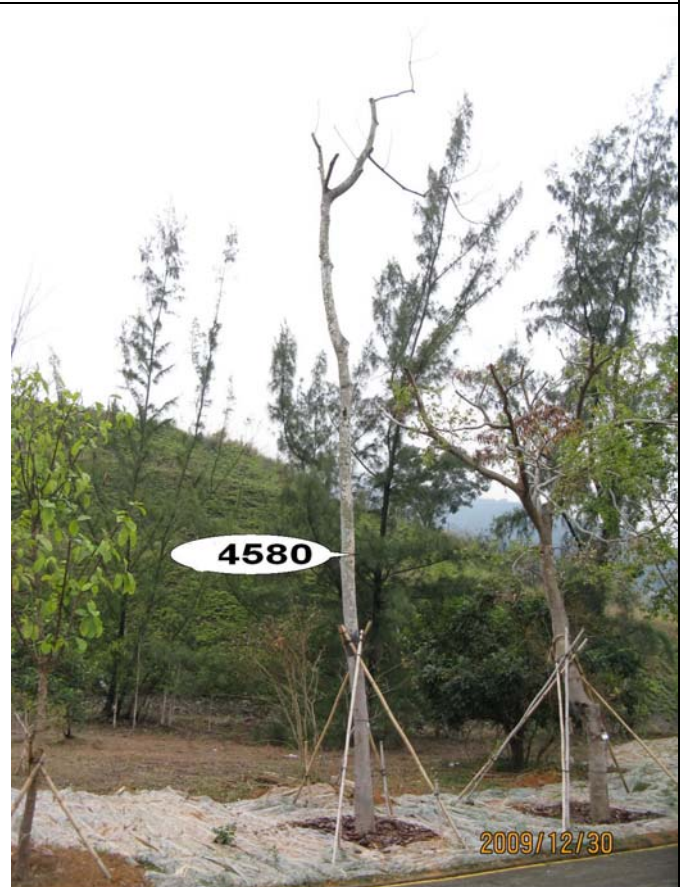
Tree No: 4580

| Tree Number | Species | Chinese name | Height (m) | Diameter (m) | Spread (m) | Remark | | | |
|---|---|---|---|---|---|---|---|---|---|
| 4580 | <i>Aleurites moluccana</i> | 石栗 | 8 | 0.22 | 1 | Poor condition, Pruned, Heavy sparse crown | Poor condition, Pruned, Heavy sparse crown | Poor condition, Pruned, Heavy sparse crown | Poor condition, Pruned, Heavy sparse crown |

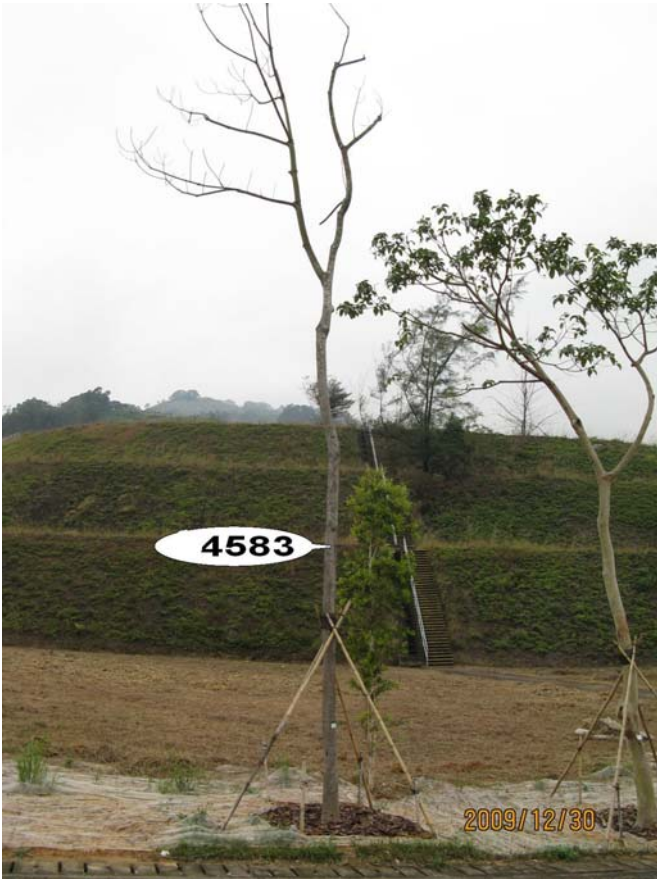
| Tree No: 4583 | |

| Tree Number | Species | Chinese name | Height (m) | Diameter (m) | Spread (m) | Remark | | | |
|---|---|---|---|---|---|---|---|---|---|
| 4583 | <i>Aleurites moluccana</i> | 石栗 | 8 | 0.28 | 3 | Poor condition, Heavy sparse crown | Poor condition, Heavy sparse crown | Poor condition, Heavy sparse crown | Poor condition, Heavy sparse crown |
