**EP-344/2009 – New Sewage Pumping Stations
Serving KTD
EP-337/2009 – New Distributor Roads Serving the
Planned KTD**

**Contract No. KL/2012/03
Kai Tak Development –Stage 4 Infrastructure at
Former North Apron Area**

Final EM&A Review Report

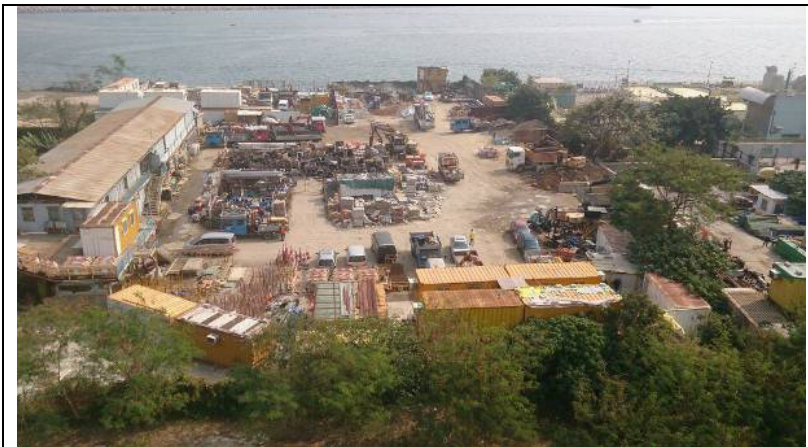
Photo 1

- During the noise monitoring conducted at 11:27 a.m., mobile excavators were found operating in the open ground outside of the work areas of this Project as shown in Photo 1.
- According to field staffs' observation, major noise source identified was the loading and unloading works from the mobile excavator as shown in Photo 2.
- As the major noise source was located outside the work areas of this Project, the exceedance recorded at Station M8 - Po Leung Kuk Ngan Po Ling College was considered to be non-Project related.

(Construction works conducting outside KTD Project Area.)

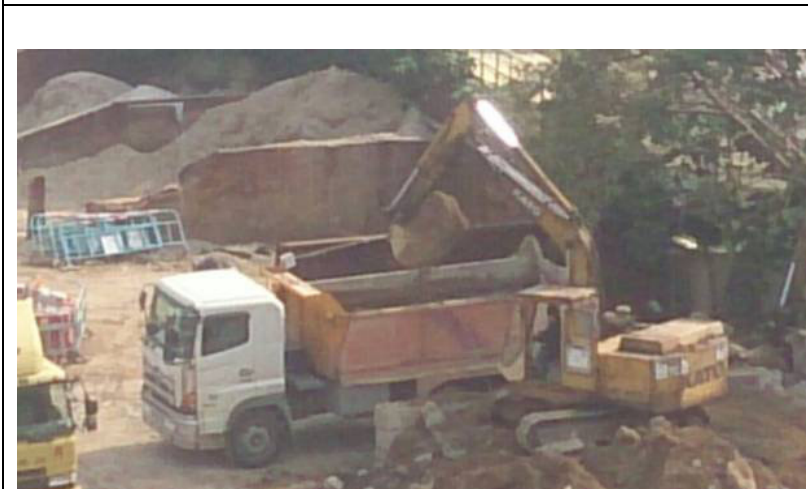
Photo 2

(Mobile excavators were found operating)

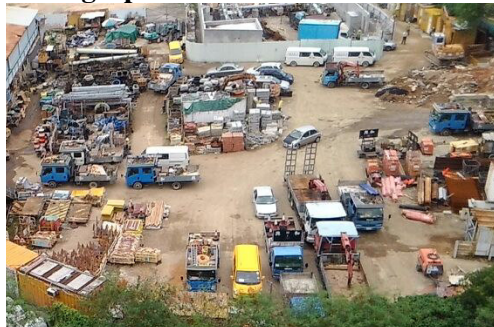
- During the noise monitoring conducted at 13:15, mobile cranes were found operating in the open ground outside Kai Tak Development Area.
- According to field staffs’ observation, the major noise source came from the loading and unloading works from the mobile crane. (Shown in Photo 2.)
- As the major noise source was located outside the project area of Kai Tak Development, the exceedance recorded at Station M8 - Po Leung Kuk Ngan Po Ling College was considered to be non-Project related.

(Photo 1: Construction works conducting outside KTD Project Area.)

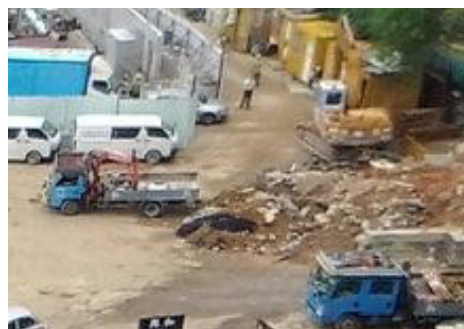
(Photo 2: Mobile excavators were found operating)
