Appendix 10.1

Agreement No. CE 35/2006 (CE)

Kai Tak Development Engineering Study cum Design and Construction of Advance Works – Investigation, Design and Construction

Contamination Assessment Plan (CAP)
For Hong Kong Aviation Club (Rev.2)

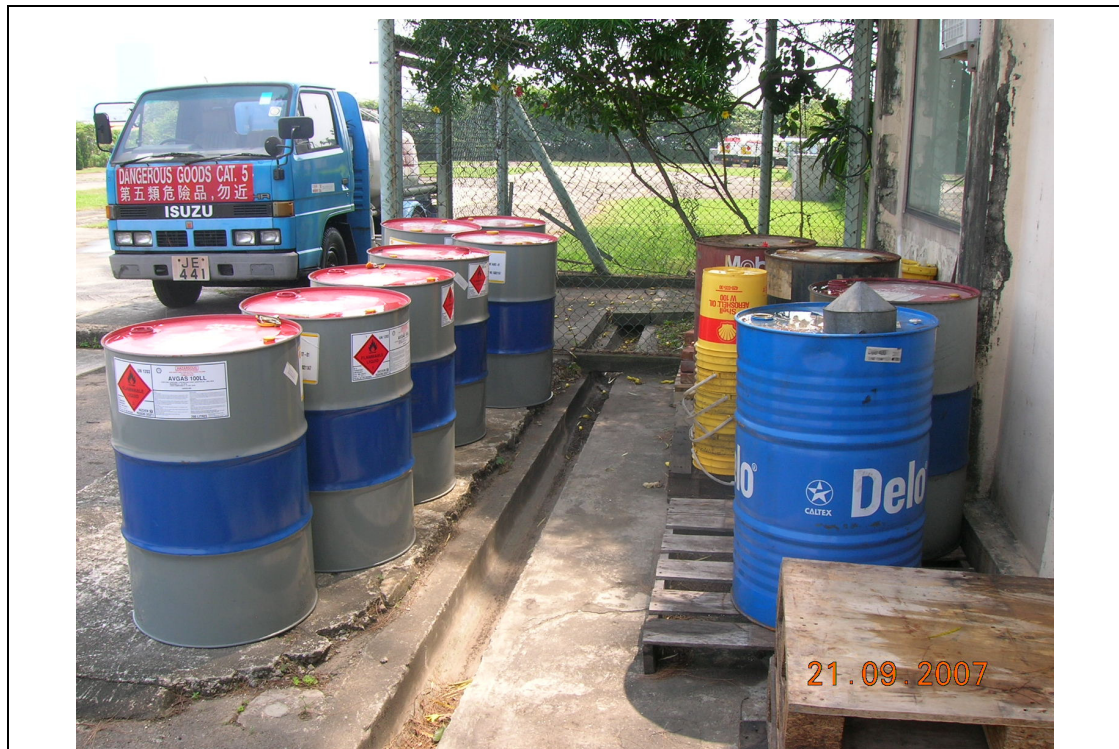
Photo 1:AVGAS and Diesel Engine Oil Storage Area Located at the HKAC Apron

- 3.5.11 Apron area was found on the northern portion of the HKAC site. According to the site representative, the apron area was used for plane/helicopters parking, landing and fuelling. During the site inspections, around 11 drums of 200L containers were observed near the gate of the hangar. As reported from the site representative, these containers were used for storing AVGAS and Diesel Engine Oil. Since all the drums were found to be well lidded and placed in a designated area, sitting on thick concrete slab or wooden blocks with no apparent stains, site investigation was not proposed in this area.

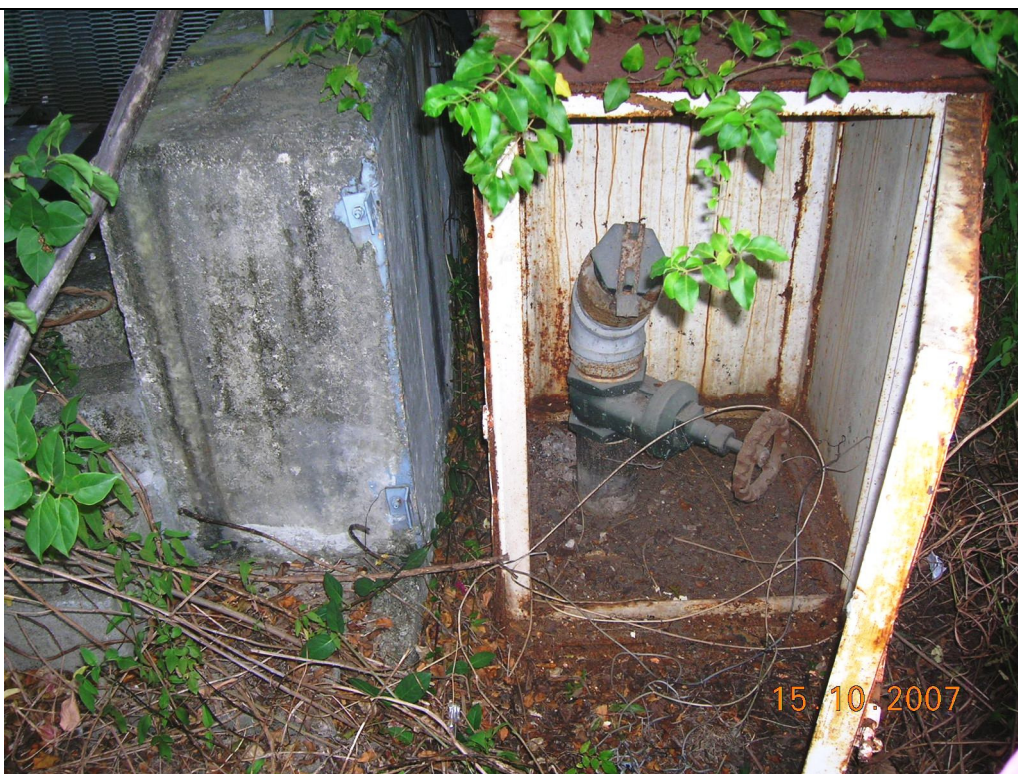
Photo 3: Filling Point

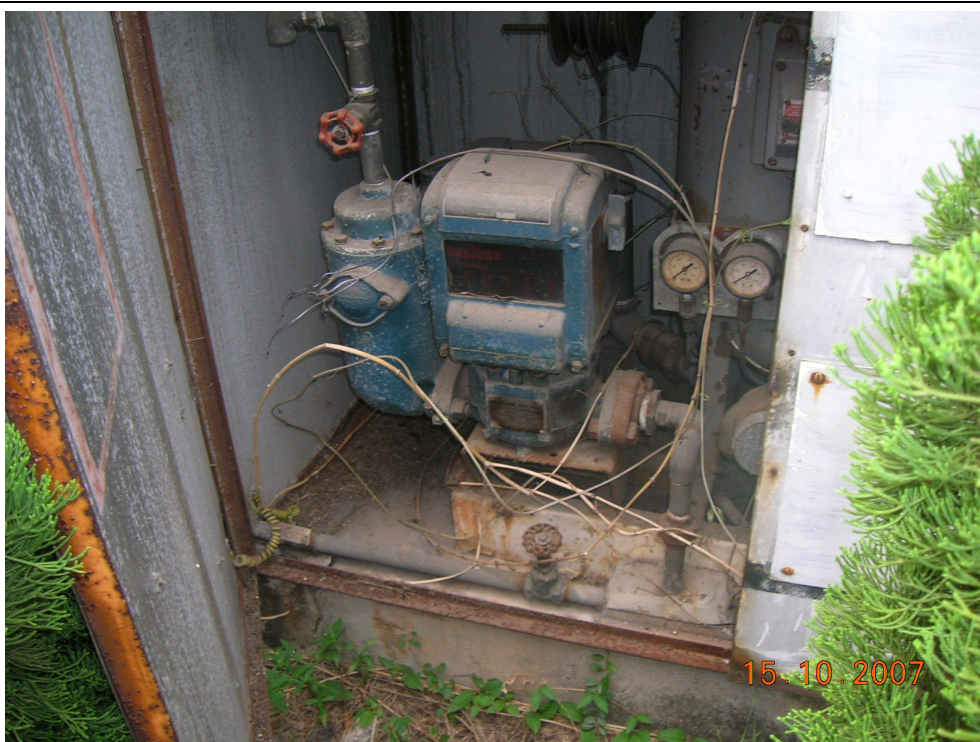
Photo 4: Flow Meter

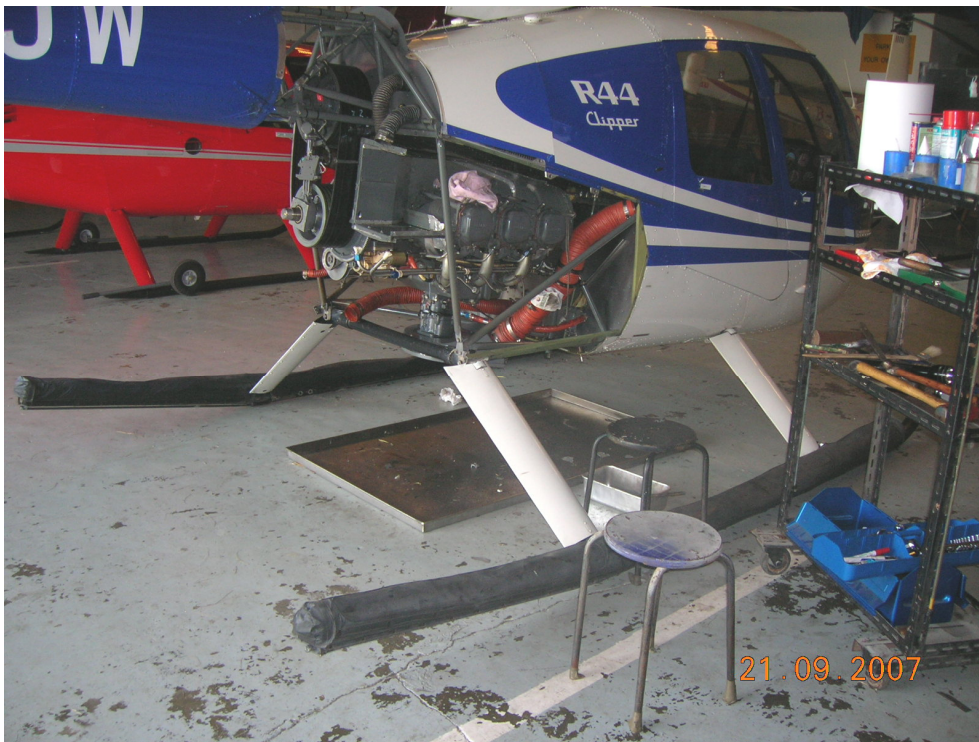
Photo 5:Drip Tray placed under Helicopter during Maintenance

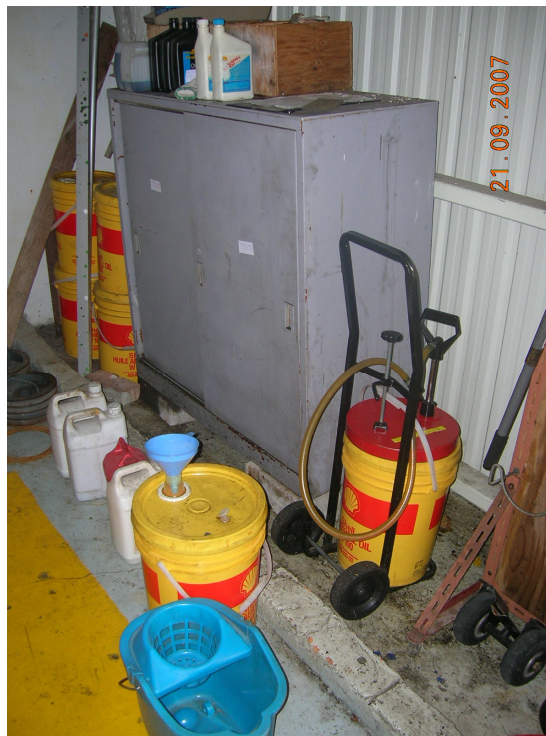
Photo 6: Chemical Storage Area Located inside Hangar

- 3.5.8 A chemical storage area was found near the gate of the hangar. As observed, several plastic containers were stored within this chemical storage area. As indicated by the site representative, aeroshell oil, bleach and lubricating oil were stored within these plastic containers. The site representative also revealed that these chemical wastes were generally collected by a licensed chemical waste collector. As observed, those plastic containers were well lidded but no secondary containment or drip tray was found underneath the containers. Based on the findings from the site inspections, it is possible that spillage of chemicals might occurred within the chemical storage area. As a result, this area is considered likely to have potential land contamination and 1 borehole is thus proposed.

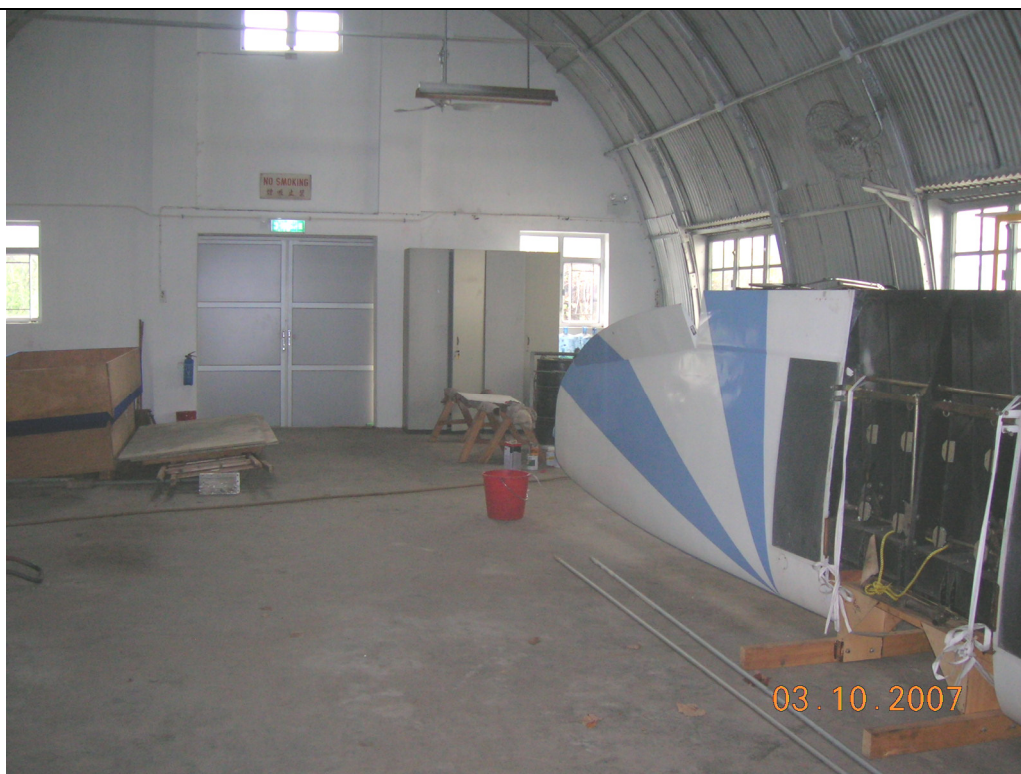
Photo 7: Modules of Plans/ Helicopter Stored inside Semi-cylindrical Workshop

- 3.5.6 The semi-cylindrical workshop was located on the south western portion of the HKAC site. According to the site personnel, the workshop had been used for storing modules of planes / helicopter and equipment for maintenance. During the site inspection, the workshop was found to be well paved with concrete and no apparent stains were observed. It was thus envisaged that the workshop area is unlikely to have potential land contamination issues. Hence, no site investigation was proposed in this area.

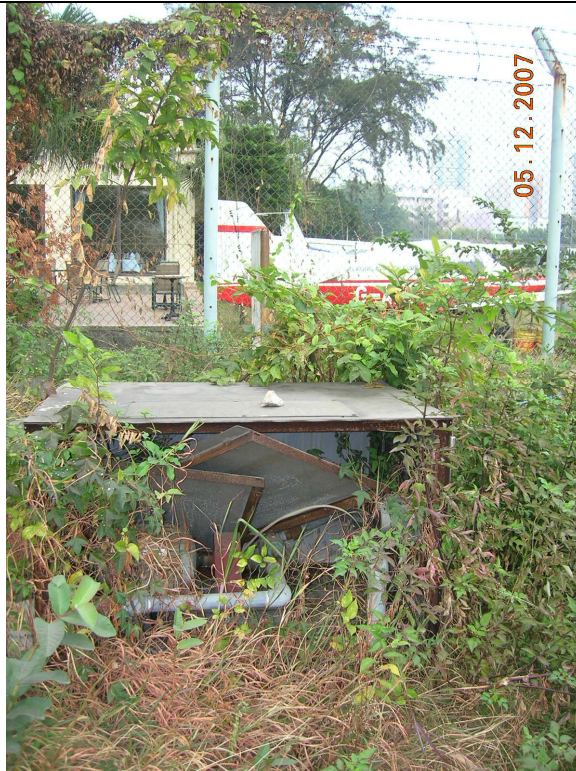
Photo 9: Pump Set

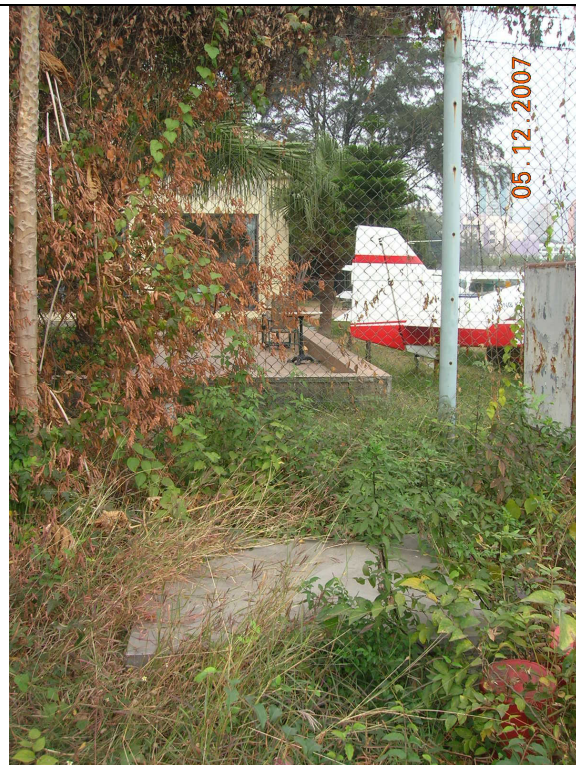
Photo 10: Underground Tank

- 3.5.14 Another site investigation was carried out on 5 December after the acquisition of the drawing from FSD, showing the details of the underground fuel tank and the associated fuel pipeline. During the site visit, the underground tank was found at the south-eastern part of the HKAC site with a pump set and a tank ventilation pipe located next to it. The pump set was found to be situated in a metallic cabinet. All these facilities were surrounded by grass and no apparent stains were noted during the inspection. As reported by the site personnel, the underground tank and the pumpset were abandoned. The location of the underground tank is depicted in **Drawing 3.2**.
