## **Kai Tak Development Engineering Study cum Design and Construction of Advance Works – Investigation, Design and Construction**

Revised Contamination Assessment Plan (CAP)  
For Ex-Government Flying Services Building (Rev.3)

**REVISED CONTAMINATION ASSESSMENT PLAN  
FOR EX-GOVERNMENT FLYING SERVICES BUILDING (REV. 3)**

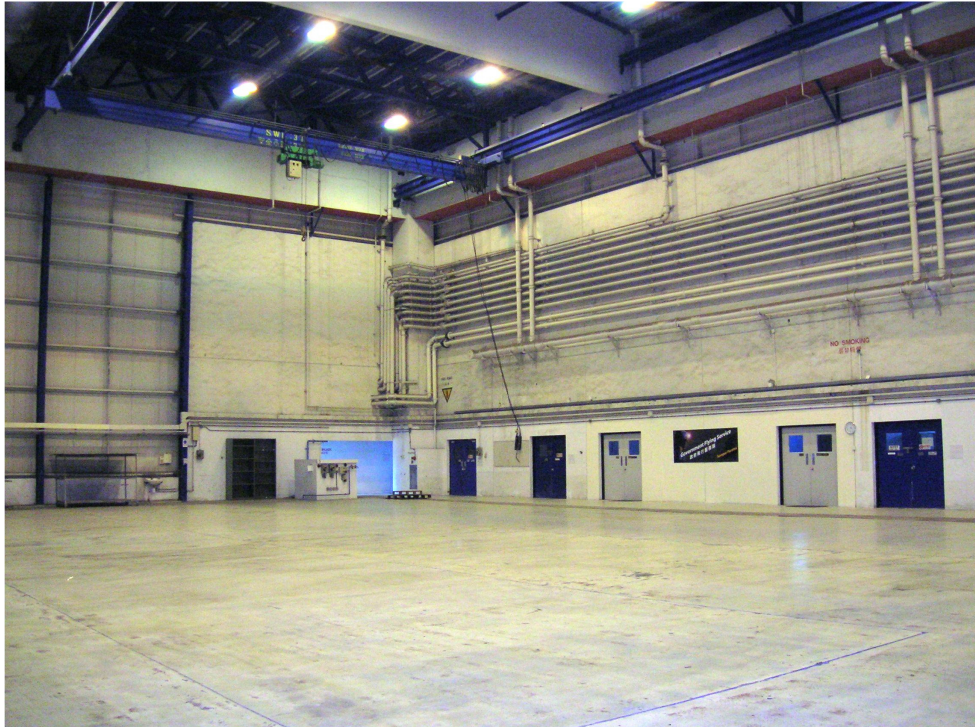
Photo 2: Hanger Area of the Ex-GFS Building Being Occupied by Government Flying Service (GFS)

- 3.5.8 For the hangar inside the ex-GFS building, as reported from the GFS representative, 1/3 of the hangar is currently occupied by GFS while the remaining 2/3 area of the hangar has been leased to Customs and Excise Department (C&ED). The hangar area occupied by GFS was reported to be used for aircraft parking and maintenance. 3 fire points have been observed within the hangar. As stated by the GFS representative, no fuel or chemical wastes have been stored in this hangar area. All the chemical wastes generated from the hangar (due to aircraft maintenance activities) would be collected and transferred to the D.G. store and disposed of through a registered chemical waste disposal agent. The ground of this hangar area was tidy and no apparent signs of contamination were found during the site inspection.

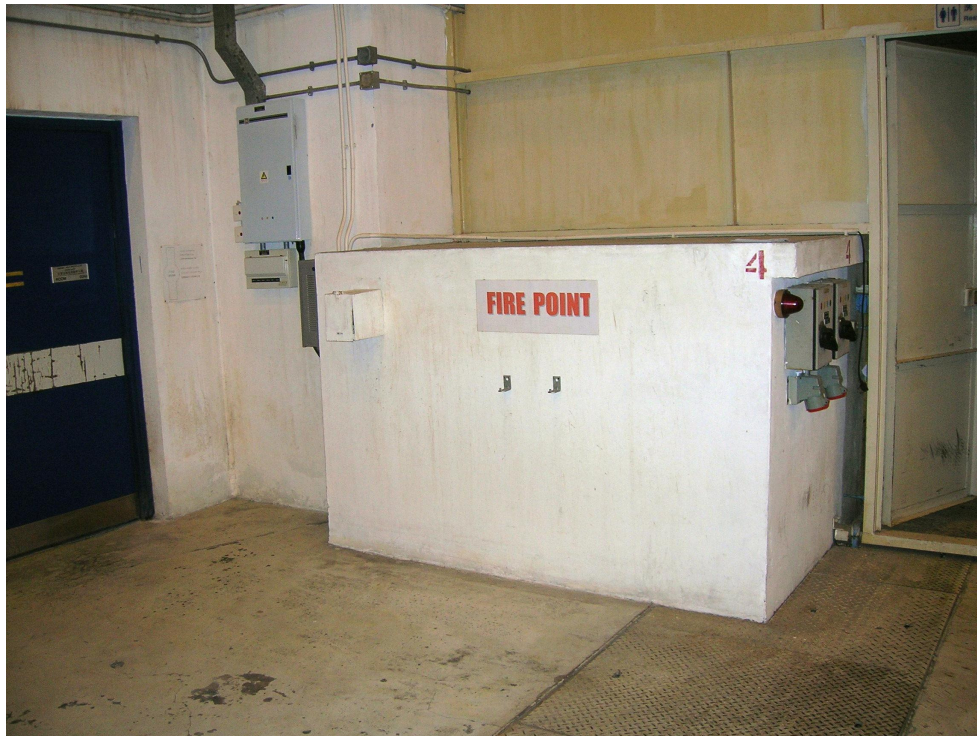
Photo 3: Fire Point Located at the Hanger Area of the Ex-GFS Building

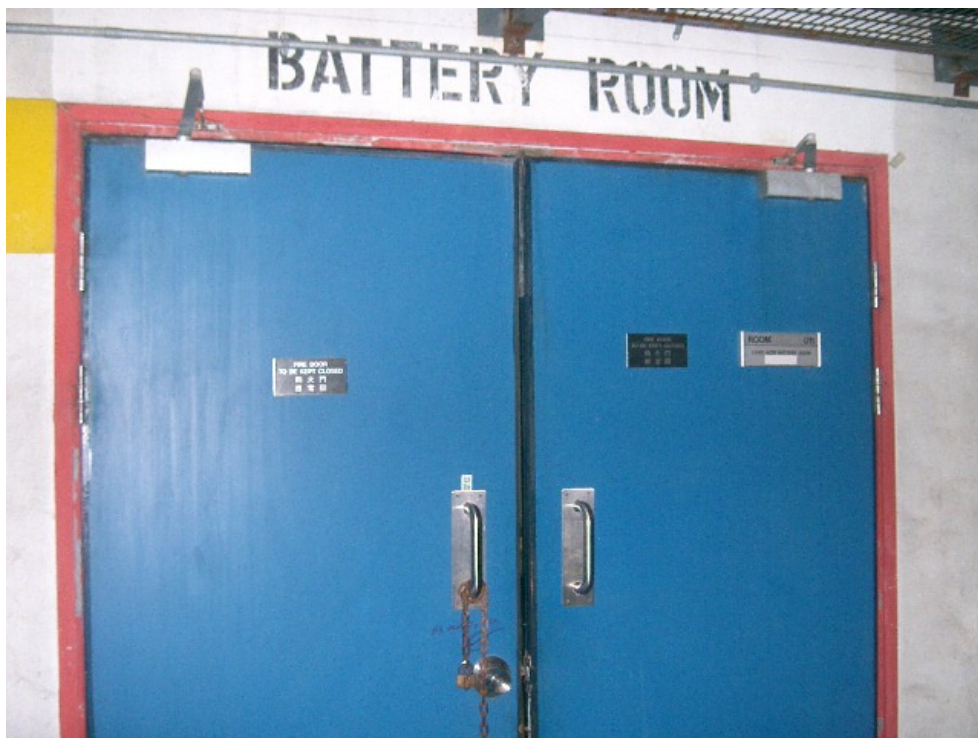
Photo 4: Lead Acid Battery Room Inside Ex-GFS Building

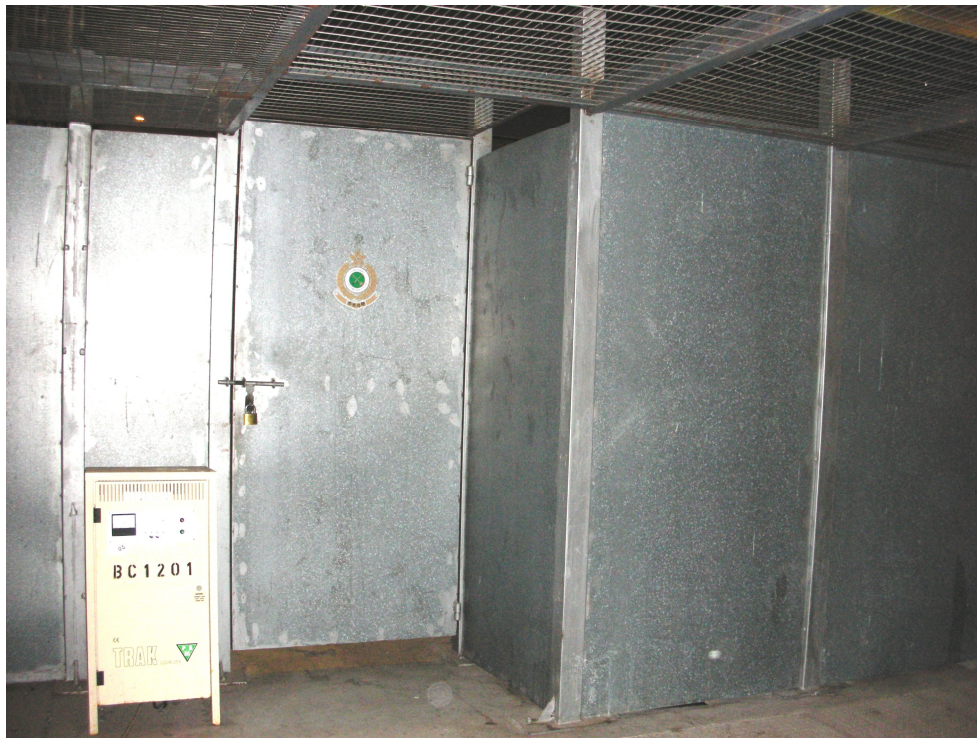
Photo 5: Inaccessible Area of the Ex-GFS Building Occupied by Customs and Excise Department (C&ED)

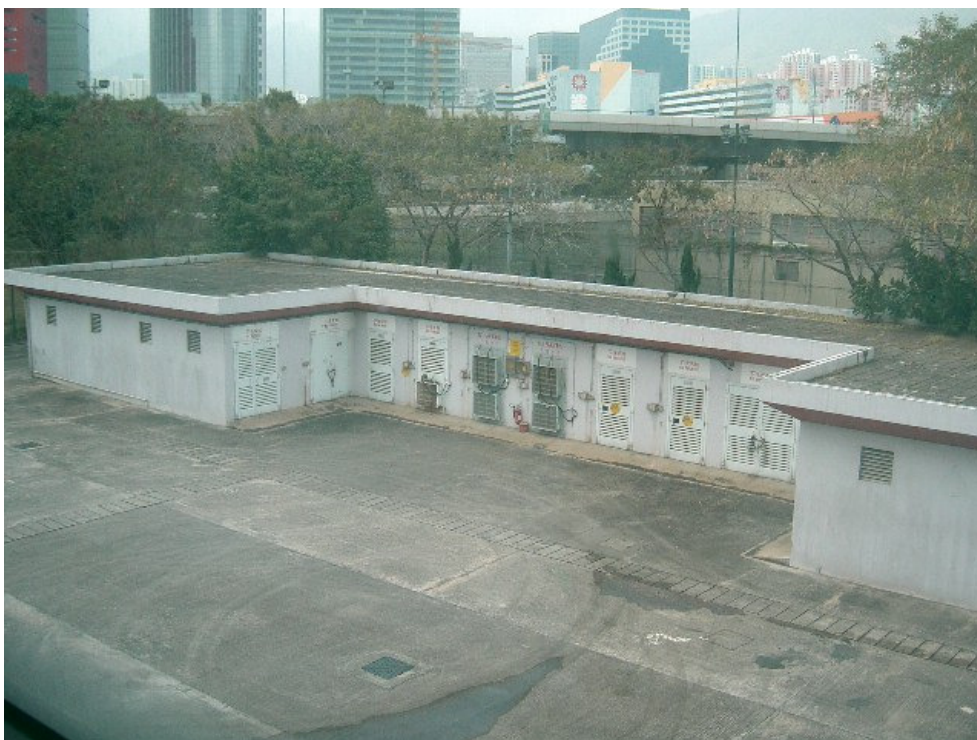
Photo 6: Dangerous Goods Store (D.G. Store)

- 3.5.20 According to the drawings provided by ArchSD, there has been an underground fuel tank in between the D.G. store and the hanger. In addition, the dangerous goods information provided from FSD indicated that this underground tank was used for diesel fuel storage and the capacity was 18,000L. In order to assess any land contamination due to spillage or leakage of the underground tank, it is proposed that 2 boreholes should be drilled in the upstream and downstream of the underground tank as shown in **Drawing 3.3**.

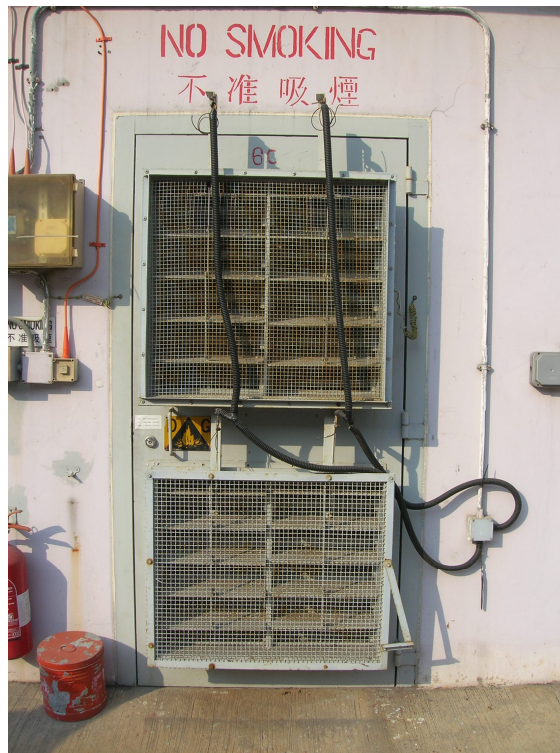
Photo 7: D.G. Store Room Occupied by GFS for Chemical Waste Storage

- 3.5.18 The room occupied by GFS was used for chemical waste storage and the chemical waste would be disposed of through a registered chemical waste disposal agent monthly. During the site inspection, waste oil has been stored in glass jars and oil drums and they were all lidded. The ground was well paved with concrete and no apparent stains have been found in the room.

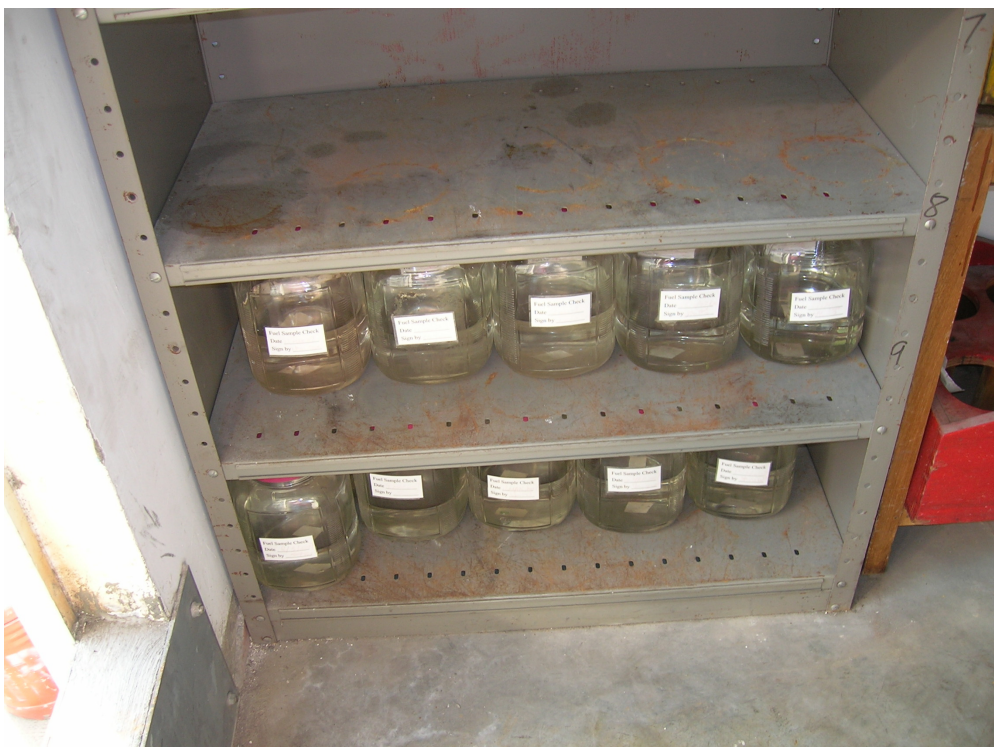
Photo 8: Chemical Waste Stored in D.G. Store Room Occupied by GFS

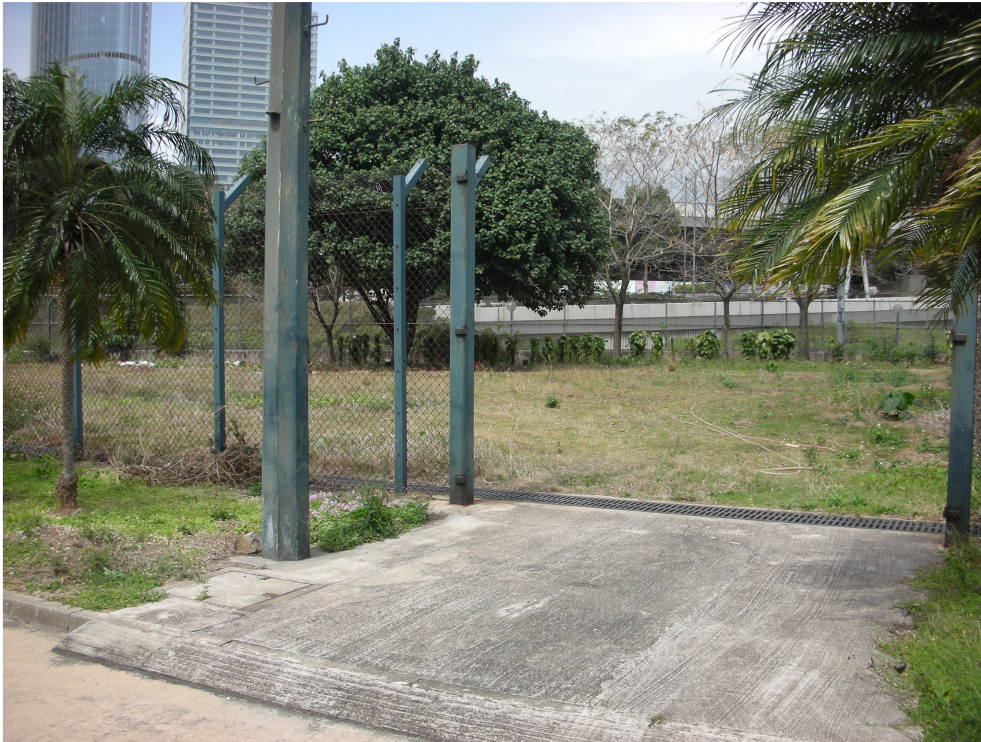
Photo 9: Grassland Located next to D.G. Store

- 3.5.24 For the grassland, it was reported to be used for Immigration Department Dog Team training. During the site inspection, no activities were observed in this area.

- 3.5.25 It is proposed that 2 boreholes should be drilled in the grassland and the playground in order to check any potential land contamination in these two vacant areas. In addition, in order to assess any potential migration of contaminants from the ex-GFS building, 2 additional boreholes as depicted in **Drawing 3.3** are proposed next to the ex-GFS building. Besides, these four boreholes will also serve to provide information on general soil and groundwater conditions.

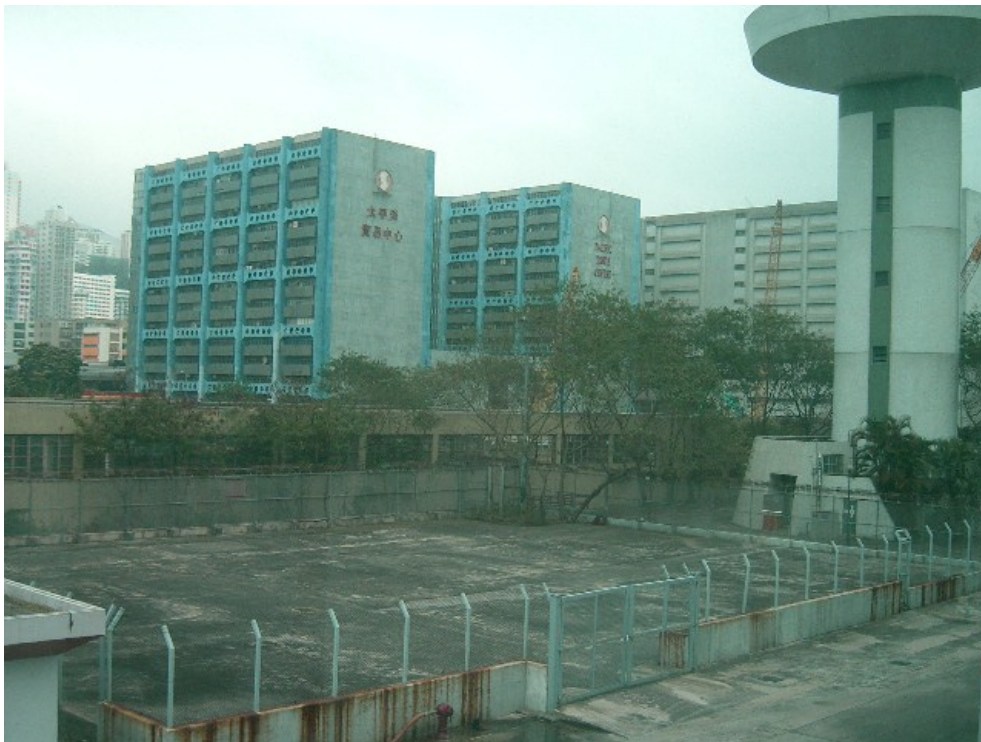
Photo 10: Playground Located in between D.G. Store and Radar Station

- 3.5.23 As reported from the site personnel, the playground area had been used for car parking and used as kennels for the Immigration Department Dog Team. The area is now vacant and no activities have been observed during the site inspections. As observed, the ground was generally well paved with concrete and no apparent stains were found during site inspection.
