Central Kowloon Route

Yau Ma Tei West

Monthly EM&A Report No. 10

(Period from 1 to 30 November 2019)

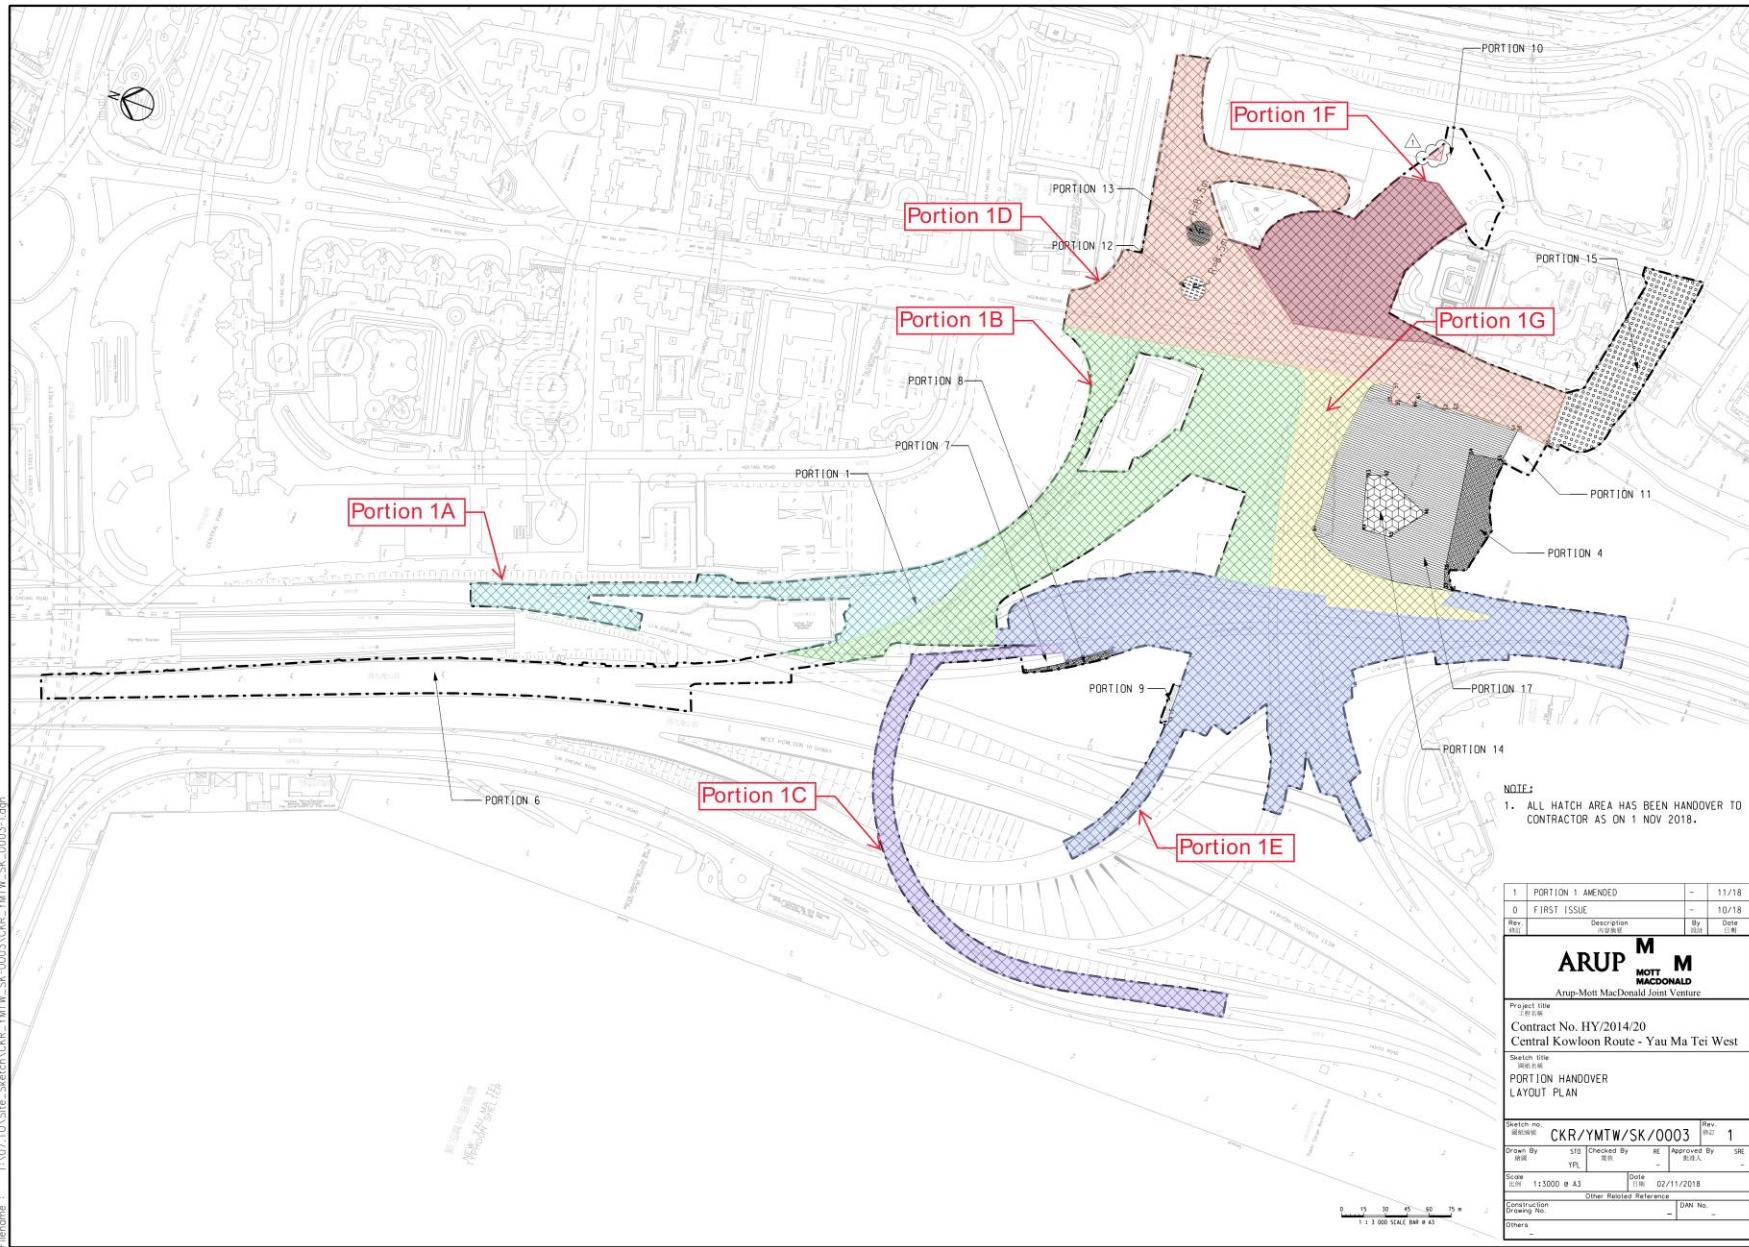
Alignment and Works Area For the Contract No. HY/2014/20

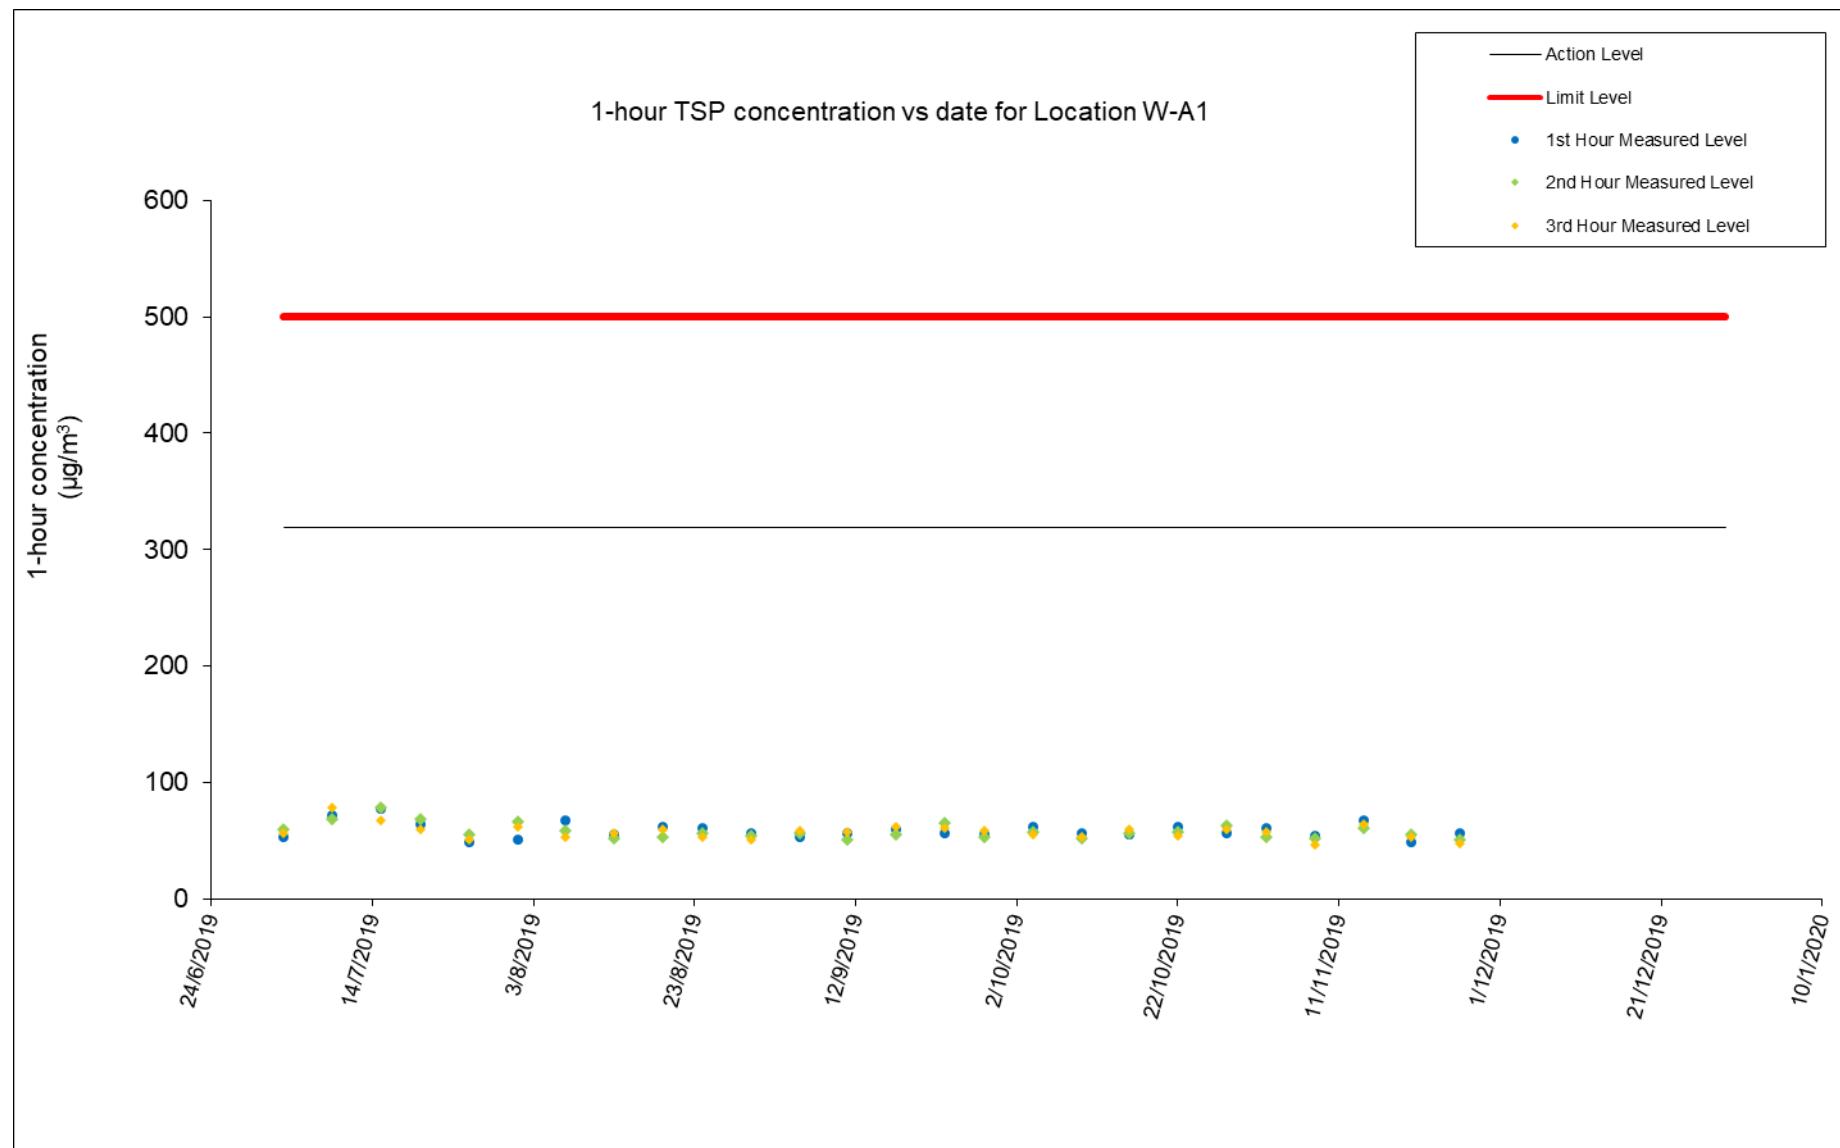
Figure 1: Graphical Illustration of Measured 1-hour TSP ($\mu\text{g}/\text{m}^3$) Levels at W-A1

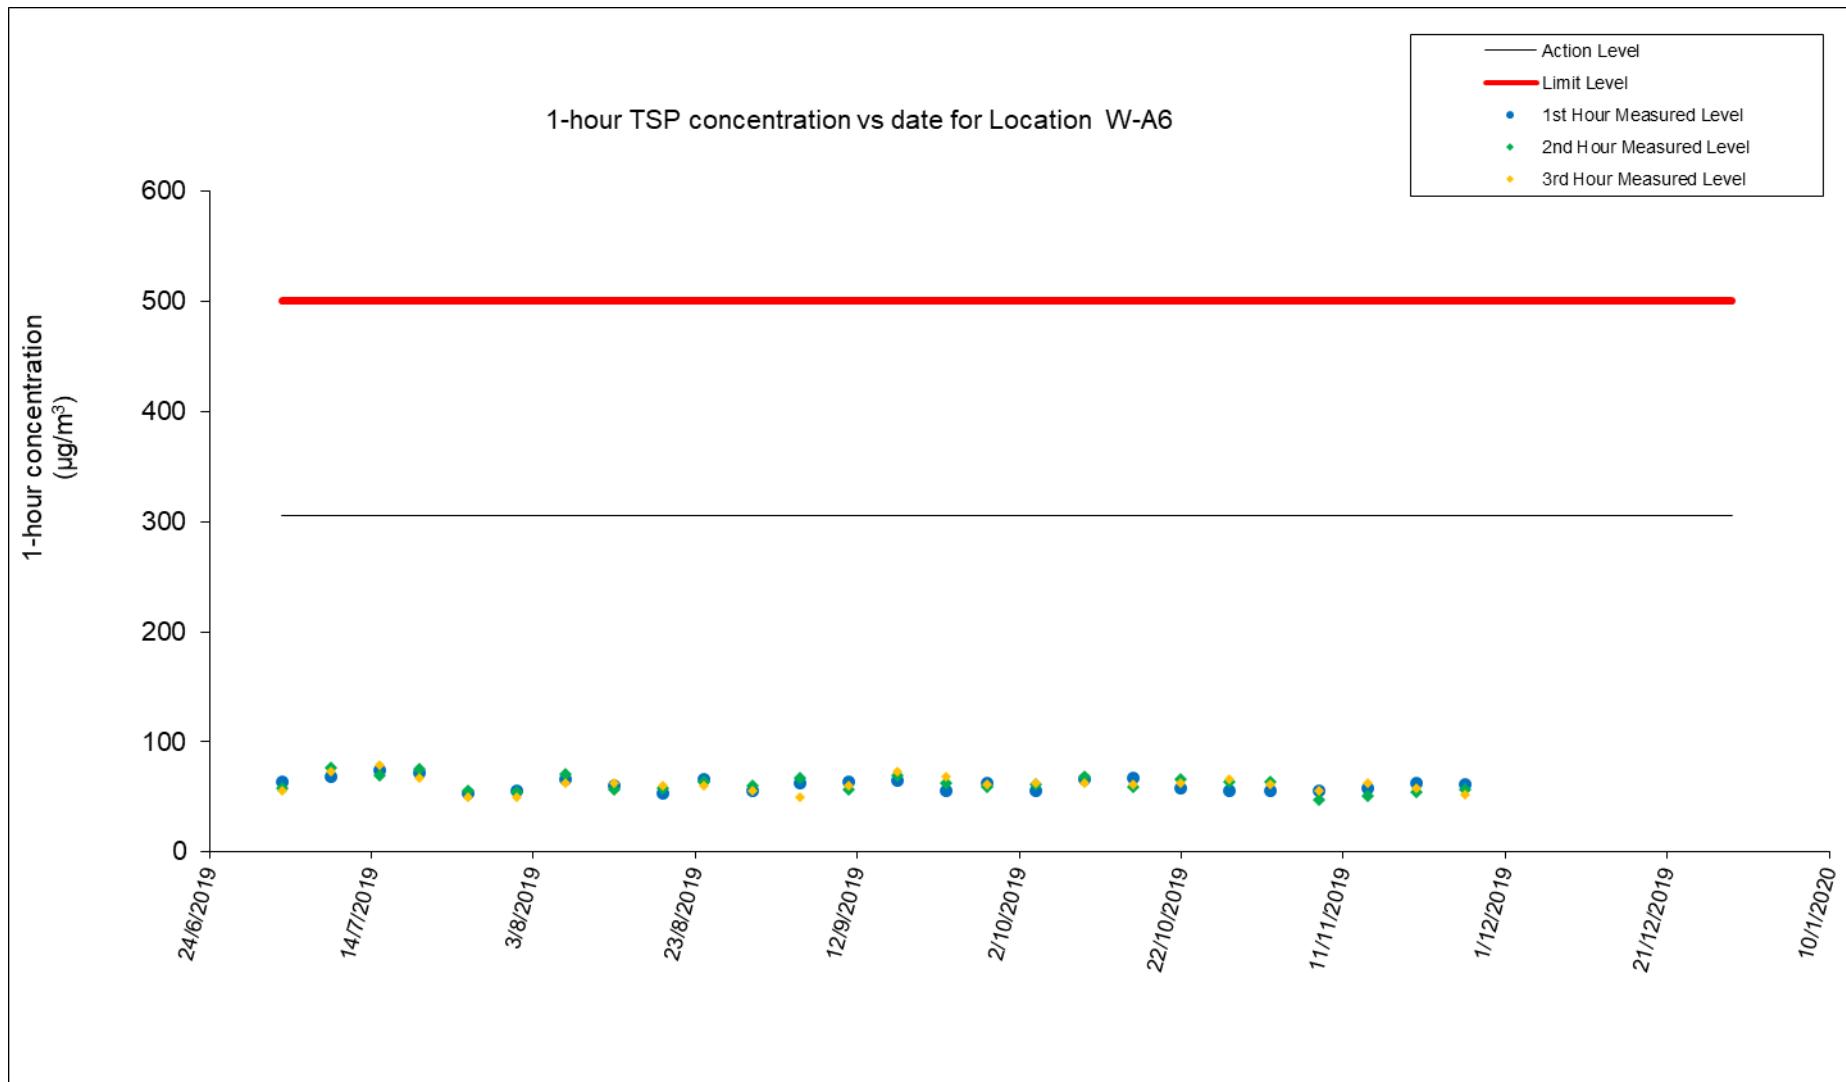
Figure 2: Graphical Illustration of Measured 1-hour TSP ($\mu\text{g}/\text{m}^3$) Levels at W-A6

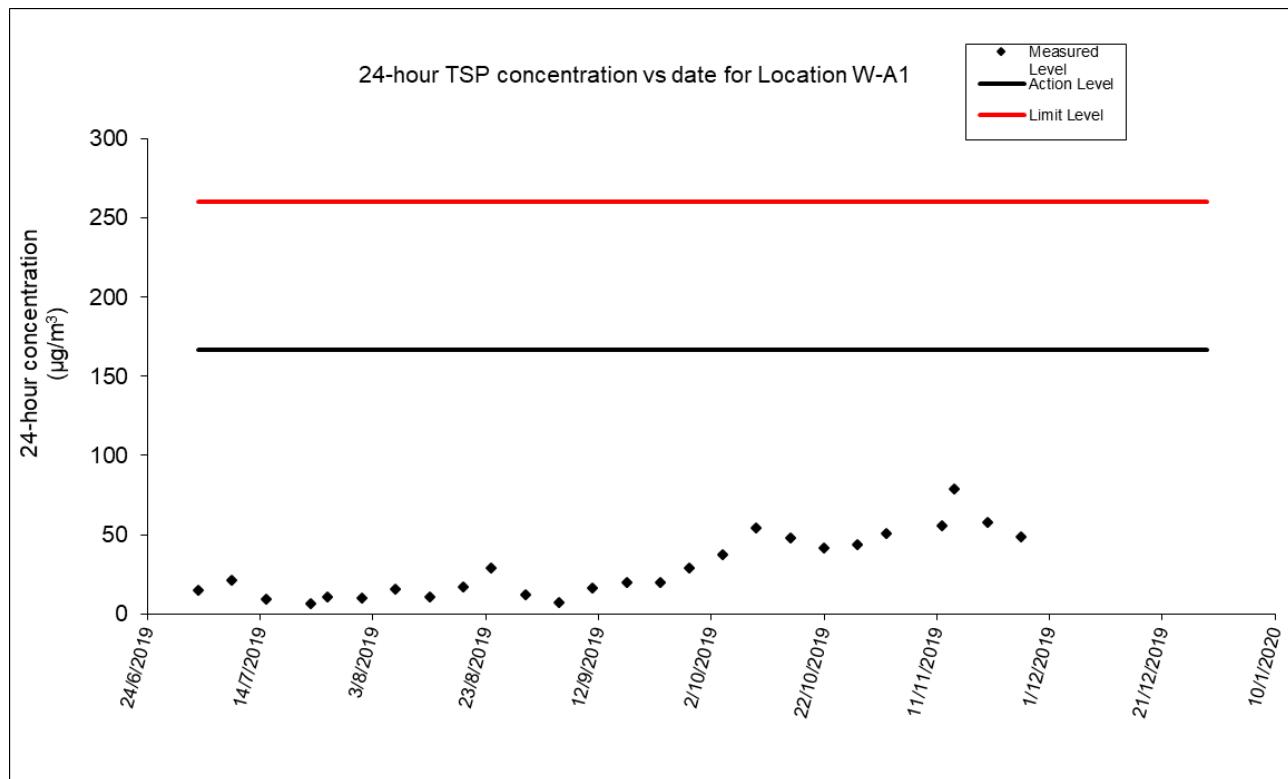
Figure 3: Graphical Illustration of Measured 24-hour TSP ($\mu\text{g}/\text{m}^3$) Levels at W-A1

Location: Yau Ma Tei Catholic Primary School (Hoi Wang Road) (W-A1)
 Monitoring date: 2, 8, 12, 14, 20, 26 November 2019
 Parameter : TSP 24-hour
 Other Factors Nearby traffic, construction work from West Kowloon Government Offices

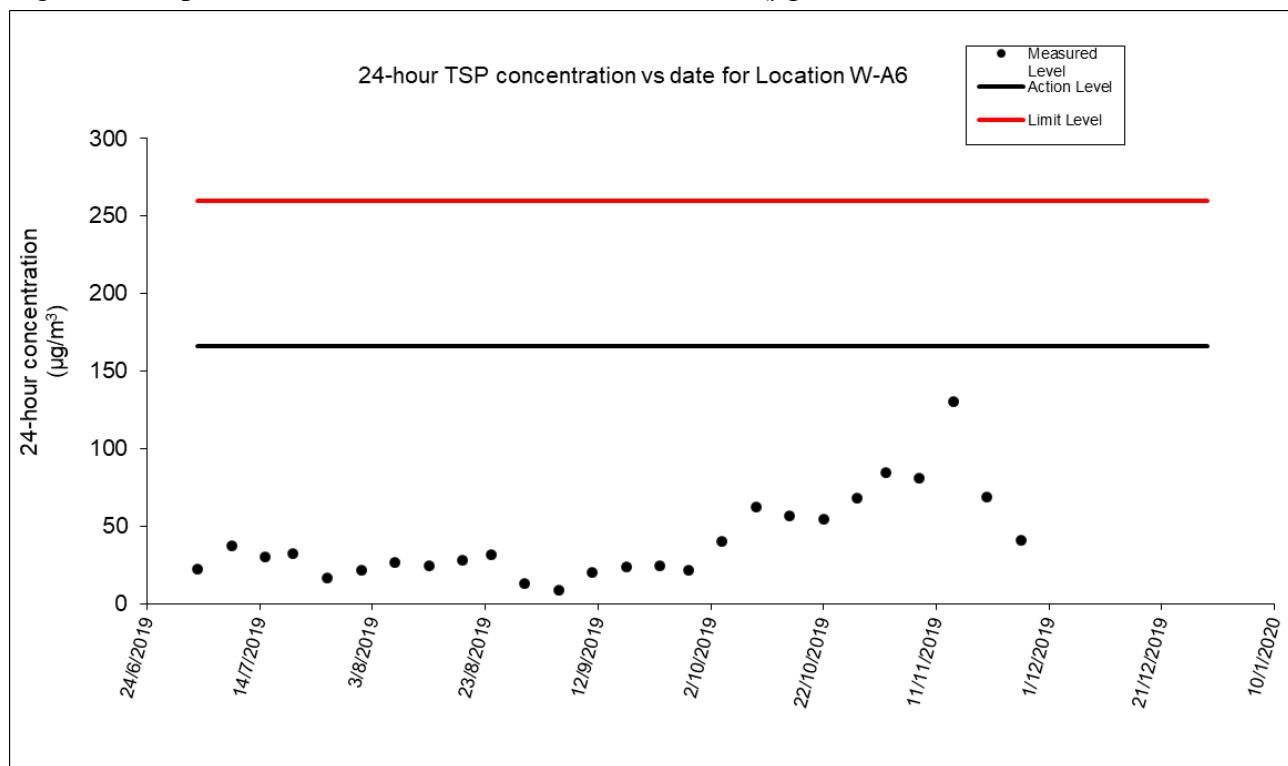
Figure 4: Graphical Illustration of Measured 24-hour TSP ($\mu\text{g}/\text{m}^3$) Levels at W-A6

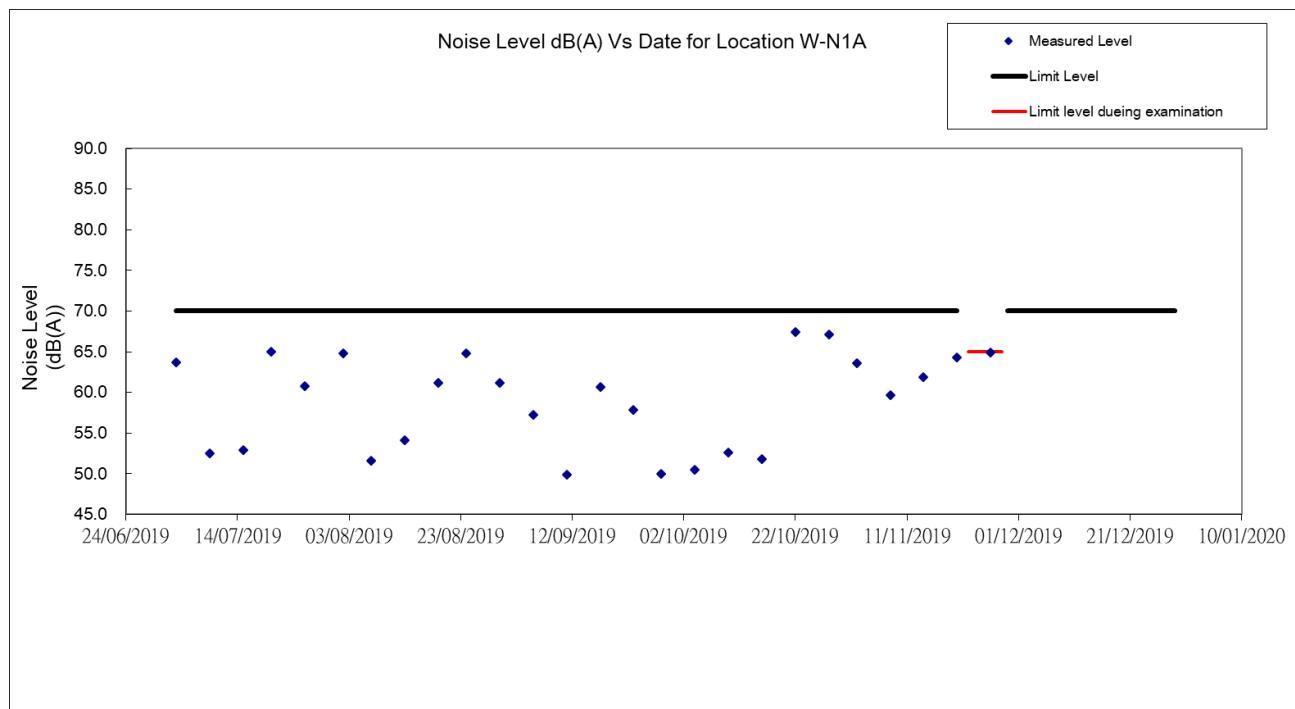
Figure 1: Graphical Illustration of Measured Noise Levels at W-N1A

Remark: Examination was held on 26 November 2019. Limit level was changed to 65 dB(A).

Remarks: 1. # If works are to be carried out during restricted hours, the conditions stipulated in the construction noise permit by the Noise Control Authority have to be followed.
2. Limit level was 65 dB(A) during examination period from 21-29 November 2019 at W-N1A.

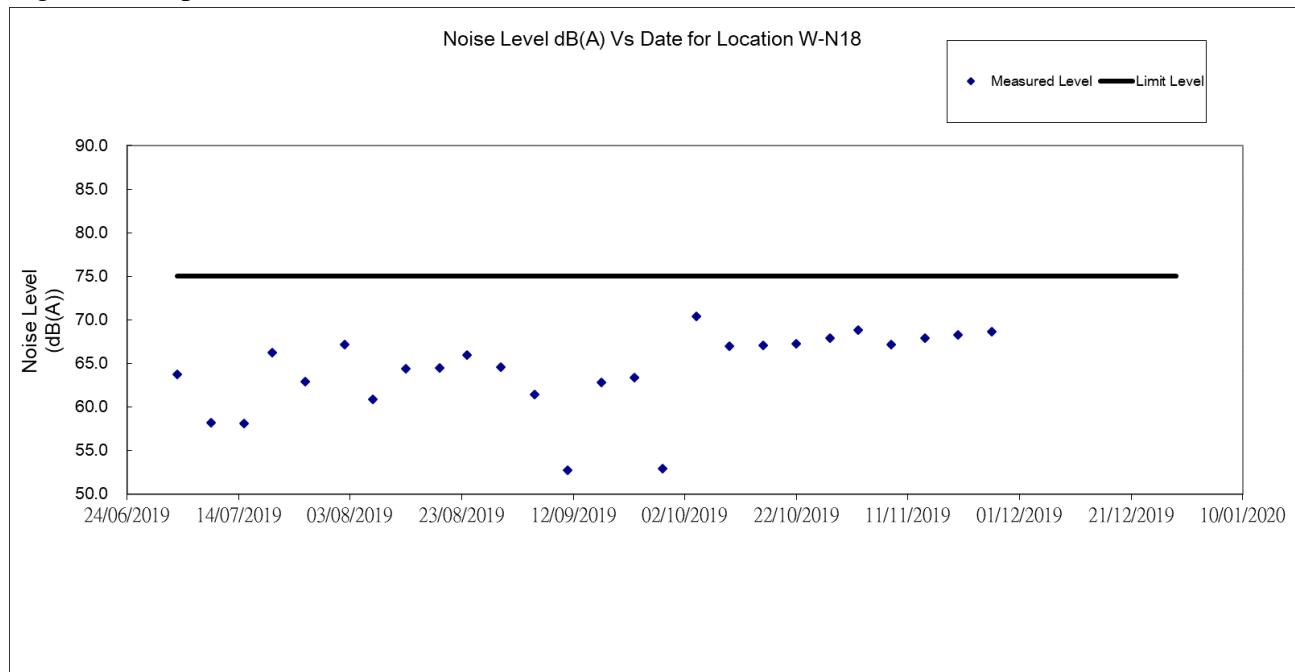
Figure 2: Graphical Illustration of Measured Noise Levels at W-N18

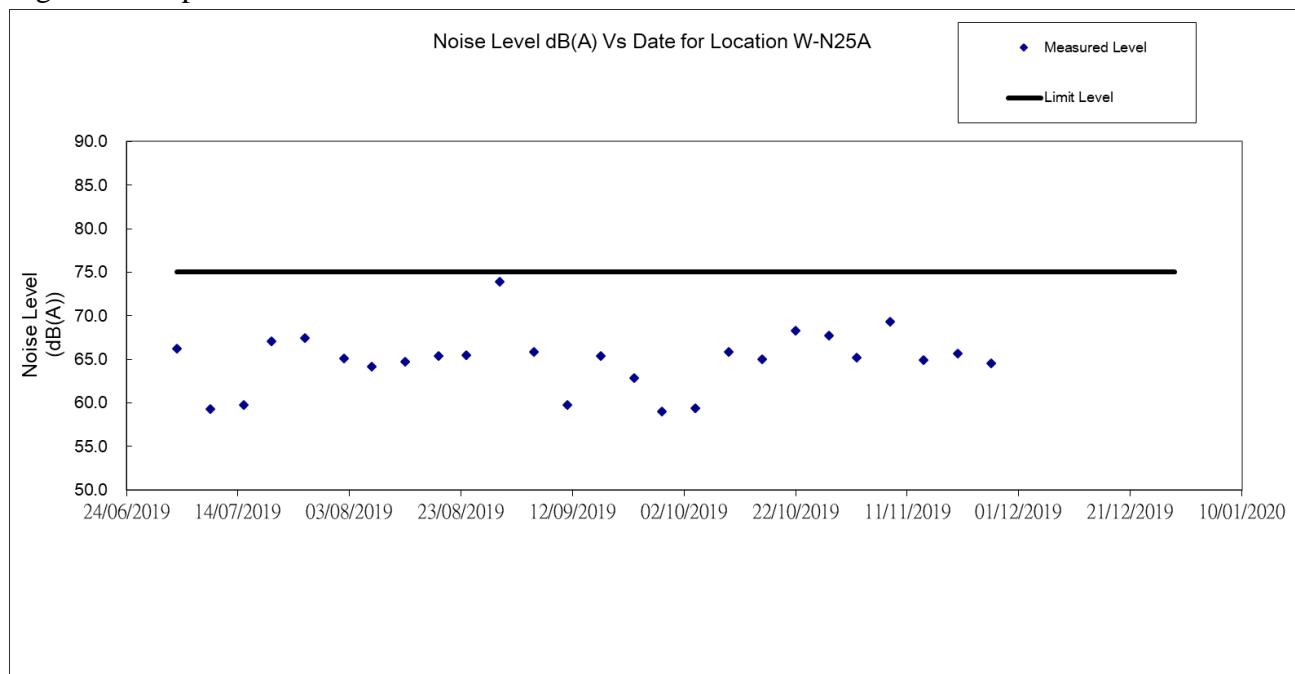
Figure 3: Graphical Illustration of Measured Noise Levels at W-N25A

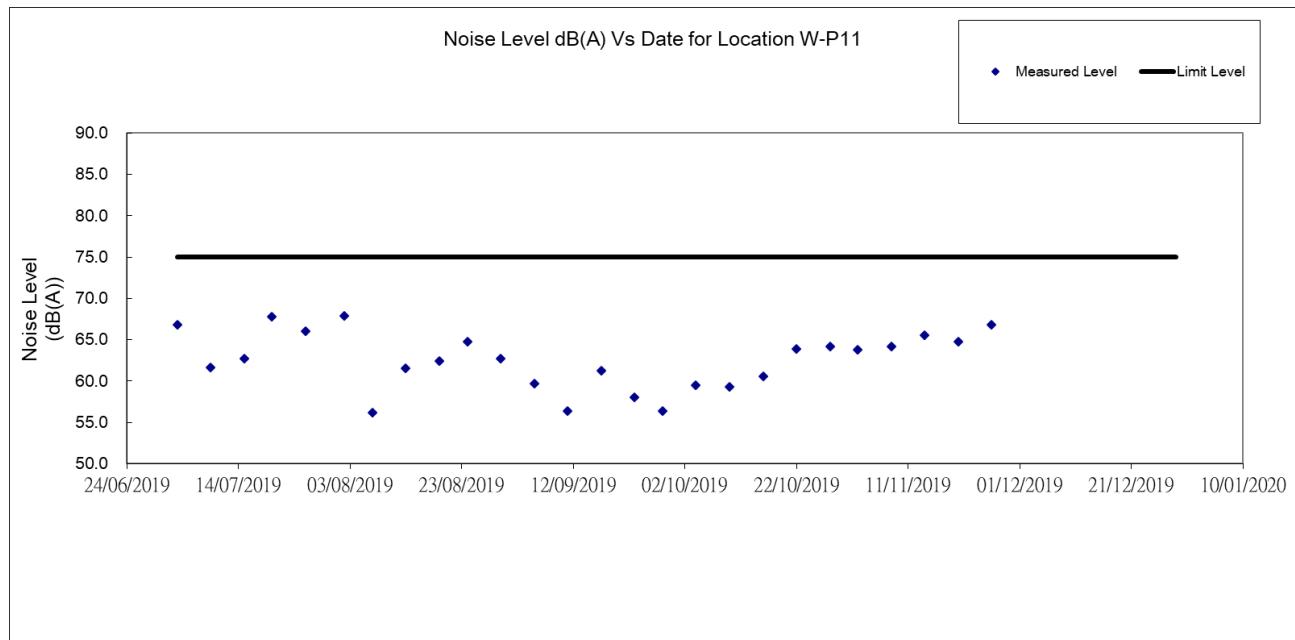
Figure 4: Graphical Illustration of Measured Noise Levels at W-P11
