**Construction of Sewage Pumping Station near Tsz Tin Road and Associated Sewerage Works  
in Area 54, Tuen Mun**

**Monthly Environmental Monitoring and Audit Report – March 2013**

Environmental Team Services for Contract No. CV/2012/02  
Construction of Sewage Pumping Station near Tsz Tin Road  
and Associated Sewerage Works in Area 54, Tuen Mun

Monthly EM&A Report for March 2013 (Rev. A)

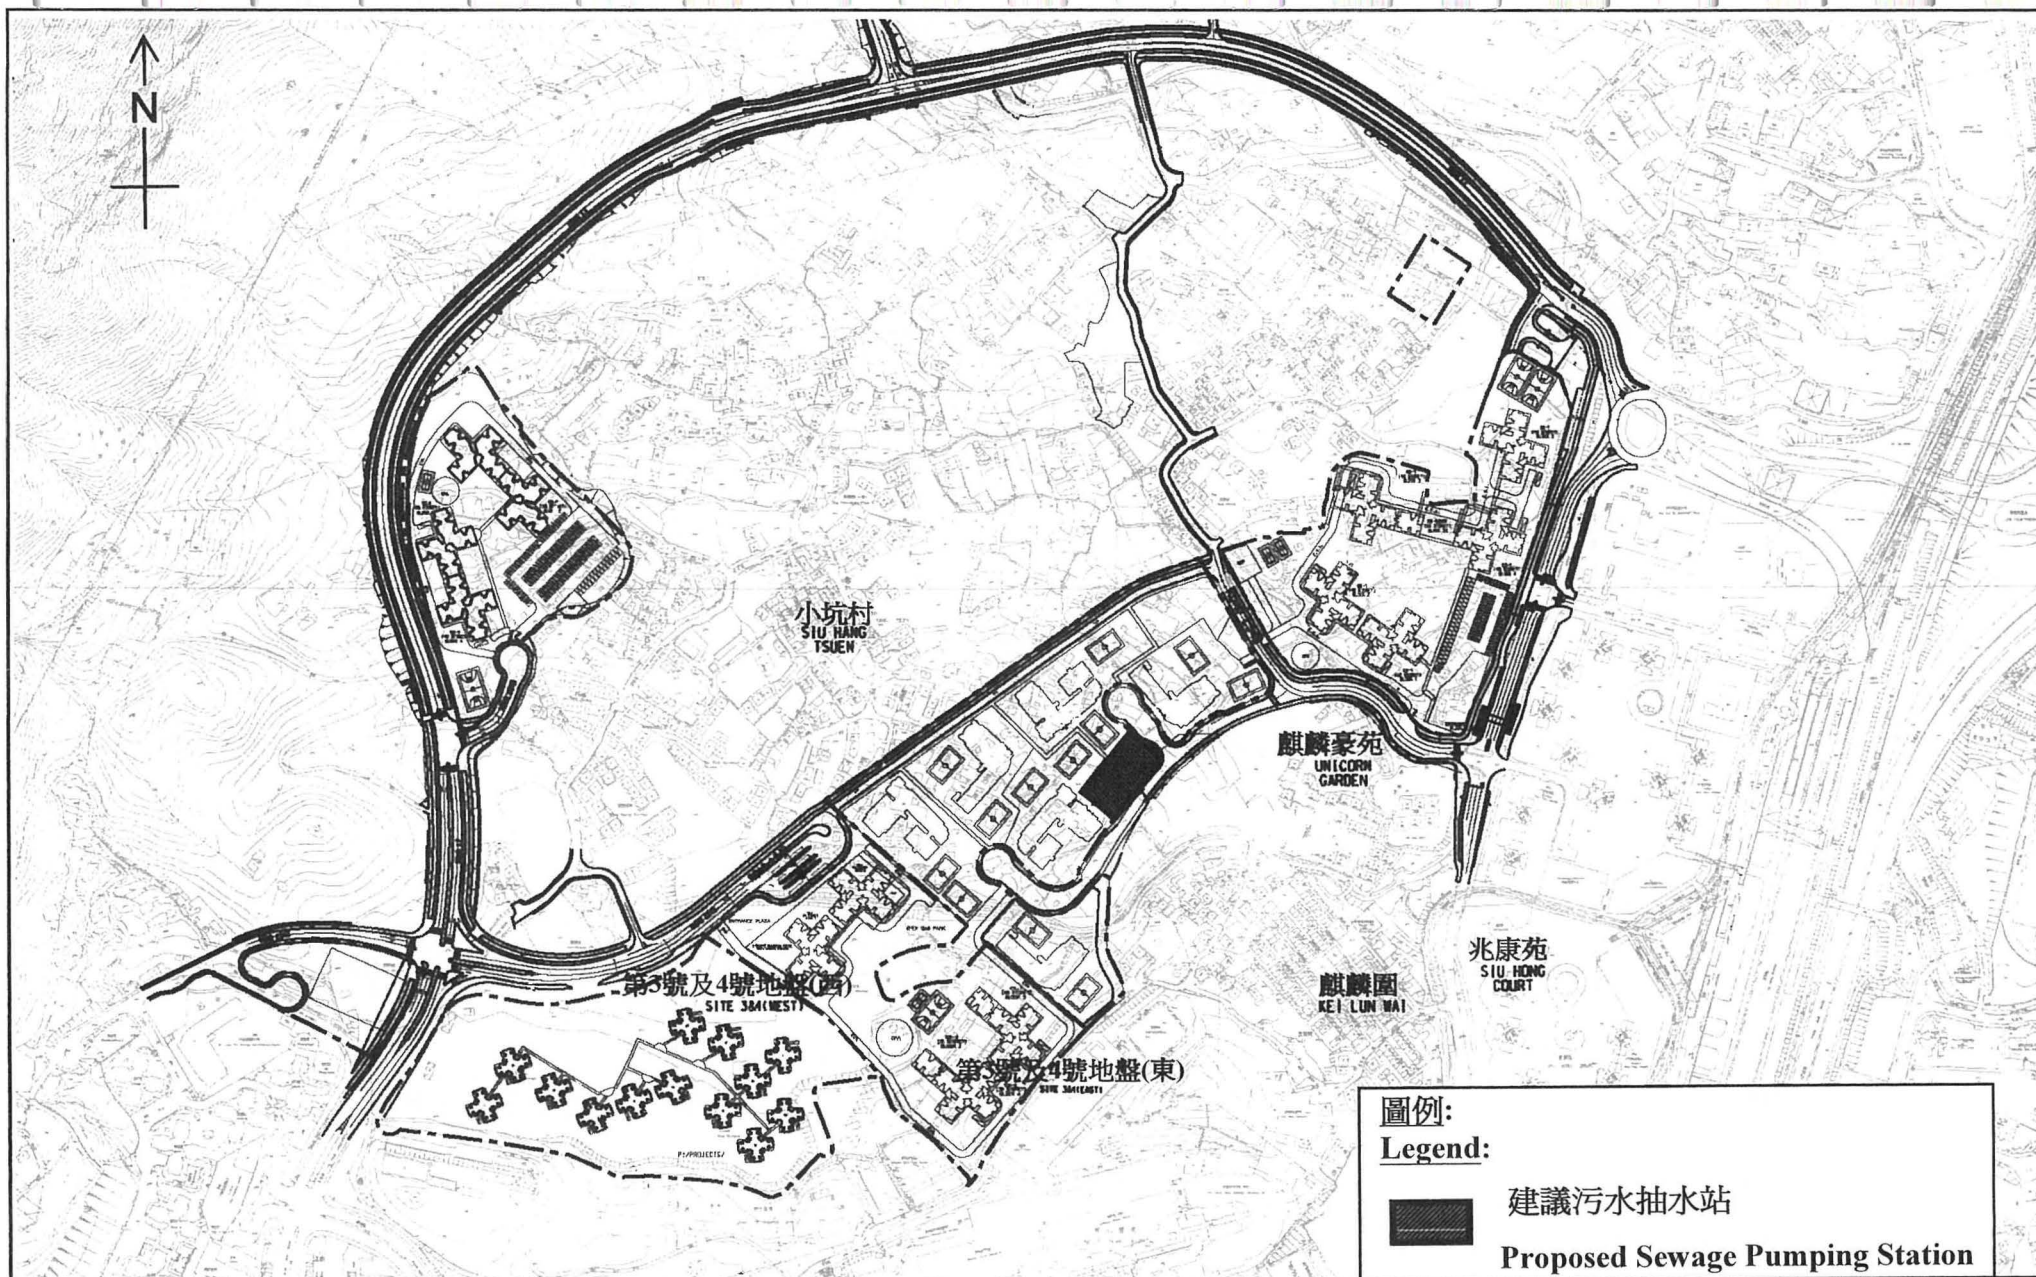
Figure 1.1

屯門第54區污水抽水站 –  
Tuen Mun Area 54 Sewage Pumping Station –  
建議污水抽水站位置  
Location of Proposed Sewage Pumping Station

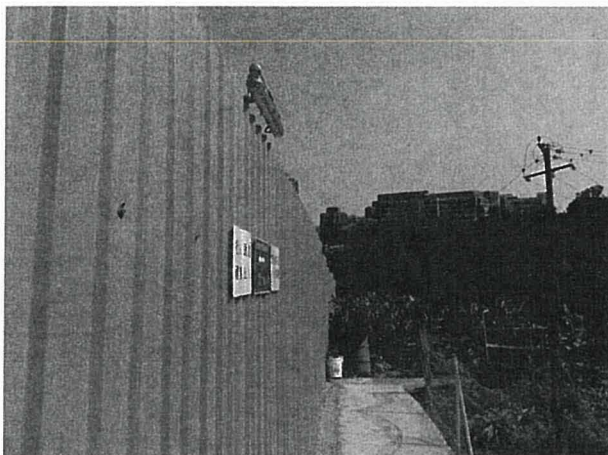
CM2

Hoarding was set up around Project site area with lightings for pedestrians.

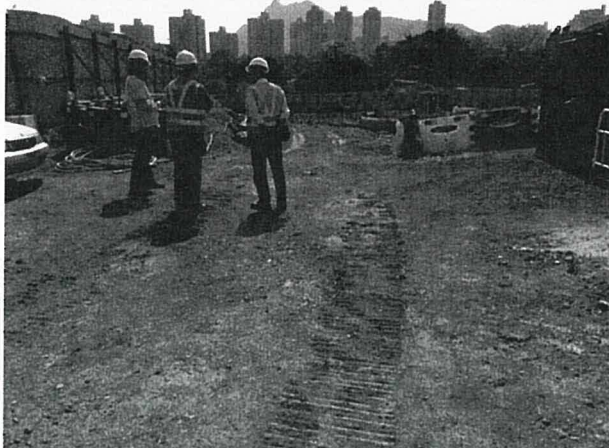
CM3

All on site staff was wearing uniform and cleanly dressed.

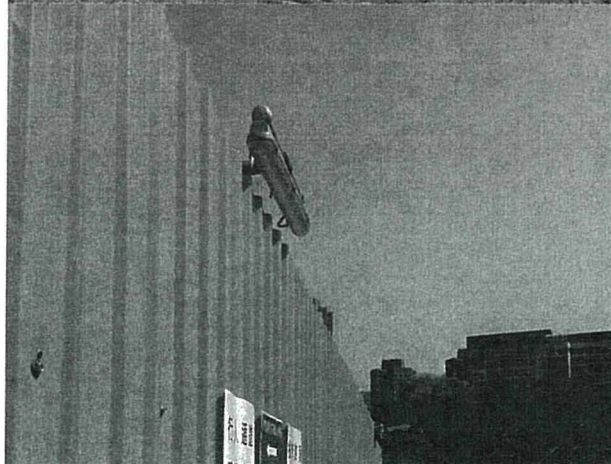
| ID No. | Landscape and Visual Mitigation Measures | Observation | Recommendation |
|---|---|---|---|
| CM5 | All security floodlights for construction sites are equipped with adjustable shield, frosted diffusers and reflective covers, and carefully controlled to minimize light pollution and night-time glare to nearby village. | Yes | No |

Security lighting was placed facing away from sensitive receivers.
