APPENDIX A

附錄一

Test Pit and Auger Hole Recording Sheets

探方鑽孔紀錄表

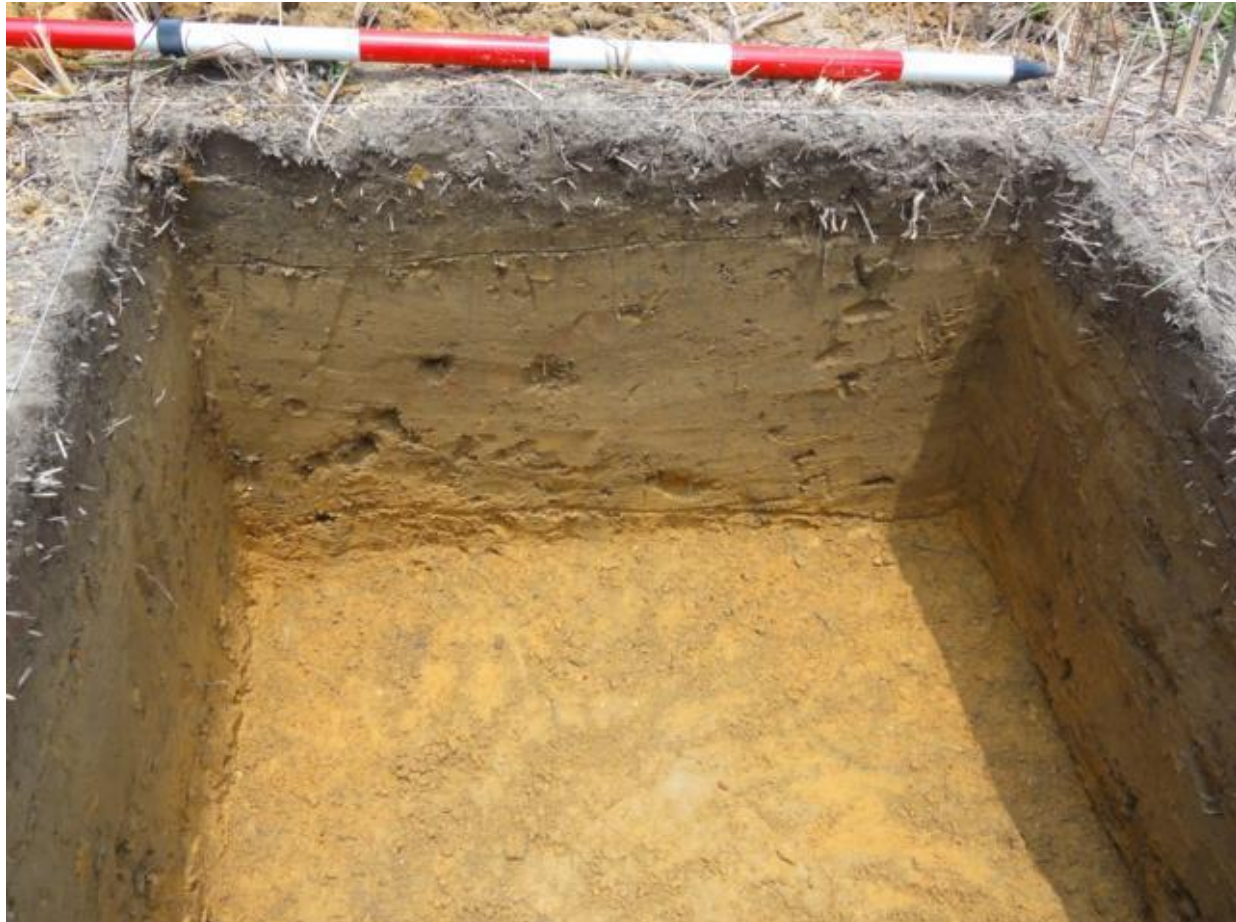
Northern Profile of K1a

Location	Kwu Tung North	Area Code	KTN	Test Pit No.	K1a
Test Pit Coordinate	827962E	842207N	Test Pit Measurement	1 m x 1 m	
Digging Method	Hand Digging		Ground Level	c.a. +12.7mPD	
Stratigraphy and Finds					
Layer	Soil Texture		Soil Colour	Finds	Chronology
L1	Humus soil		Light Black	Nil	Modern
L2	Sandy clay with rock granules		Grayish Yellow	Nil	
L3	Clay with rock granules		Reddish Yellow	Nil	Regolith

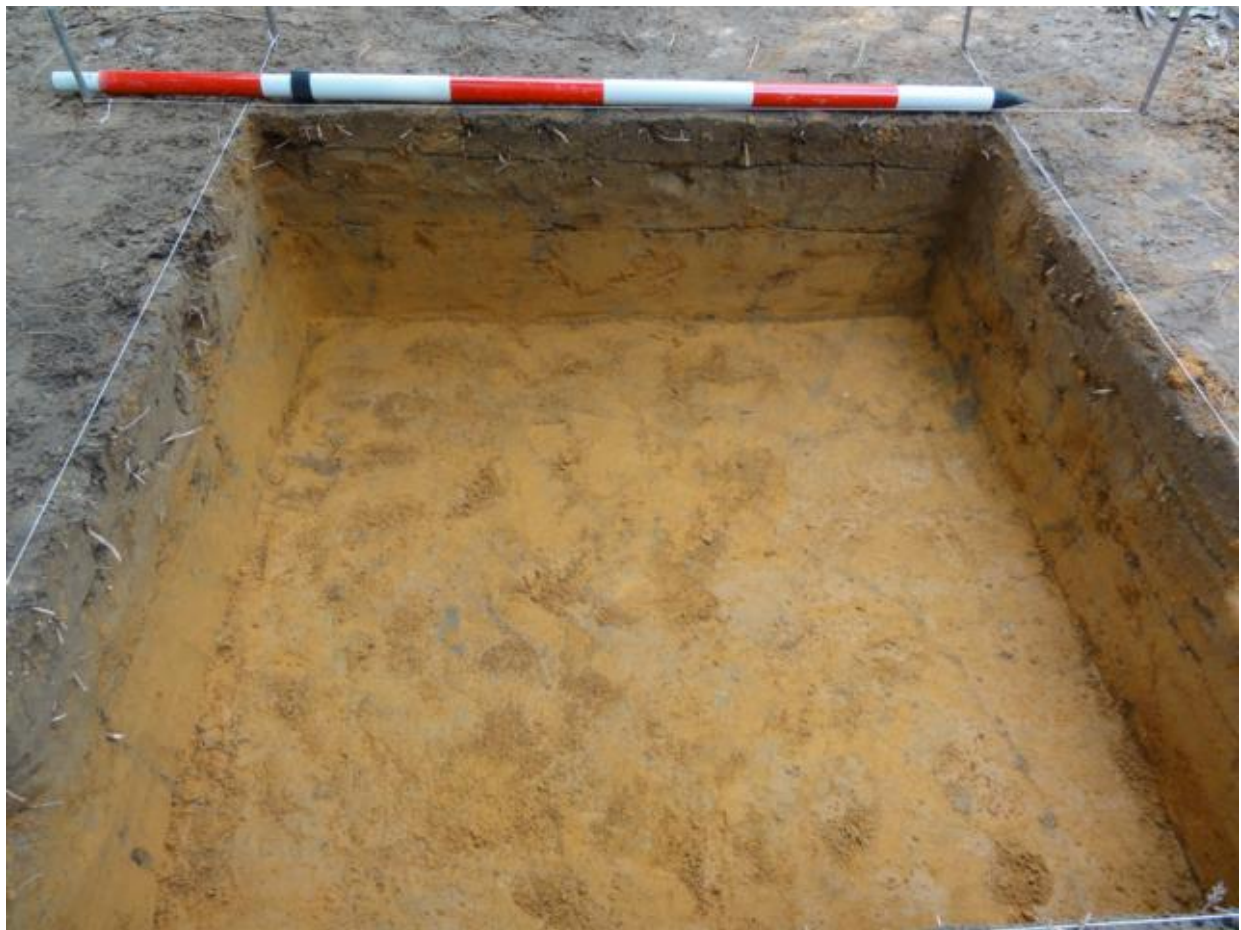
Northern Profile of K2a

Location	Kwu Tung North	Area Code	KTN	Test Pit No.	K2a
Test Pit Coordinate	828032E	842040N	Test Pit Measurement	1 m × 1 m	
Digging Method	Hand Digging		Ground Level	c.a. +14.9mPD	
Stratigraphy and Finds					
Layer	Soil Texture		Soil Colour	Finds	Chronology
L1	Loose silt		Light Black	Nil	Modern
L2	Loose silty clay		Grayish Yellow	Nil	
L3	Fine clay		Reddish Yellow	Nil	Regolith

(Auger hole in the middle of the test pit)

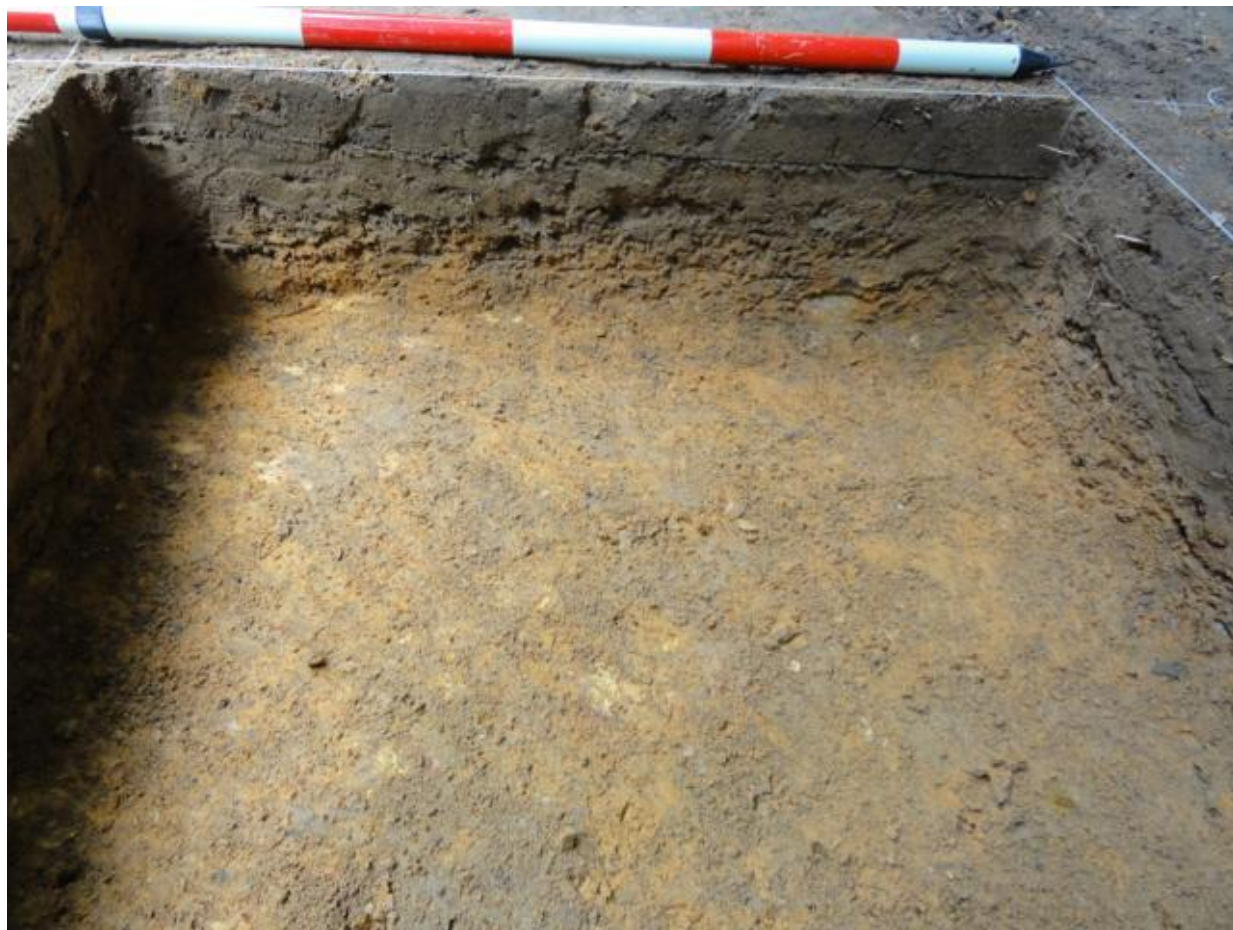
Northern Profile of K2c

Location	Kwu Tung North	Area Code	KTN	Test Pit No.	K2c
Test Pit Coordinate	828054E	841930N	Test Pit Measurement	1 m x 1 m	
Digging Method	Hand Digging		Ground Level	c.a. +14.8mPD	
Stratigraphy and Finds					
Layer	Soil Texture		Soil Colour	Finds	Chronology
L1	Loose silt		Light Black	Nil	Modern
L2	Loose silty clay		Grayish Yellow	Nil	
L3	Clay with rock granules		Reddish Yellow	Nil	Regolith

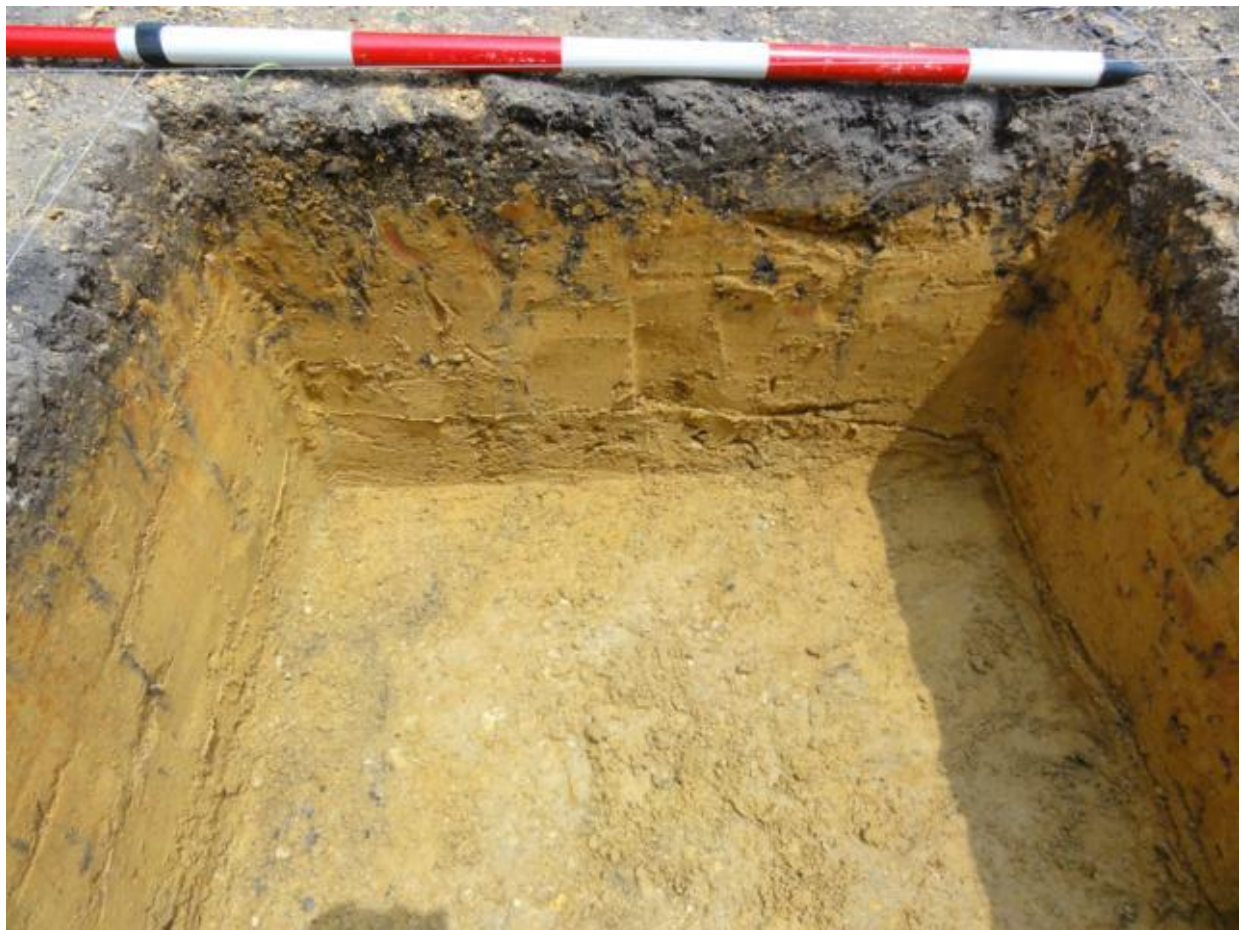
Northern Profile of K3b

Location	Kwu Tung North	Area Code	KTN	Test Pit No.	K3b
Test Pit Coordinate	828117E	841802N	Test Pit Measurement	1 m x 1 m	
Digging Method	Hand Digging		Ground Level	c.a. +14.7mPD	
Stratigraphy and Finds					
Layer	Soil Texture		Soil Colour	Finds	Chronology
L1	Humus soil		Light Black	Nil	Modern
L2	Clay		Reddish Yellow	Nil	Regolith
L3	Clay with rock fragments		Reddish Yellow	Nil	Regolith

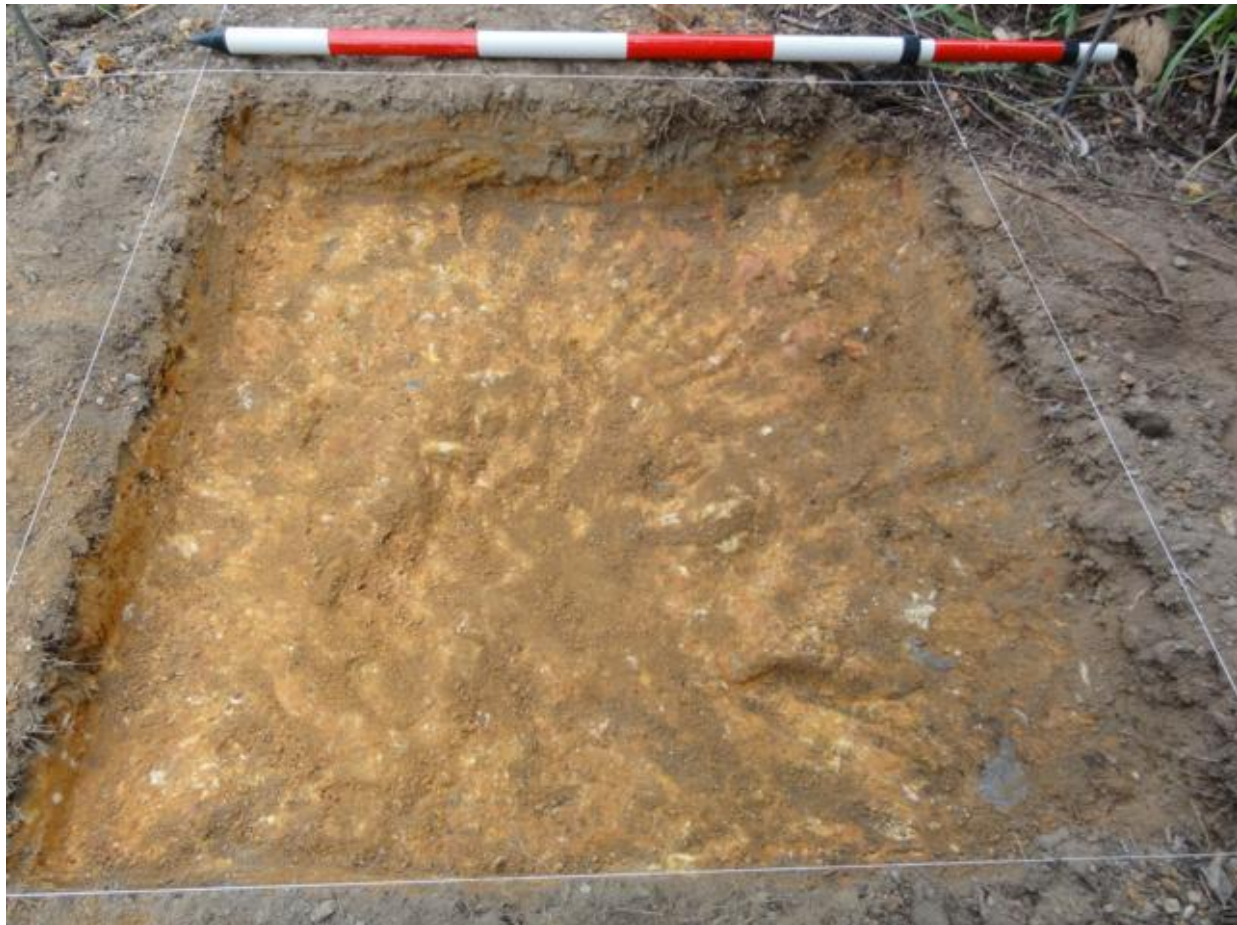
Northern Profile of K5b

Location	Kwu Tung North	Area Code	KTN	Test Pit No.	K5b
Test Pit Coordinate	828620E	841870N	Test Pit Measurement	1 m × 1 m	
Digging Method	Hand Digging		Ground Level	c.a. +28.8mPD	
Stratigraphy and Finds					
Layer	Soil Texture		Soil Colour	Finds	Chronology
L1	Loose silt		Light Black	Nil	Modern
L2	Hard clay with rock fragments		Reddish Yellow	Nil	Regolith

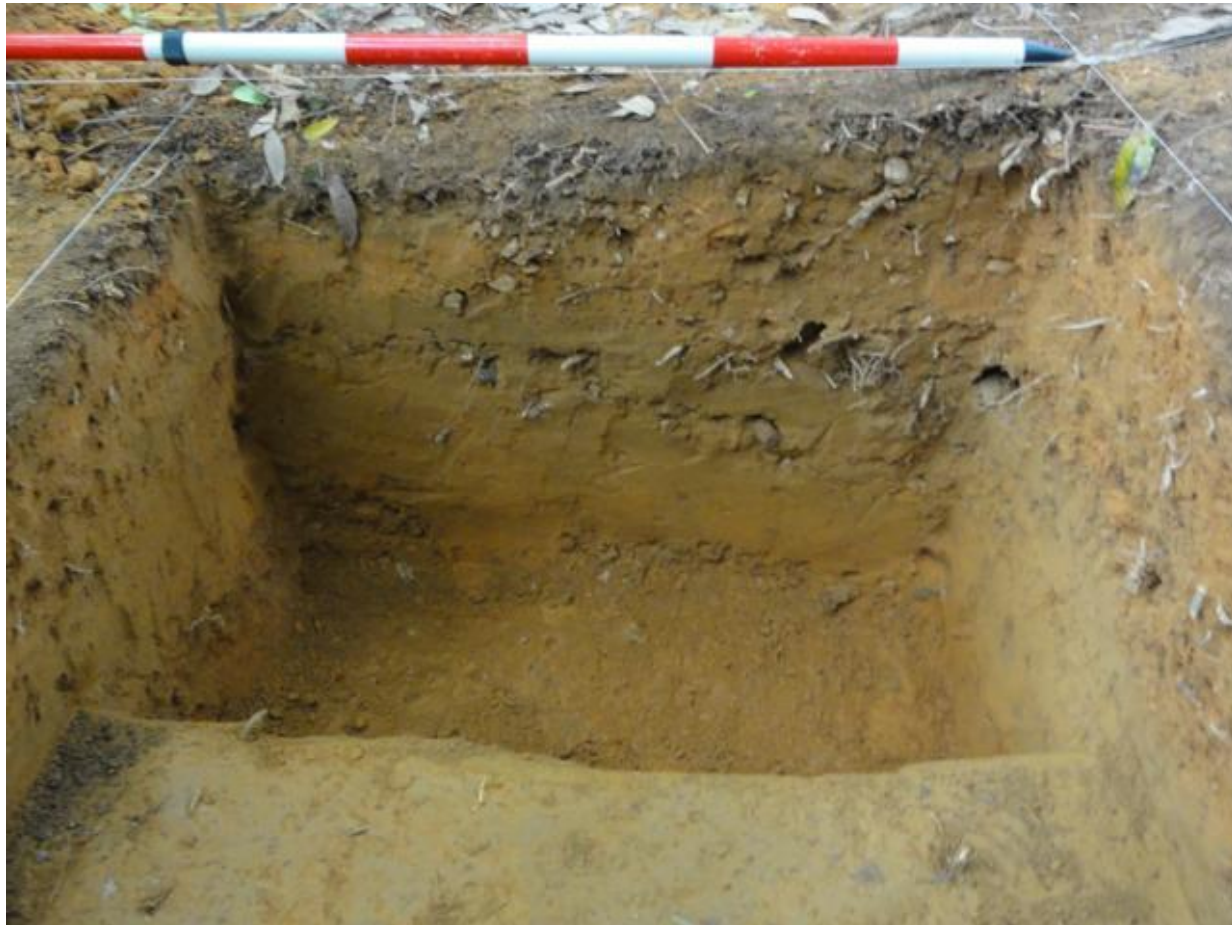
Northern Profile of K5e

Location	Kwu Tung North	Area Code	KTN	Test Pit No.	K5e
Test Pit Coordinate	828744E	841774N	Test Pit Measurement	1 m x 1 m	
Digging Method	Hand Digging		Ground Level	c.a. +30.0mPD	
Stratigraphy and Finds					
Layer	Soil Texture		Soil Colour	Finds	Chronology
L1	Loose silt		Light Black	Nil	Modern
L2	Fill with glass		Mixed Red-Yellow-Brown	Nil	Modern
L3	Clay		Reddish Yellow	Nil	Regolith

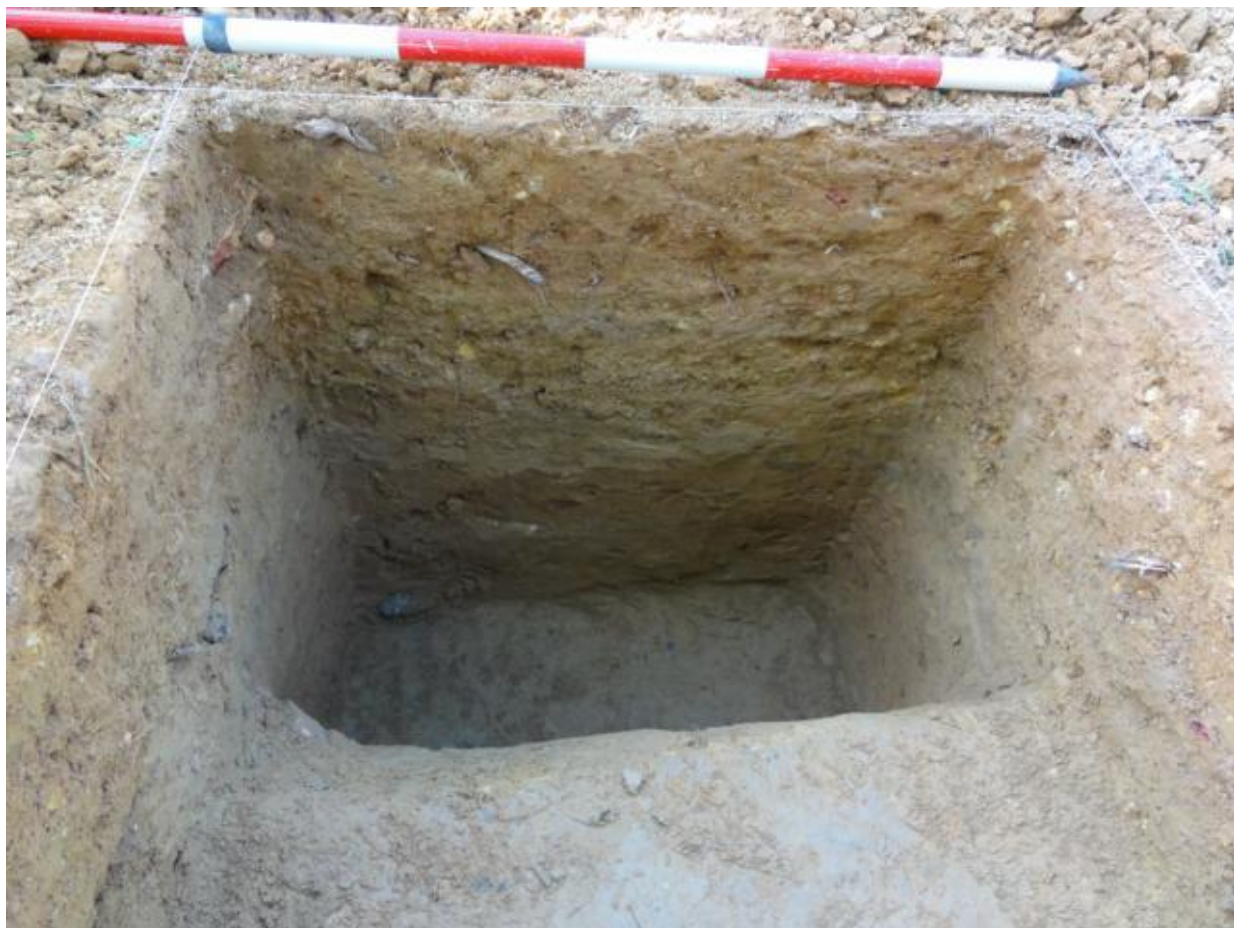
Northern Profile of K6d

Location	Kwu Tung North	Area Code	KTN	Test Pit No.	K6d
Test Pit Coordinate	829336E	841707N	Test Pit Measurement	1 m x 1 m	
Digging Method	Hand Digging		Ground Level	c.a. +11.4mPD	
Stratigraphy and Finds					
Layer	Soil Texture	Soil Colour	Finds	Chronology	
L1	Silty Clay	Light Brown	Nil	Modern	
L2	Clayey fill with tile sherd	Light Yellow	Glazed Ware, Tiles	Modern	
L3	Clayey fill	Grayish Yellow	Nil	Modern	
L4	Clayey fill with houseware sherd	Grayish Brown	Glazed Ware	Modern	
L5	Clayey fill	Brown	Nil	Modern

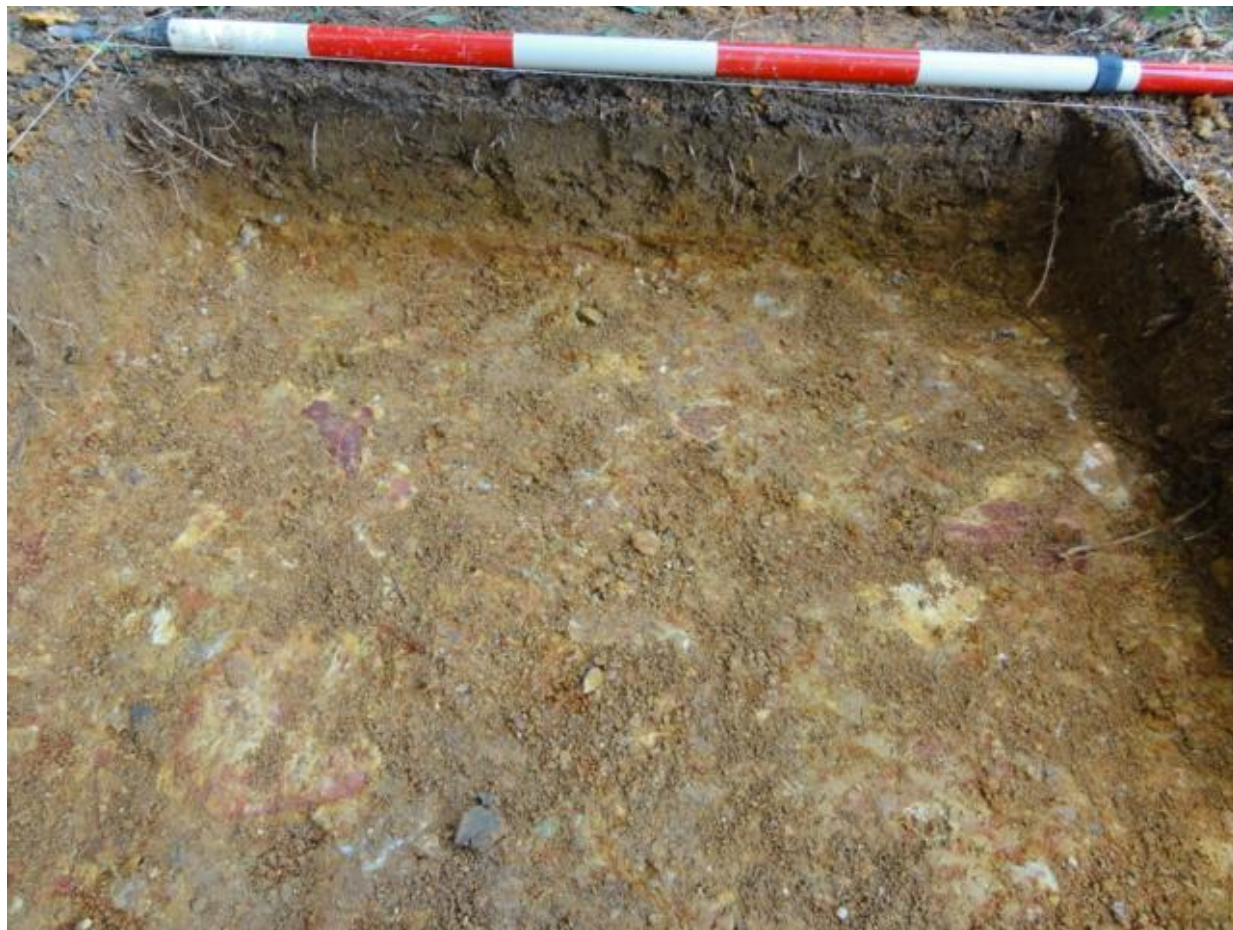
Northern Profile of K6e

Location	Kwu Tung North	Area Code	KTN	Test Pit No.	K6e
Test Pit Coordinate	829381E	841664N	Test Pit Measurement	1 m x 1 m	
Digging Method	Hand Digging		Ground Level	c.a. +10.4mPD	
Stratigraphy and Finds					
Layer	Soil Texture		Soil Colour	Finds	Chronology
L1	Humus soil		Light Black	Nil	Modern
L2	Clay		Reddish Brown	Nil	
L3	Clay with sandstone boulders		Reddish Yellow	Nil	Regolith

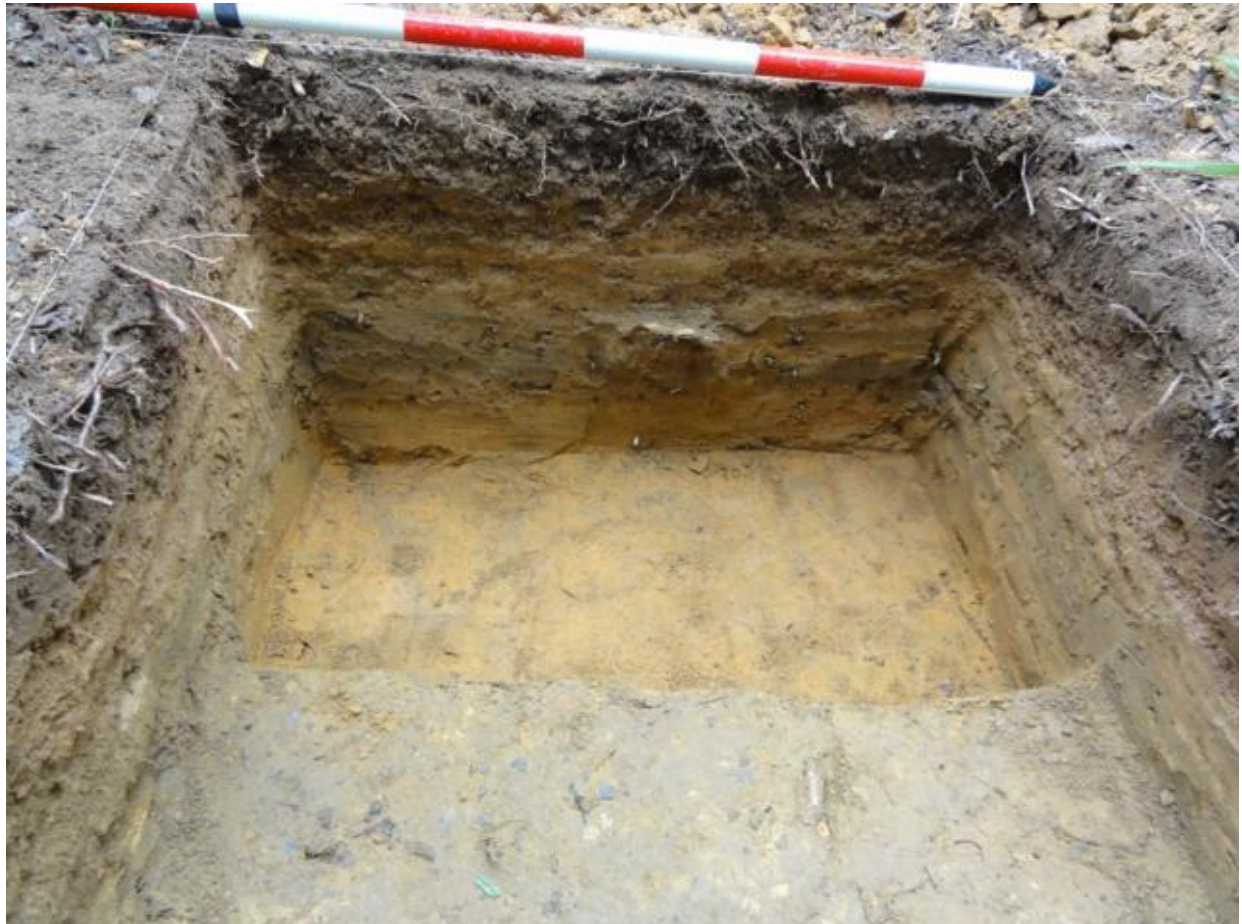
Northern Profile of K7a

Location	Kwu Tung North	Area Code	KTN	Test Pit No.	K7a
Test Pit Coordinate	828388E	841607N	Test Pit Measurement	1 m x 1 m	
Digging Method	Hand Digging		Ground Level	c.a. +27.6mPD	
Stratigraphy and Finds					
Layer	Soil Texture	Soil Colour	Finds	Chronology	
L1	Humus soil	Light Black	Nil	Modern	
L2	Silt with rock granules	Light Brown	Nil		
L3	Loose fine clay	Grayish Yellow	Nil		
L4	Fine clay	Reddish Yellow	Nil	Regolith

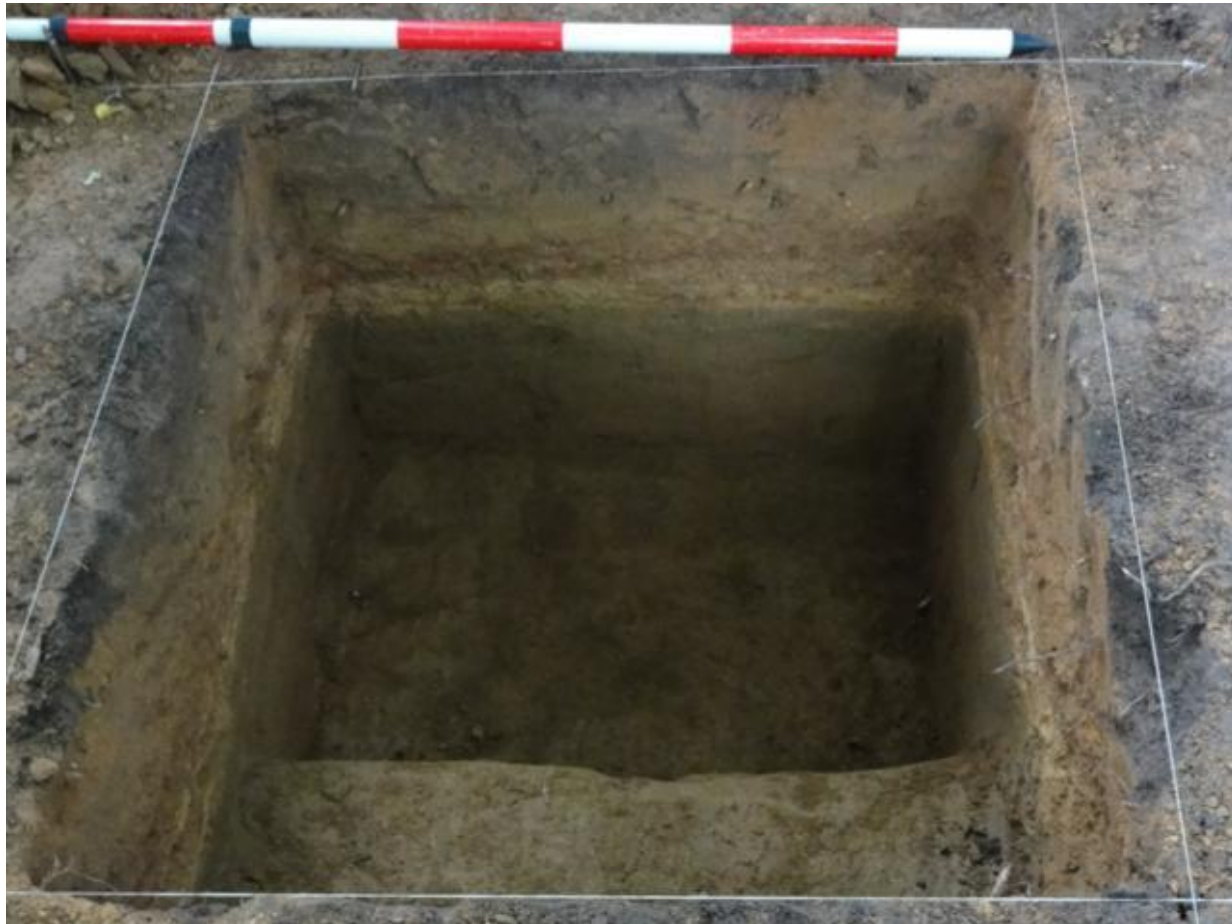
Northern Profile of K7b

Location	Kwu Tung North	Area Code	KTN	Test Pit No.	K7b
Test Pit Coordinate	828512E	841531N	Test Pit Measurement	1 m x 1 m	
Digging Method	Hand Digging		Ground Level	c.a. +24.0mPD	
Stratigraphy and Finds					
Layer	Soil Texture	Soil Colour	Finds	Chronology	
L1	Humus soil	Light Black	Nil	Modern	
L2	Silty clay with rock granules	Light Brown	Nil		
L3	Fine clay sludge	Dark Gray	Nil		
L4	Fine clay	Reddish Yellow	Nil	Regolith

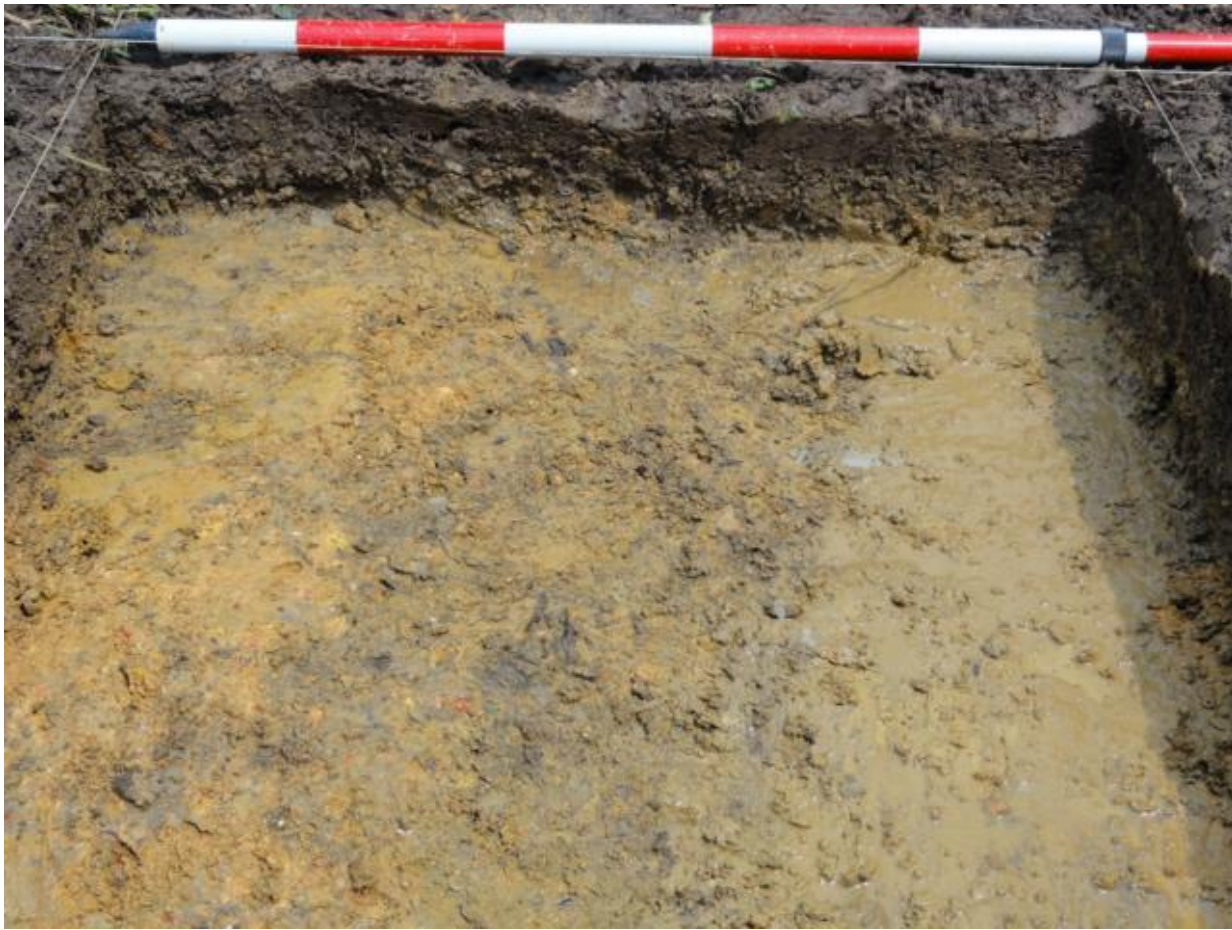
Northern Profile of K8a

Location	Kwu Tung North	Area Code	KTN	Test Pit No.	K8a
Test Pit Coordinate	827725E	841455N	Test Pit Measurement	1 m x 1 m	
Digging Method	Hand Digging		Ground Level	c.a. +22.3mPD	
Stratigraphy and Finds					
Layer	Soil Texture	Soil Colour	Finds	Chronology	
L1	Humus soil	Light Black	Nil	Modern	
L2	Clay with granules	Reddish Yellow	Nil	Regolith	
Test Pit Wall Photography

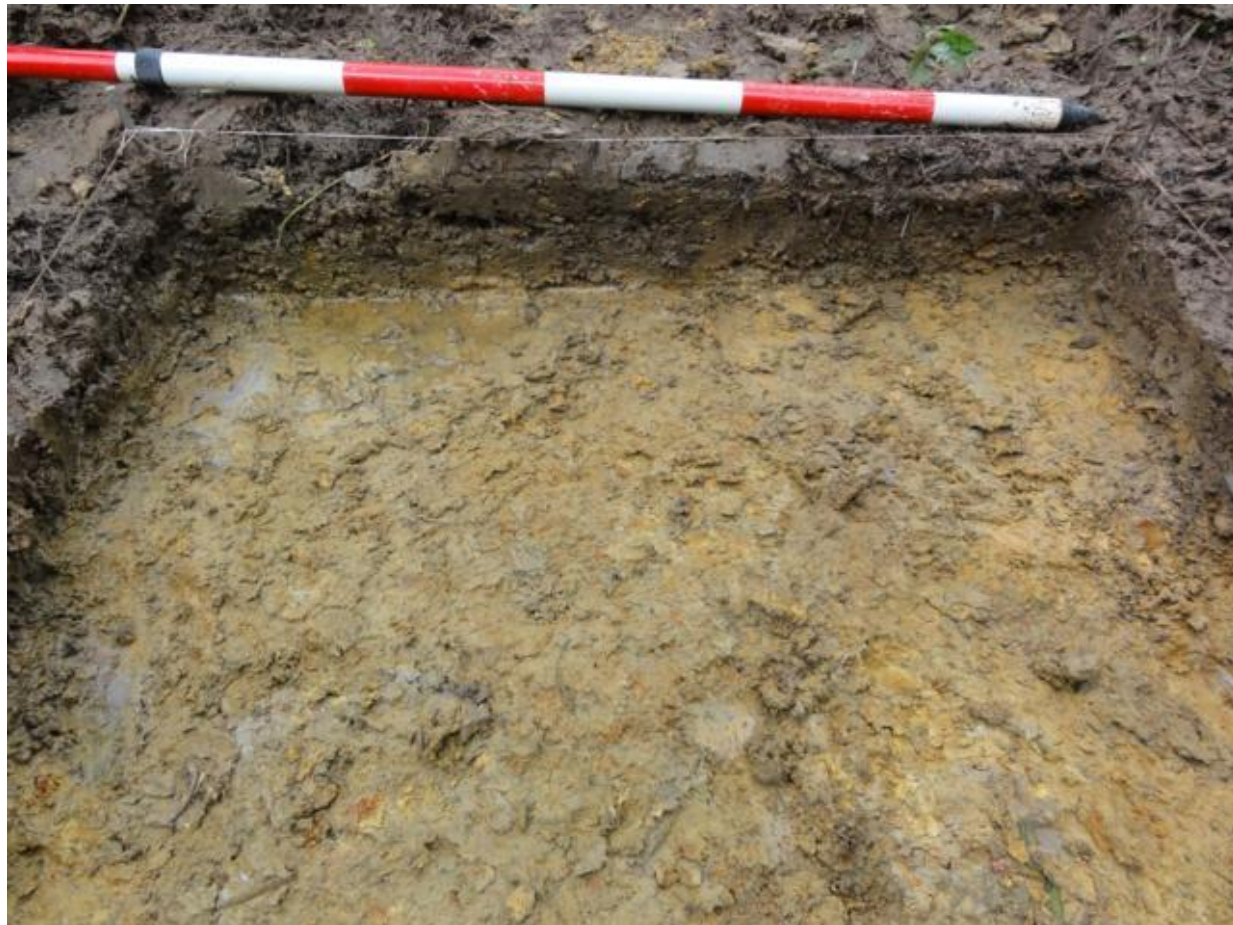
Northern Profile of K8b

Location	Kwu Tung North	Area Code	KTN	Test Pit No.	K8b
Test Pit Coordinate	827722E	841425N	Test Pit Measurement	1 m x 1 m	
Digging Method	Hand Digging		Ground Level	c.a. +22.3mPD	
Stratigraphy and Finds					
Layer	Soil Texture		Soil Colour	Finds	Chronology
L1	Humus soil		Light Black	Nil	Modern
L2	Clay with granules		Reddish Yellow	Nil	Regolith

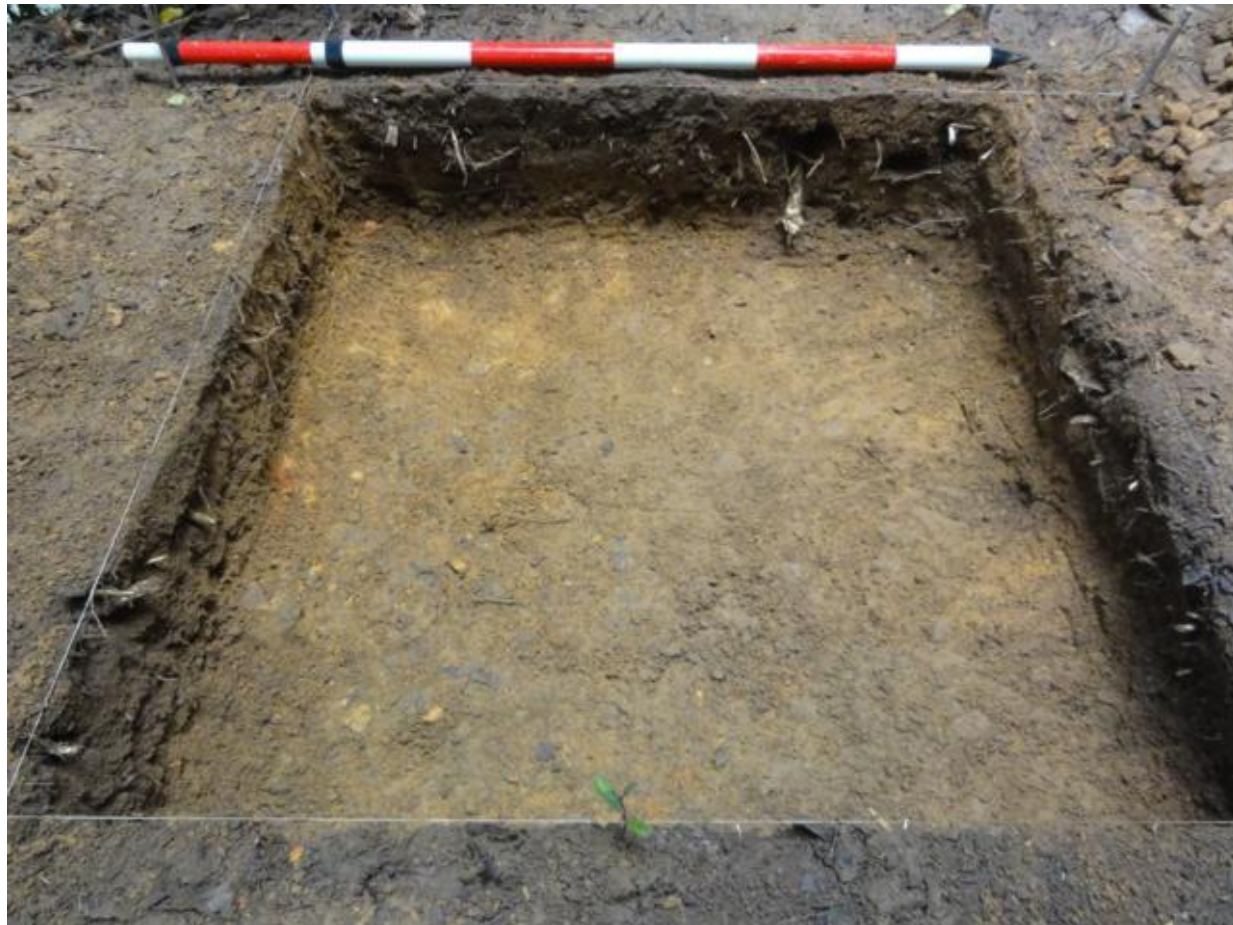
Northern Profile of K9a

Location	Kwu Tung North	Area Code	KTN	Test Pit No.	K9a
Test Pit Coordinate	828344E	841542N	Test Pit Measurement	1 m x 1 m	
Digging Method	Hand Digging		Ground Level	c.a. +22.0mPD	
Stratigraphy and Finds					
Layer	Soil Texture		Soil Colour	Finds	Chronology
L1	Humus soil with rocks		Light Black	Nil	Modern
L2	Clay with rock fragments		Reddish Yellow	Nil	Regolith

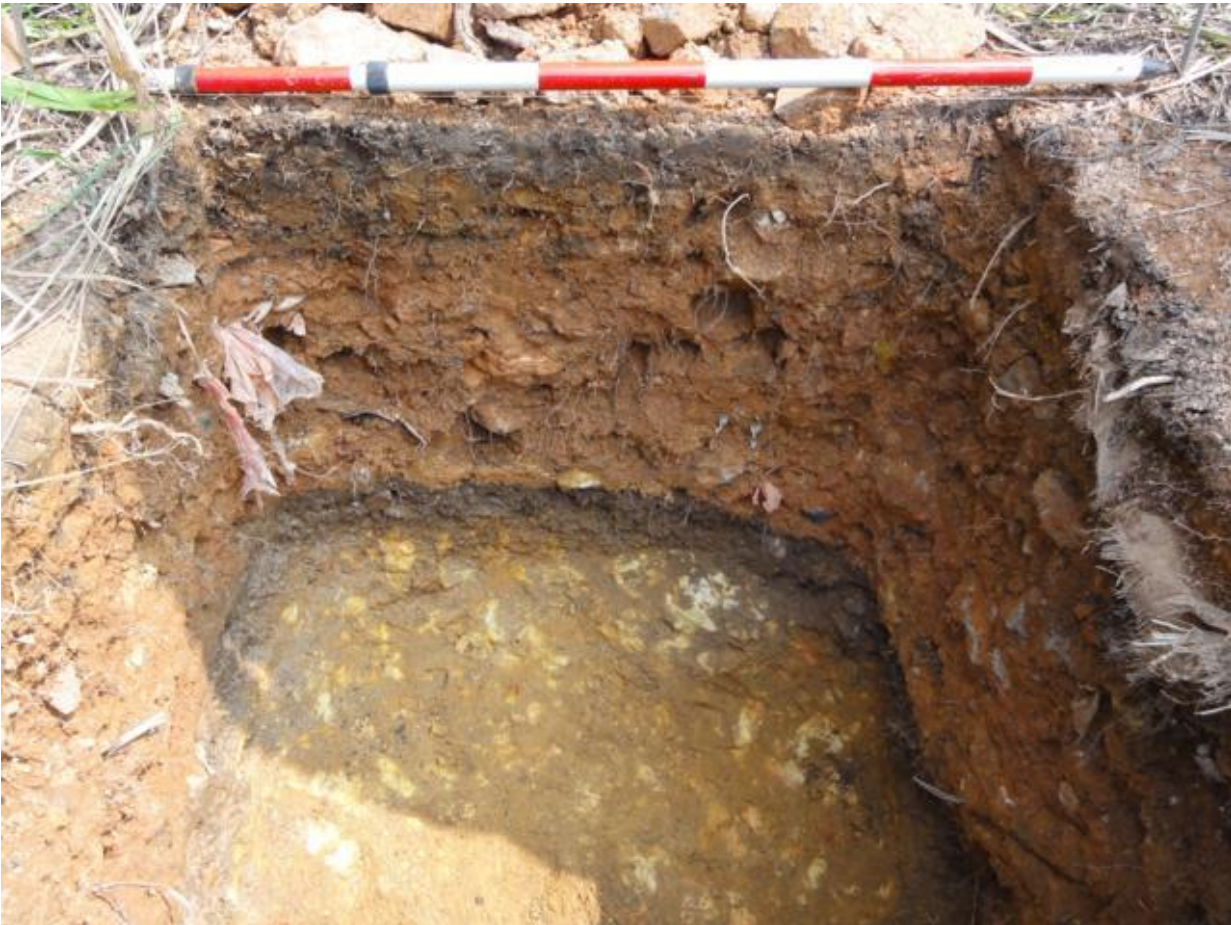
Northern Profile of K9c

Location	Kwu Tung North	Area Code	KTN	Test Pit No.	K9c
Test Pit Coordinate	828469E	841367N	Test Pit Measurement	1 m x 1 m	
Digging Method	Hand Digging		Ground Level	c.a. +25.0mPD	
Stratigraphy and Finds					
Layer	Soil Texture	Soil Colour	Finds	Chronology	
L1	Humus soil with rocks	Light Black	Nil	Modern	
L2	Clayey fill with rocks, bricks, plastic sheets, iron bars	Reddish Brown	Nil	Modern	
L3	Silty clay (original surface)	Light Black	Nil	Modern	
L4	Clay with rock fragments	Reddish Yellow	Nil	Regolith

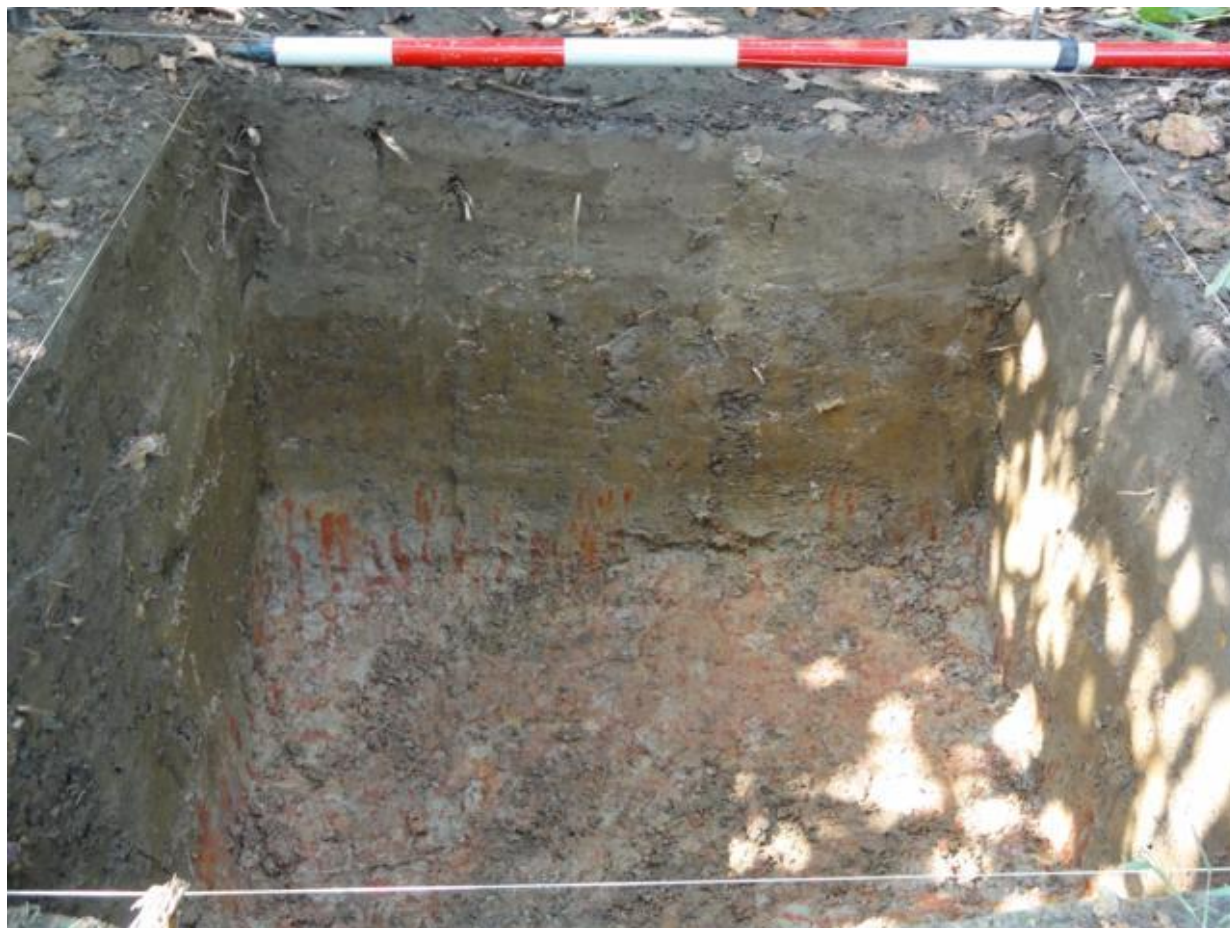
Northern Profile of K10b

Location	Kwu Tung North	Area Code	KTN	Test Pit No.	K10b
Test Pit Coordinate	828478E	841188N	Test Pit Measurement	1 m x 1 m	
Digging Method	Hand Digging		Ground Level	c.a. +11.5mPD	
Stratigraphy and Finds					
Layer	Soil Texture		Soil Colour	Finds	Chronology
L1	Humus soil		Light Black	Nil	Modern
L2	Sandy clay		Gray	Nil	
L3	Clay		Brown	Nil	
L4	Clay with rock fragments		Reddish Yellow	Nil	Regolith

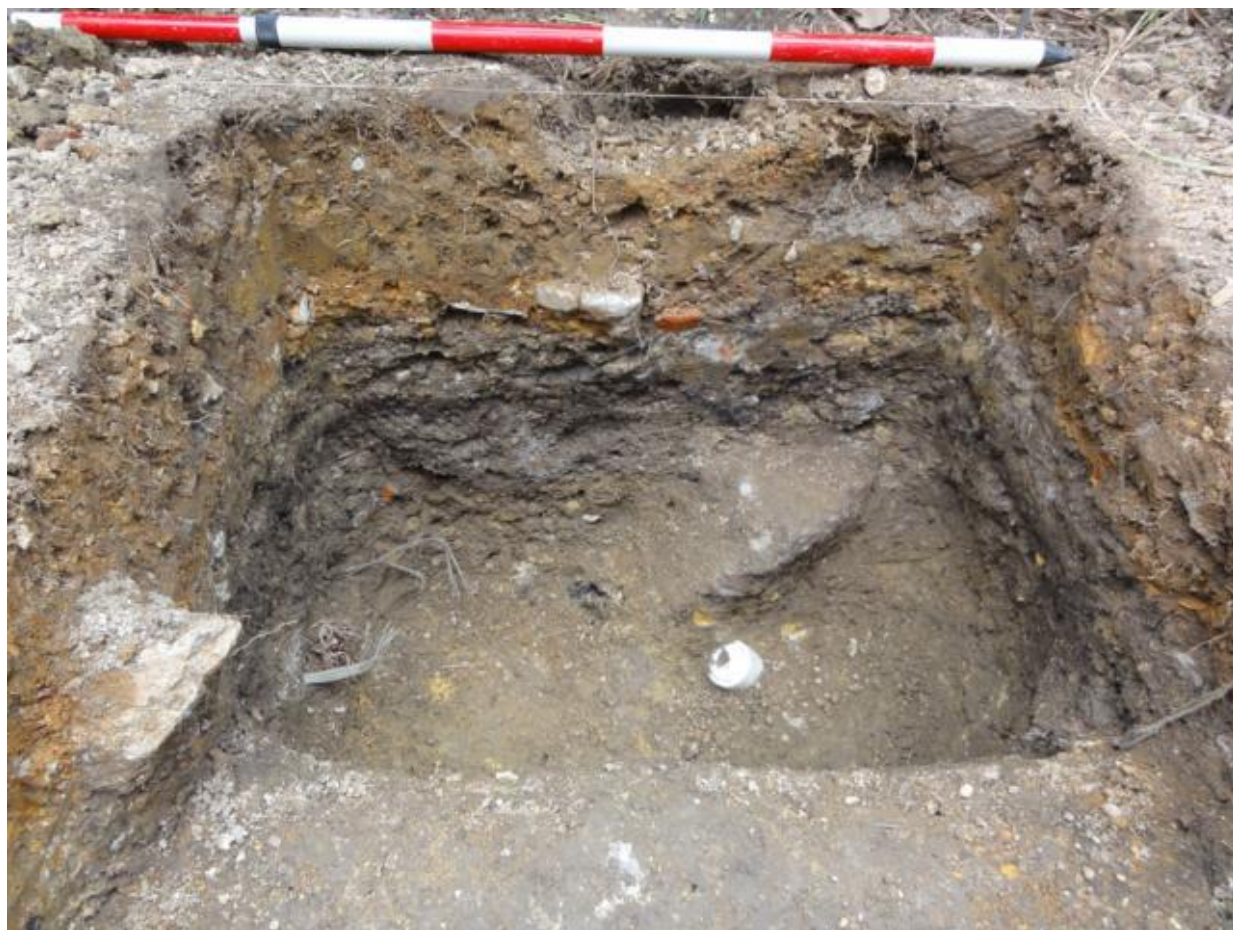
Northern Profile of K10d

Location	Kwu Tung North	Area Code	KTN	Test Pit No.	K10d
Test Pit Coordinate	828470E	841134N	Test Pit Measurement	1 m x 1 m	
Digging Method	Hand Digging		Ground Level	c.a. +12.3mPD	
Stratigraphy and Finds					
Layer	Soil Texture		Soil Colour	Finds	Chronology
L1	Humus soil		Light Black	Nil	Modern
L2	Silty fill with modern ceramics, glass and plastics		Mixed Gray, Yellow and Black	Nil	Modern

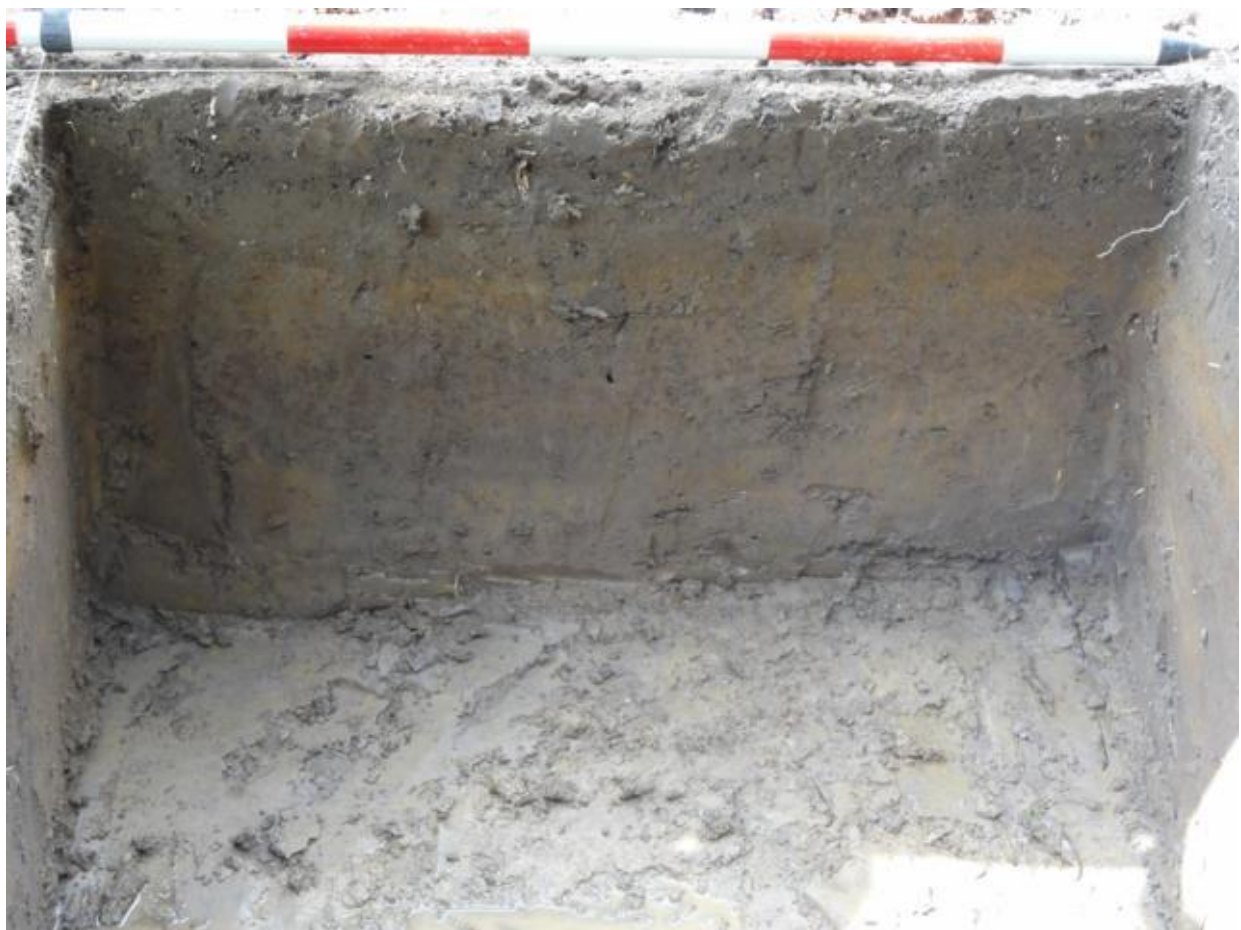
Northern Profile of K10e

Location	Kwu Tung North	Area Code	KTN	Test Pit No.	K10e
Test Pit Coordinate	828470E	841126N	Test Pit Measurement	1 m x 1 m	
Digging Method	Hand Digging		Ground Level	c.a. +11.3mPD	
Stratigraphy and Finds					
Layer	Soil Texture		Soil Colour	Finds	Chronology
L1	Humus soil		Light Black	Nil	Modern
L2	Fluvial sediment soaked with water		Mixed Yellow and Gray	Nil	Modern

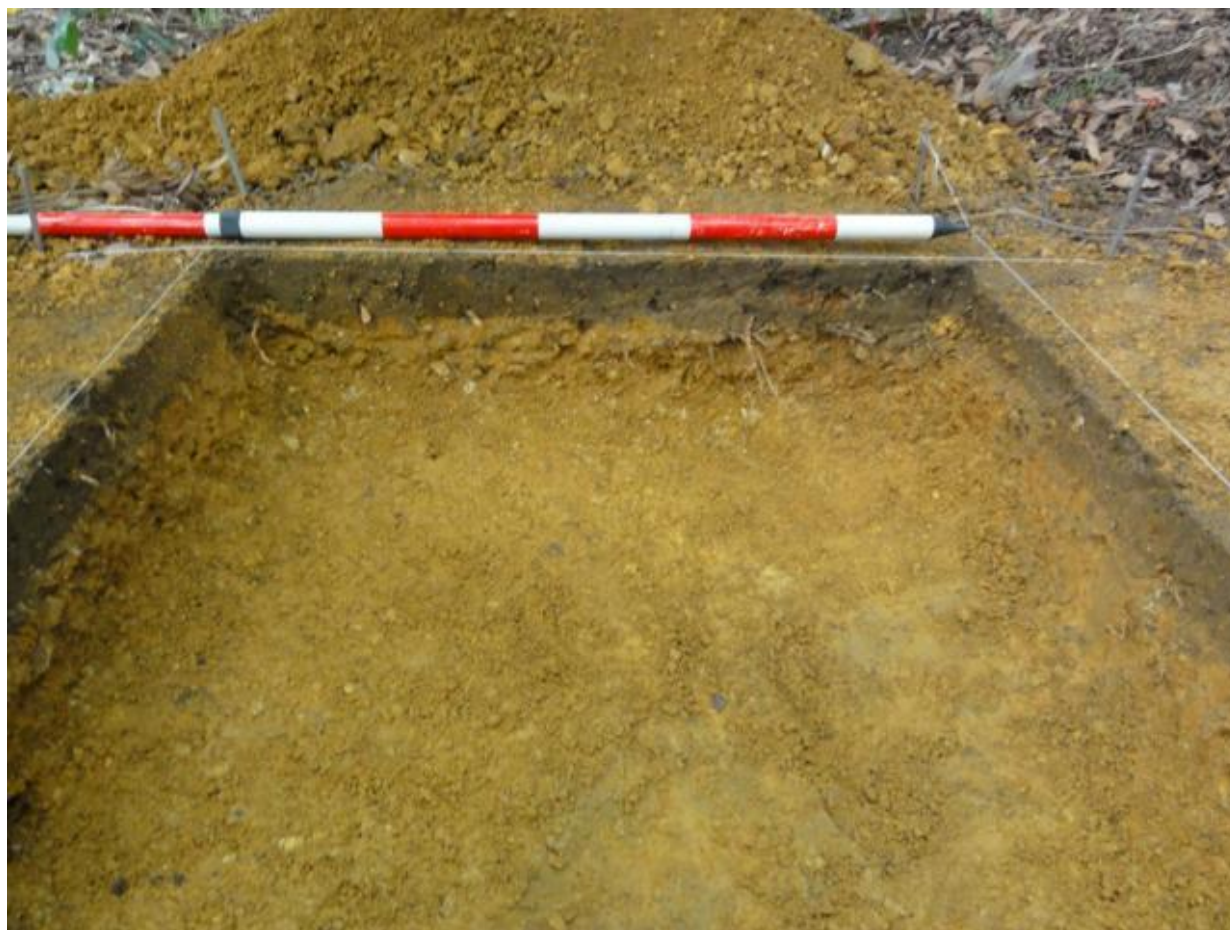
Northern Profile of K11d

Location	Kwu Tung North	Area Code	KTN	Test Pit No.	K11d
Test Pit Coordinate	828143E	842122N	Test Pit Measurement	1 m x 1 m	
Digging Method	Hand Digging		Ground Level	c.a. +10.5mPD	
Stratigraphy and Finds					
Layer	Soil Texture		Soil Colour	Finds	Chronology
L1	Loose silt		Light Black	Nil	Modern
L2	Silt with rock fragments		Yellow	Nil	Regolith
