APPENDIX A

附錄一

Test Pit and Auger Hole Recording Sheets

探方鑽孔紀錄表

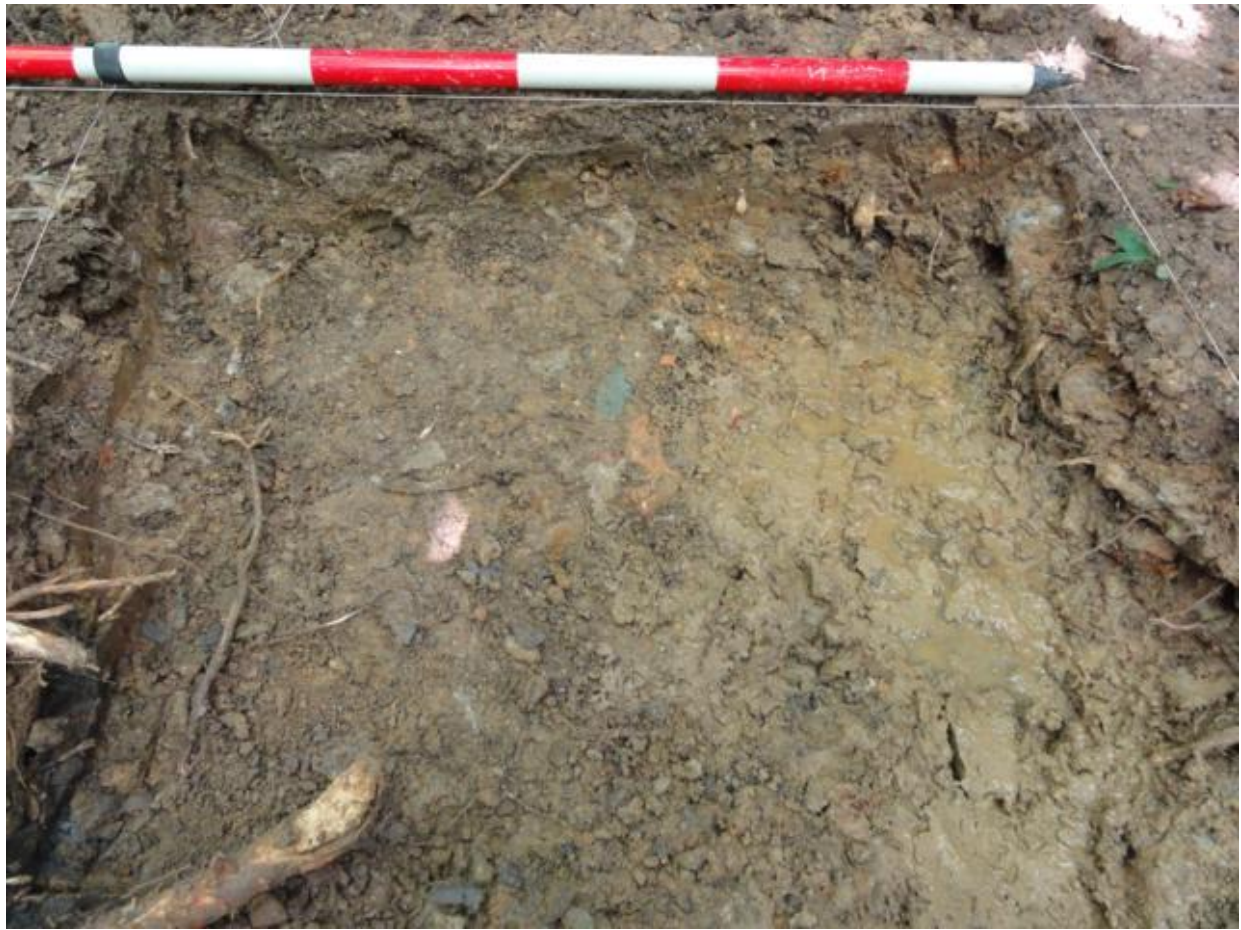
Northern Profile of K12a

Location	Kwu Tung North	Area Code	KTN	Test Pit No.	K12a
Test Pit Coordinate	829008E	841195N	Test Pit Measurement	1 m x 1 m	
Digging Method	Hand Digging		Ground Level	c.a. +8.8mPD	
Stratigraphy and Finds					
Layer	Soil Texture		Soil Colour	Finds	Chronology
L1	Humus soil		Light Black	Nil	Modern
L2	Silty fill with rock boulders		Mixed colours	Nil	Modern

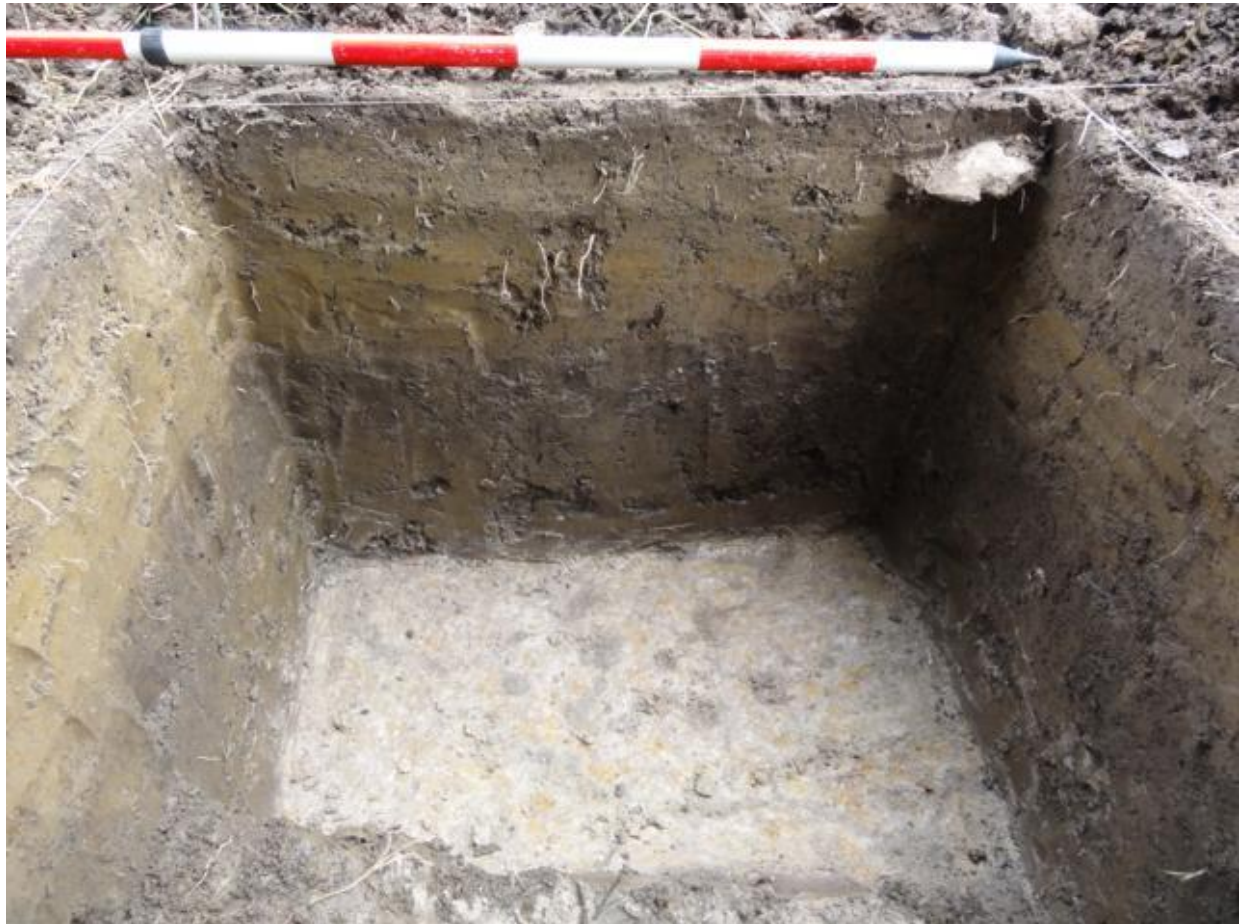
Northern Profile of K13a

Location	Kwu Tung North	Area Code	KTN	Test Pit No.	K13a
Test Pit Coordinate	828590E	841108N	Test Pit Measurement	1 m x 1 m	
Digging Method	Hand Digging		Ground Level	c.a. +9.4mPD	
Stratigraphy and Finds					
Layer	Soil Texture		Soil Colour	Finds	Chronology
L1	Humus soil		Light Black	Nil	Modern
L2	Silty clay		Grayish Yellow	Nil	
L3	Sticky clay		Blackish Brown	Nil	
L4	Sandy clay		Grayish white	Nil	Regolith

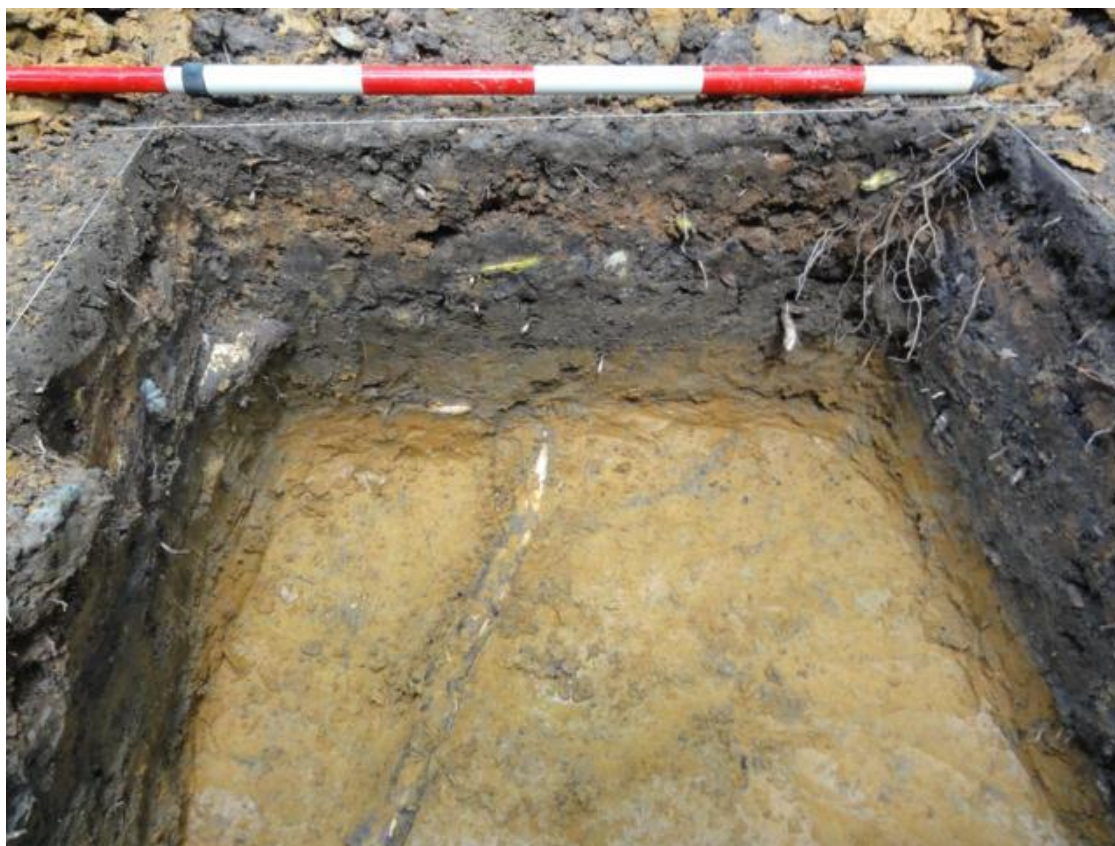
Northern Profile of K14a

Location	Kwu Tung North	Area Code	KTN	Test Pit No.	K14a
Test Pit Coordinate	829030E	841066N	Test Pit Measurement	1 m x 1 m	
Digging Method	Hand Digging		Ground Level	c.a. +8.0mPD	
Stratigraphy and Finds					
Layer	Soil Texture		Soil Colour	Finds	Chronology
L1	Humus soil		Light Black	Nil	Modern
L2	Silty clay		Yellow	Nil	
L3	Sludge		Black	Stoneware and Tile sherds	Ming dynasty
L4	Clay		Grayish Yellow	Celadon, glazed stone ware, tile sherds	Song dynasty
L5	Clay		Brown	Nil	Regolith

- 7.3.7 The other ceramic shards unearthed from Layer 4 in K14a include a grayish stoneware shard with burnished black surface and incised horizontal lines (see **Plate 7.9** in **Appendix D**), a grayish terra-cotta tile with scratching traces on the upside and textile impression on the downside (see **Plate 7.10** in **Appendix D**), and a thick rim belonging to a partially glazed brownish stoneware jar (see **Plate 7.11** in **Appendix D**).

- 7.4.2 The gray tile with textile impression from Layer 4 can also be dated to the Song dynasty based on a previous study on tiles of the Song dynasty in Hong Kong (HKIA 1999). The other shards from Layer 4 are uneasy to be dated. Therefore, the deposit of Layer 4 is now dated to the Song dynasty, but it requires further confirmation (of later dates) in the future by more supporting material unearthed from the same layer in the vicinity. Further archaeological fieldwork is recommended near test pit K14a.

- 7.5.1 The archaeological survey has been carried out in KTN through applying field methods of surface scan, auger hole and test-pit excavation. The results of the archaeological survey reveals, however, the only location in this area with identified archaeological deposit is in Ho Sheung Heung on a terrace between a small hill and a river course. This archaeological potential area in Ho Sheung Heung was found in 2000 and re-identified in this field survey (see **IAAP-1** in **Appendix E**). Based on the datable artefacts, this potential area can be dated from the Song dynasty to the Qing period. The identification of this archaeological potential area is supported by the surface collection of ceramic shards, test pitting and a small terrace landscape in front of the hill. The ceramics found in this potential area are dated to the Song to Qing periods and, more significantly, by the reveal of undisturbed deposit layers dating to the Song and the Ming periods in test pit K14a.

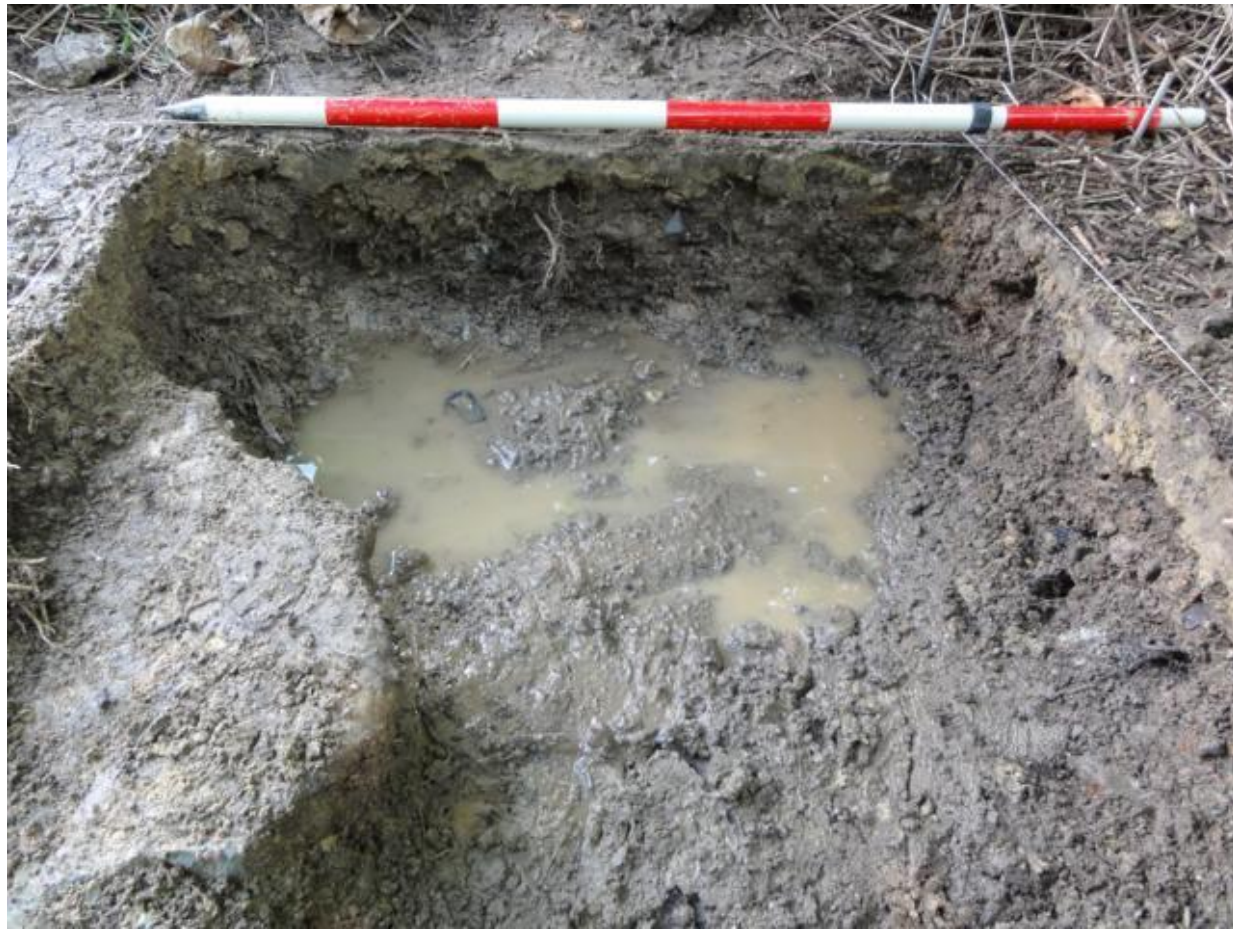
Northern Profile of K16a

Location	Kwu Tung North	Area Code	KTN	Test Pit No.	K16a
Test Pit Coordinate	829425E	840602N	Test Pit Measurement	1 m x 1 m	
Digging Method	Hand Digging		Ground Level	c.a. +6.0mPD	
Stratigraphy and Finds					
Layer	Soil Texture		Soil Colour	Finds	Chronology
L1	Humus soil		Grayish Yellow	Nil	Modern
L2	Fill with rocks and plastics		Black	Nil	Modern

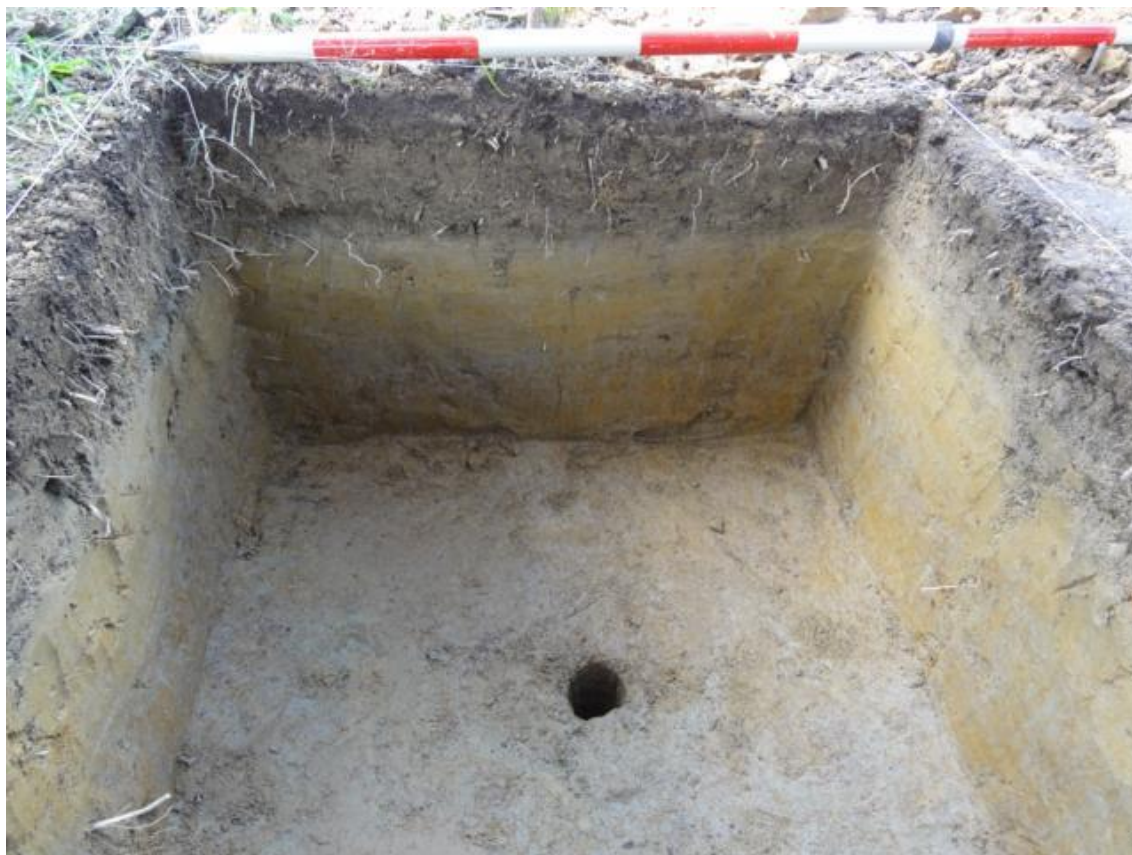
Northern Profile of K17a

Location	Kwu Tung North	Area Code	KTN	Test Pit No.	K17a
Test Pit Coordinate	829214E	840527N	Test Pit Measurement	1 m x 1 m	
Digging Method	Hand Digging		Ground Level	c.a. +5.9mPD	
Stratigraphy and Finds					
Layer	Soil Texture		Soil Colour	Finds	Chronology
L1	Loose garden soil		Light Black	Glazed ware	Modern
L2	Sandy clay		Grayish Yellow	Unglazed stoneware, glazed ware	Modern
L3	Clay		Yellowish Gray	Unglazed stoneware, glazed ware	Modern
L4	Clay		Grayish Brown	Nil	
L5	Sandy clay		Brown	Nil	
L6	Sand with cobbles		Yellowish Brown	Nil	Regolith

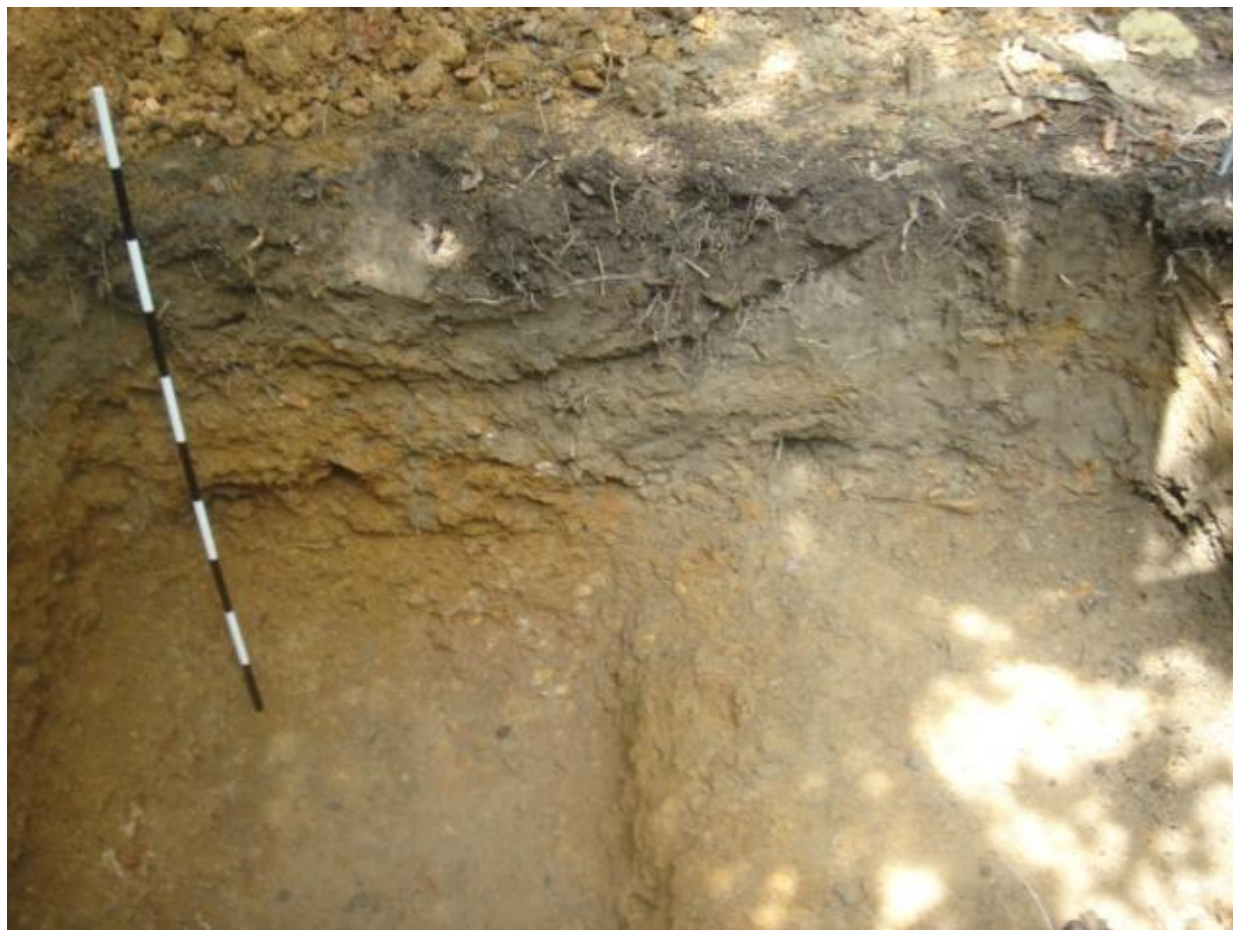
F1c Northern Profile

Location	Fanling North	Area Code	FLN	Test Pit No.	F1c
Test Pit Coordinate	830514E	841723 N	Test Pit Measurement	1.7 m × 1 m	
Digging Method	Hand Digging		Ground Level	c.a. +5.9mPD	
Stratigraphy and Finds					
Layer	Soil Texture	Soil Colour	Finds	Chronology	
L1	Sandy Silt	Dark Brown	Nil	Modern Topsoil	
L2	Clayey sand	Brownish Yellow	Shreds of blue-and-white porcelain, white wares glazed wares, pottery shards; tiles; bricks	Late Qing Subsoil	
L3	Clayey Silt	Yellow	Nil	Qing or earlier Subsoil	
L4	Sandy Clay	Reddish Yellow	Nil	Regolith	
L5	Clay	Orange	Nil	Regolith

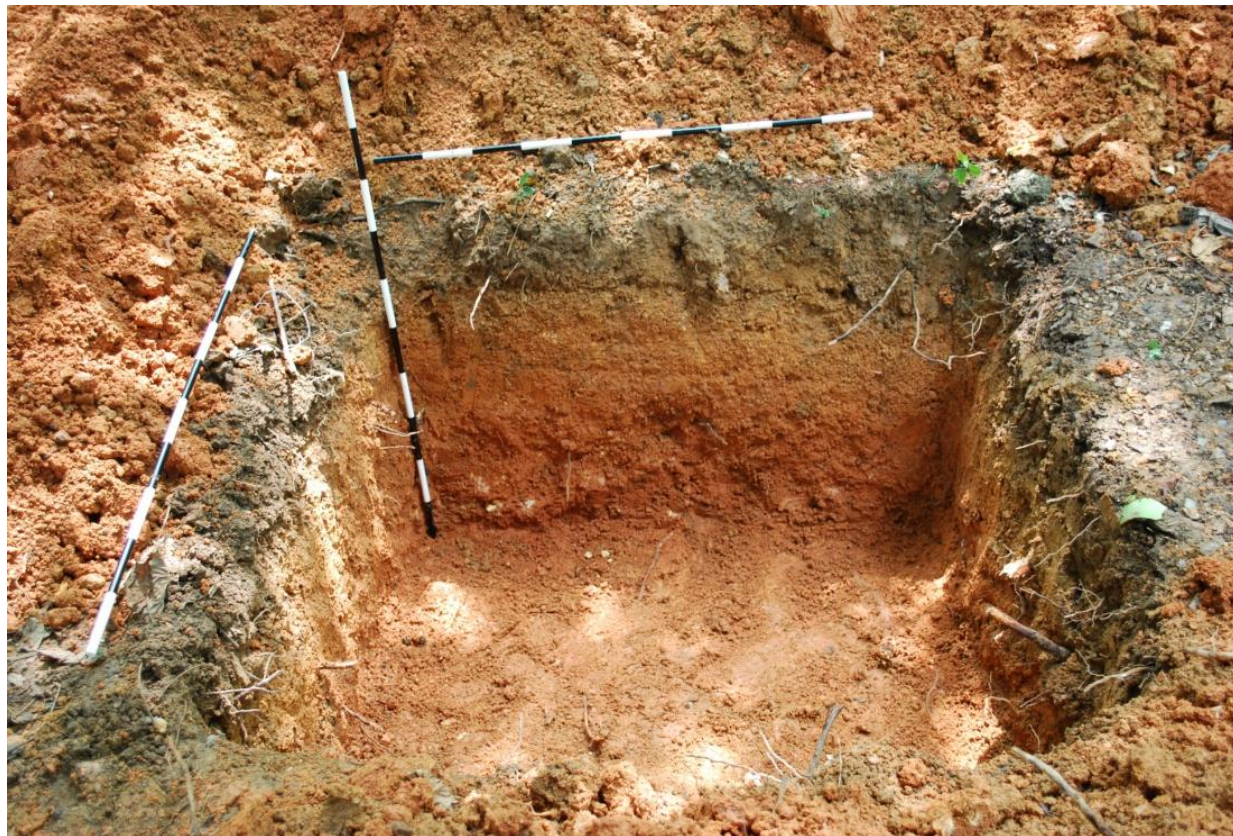
F2b Northern Profile

Location	Fanling North	Area Code	FLN	Test Pit No.	F2b
Test Pit Coordinate	830769E	841971N	Test Pit Measurement	1.2 m x 1.2 m	
Digging Method	Hand Digging		Ground Level	c.a. +18.5mPD	
Stratigraphy and Finds					
Layer	Soil Texture	Soil Colour	Finds		Chronology
L1	Clay	Dark Brown	Nil		Modern Topsoil
L2	Clayey Sand	Reddish Brown	Nil		Regolith

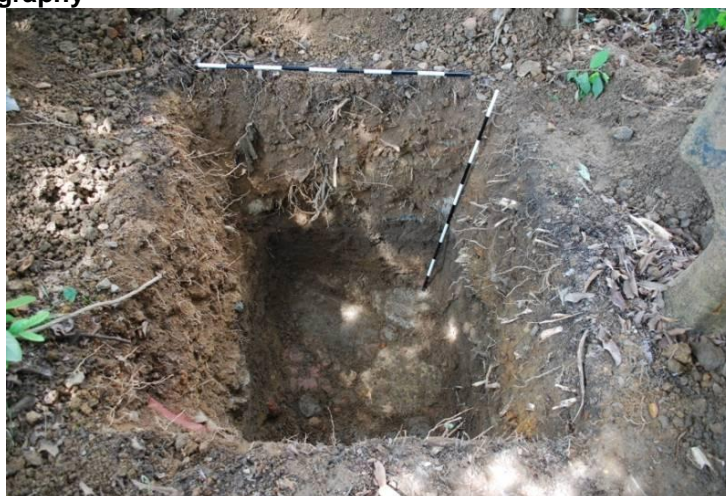
Location	Fanling North	Area Code	FLN	Test Pit No.	F4a
Test Pit Coordinate	831042E	841954N	Test Pit Measurement	1.4 m x 1.2 m	
Digging Method	Hand Digging		Ground Level	c.a. +9.5mPD	
Stratigraphy and Finds					
Layer	Soil Texture	Soil Colour	Finds		Chronology
L1	Sandy Clay	Reddish Brown	Modern ware		Modern Topsoil
L2	Clayey Sand	Greyish Brown	Blue-and-white porcelain shreds,mixed with plastic strings and concrete dumps, white wares, tiles		Late Qing Subsoil
L3	Clayey Sand	Brown	Blue-and-white porcelain shreds, village ware shreds, tiles and bricks		Late Qing Subsoil
L4	Clay	Reddish Brown	Nil		Regolith

F4a Northern Profile at a depth of c.a. 90cm

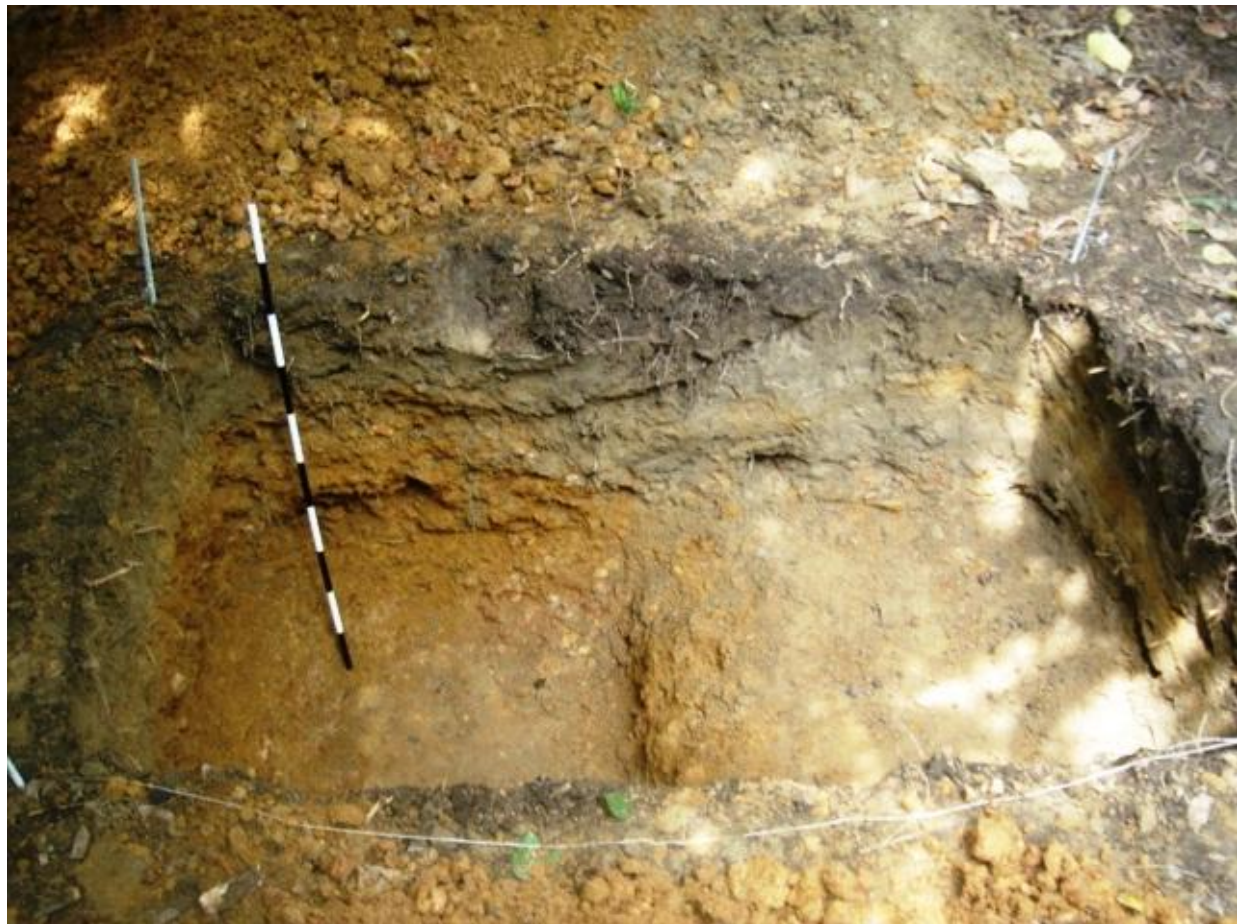
F4b Northern Profile

Location	Fanling North	Area Code	FLN	Test Pit No.	F4b
Test Pit Coordinate	831209E	841978N	Test Pit Measurement	1.6 m × 1 m	
Digging Method	Hand Digging		Ground Level	c.a. +7.9mPD	
Stratigraphy and Finds					
Layer	Soil Texture	Soil Colour	Finds	Chronology	
L1	Clayey Silt	Greyish Brown	Tiles, bricks	Modern Topsoil	
L2	Sandy Silt	Dull Yellow Orange	Nil	Regolith	
L3	Clay with (quartz) pebbles	Orange	Nil	Bedrock

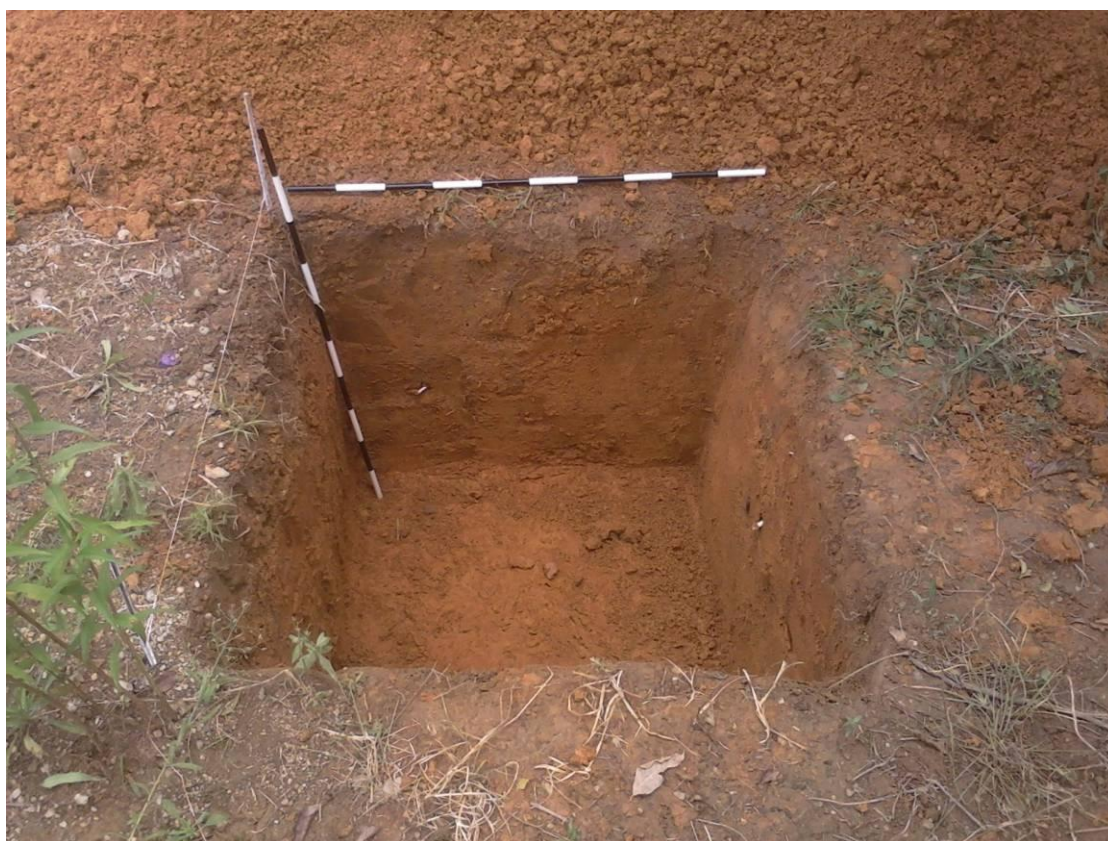
F6a Northern Profile

Location	Fanling North	Area Code	FLN	Test Pit No.	F6a
Test Pit Coordinate	831899E	841512N	Test Pit Measurement	1 m x 1 m	
Digging Method	Hand Digging		Ground Level	c.a. +10.3mPD	
Stratigraphy and Finds					
Layer	Soil Texture	Soil Colour	Finds		Chronology
L1	Clayey Sand	Dark Brown	Nil		Modern Topsoil
L2	Clayey Silt	Reddish Brown	Nil		Regolith

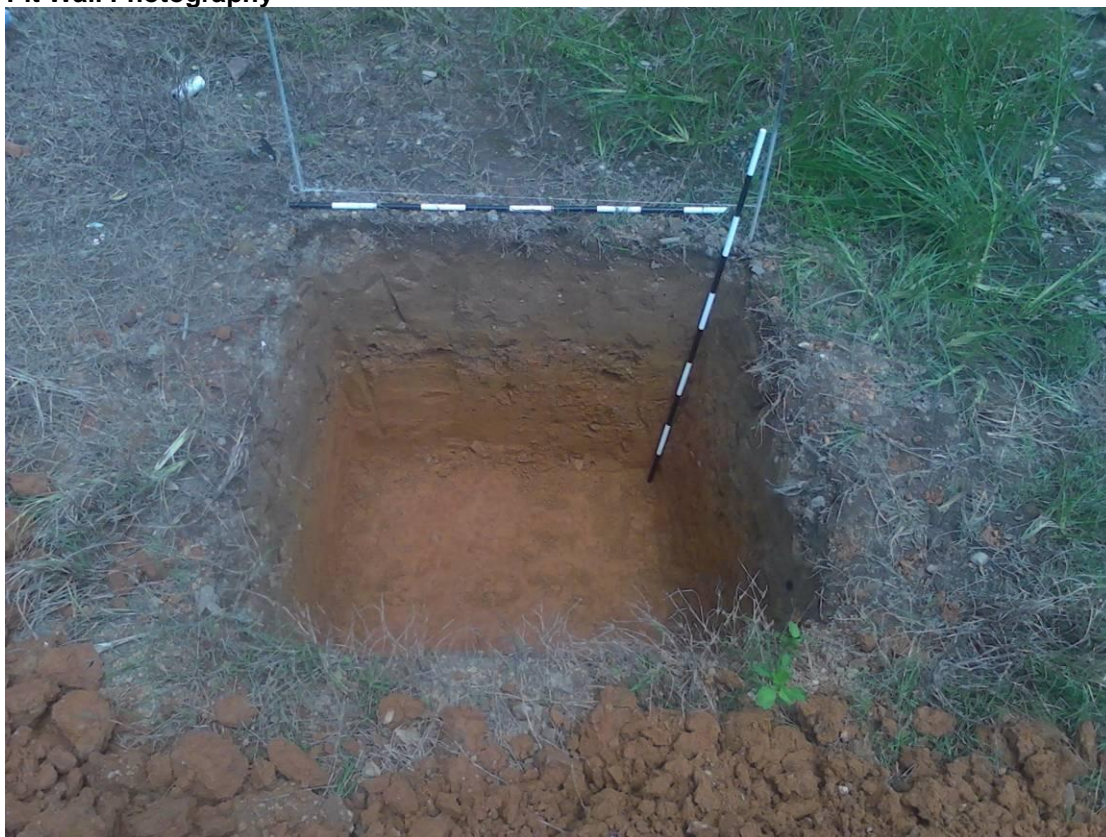
F6c Northern Profile

Layer	Soil Texture	Soil Colour	Finds	Chronology
L1	Clayey Sand	Greyish Brown	Modern rubbish	Modern Topsoil
L2	Clay	Yellowish Brown	Nil	Subsoil
L3	Clayey Sand	Reddish Brown	Nil	Regolith

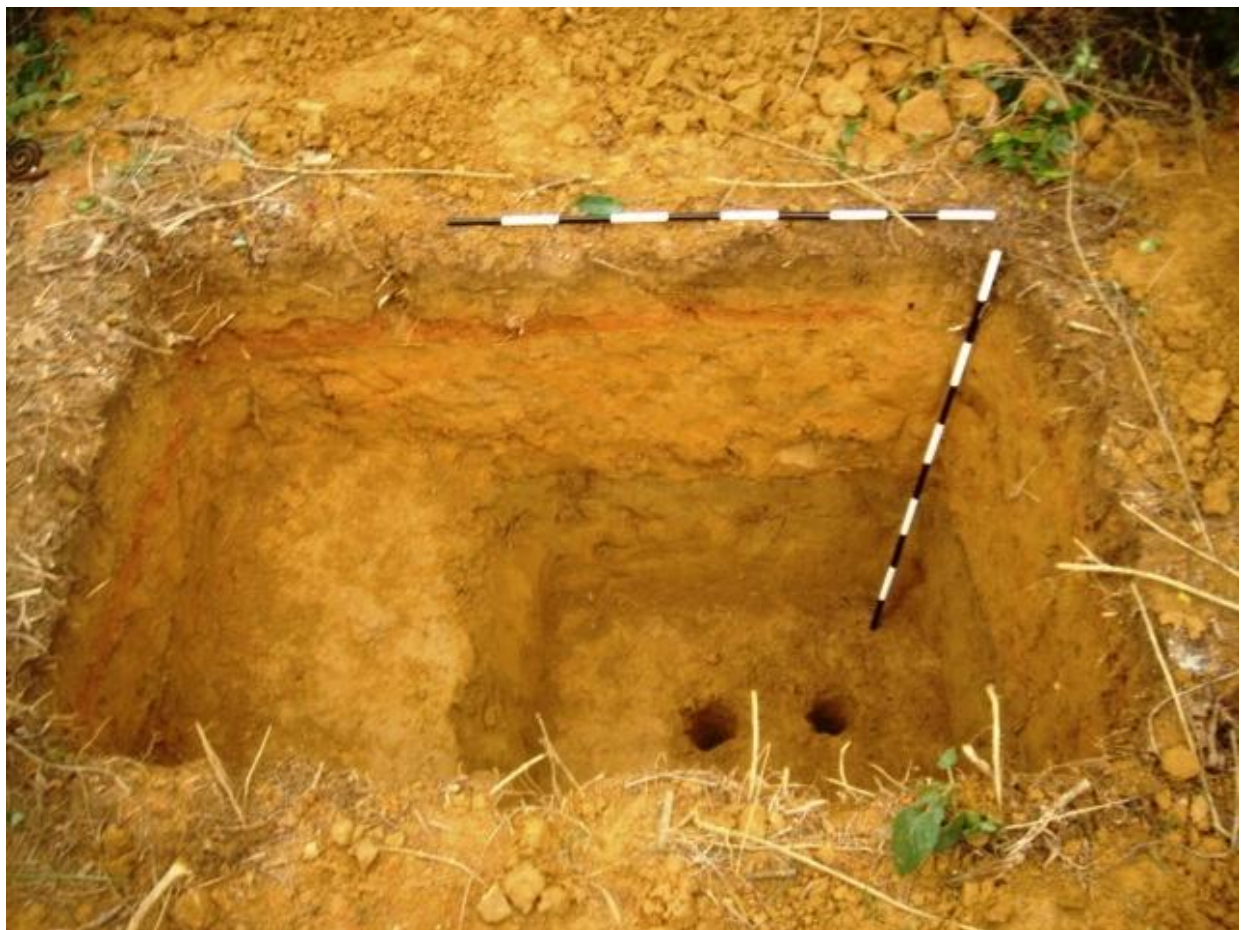
Western Profile of F6g

Location	Fanling North	Area Code	FLN	Test Pit No.	F6g
Test Pit Coordinate	832000E	841454N	Test Pit Measurement	1.6 m x 1 m	
Digging Method	Hand Digging		Ground Level	c.a. +16.5mPD	
Stratigraphy and Finds					
Layer	Soil Texture	Soil Colour	Finds	Chronology	
L1	Sandy Loam	Greyish Brown	Nil	Modern Topsoil	
L2	Clayey Sand	Dull Orange	Nil	Modern Subsoil	
L3	Clayey Loam	Orange	Nil	Modern fill soil of school foundation	
L4	Clayey Loam	Light Yellow Orange	Nil	In situ soil prior to the school construction	
L5	Sandy Loam	Greyish Brown	Nil	Regolith	
L6	Bedrock	Reddish Brown	Nil	Bedrock	
Test Pit Wall Photography

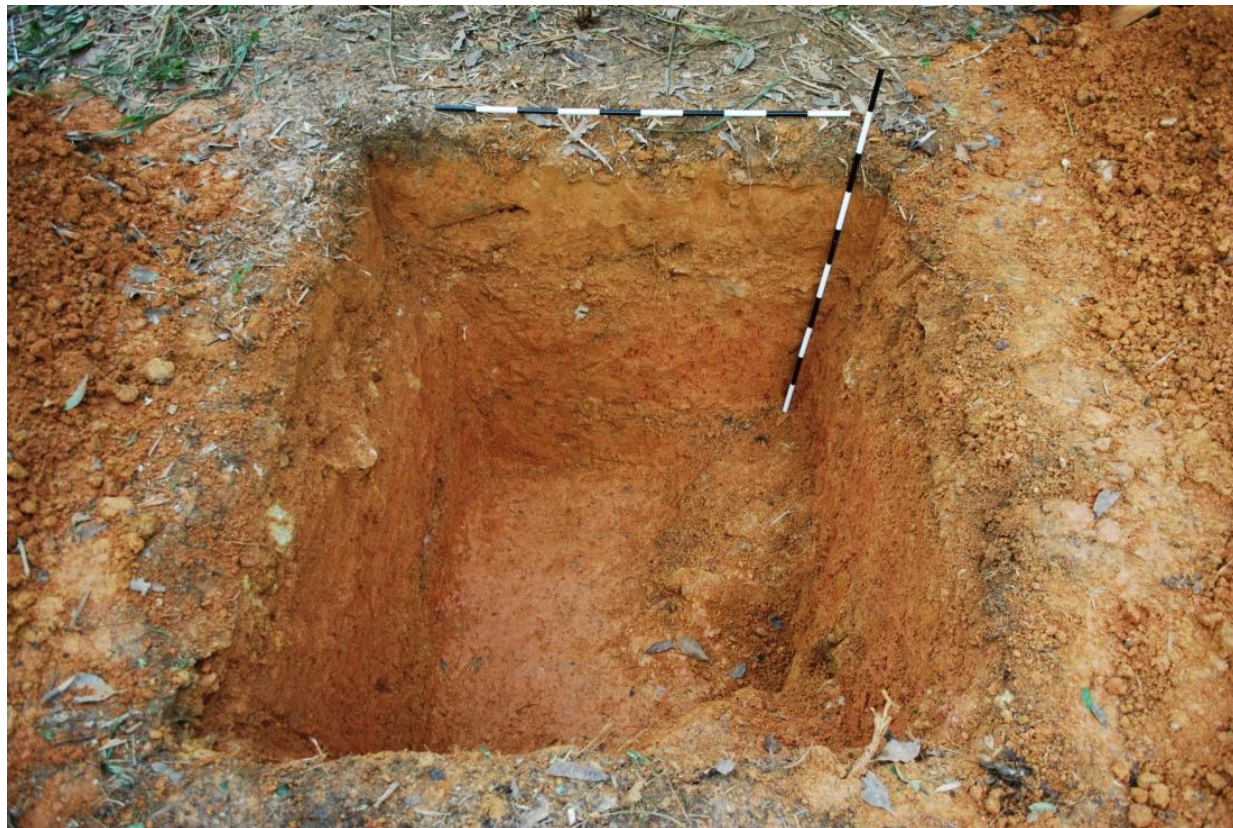
F6h Northern Profile

Location	Fanling North	Area Code	FLN	Test Pit No.	F6h
Test Pit Coordinate	832041E	841455N	Test Pit Measurement	1.6 m × 1.2 m	
Digging Method	Hand Digging		Ground Level	c.a. +16.9mPD	
Stratigraphy and Finds					
Layer	Soil Texture	Soil Colour	Finds		Chronology
L1	Clay	Dark Brown	Nil		Modern Topsoil
L2	Clayey Silt	Orange Brown	Nil		Regolith

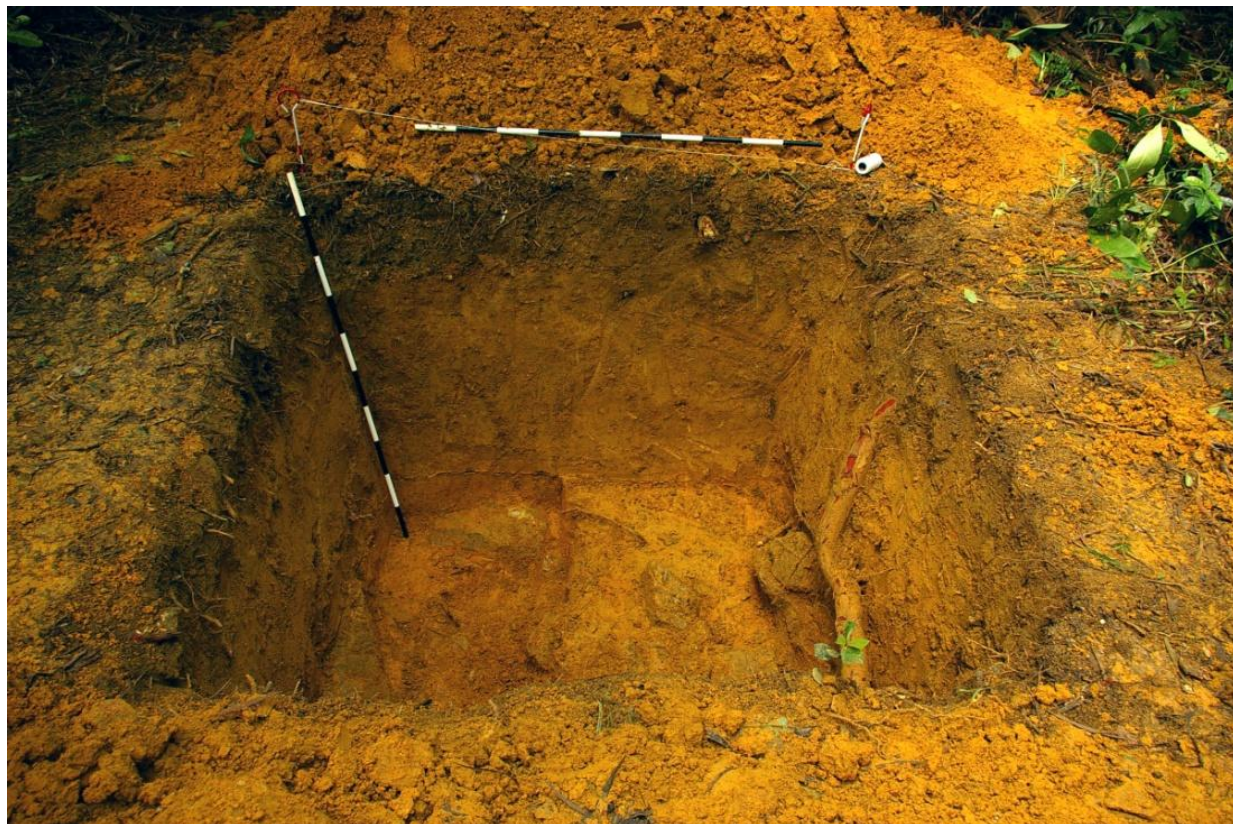
F6j Northern Profile

Location	Fanling North	Area Code	FLN	Test Pit No.	F6j
Test Pit Coordinate	832120E	841489N	Test Pit Measurement	1.5 m x 1.4 m	
Digging Method	Hand Digging		Ground Level	c.a. +22.7mPD	
Stratigraphy and Finds					
Layer	Soil Texture	Soil Colour	Finds		Chronology
L1	Clayey Silt	Dark Brown	Nil		Modern Topsoil
L2	Clayey Silt	Brownish Yellow	Nil		Subsoil
L3	Clayey Silt	Reddish Brown	Nil		Regolith

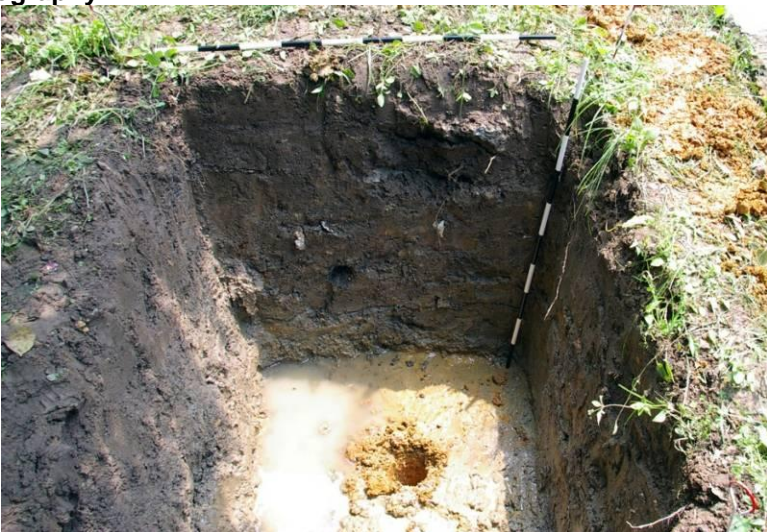
F7a Eastern Profile

Location	Fanling North	Area Code	FLN	Test Pit No.	F7a
Test Pit Coordinate	831860E	840527N	Test Pit Measurement	1.1 m x 1.1 m	
Digging Method	Hand Digging		Ground Level	c.a. +8.8mPD	
Stratigraphy and Finds					
Layer	Soil Texture	Soil Colour	Finds		Chronology
L1	Clayey Silt	Yellowish Brown	Nil		Modern Topsoil
L2	Clayey Silt	Greyish Brown	Nil		Modern Subsoil
L3	Clayey Silt	Greyish Yellow	Nil		Alluvium
L4	Clayey Silt	Orange Red	Nil		Regolith
L5	Clayey Silt	Bright Orange Red	Nil		Regolith

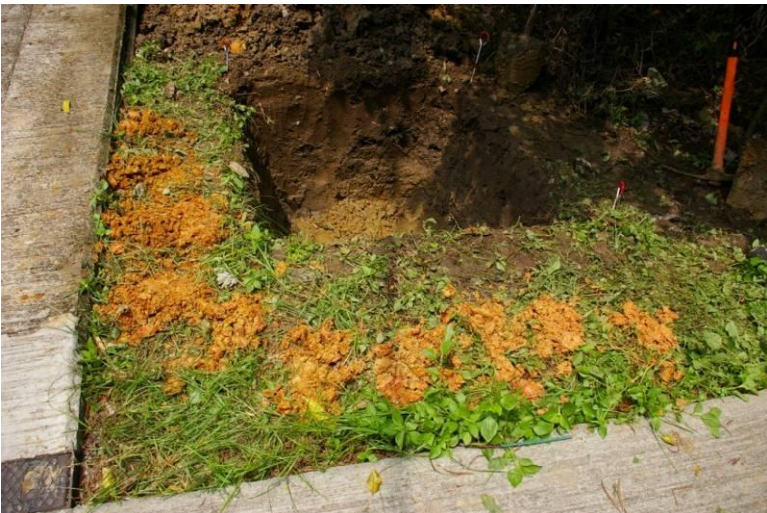
F7a Soil of L4 and L5

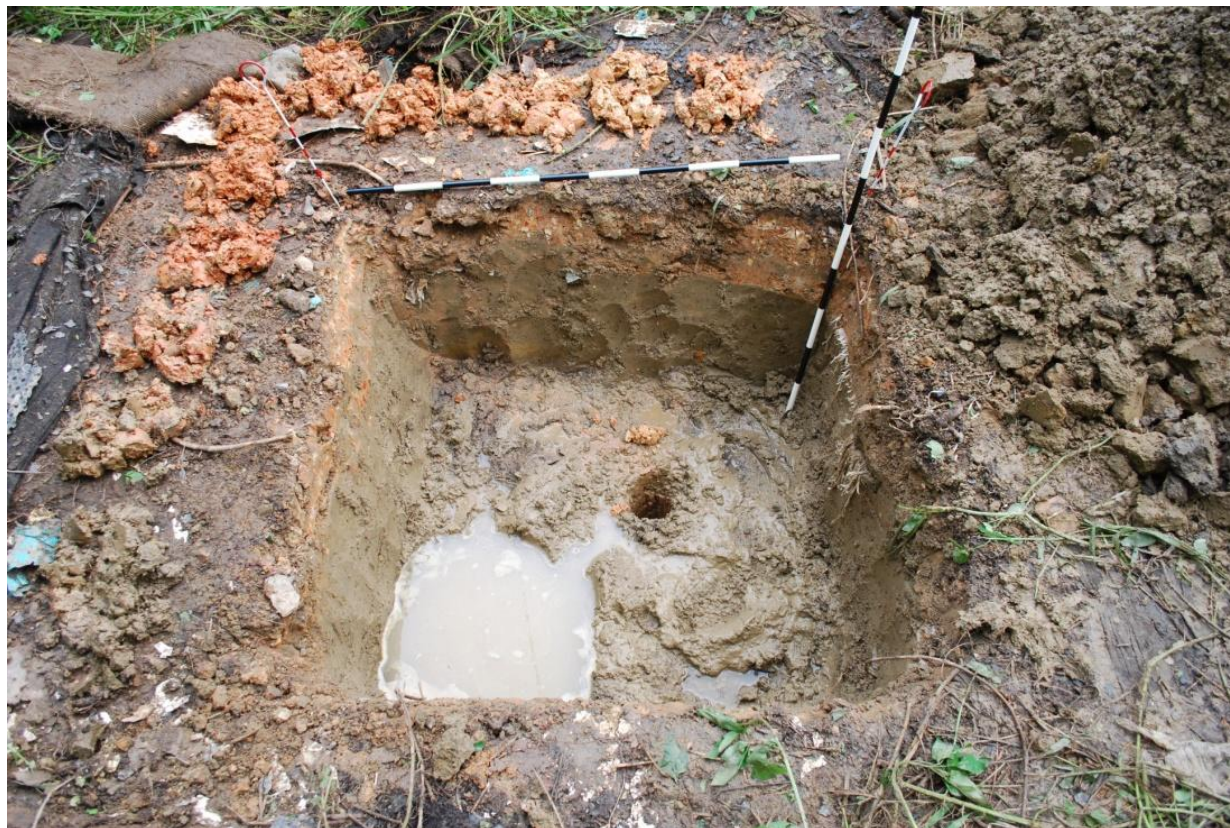
Location	Fanling North	Area Code	FLN	Test Pit No.	F8a
Test Pit Coordinate	832190E	840499N	Test Pit Measurement	1 m x 1 m	
Digging Method	Hand Digging		Ground Level	c.a. +8.6mPD	
Stratigraphy and Finds					
Layer	Soil Texture	Soil Colour	Finds		Chronology
L1	Reddish Brown	Clayey Sand	Nil		Modern Fill soil
L2	Greyish Brown	Clayey Silt	Nil; underground water emerged at c.a. 40cm deep		Modern
L3	Reddish Brown	Clay	Nil		Regolith

F8a Northern Profile with Soil from L3 near the top of the photo

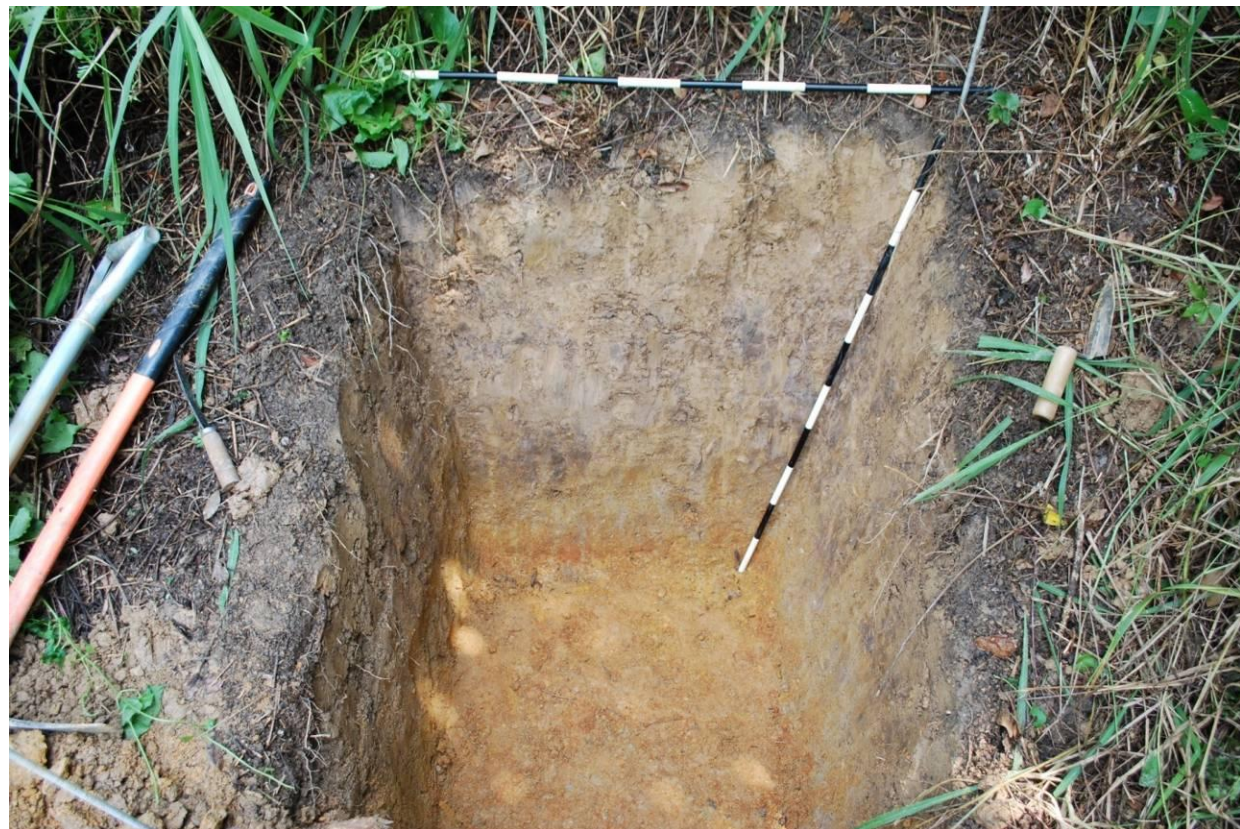
Northern Profile of P1a

Location	Ping Che –Ta Kwu Ling	Area Code	PC/TKL	Test Pit No.	P1a
Test Pit Coordinate	834 628E	844 338N	Test Pit Measurement	1m x 1m	
Digging Method	Hand Digging		Ground Level	c.a. +15.6mPD	
Stratigraphy and Finds					
Layer	Soil Texture	Soil Colour	Finds		Chronology
L1	Clay	Greyish Brown	Nil		Modern
L2	Clayey Silt	Brown	Nil		
L3	Clayey Sand	Reddish Yellow	Nil		Regolith

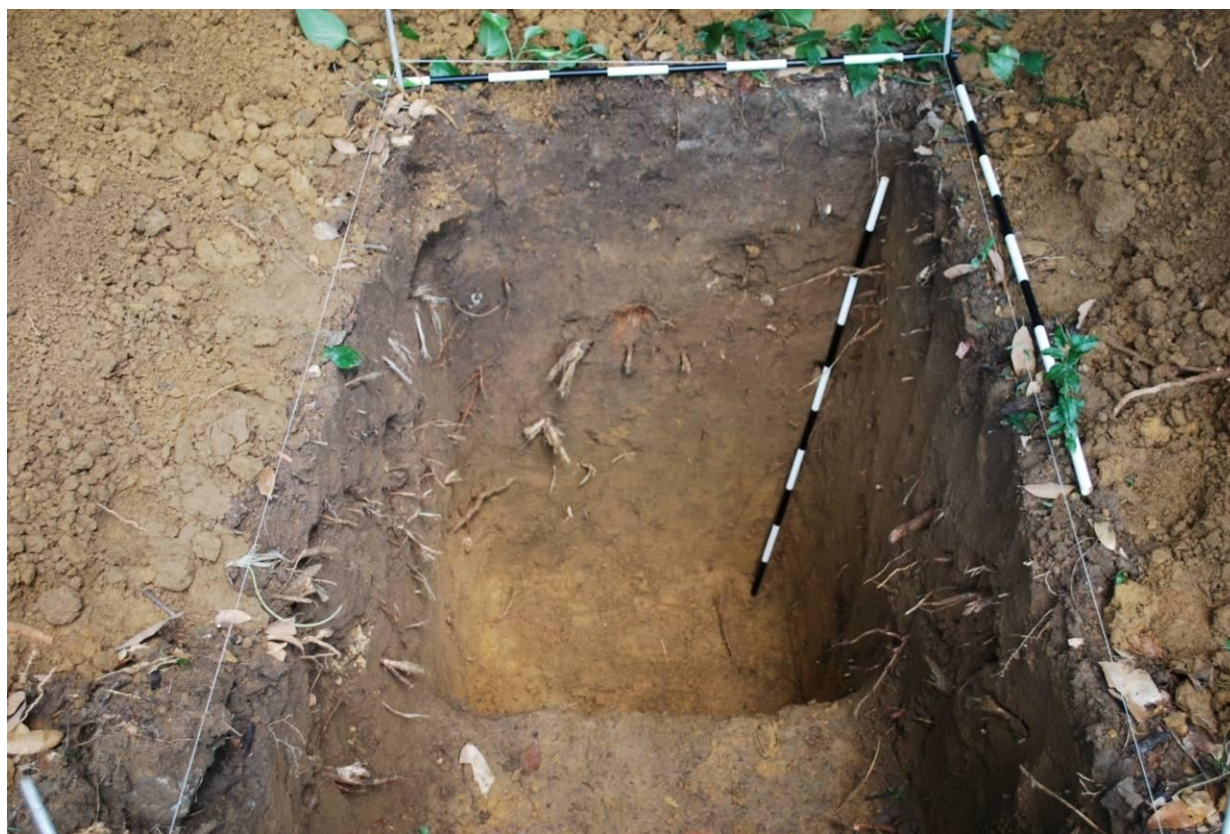
Northern Profile of P2a

Location	Ping Che –Ta Kwu Ling	Area Code	PC/TKL	Test Pit No.	P2a
Test Pit Coordinate	834 452E	843 790N	Test Pit Measurement	1.6m x 1m	
Digging Method	Hand Digging		Ground Level	c.a. +14.5mPD	
Stratigraphy and Finds					
Layer	Soil Texture	Soil Colour	Finds		Chronology
L1	Clay	Blackish Brown	Nil		
L2	Clay	Yellowish Brown	Nil		
L3	Clay	Light Yellowish Brown	Nil		Regolith

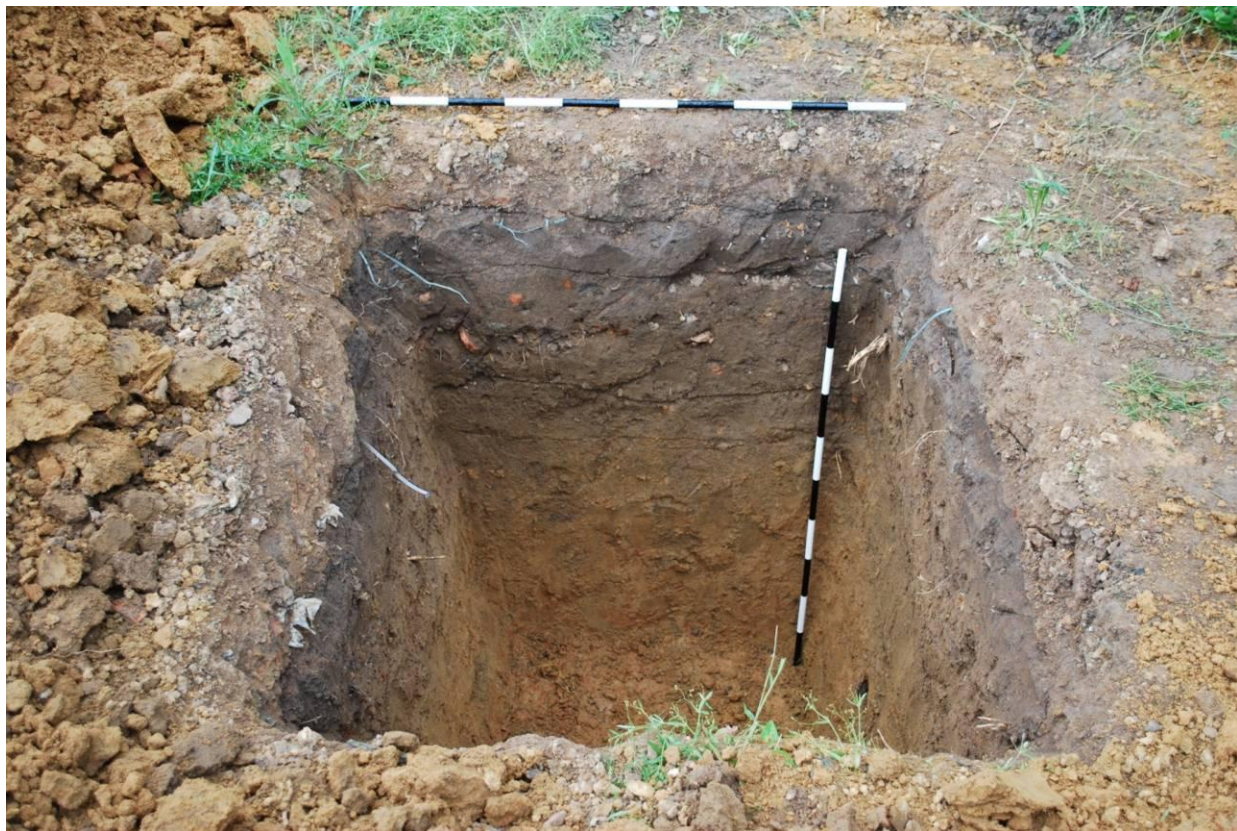
Northern Profile of P8c

Location	Ping Che –Ta Kwu Ling	Area Code	PC/TKL	Test Pit No.	P8c
Test Pit Coordinate	834 485E	843 197N	Test Pit Measurement	1m x 1m	
Digging Method	Hand Digging		Ground Level	c.a. +15.5mPD	
Stratigraphy and Finds					
Layer	Soil Texture	Soil Colour	Finds	Chronology	
L1	Silty Sand	Brown	Pottery shards, tiles	Modern	
L2	Clayey Sand	Dark Brown	Blue-and-white Porcelain bowl fragment, plastic	Modern	
L3	Clayey Sand	Yellowish Brown	Blue-and-white Porcelain, pottery shreds, tile fragments	Qing	
L4	Clayey Silt	Yellowish Brown	Nil		
L5	Silty Clay	Reddish Brown	Nil	Regolith

- 9.4.4 調查發掘及鑽探在大多數地點沒有觀察到具考古意義的遺蹟。雖然如此，P8c、P8d 以及 P7b 的出土物包含日用器皿及建築材料，表明在清代初期至晚期之間這些地點附近曾有人居住。然而，元下村的 P7b 鑽孔發現支離破碎，曾受到干擾，所以未能提供年代信息。隔田的 P8c 及 P8d 探方中發現穩定文化層，因此被認作是具考古潛質區域。
- 9.4.5 對兩個具考古潛質區域的判斷基於地表採集到的陶片、探方發掘結果以及區域附近的河流階地地貌及穩定文化層，在上述兩個具考古潛質區域出土的陶片可追溯至清代。
