APPENDIX A

附錄一

Test Pit and Auger Hole Recording Sheets

探方鑽孔紀錄表

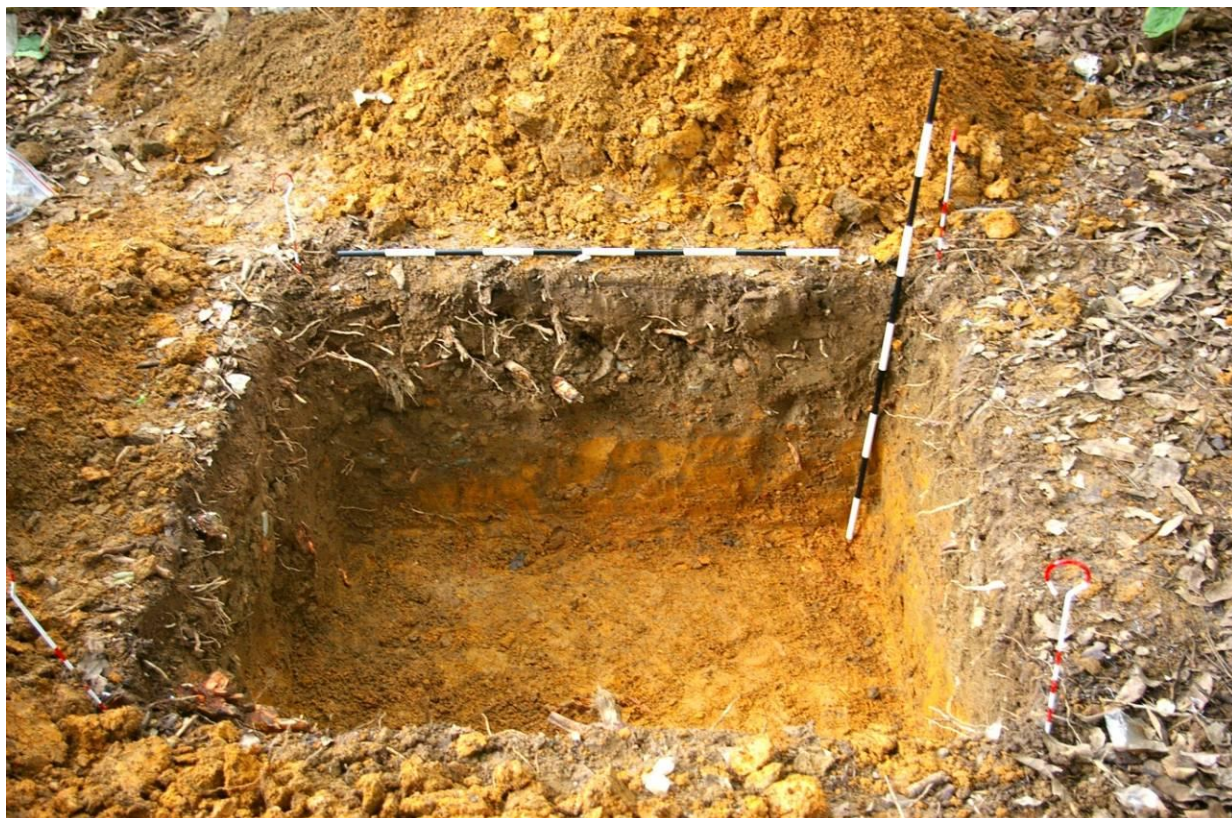
Northern Profile of P8d

Location	Ping Che –Ta Kwu Ling	Area Code	PC/TKL	Test Pit No.	P8d
Test Pit Coordinate	834 644E	843 185N	Test Pit Measurement	1.2m x 1.2m	
Digging Method	Hand Digging		Ground Level	c.a. +15.3mPD	
Stratigraphy and Finds					
Layer	Soil Texture	Soil Colour	Finds	Chronology	
L1	Clayey Silt	Dark Brown	Tiles, bricks, porcelain and pot shreds	Qing to Modern	
L2	Clayey Silt	Orangish Yellow	Nil	Regolith

- 9.4.4 調查發掘及鑽探在大多數地點沒有觀察到具考古意義的遺蹟。雖然如此，P8c、P8d 以及 P7b 的出土物包含日用器皿及建築材料，表明在清代初期至晚期之間這些地點附近曾有人居住。然而，元下村的 P7b 鑽孔發現支離破碎，曾受到干擾，所以未能提供年代信息。隔田的 P8c 及 P8d 探方中發現穩定文化層，因此被認作是具考古潛質區域。
- 9.4.5 對兩個具考古潛質區域的判斷基於地表採集到的陶片、探方發掘結果以及區域附近的河流階地地貌及穩定文化層，在上述兩個具考古潛質區域出土的陶片可追溯至清代。

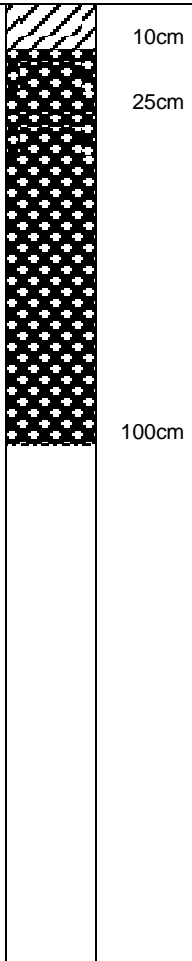
Location	Kwu Tung North	Area Code	KTN	Auger Hole No.	K2b																									
Auger Hole Coordinate	828030E	841980N	Auger Hole Drill Size	10cm diameter																										
Augering Method	Hand Augering		Ground Level	c.a. +18.0 mPD																										
SOIL PROFILE	DEPTH (CM)	STRATUM	SOIL COLOUR	SOIL TEXTURE	FINDS	REMARKS																								
Ground Surface

10cm	L1	Light Black	Loamy soil																										
	25cm	L2	Light Yellow	Loose clay																										
	100cm	L3	Reddish Yellow	Clay		Regolith																								
Legend			Interpretation

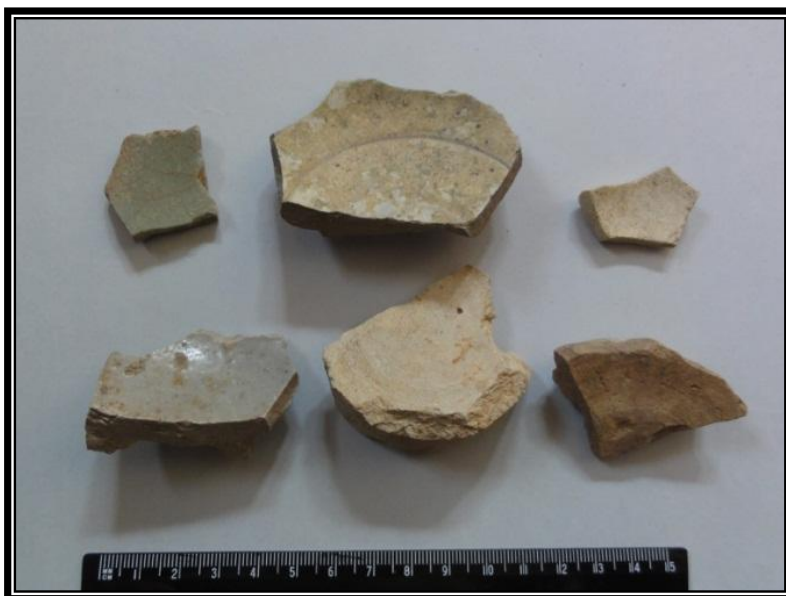
Plate 7.1 Celadon Sherds from Find Spot 1, SS-KTN-5

圖 7.1 SS-KTN-5 一號地點採集的青瓷

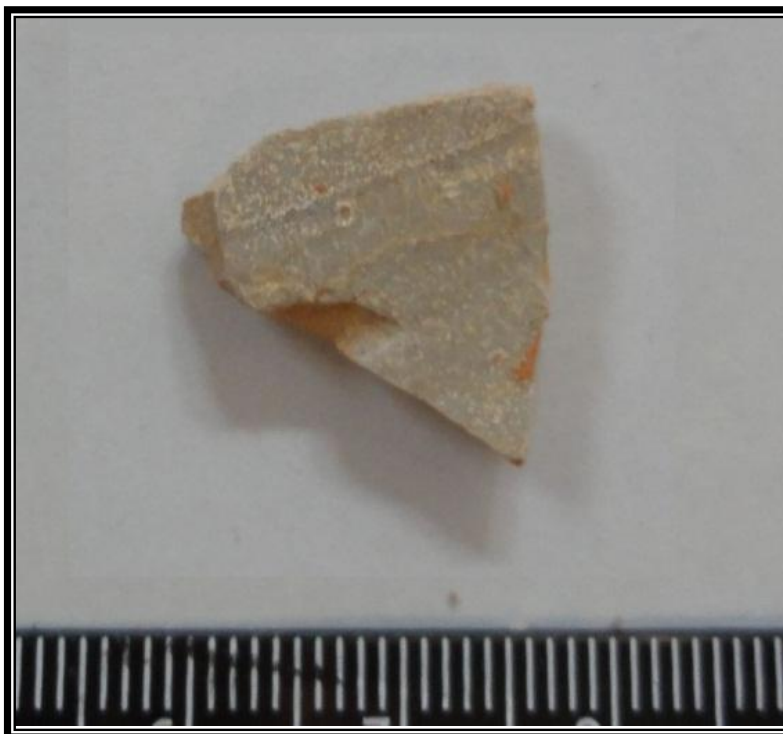
Plate 7.4 Celadon Sherd from Find Spot 3, SS-KTN-5

圖 7.4 SS-KTN-5 三號地點採集的青瓷

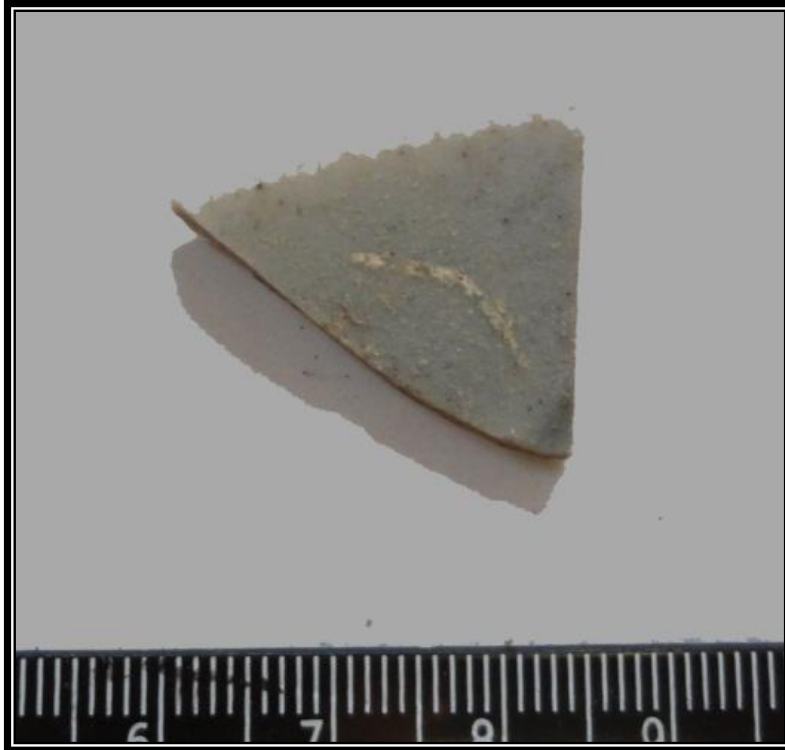
Plate 7.5 Celadon Sherd from Find Spot 4, SS-KTN-5

圖 7.5 SS-KTN-5 四號地點採集的青瓷

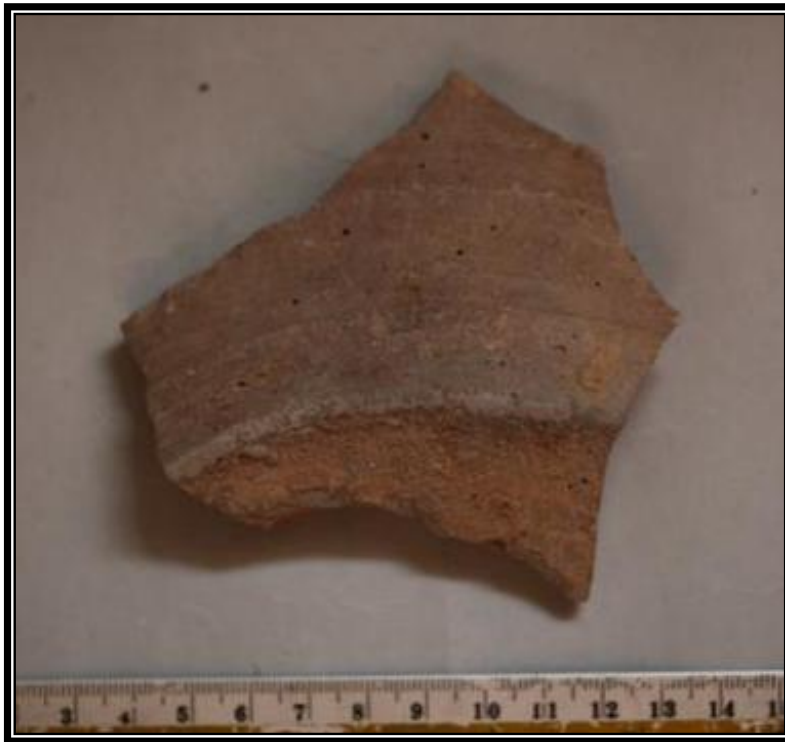
Plate 7.6 Reddish stoneware basin with gray surface and flat bottom, K14aC3:1

圖 7.6 K14aC3:1 平底灰衣紅陶器底

- 7.3.5 Two shards were unearthed from Layer 3, including a reddish stoneware probably in the form of basin with gray surface and flat bottom (see **Plate 7.6** in **Appendix D**), and a grayish coarse ware with thick body and large crystal grains in the paste(see **Plate 7.7** in **Appendix D**), which is probably a tile judged by its curved shape.

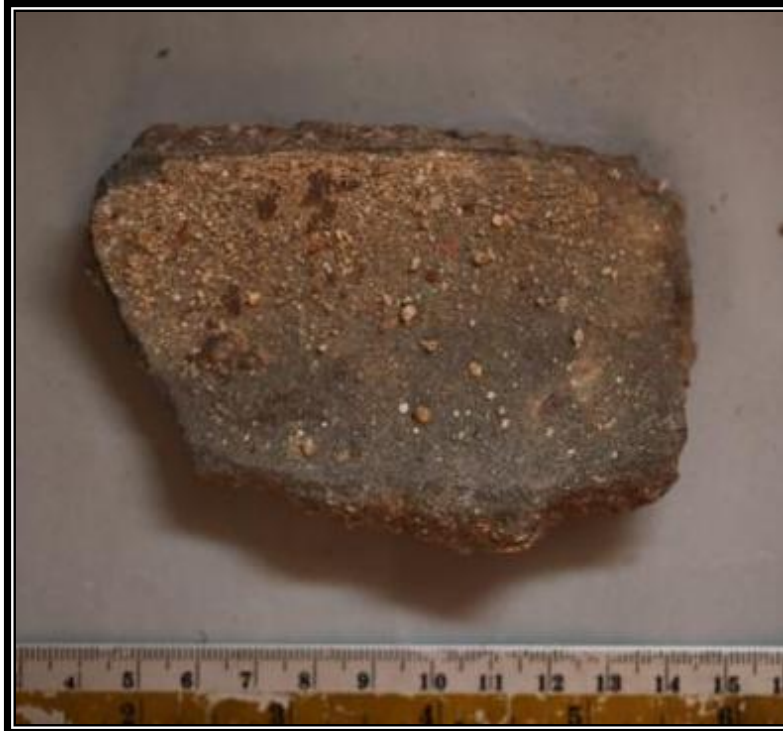
Plate 7.7 Grayish coarse ware with large crystal grains, curved body, probably a tile, K14aC3:2

圖 7.7 K14aC3:2 粗砂灰陶，器身彎弧，疑為瓦

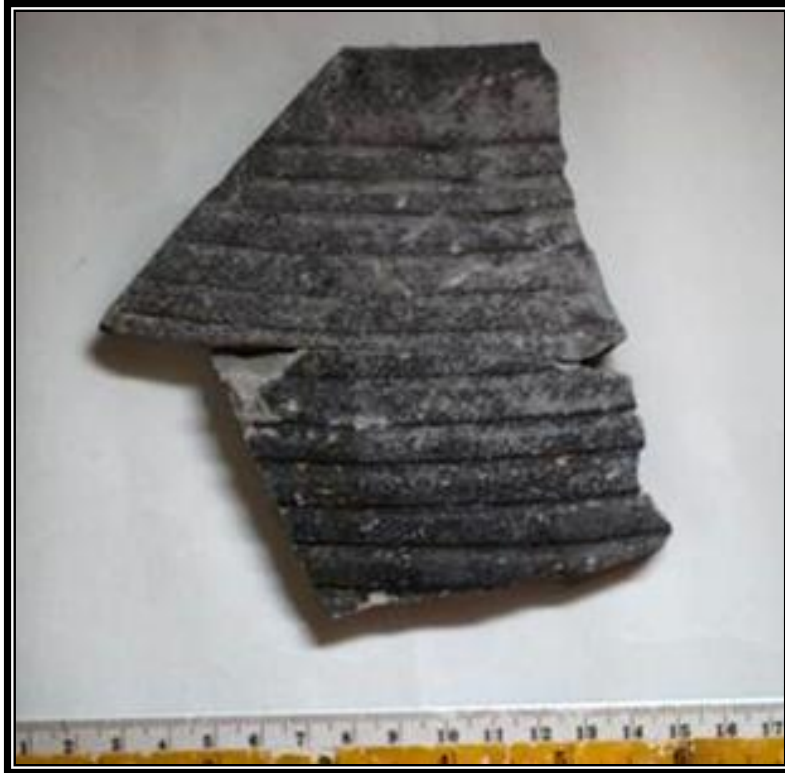
Plate 7.9 Grayish stoneware with burnished black surface and incised horizontal lines (K14aC4:2)

圖 7.9 K14aC4:2 陰刻重環紋磨光黑衣灰陶

- 7.3.7 The other ceramic shards unearthed from Layer 4 in K14a include a grayish stoneware shard with burnished black surface and incised horizontal lines (see **Plate 7.9** in **Appendix D**), a grayish terra-cotta tile with scratching traces on the upside and textile impression on the downside (see **Plate 7.10** in **Appendix D**), and a thick rim belonging to a partially glazed brownish stoneware jar (see **Plate 7.11** in **Appendix D**).

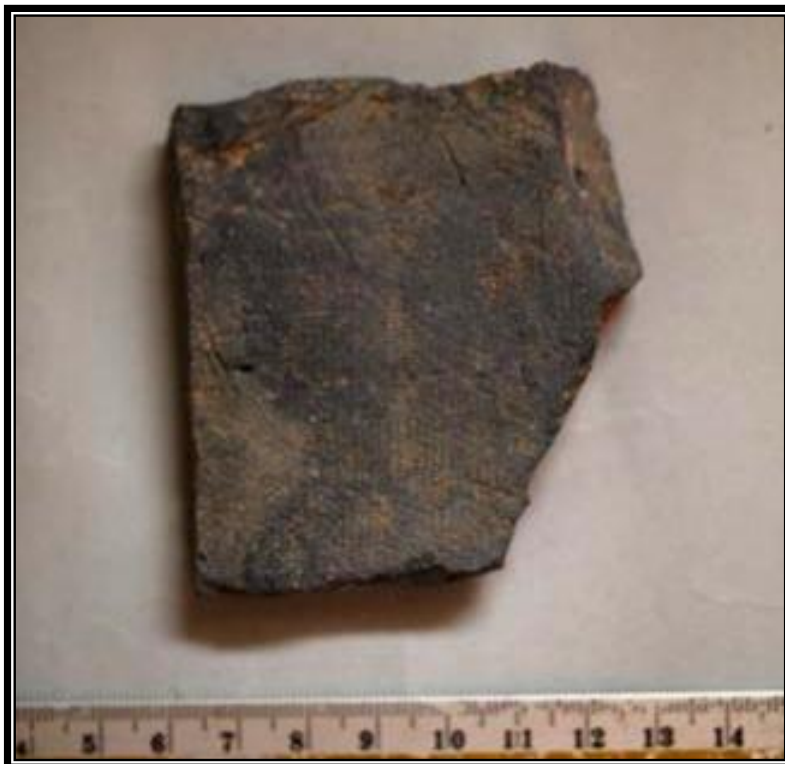
Plate 7.10 Grayish terra-cotta tile; upside with scratching traces, downside with impression of textile, K14aC4:3

圖 7.10 K14aC4:3 灰陶瓦，表面帶劃痕，底面帶布紋

- 7.4.2 The gray tile with textile impression from Layer 4 can also be dated to the Song dynasty based on a previous study on tiles of the Song dynasty in Hong Kong (HKIA 1999). The other shards from Layer 4 are uneasy to be dated. Therefore, the deposit of Layer 4 is now dated to the Song dynasty, but it requires further confirmation (of later dates) in the future by more supporting material unearthed from the same layer in the vicinity. Further archaeological fieldwork is recommended near test pit K14a.

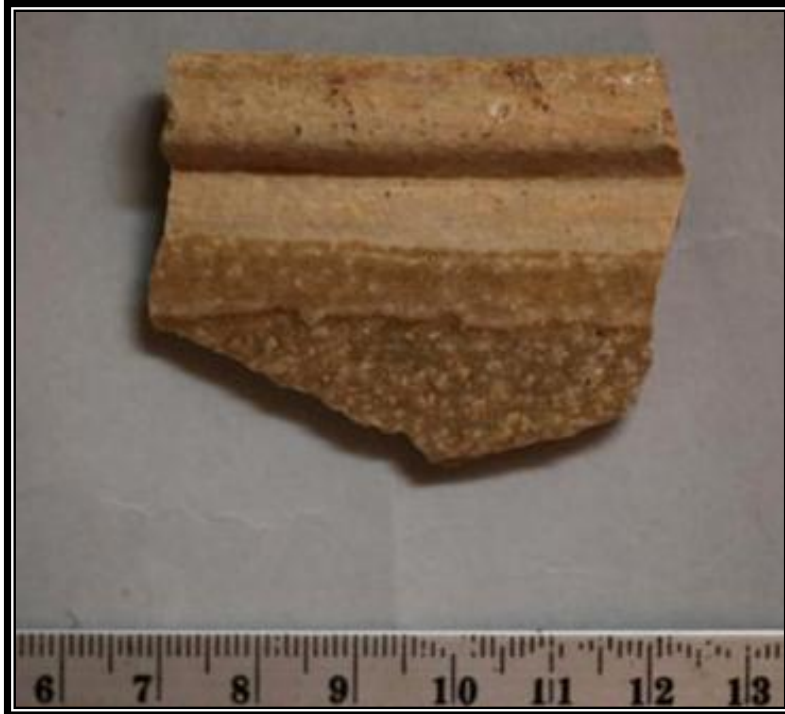
Plate 7.11 Brownish stoneware jar, partially glazed, thick rim, K14aC4:4

圖 7.11 K14aC4:4 褐陶罐，部分施釉，口沿厚

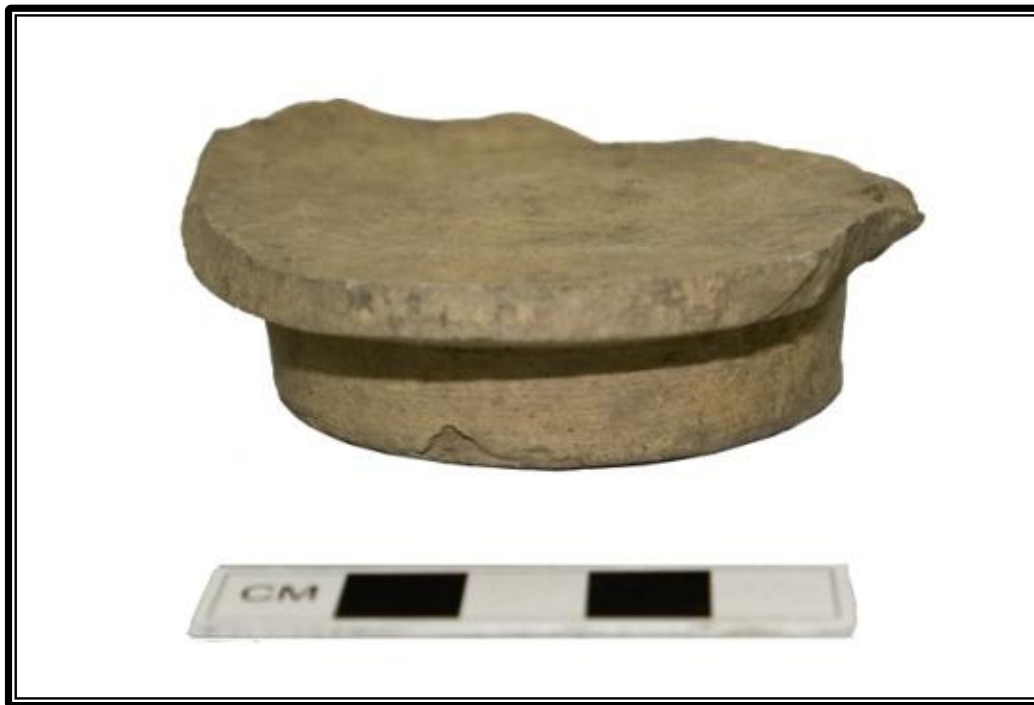
Plate 8.1 Pottery bowl base, Spot 1, SS-FLN-1

圖 8.1 SS-FLN-1 一號地點 陶碗底

8.2.3 Four spots with archaeological finds are discovered in this area. At Spot 1, tiles and bowl base fragments (see **Plate 8.1** in **Appendix D**) were discovered. At Spot 2, an exposed slope profile revealed a layer of tiles with shards of blue-and-white porcelain and celadon (see **Plate 8.2** in **Appendix D**). Spot 2 is situated on a terrace before the hill slope – the tertiary river terrace of Ng Tung River. At Spot 3, celadon bowl fragments were discovered (see **Plate 8.3** in **Appendix D**). At Spot 4, large areas (approximately 38m × 15m) of the surface contain shards of blue-and-white porcelain (see **Plate 8.4** in **Appendix D**). This Spot 4 has been previously studied in the 2003 EIA (Maunsell 2003) and has discovered an Early Qing housing ruin.

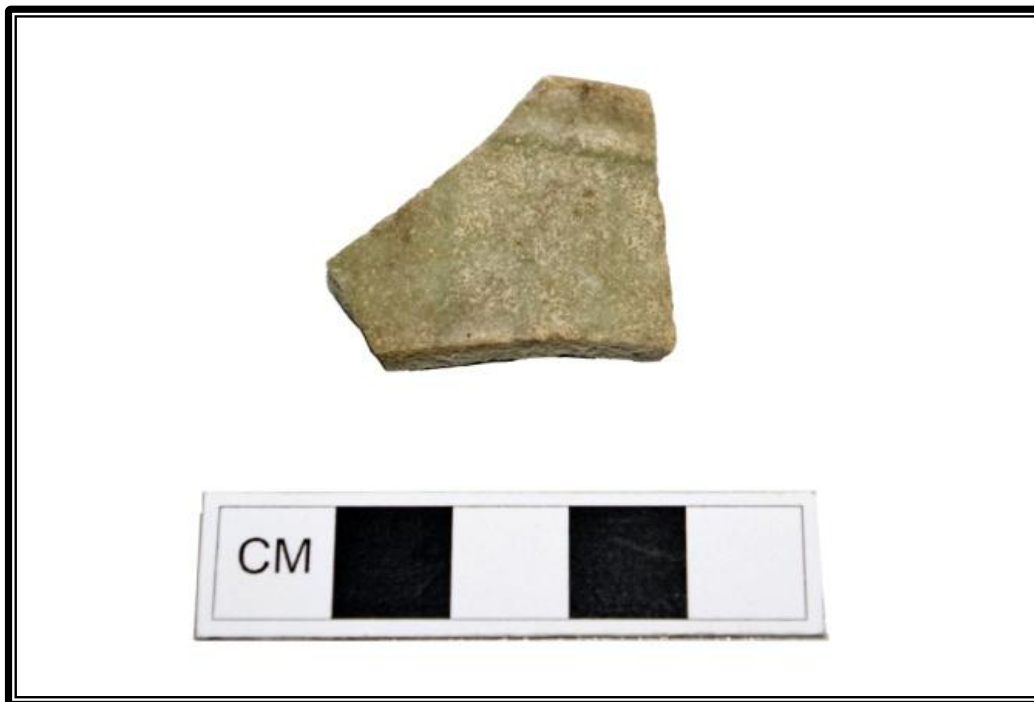
Plate 8.2 Celadon shred, Spot 2, SS-FLN-1

圖 8.2 SS-FLN-1 二號地點 青瓷片

- 8.2.10 The surface scanning produced a small quantity of celadon and blue-and-white porcelain shards as well as a square-geometric pottery shard. Celadon shards with greyish green glaze discovered at both SS-FLN-1 Spot 2 and SS-FLN-1 Spot 3 (see **Plate 8.2** and **8.3** in **Appendix D**) can probably be dated to Song to Yuan periods. Some blue-and-white porcelain shards found at SS-FLN-1 Spot 4 and SS-FLN-4 Spot 9 (see **Plate 8.4** and **8.7** in **Appendix D**) are decorated with chrysanthemum pattern painted in the impressionistic manner, some with rows of three vertical strokes on the exterior close to rim, and one shard with patternized chrysanthemum.

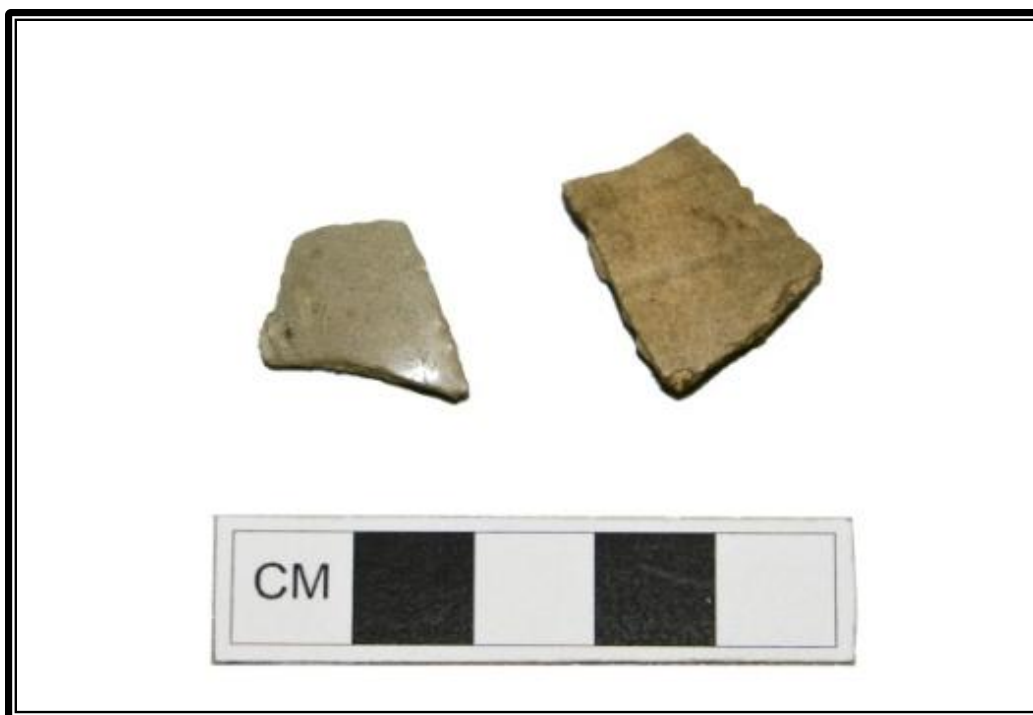
Plate 8.3 Celadon sherd and potshreds, Spot 3, SS-FLN-1

圖 8.3 SS-FLN-1 三號地點 青瓷片及陶片

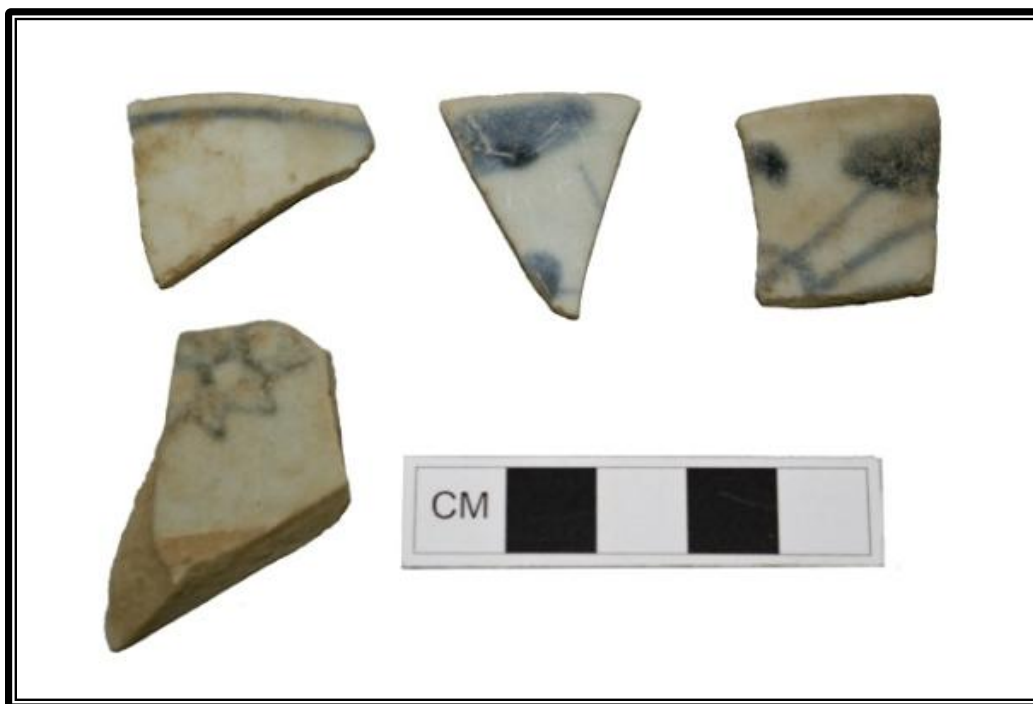
Plate 8.4 Blue-and-white porcelain sherds, Spot 4, SS-FLN-1

圖 8.4 SS-FLN-1 四號地點 青花瓷片

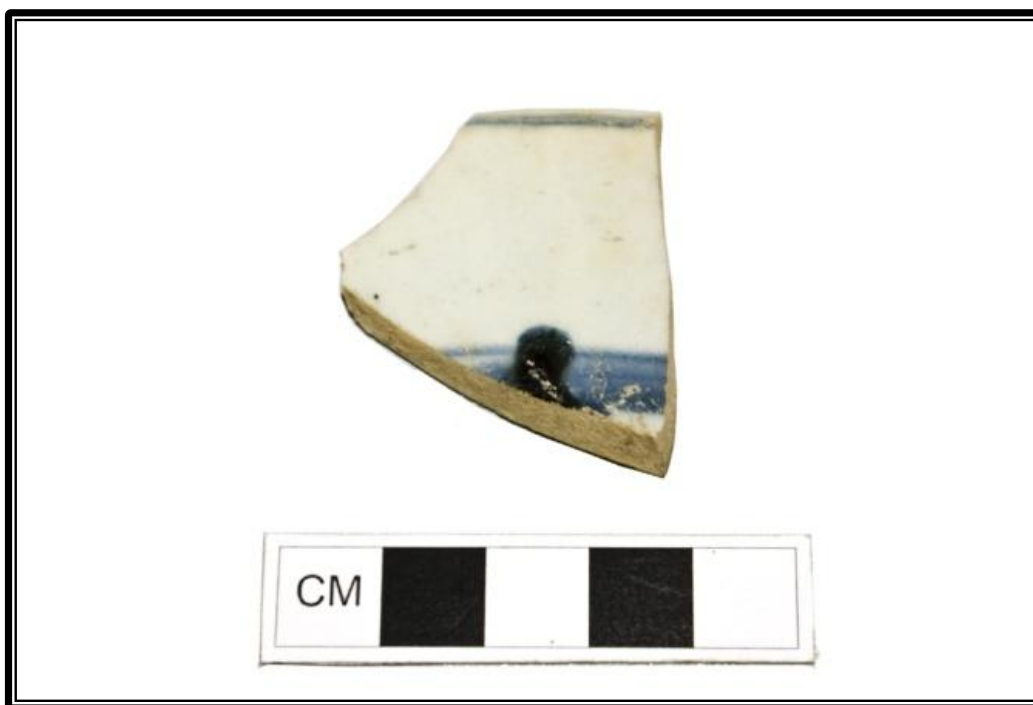
Plate 8.5 Square-geometric potshred, Spot 7, SS-FLN-3

圖 8.5 SS-FLN-3 七號地點 方格印紋陶片

- 8.2.6 The area is around Wa Shan Public School near Ng Tung River. This area contains many fenced farmlands/orchards and private residence. Access is limited to outside of these lands. The now-abandoned Wa Shan Public School is covered by concrete paving with thick vegetation surrounding the school. No archaeological finds is observed in the school.
- 8.2.7 Two spots with archaeological finds are discovered in this area. Spot 6 has some shards of blue-and-white porcelain, and some yellow tile and bricks; however, they do not bear characteristics that can yield dating and typological data and hence not collected. Spot 7 has a square-geometric pottery (see **Figure 1** in **Appendix C**; also see **Plate 8.5** in **Appendix D**) shard near to some funerary urns on a slope to the south of the School.

- 8.2.12 The square-geometric pottery shard found in SS-FLN-3 Spot 7 (see **Figure 1** in **Appendix C**; also see **Plate 8.5** in **Appendix D**) has a grey clay fabric. Its clay fabric is well-sorted with no sand and stone temper. The firing temperature is relatively high, possibly over 800 degree, resulting in high degree hardness.

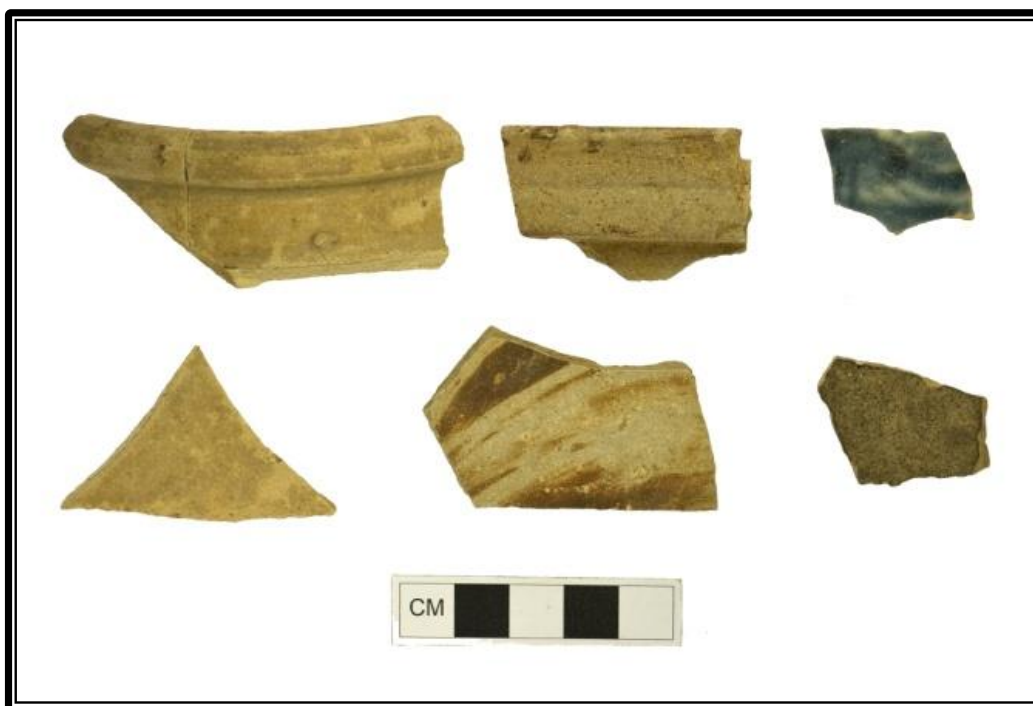
Plate 8.7 Blue-and-white porcelain shreds, Spot 9, SS-FLN-4

圖 8.7 SS-FLN-4 九號地點 青花瓷片

- 8.2.8 The area is on the opposite bank of Wu Nga Lok Yeung of Ng Tung River. Although thin in vegetation, steep slopes have hindered safe access to most area. Only naked-eye observation and landscape topography can be used to ascertain the existence of archaeology in this area.
- 8.2.9 Two spots with archaeological finds are discovered in this area. Spot 8 has some shards of Late Qing blue-and-white porcelains and brown-glazed pottery (see **Plate 8.6** in **Appendix D**). Spot 9 has some shards of Qing blue-and-white porcelains (see **Plate 8.7** in **Appendix D**), as well as some grey tiles.

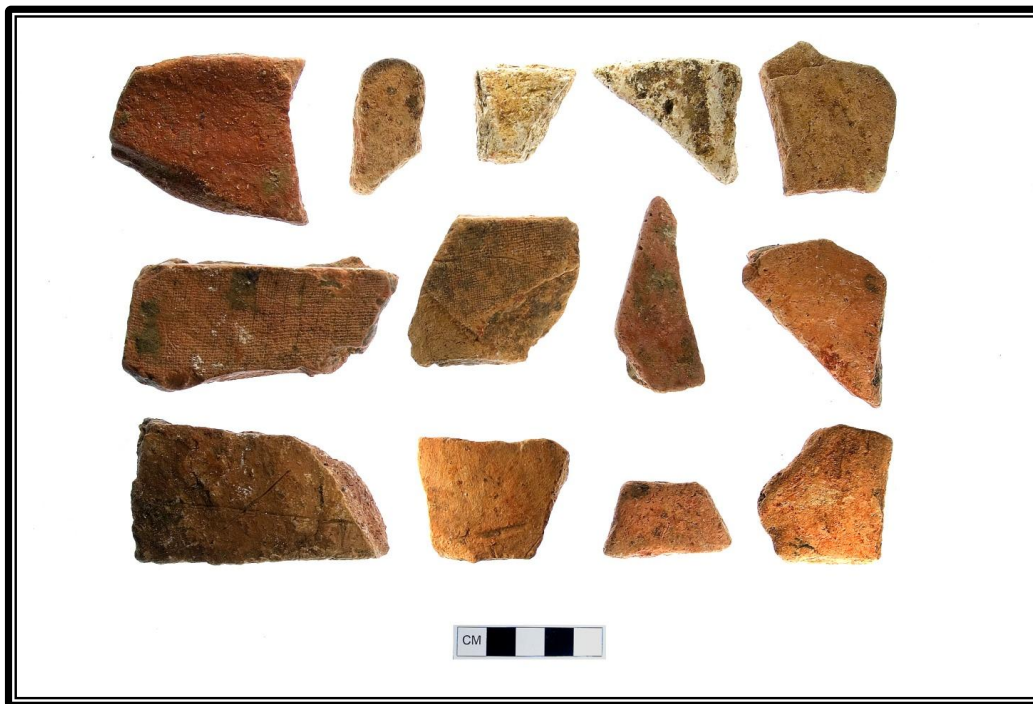
Plate 8.8 Pottery shreds and blue-and-white porcelain shred, F1c L2

圖 8.8 F1c L2 陶片及青花瓷片

8.3.1.3 Stratum L2 (40 – 50cm deep, c.a. 7.7mPD) unearthed some blue-and-white porcelain shards and some pottery jar shards and shattered bricks and tiles (see **Plate 8.8 - 8.10** in **Appendix D**), which could be dated to the Qing dynasty *terminus post quem*. Regolith was encountered at a depth of 116cm (c.a. +2.0mPD). The findings are insufficient to indicate that there are stable cultural layers and long term human inhabitancy in the areas at or surrounding F1c. As a result, the area is not regarded as an archaeological potential area.

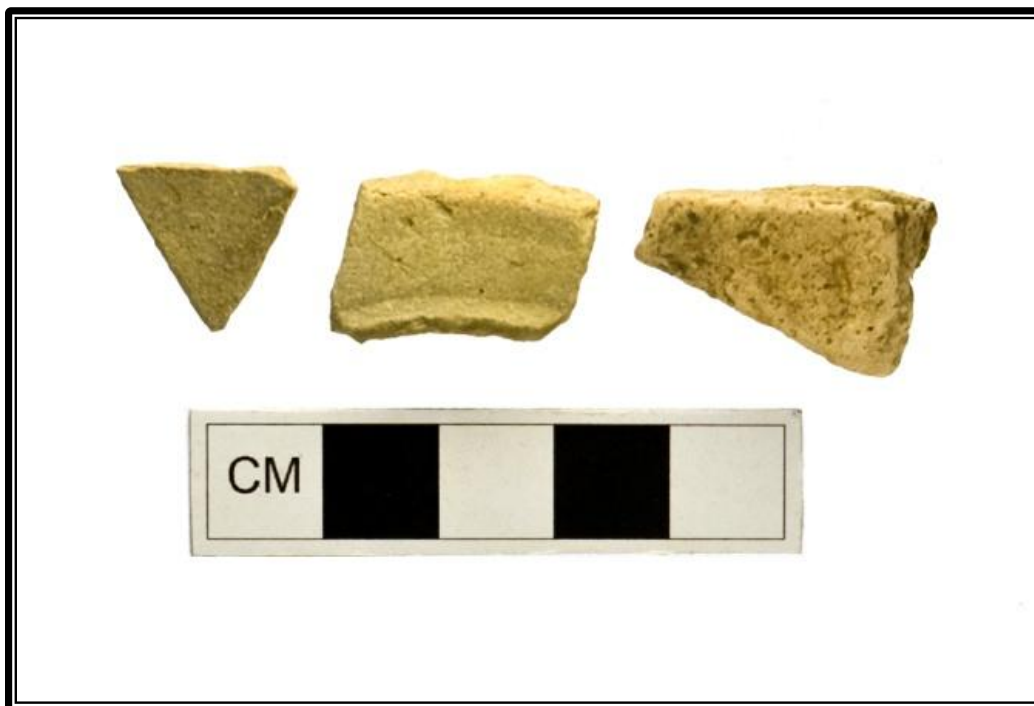
Plate 9.1 Blue-and-white porcelain shreds, Spot 1, SS-TKL-1

圖 9.1 SS-TKL-1 一號地點 青花瓷片

- 9.2.2 The sub-area is a small hill owned by the government situated near Ko Po next to Lau Shui Heung. It is fully fenced and surrounded by village houses at the hill foot. At Spot 1 found a few blue-and-white porcelain shards of a probable Qing dating (see **Plate 9.1 in Appendix D**).
