**WSD Contract No.: 3/WSD/20 -
Reclaimed Water Supply to Sheung Shui and Fanling**

**MONTHLY ENVIRONMENTAL MONITORING & AUDIT
REPORT (NO.48) – NOVEMBER 2025**

**PREPARED FOR
WATER SUPPLIES DEPARTMENT**

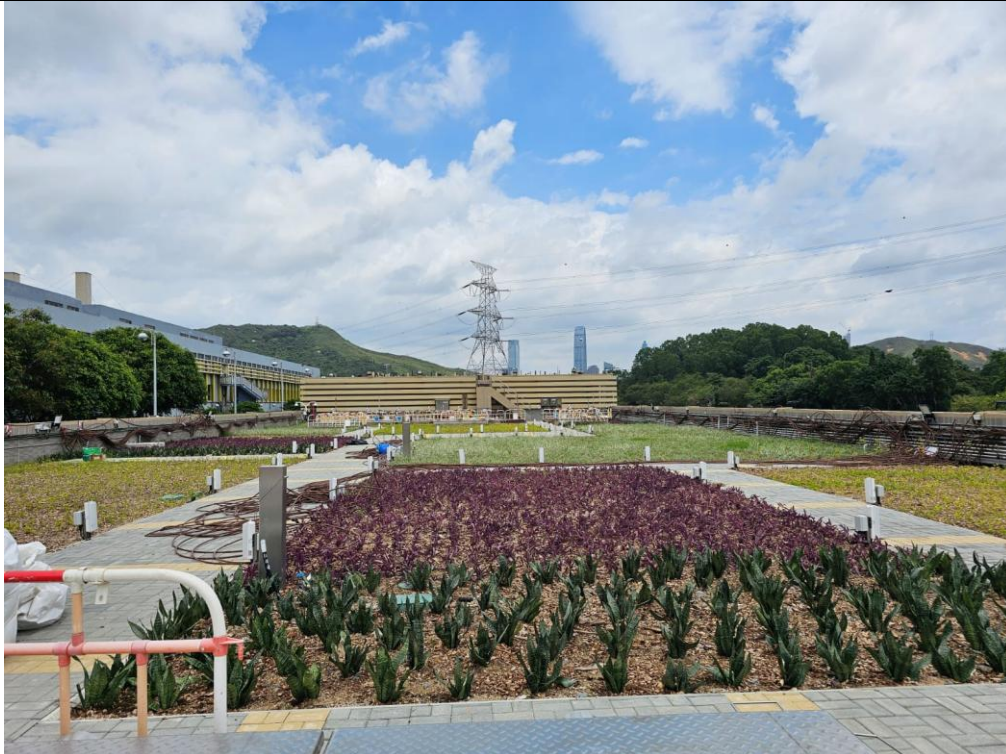
General View of HCF Roof
