**WSD Contract No.: 3/WSD/20 -
Reclaimed Water Supply to Sheung Shui and Fanling**

**MONTHLY ENVIRONMENTAL MONITORING & AUDIT
REPORT (NO.49) – JANUARY 2026**

**PREPARED FOR
WATER SUPPLIES DEPARTMENT**

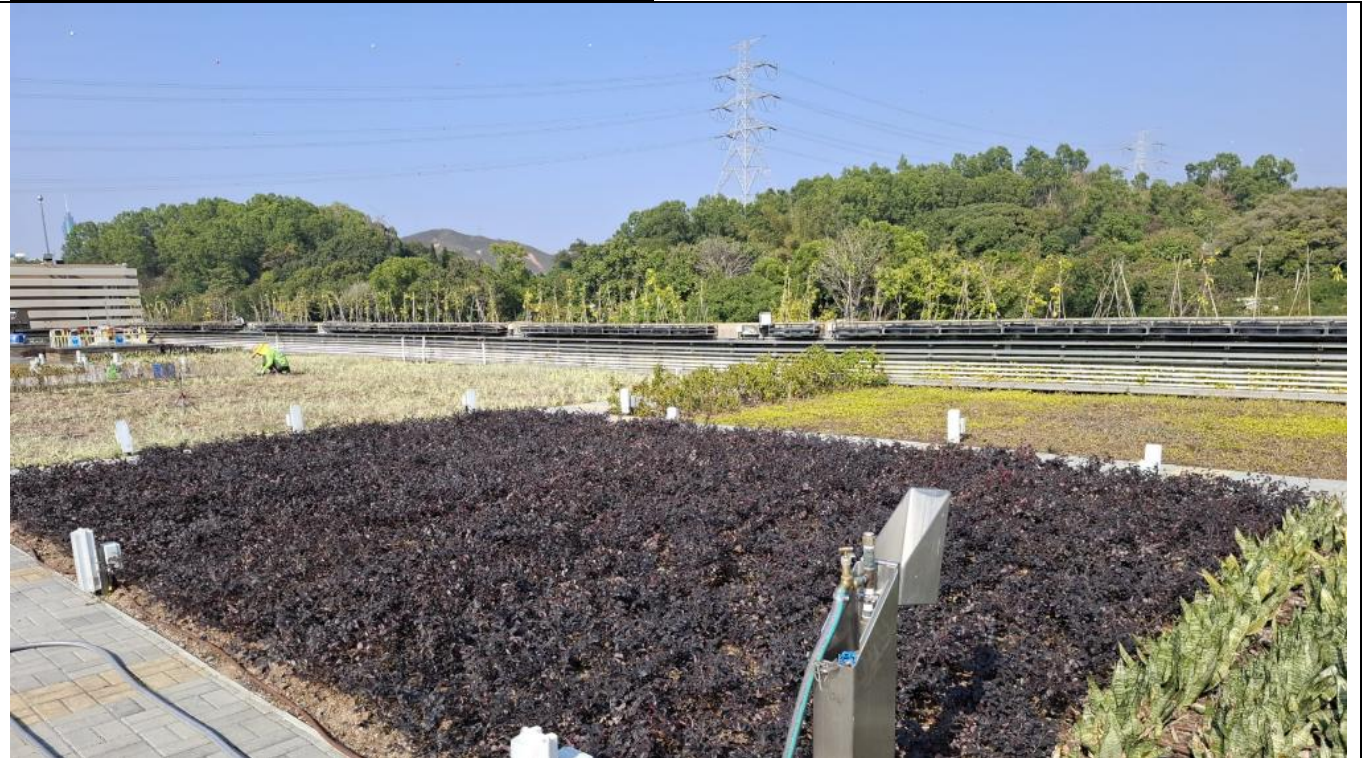
SITE OVERVIEW PHOTO IN THE REPORTING PERIOD

Landscape Softworks at HCF Roof
