**WSD Contract No.: 3/WSD/20 -  
Reclaimed Water Supply to Sheung Shui and Fanling**

**MONTHLY ENVIRONMENTAL MONITORING & AUDIT  
REPORT (NO.51) – FEBRUARY 2026**

**PREPARED FOR  
WATER SUPPLIES DEPARTMENT**

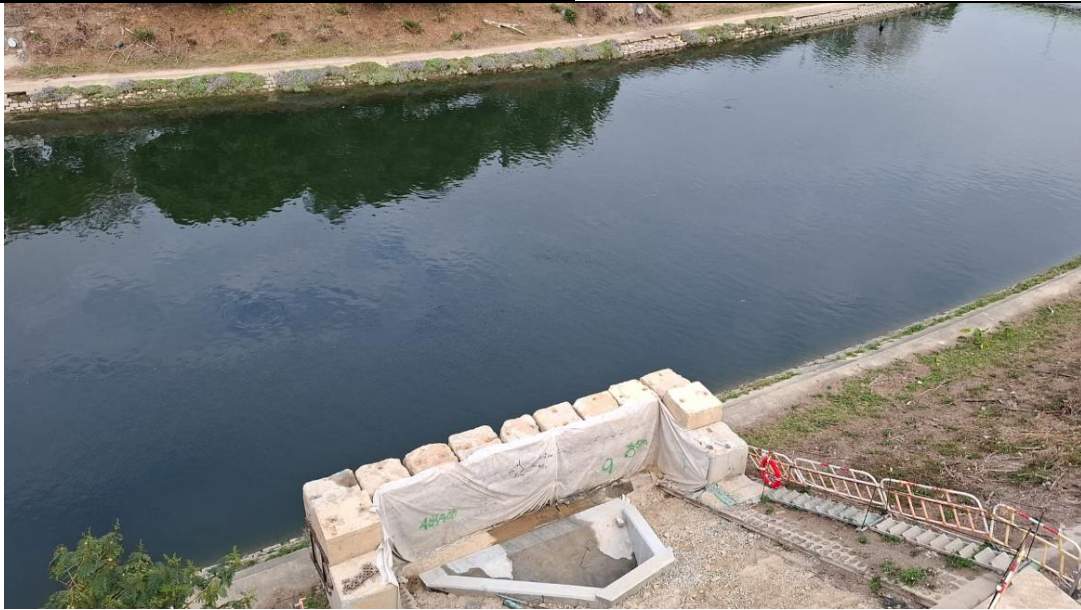
Commencement of Outfall Construction

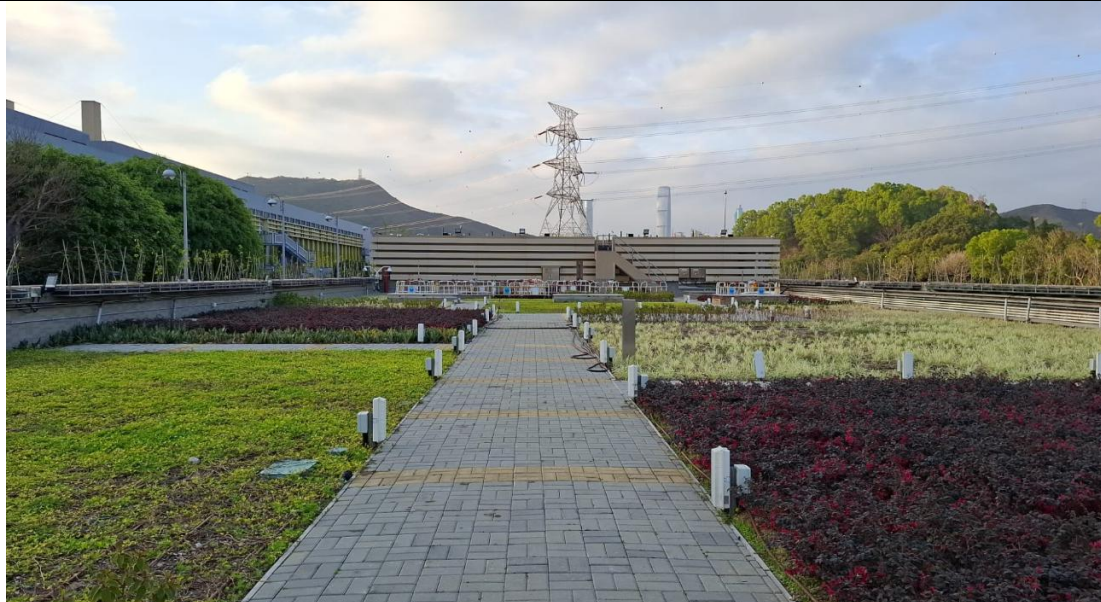
General view of HCF Roof Landscape Softworks

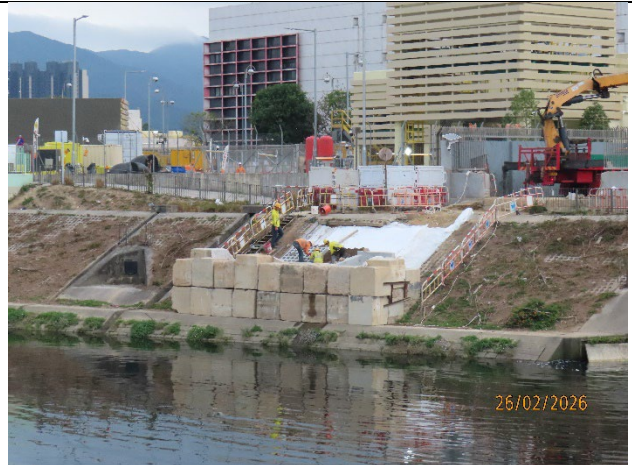
**Photo 2** Construction at drainage outlets from the current project at T2 (26/2/2026)

- 5.2.5 As observed during the surveys, Construction at drainage outlets has been observed near T2 of the current project for the laying of drainage. Nevertheless, other construction and anthropogenic activities around the survey transects were still active during the reporting month and the following activities were noted.

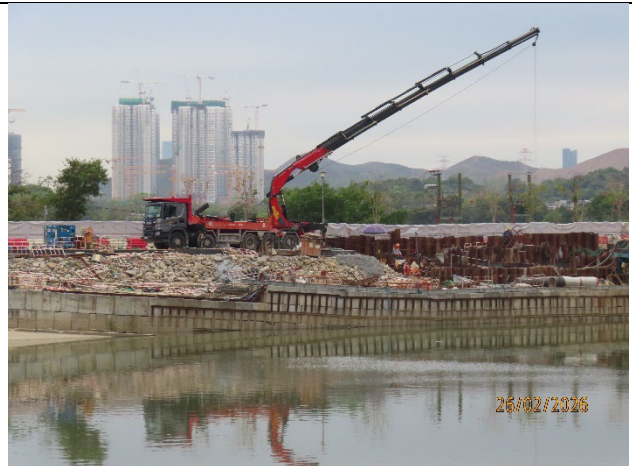
**Photo 4** Works at P6 (26/2/2026)

- 5.2.9 The construction work by other Project near P7 was also observed active throughout the entire reporting month. Piling works of the same construction was also observed at T3, roughly midway between P6 and P7, and since the survey on 11<sup>th</sup> September 2023, excavators were observed on the opposite bank to the survey transect. Additionally, Construction works on the riverbank were observed since 31 December 2024, while various portions of the riverbank were being backfilled since the survey on 10 March 2025.

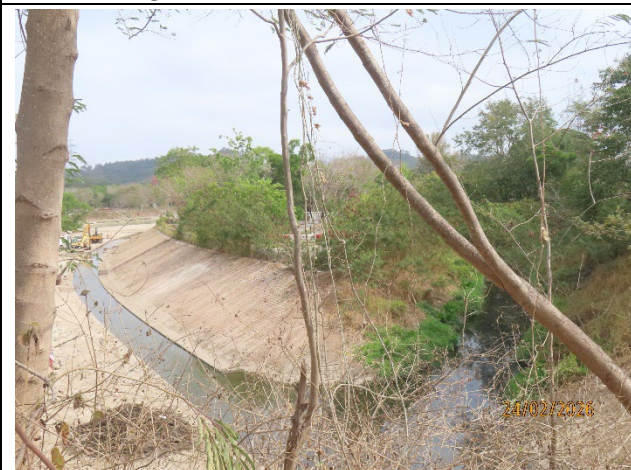
**Photo 5** Vegetation clearance at P5 (24/2/2026)

- 5.2.11 The construction works by other Project, was also observed in the main channel of Shek Sheung River at P5, where excavators were observed to be driven on the channel, since the survey on 18 November 2025. Vegetation clearance on the riverbank of Shek Sheung River were observed, reducing the area available for waterbirds to forage in at P5.
