**JOB No.: TCS01216/21**

**WSD Contract No.: 3/WSD/20 -  
Reclaimed Water Supply to Sheung Shui and Fanling**

**MONTHLY ENVIRONMENTAL MONITORING & AUDIT  
REPORT (No.56) – JULY 2026**

**PREPARED FOR  
WATER SUPPLIES DEPARTMENT**

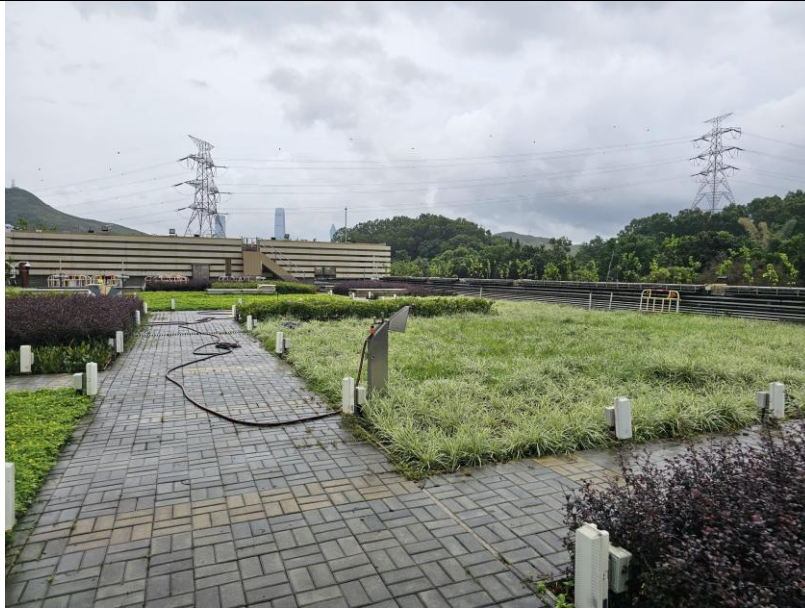
General view of HCF Roof Landscape Softworks

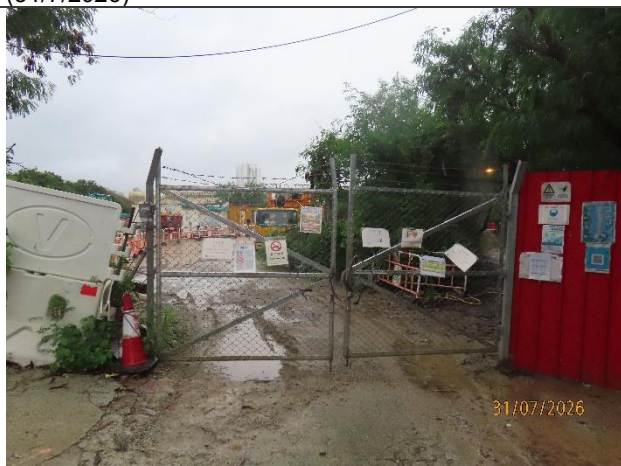
**Photo 1** Site conditions of the project site at P4 (31/7/2026)

- 5.2.5 As observed during the surveys, Construction and stockpiling has been observed near the site entrance of the current project for the laying of drainage. Nevertheless, other construction and anthropogenic activities around the survey transects were still active during the reporting month and the following activities were noted.

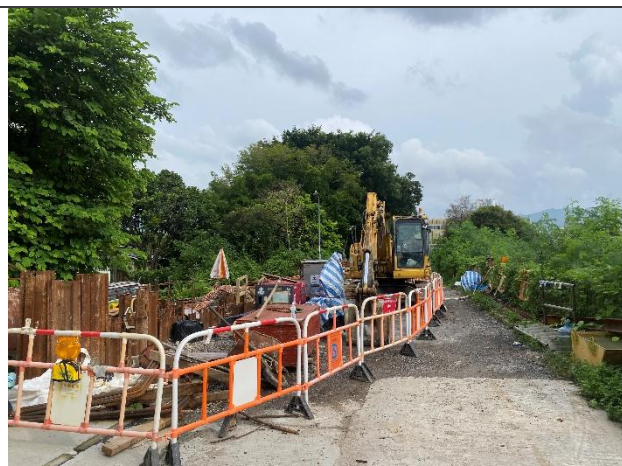
**Photo 2** Road enhancement works by T2 (20/7/2026)

- 5.2.6 Road enhancement and sewerage system upgrade works by other Project along T2 near P3 was observed active throughout the surveying month. A new excavation has been observed since the survey on 11 July 2025, resulting in the increased disturbance level at these count locations.

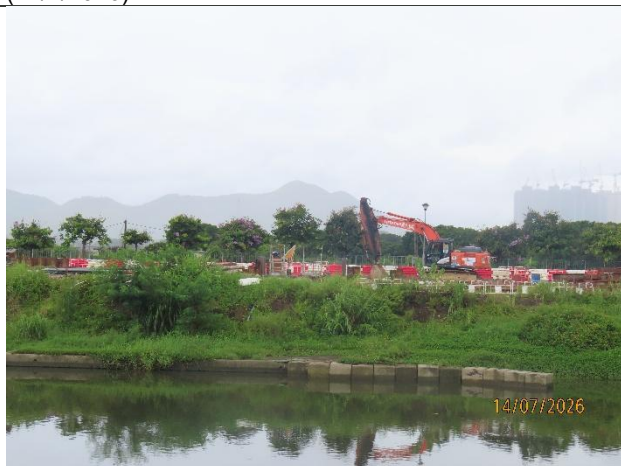
**Photo 3** Road widening construction by CEDD at T3 (14/7/2026)

- 5.2.8 The construction work by other Project near P7 was also observed active throughout the entire reporting month. Piling works of the same construction was also observed at T3, roughly midway between P6 and P7, and since the survey on 11<sup>th</sup> September 2023, excavators were observed on the opposite bank to the survey transect. Additionally, Construction works on the riverbank were observed since 31 December 2024, while various portions of the riverbank were being backfilled since the survey on 10 March 2025.
