**Service Contract No. NDO 04/2019
Environmental Team for Environmental
Monitoring and Audit Works in
Construction Phase for the First Phase
Development of Kwu Tung North and
Fanling North New Development Areas**

**Monthly Environmental Monitoring and
Audit Report for January 2021**

Monthly Environmental Monitoring and Audit Report No. 15 (January 2021)

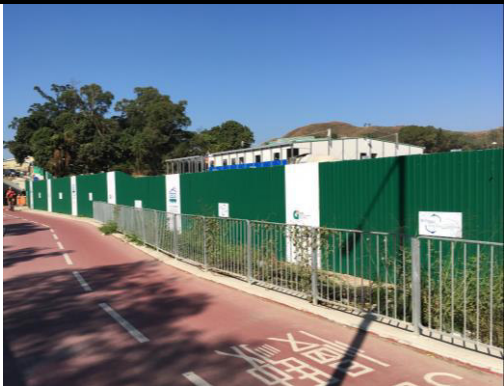
<p>To minimise adverse impacts on habitats of ecological importance in the vicinity of the Project, 2m high solid dull green site barrier fences shall be erected around all active works areas.(Figure 10)</p>	Λ _[1]

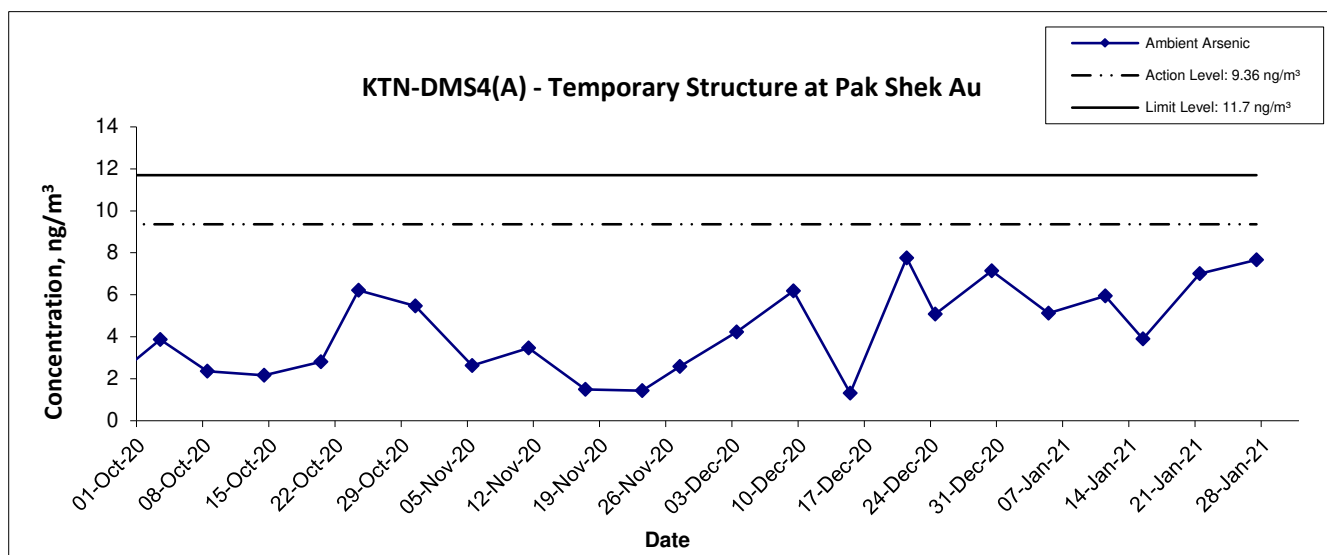
Location KTN-DMS4(A) - Temporary Structure at Pak Shek Au			
Date	Arsenic (μg)	Standard Volume, Vstd (m^3)	Ambient Arsenic Concentration (ng/m^3)
5-Jan-21	8.0	1562.4	5.12
11-Jan-21	9.0	1516.3	5.94
15-Jan-21	6.0	1538.5	3.90
21-Jan-21	11.0	1569.3	7.01
27-Jan-21	12.0	1565.8	7.66
