**Service Contract No. NDO 04/2019
Environmental Team for Environmental
Monitoring and Audit Works in
Construction Phase for the First Phase
Development of Kwu Tung North and
Fanling North New Development Areas**

**Monthly Environmental Monitoring and
Audit Report for March 2023**

Monthly Environmental Monitoring and Audit Report No. 41 (March 2023)

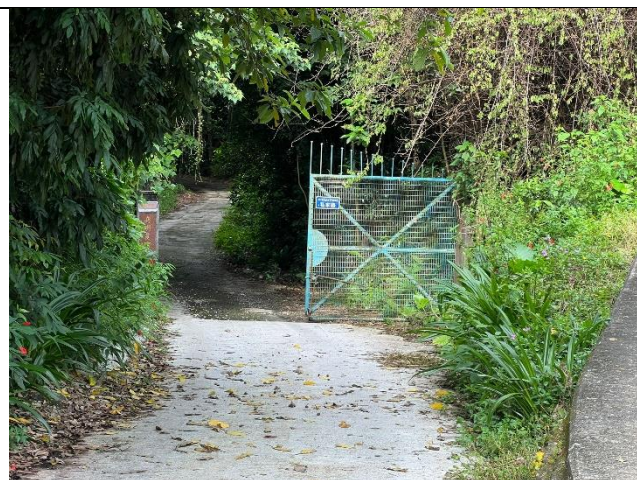
Photo 1. Inaccessible part of transect T5 located within a private property.

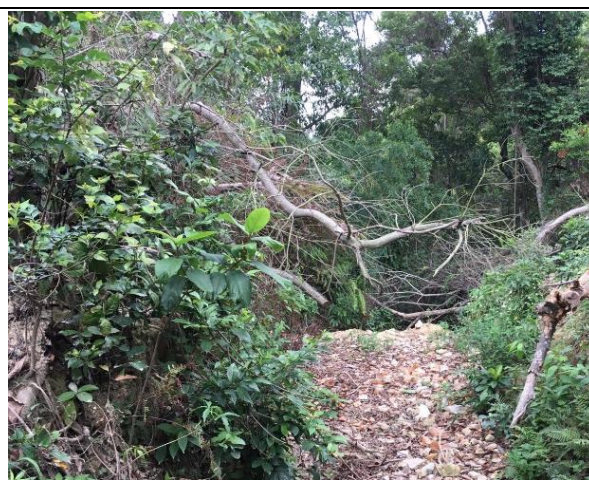
Photo 2. Inaccessible part of transect T5 blocked by fallen trees.

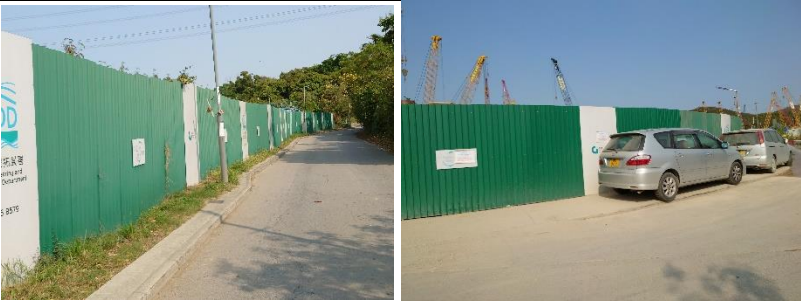
| EP No. | Condition | Photographic Record | Implementation Status |
|---|---|---|---|
| EP- 466/2013/ A | 2.9 | <p>To minimise adverse impacts on habitats of ecological importance in the vicinity of the Project, 2m high solid dull green site barrier fences shall be erected around all active works areas.</p> | $\wedge_{[1]}$ |

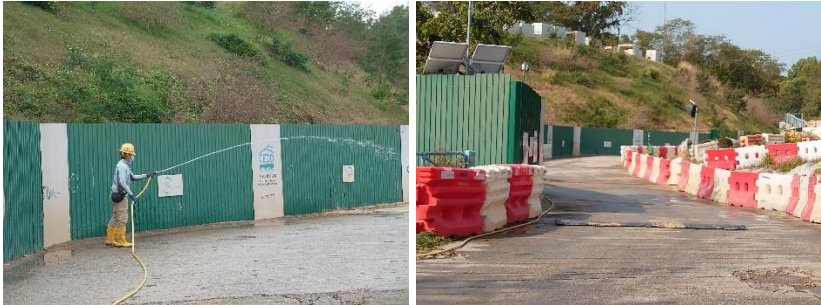
| EP No. | Condition | Photographic Record | Implementation Status |
|---|---|---|---|
| EP- 467/2013/ A | 2.9 | <p>To minimise adverse impacts on habitats of ecological importance in the vicinity of the Project, 2m high solid dull green site barrier fences shall be erected around all active works areas.</p> | $\wedge_{[1]}$ |

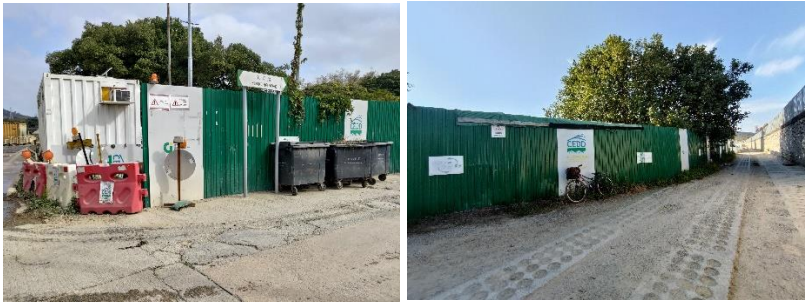
| EP No. | Condition | Photographic Record | Implementation Status |
|---|---|---|---|
| EP- 468/2013/ A | 2.11 | <p>To minimise adverse impacts on habitats of ecological importance in the vicinity of the Project, 2m high solid dull green site barrier fences shall be erected around all active works areas.</p> | $\wedge_{[1]}$ |

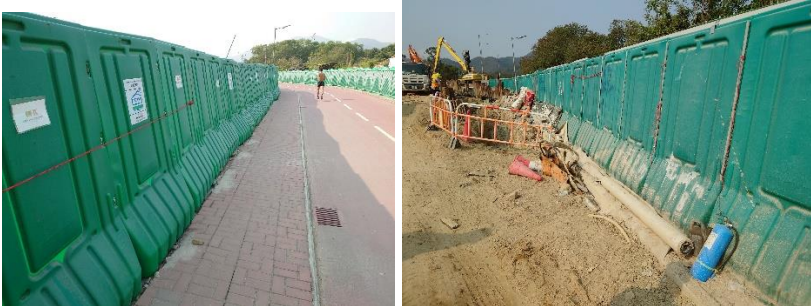
| EP No. | Condition | Photographic Record | Implementation Status |
|---|---|---|---|
| EP- 469/2013 | 2.7 | <p>To minimise adverse impacts on habitats of ecological importance in the vicinity of the Project, 2m high solid dull green site barrier fences shall be erected around all active works areas.</p> | $\wedge_{[1]}$ |

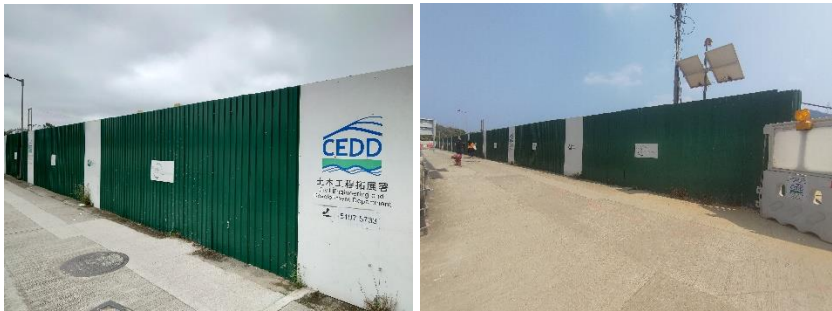
| <p>EP- 475/2013/ A</p> | <p>2.7</p> | <p>To minimise adverse impacts on habitats of ecological importance in the vicinity of the Project, 2m high solid dull green site barrier fences shall be erected around all active works areas.</p> | <p>^_[1]</p> |

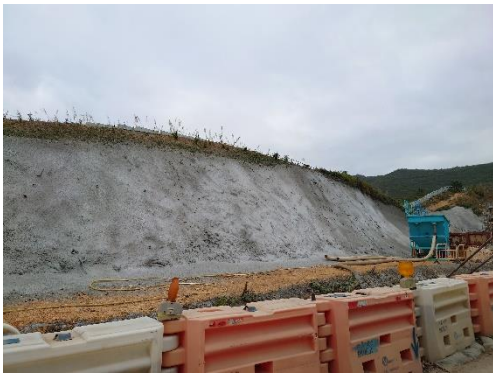
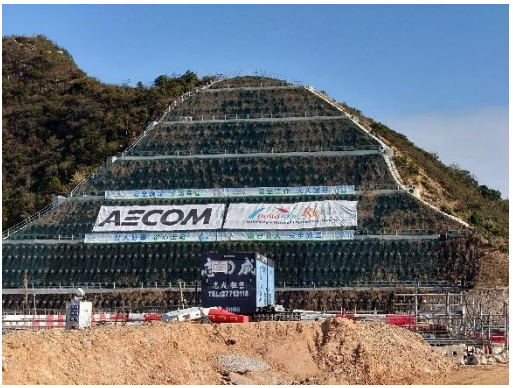
| Works Contracts | Photographic Records | |
|---|---|---|
| ND/2019/01 | <p>Hard paved exposed slope surface</p> | <p>Hydroseeding for slope area</p> |

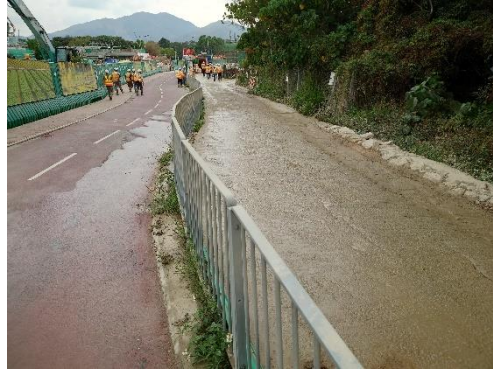
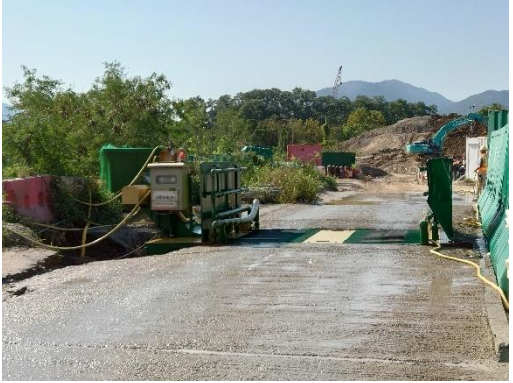
| Works Contracts | Photographic Records | |
|---|---|---|
| ND/2019/02 | <p>Hard paved exposed haul road</p> | <p>Hard paved exposed slope surface</p> |

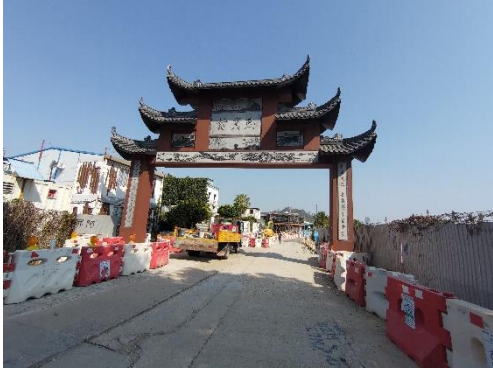
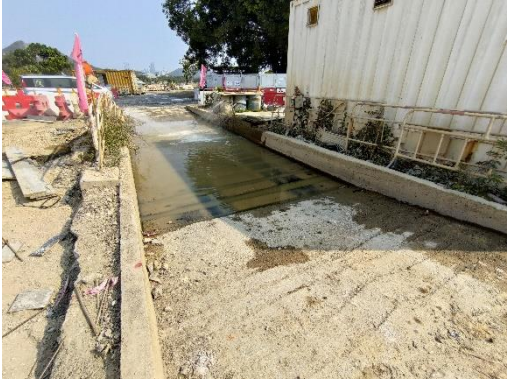
| Works Contracts | Photographic Records | |
|---|---|---|
| ND/2019/03 | <p>Hard paved exposed haul road</p> | <p>Regular clearance of water for wheel washing facility</p> |

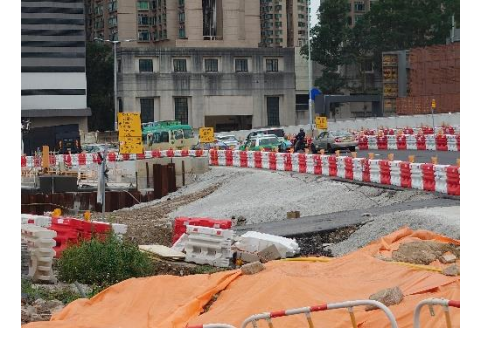
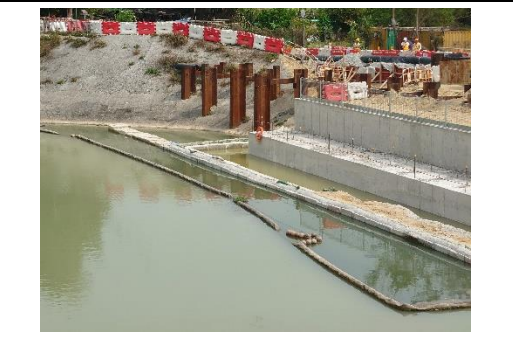
| Works Contracts | Photographic Records | |
|---|---|---|
| ND/2019/04 | <p>Hard paved exposed slope surface</p> | <p>Deployment of silt curtain around works area in Ng Tung River</p> |

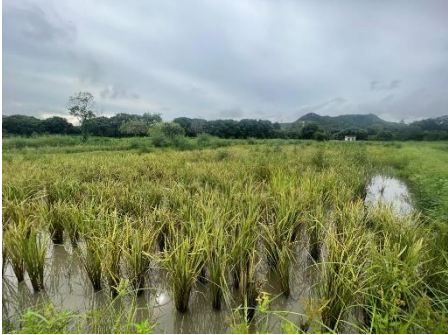
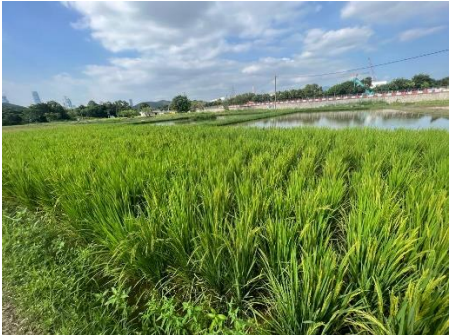
| Planting of paddy rice to provide foraging ground for Yellow-breasted Bunting | |

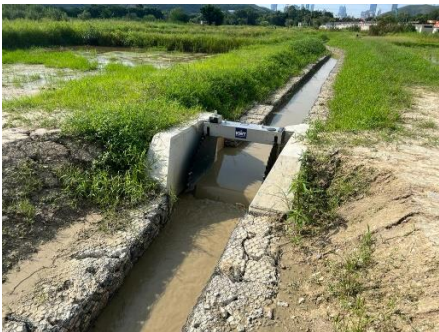
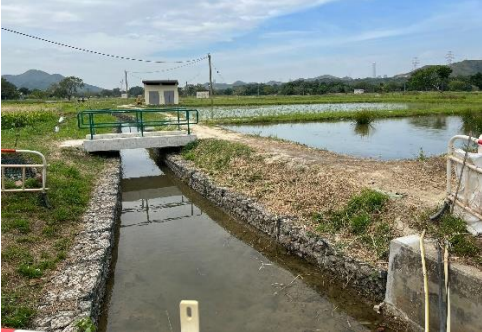
| Enhancement of irrigation channel to provide reliable water source for farmland in Long Valley | |

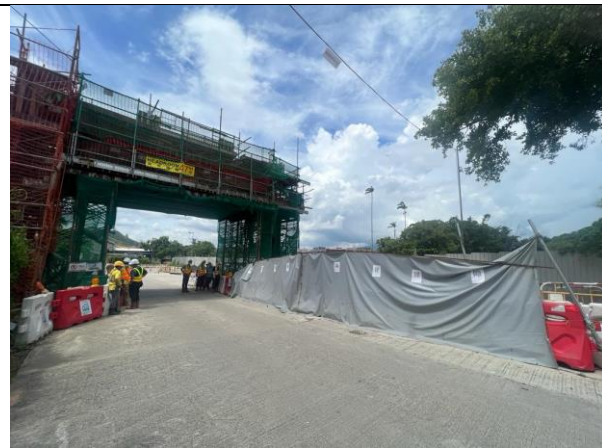
Provision of noise barrier for noisy works in Long Valley
