Contract No. ND/2019/01 Kwu Tung North New Development Area, Phase 1: Site Formation and Infrastructure Works

Cartographic and Photographic Recording Report

4 January 2021

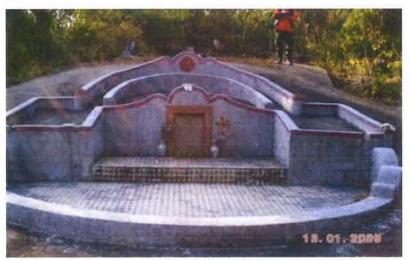
General View

Architectural Appraisal: Arm-chair shape with a headstone

Existing Condition: Well maintained.

Notes on any Modifications: Finished with modern materials

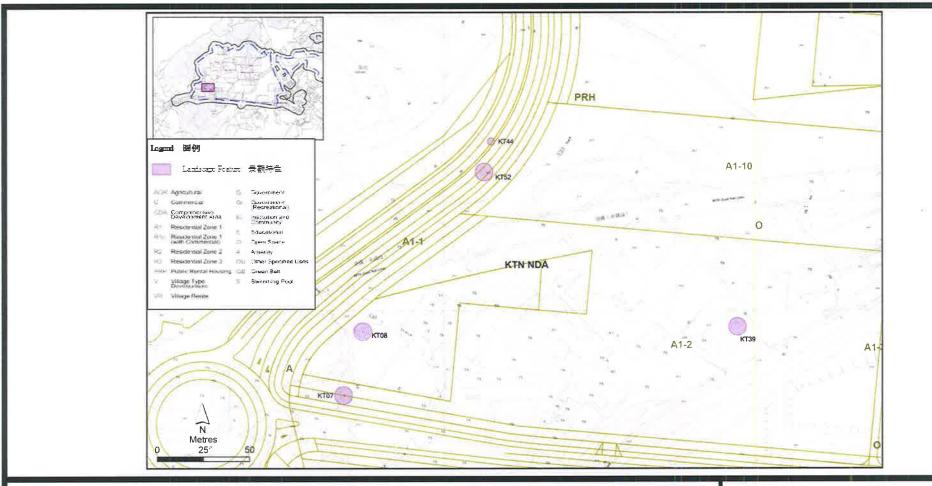
Figure 2b:

Location Plan for Identified Built Heritage Items and Landscape Features

(Extracted from Drawing No. Plan 1m of North East New Territories New Development Area Planning and Engineering Study)

As stated in Condition 2.7 of the EP of the Project, photographic and cartographic records of directly impacted cultural/ historical landscape feature at locations KT44 and KT52 ⁽¹⁾ as shown in Figure 2b of the EP (see Appendix A) shall be kept by the Permit Holder and a copy of the record shall be deposited with the Director of Environmental Protection prior to commencement of the respective removal or relocation works.

The cartographic and photographic recording work covers two graves as listed in *Table 1.1* below. For their locations, please refer to Figure 2b of the EP in Appendix A.

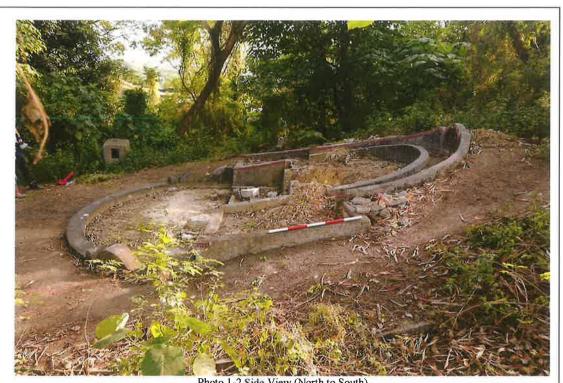
Photo 1-2 Side View (North to South)
It is located on a gentle east-facing slope with trees surrounding.

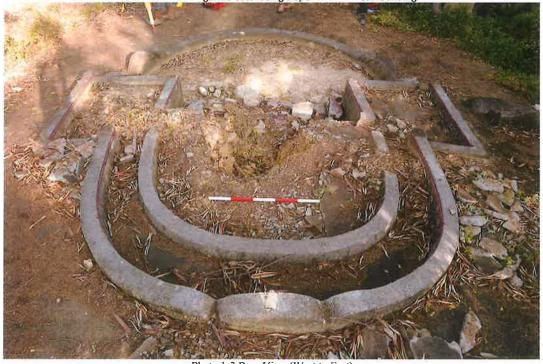
Photo 1-3 Rear View (West to East)
The concrete floor of the grave is destructed.

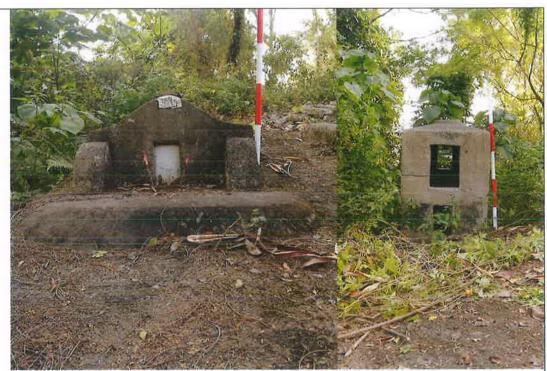
Left: Photo 1-4 (A Shrine, East to West), Right: Photo 1-5 (A Burner, Northwest to Southeast)

A Shrine is located next to the grave, and a Burner is located at the foot of the slope and on the periphery of the concrete floor.)

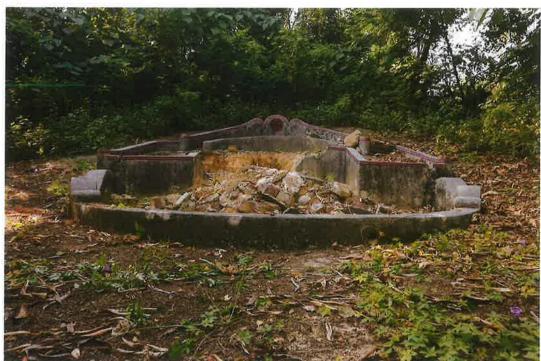
Photo 2: General View (Southeast to Northwest)
KT52 is an arm-chair shaped grave that constructed with modern material like concrete and brick.

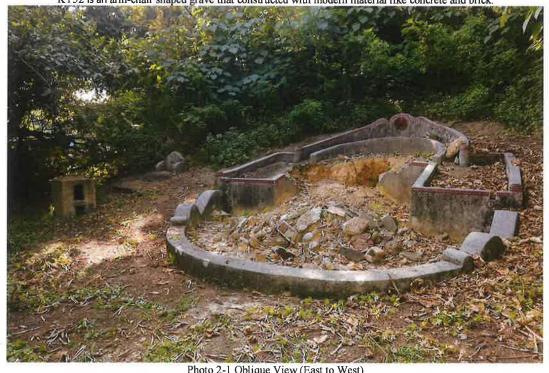
Photo 2-1 Oblique View (East to West)
The central parts of the grave ,where the headstone originally placed, are heavily destructed.

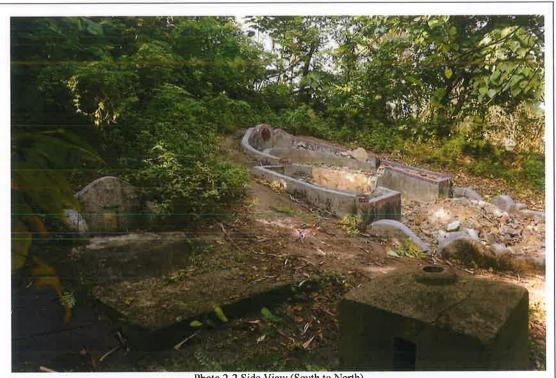
Photo 2-2 Side View (South to North)
It is located on a gentle southast-facing slope with trees surrounding.

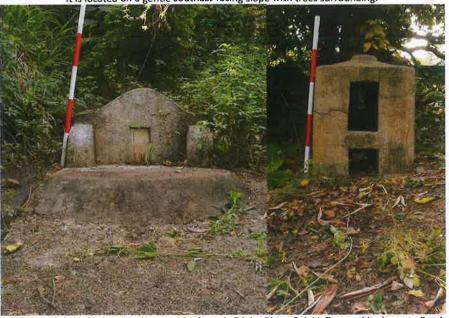
Left: Photo 2-3 (A Shrine, Southeast to Northwest), Right: Photo 2-4 (A Burner, Northeast to Southwest)

A Shrine is located next to the grave, and a Burner is located at the foot of the slope and on the periphery of the concrete floor.)
