Contract No. HY/2013/04 Hong Kong-Zhuhai-Macao Bridge Hong Kong Boundary Crossing Facilities –

Quarterly EM&A Report for October 2018 to November 2018

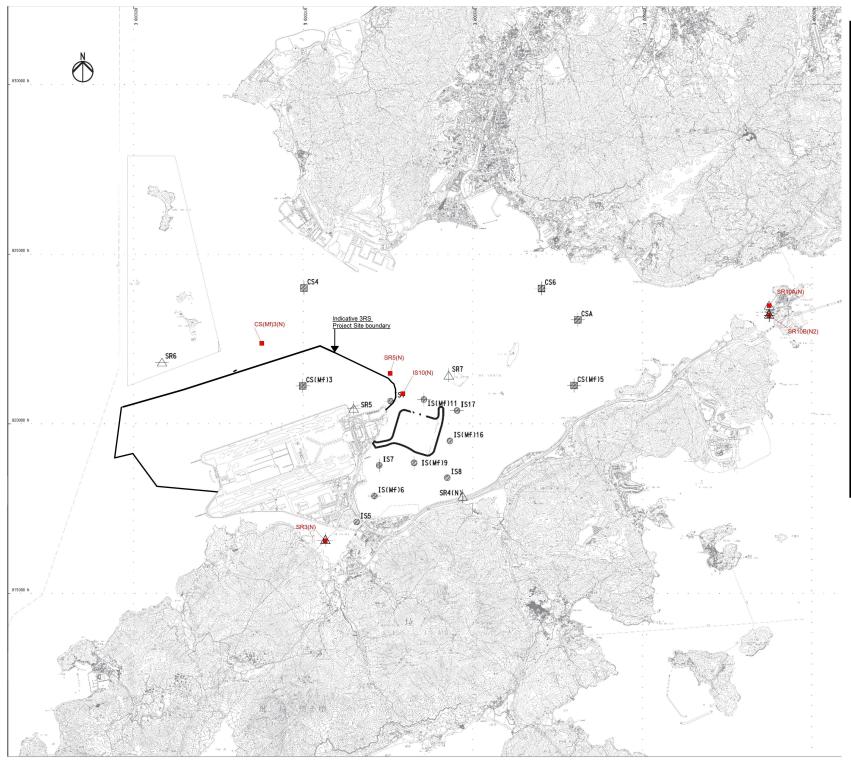
FIGURE 2.3 — LOCATION OF WATER QUALITY MONITORING STATIONS

Station	East	North
IS5	811579	817106
IS(Mf)6	812101	817873
IS7	812244	818777
IS8	814251	818412
IS(Mf)9	813273	818850
IS10(N)	812942	820881
IS(Mf)11	813562	820716
IS(Mf)16	814328	819497
IS17	814539	820391
SR3(N)	810689	816591
SR4(N)	814705	817859
SR5(N)	812569	821475
SR6	805837	821818
SR7	814293	821431
SR10A(N)	823644	823484
SR10B(N2)	823689	823159
CS(Mf)3(N)	808814	822355
CS(Mf)5	817990	821129
CS4	810025	824004
CS6	817028	823992
CSA	818103	823064

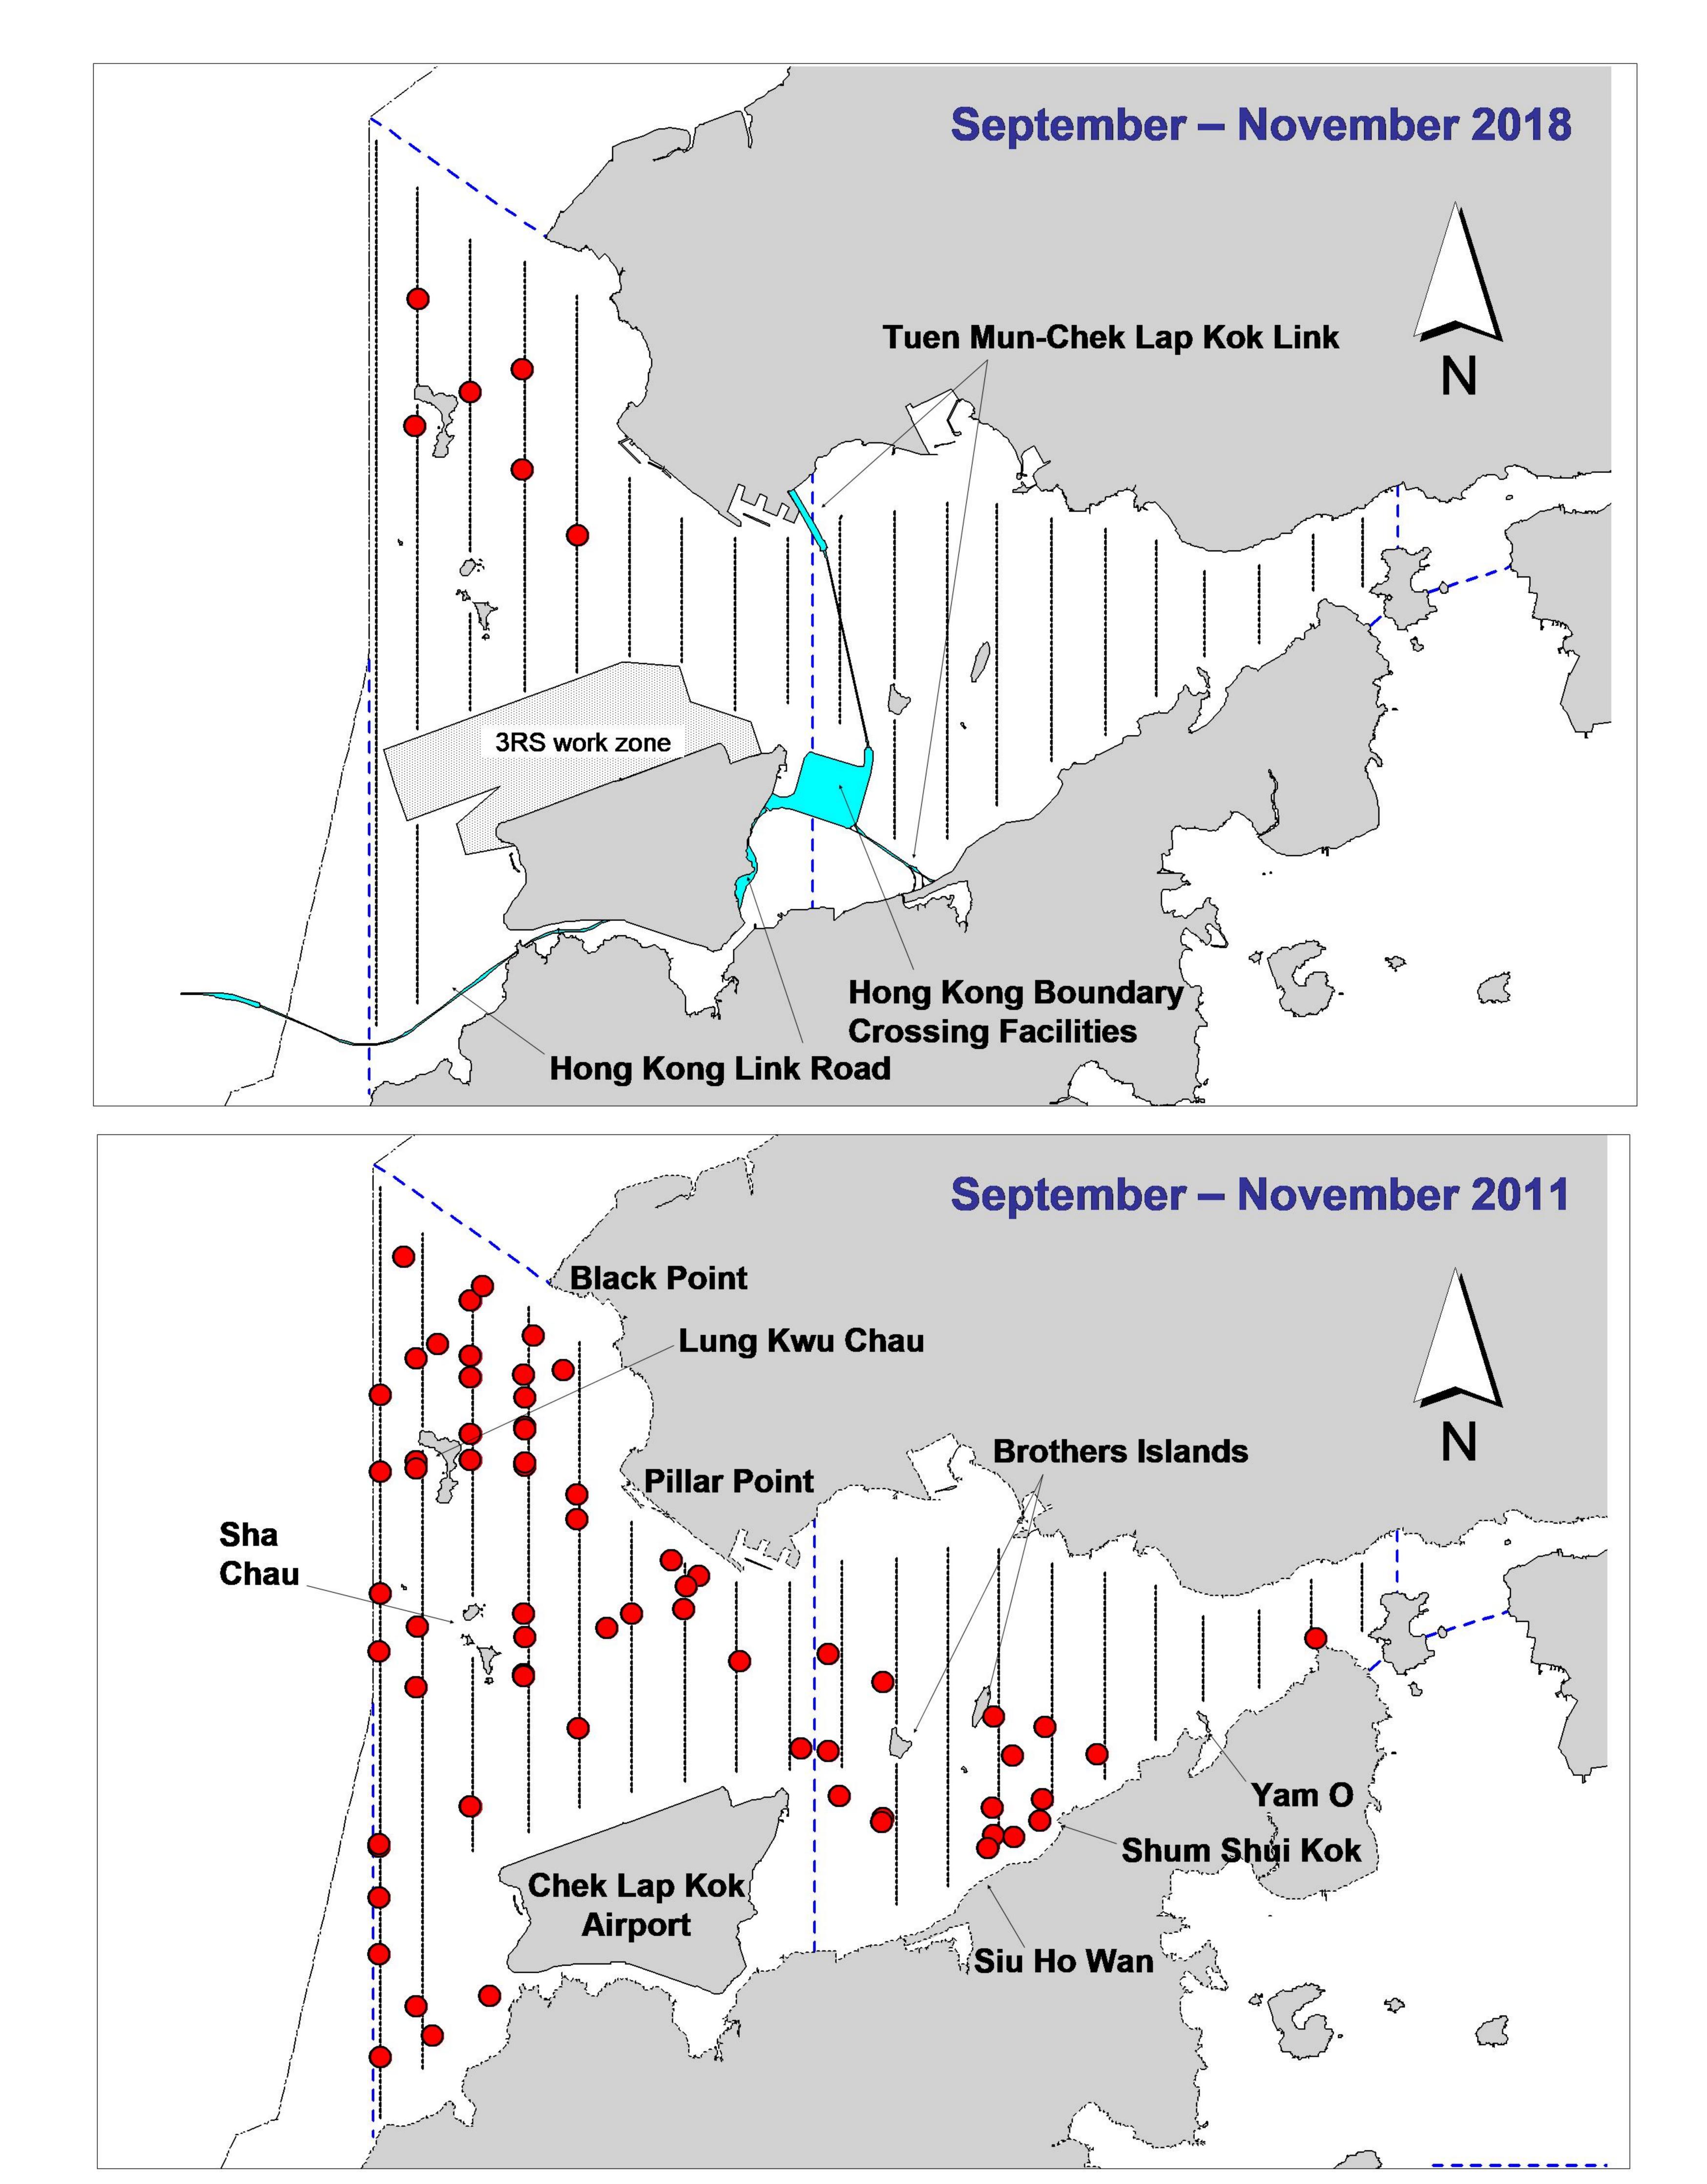
Figure 1. Distribution of Chinese white dolphin sighting in Northwest and Northeast Lantau during the present impact phase (top) and baseline monitoring surveys (bottom)

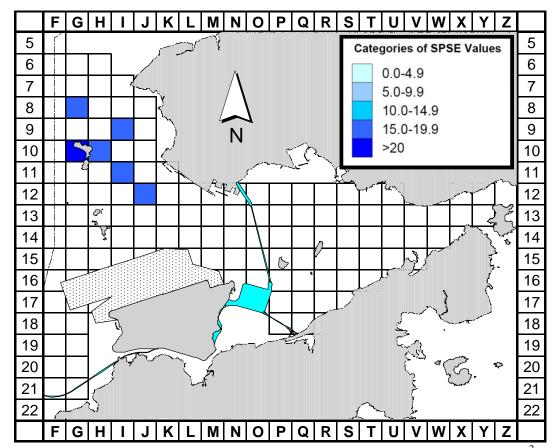
Figure 2a. Sighting density of Chinese white dolphins with corrected survey effort per km² in Northeast and Northwest Lantau survey areas, using data collected during the present impact monitoring period monitoring period (Sep-Nov 18) (SPSE = no. of on-effort sightings per 100 units of survey effort)

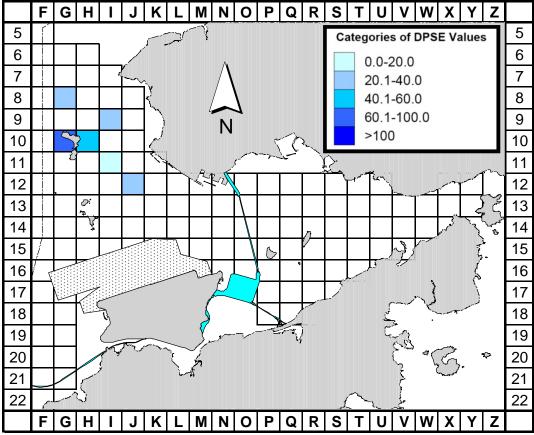
Figure 2b. Density of Chinese white dolphins with corrected survey effort per km² in Northeast and Northwest Lantau survey areas, using data collected during the present impact monitoring period (Sep-Nov 18) (DPSE = no. of dolphins per 100 units of survey effort)

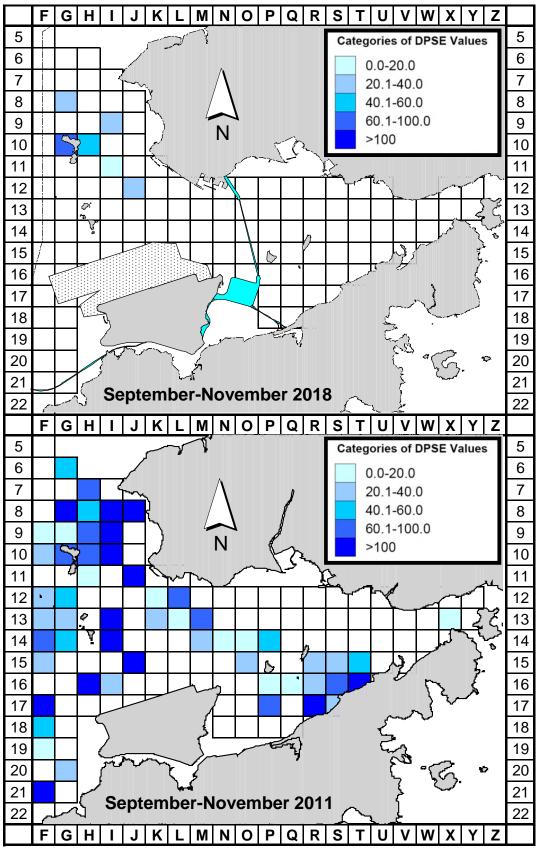
Figure 3. Comparison of density of Chinese white dolphins with corrected survey effort per km² in Northwest and Northeast Lantau survey area between the present impact monitoring period (September-November 2018) and baseline monitoring period (September-November 2011) (DPSE = no. of dolphins per 100 units of survey effort)

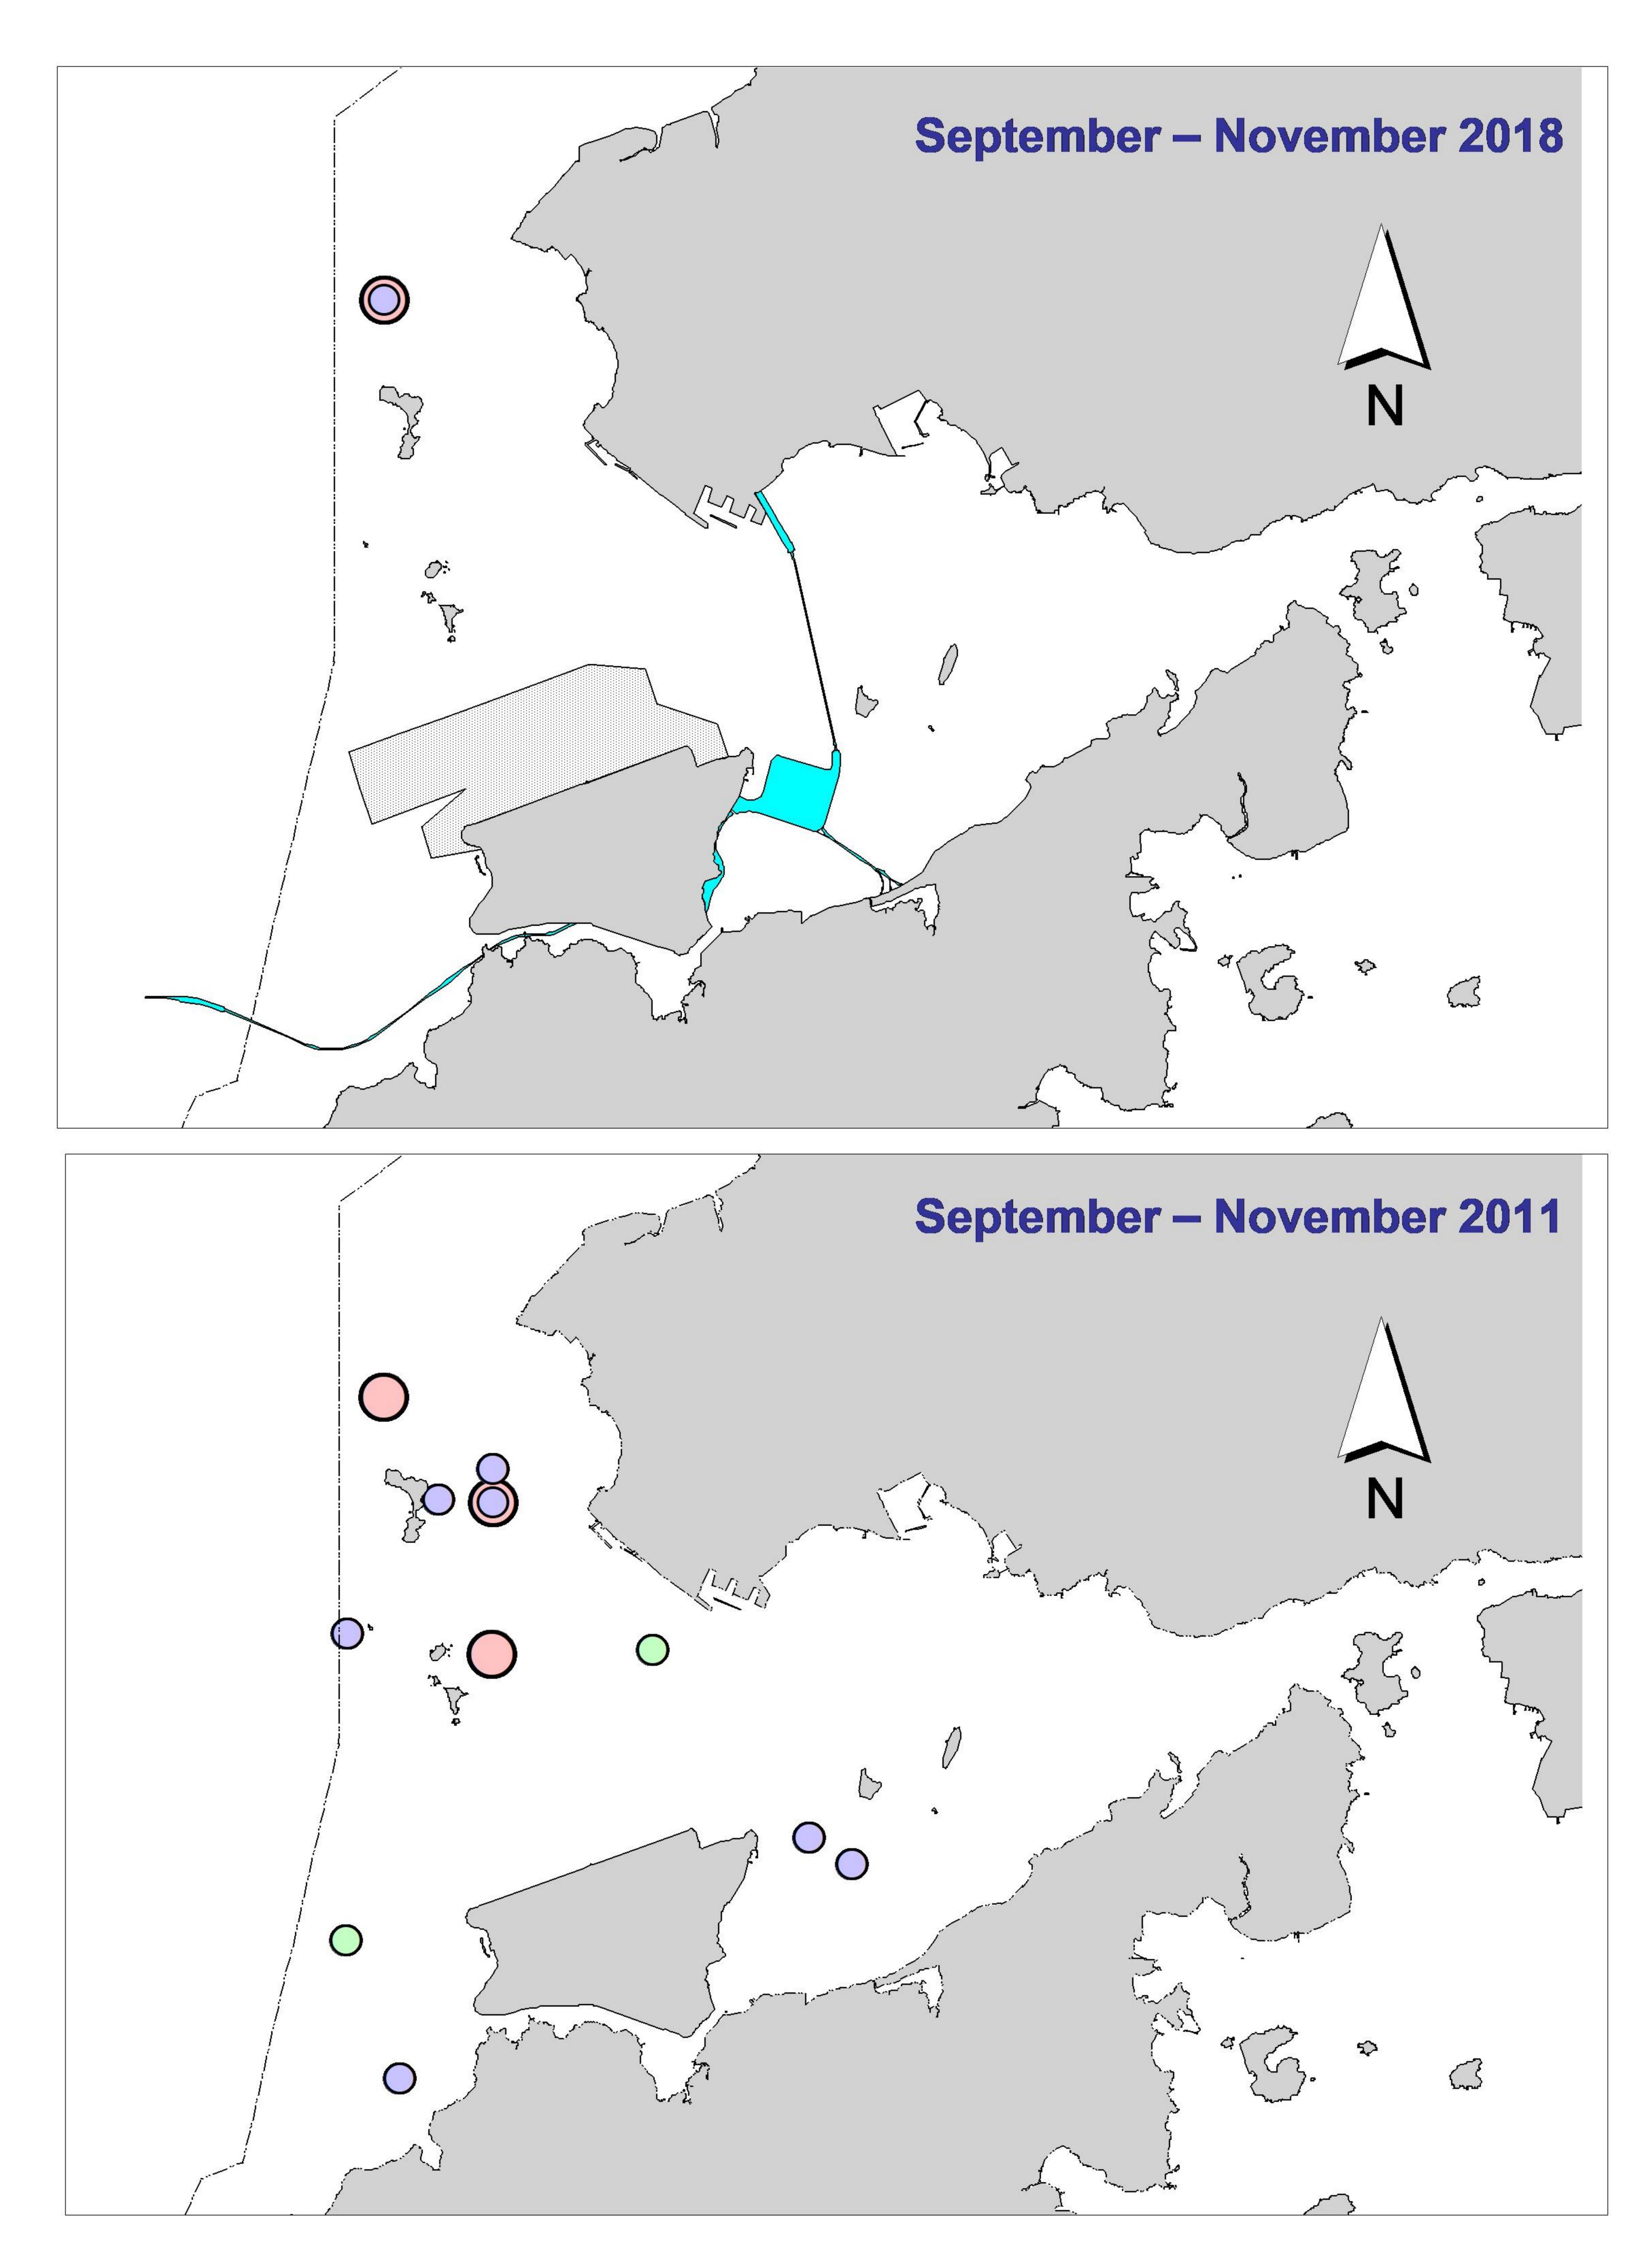
Figure 4. Distribution of Chinese white dolphins engaged in feeding (purple dots), socializing (pink dots) and traveling (green dots) activities during the present impact phase (top) and baseline monitoring surveys (bottom)
