Contract No. EP/SP/66/12

Integrated Waste Management Facilities, Phase 1

# CORAL TRANSLOCATION PLAN

(Clause 2.12, Further Environmental Permit FEP-01/429/2012/A)

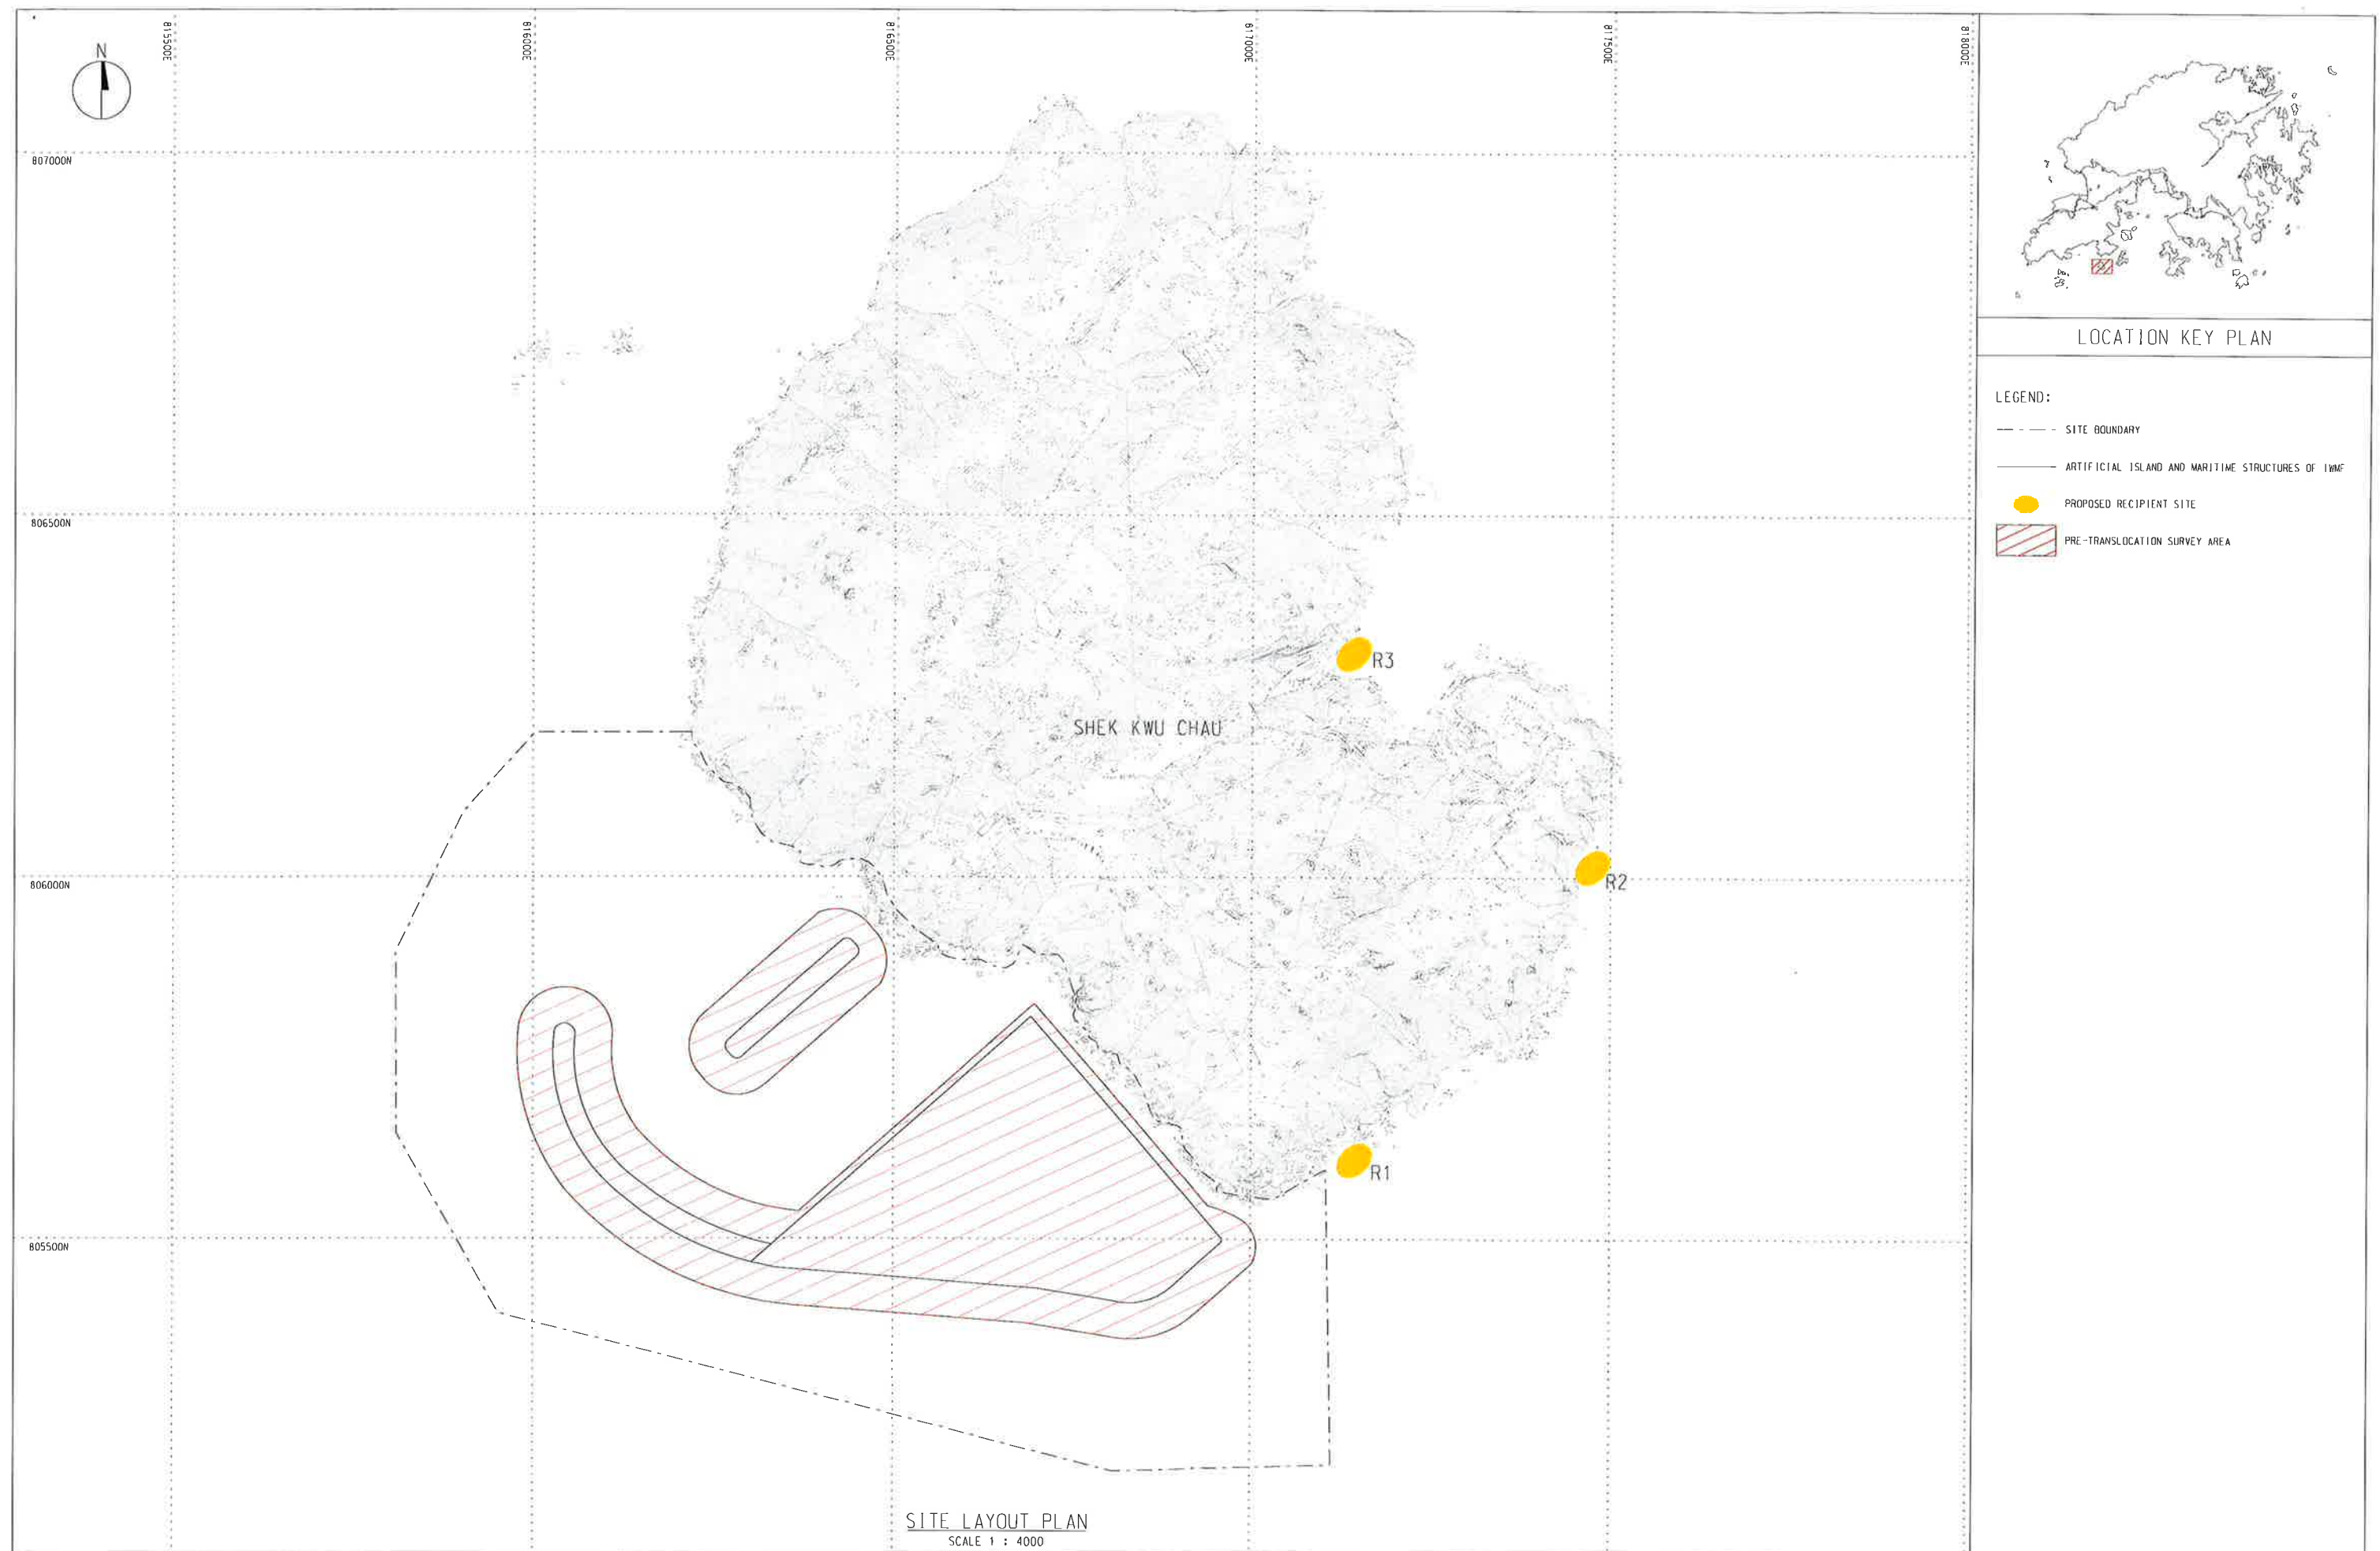
**Figure 1 Pre-Translocation Survey Area and Proposed Recipient Sites R1, R2 and R3**

- 3.2.1. The Spot-Check and REA surveys were performed in January and February 2018 for potential Recipient Site R1, R2 and R3 (**Figure 1**); and the weather conditions were summarized in **Table 3.2**. Spot-Check surveys were conducted along the hard substrate of the three proposed recipient sites at the south-eastern and eastern coast of SKC. 4 species to 7 species of coral were recorded during the spot-check surveys in the three potential recipient sites (**Table 3.3**). Following the spot-check survey, REA survey was conducted at the same date.

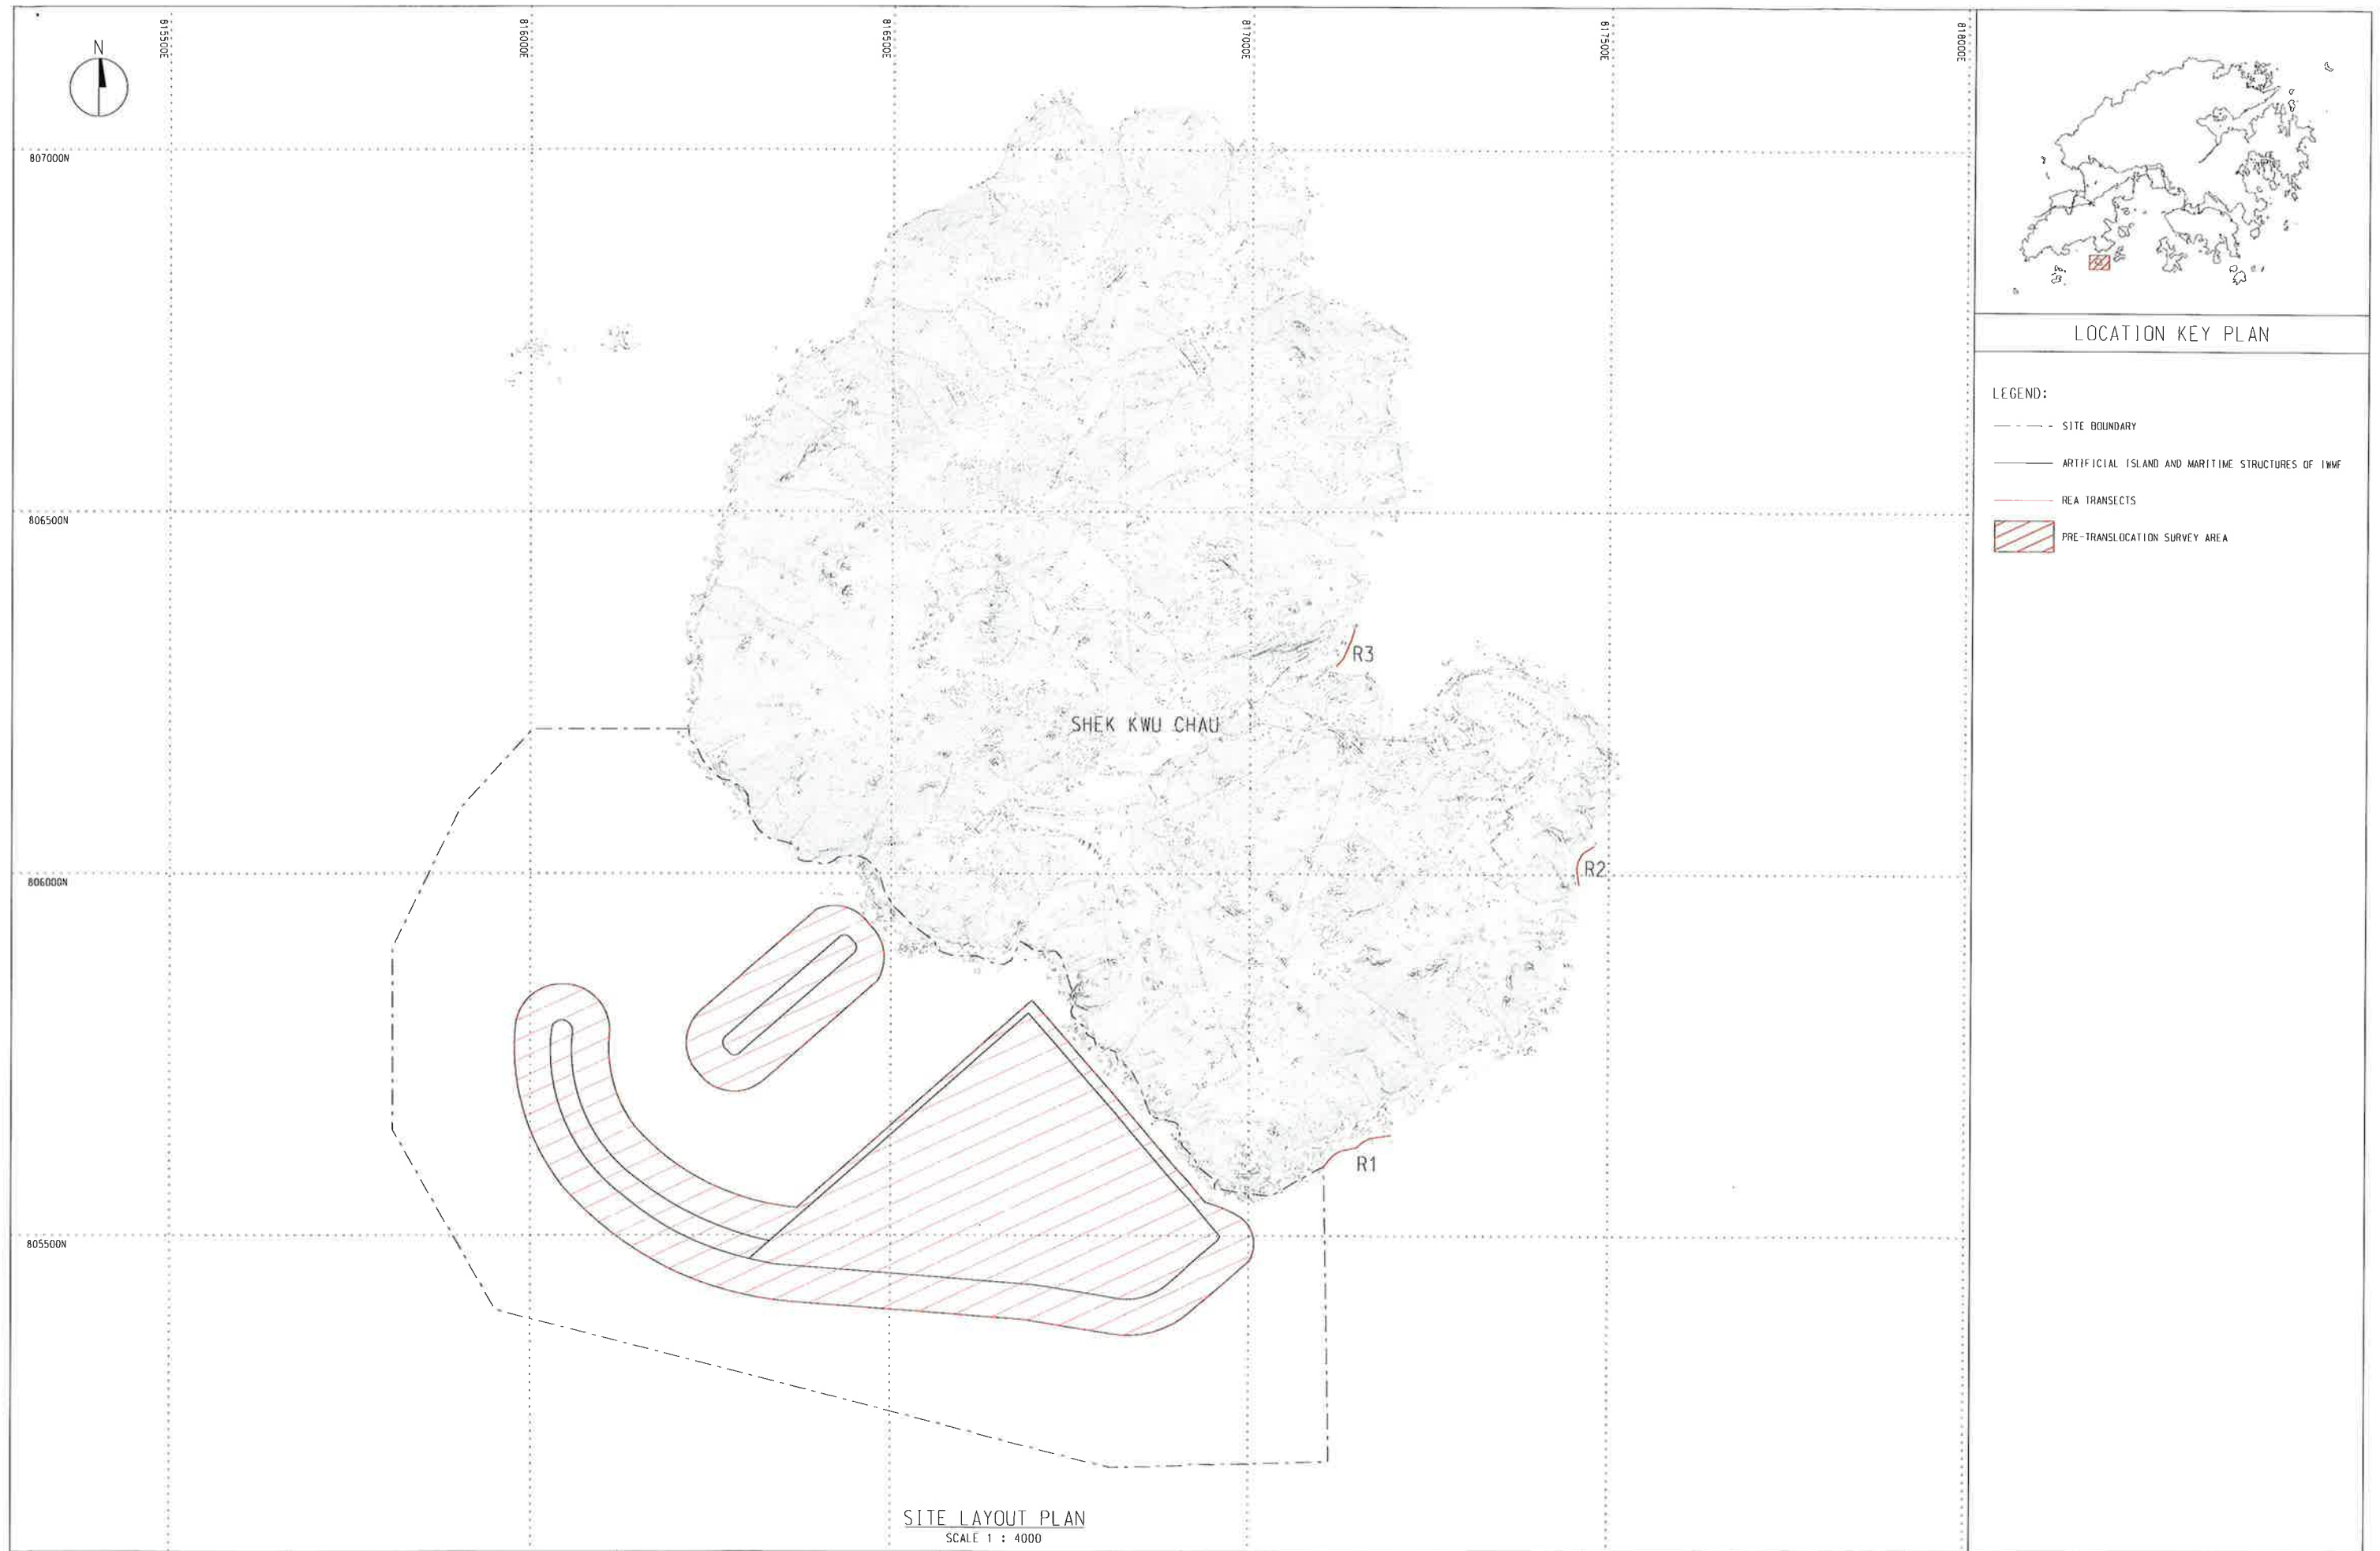
**Figure 4 Locations of REA Transects at Proposed Recipient Sites R1, R2 and R3**

- 3.2.2. A 100m transect was laid at proposed recipient Site R1 (**Figure 4**). GPS coordinates of REA Transect Starting and Ending, Maximum Depth and Bottom Substrate of the site were summarized in **Table 3.4**. The average water depth of the transect was about 2.5 to 4.5 m.
- 3.2.3. This site is mainly composed of natural bedrock and boulders down to 4.5 meters water depth along the surveyed route (**Table 3.5**). Patches of hard coral colonies were recorded along the REA transect and 4 species of hard coral were recorded. The abundance of hard coral species recorded along the transect was shown in **Table 3.6**. Besides, some invertebrates such as common sea snail: *Thais luteostoma*, Sea urchins: *Anthocardaris crassispina* and common green mussel: *Septifer virgatus* were found at the surface of the boulders.

3.2.5. A 100m transect was laid at proposed recipient Site R2 (**Figure 4**). GPS coordinates of REA Transects Starting and Ending, Maximum Depth and Bottom Substrate of the site were summarized in **Table 3.4**. The average water depth of the transect was about 3 to 4 m.

3.2.8. A 100m transect was laid at proposed recipient Site R3 (**Figure 4**). GPS coordinates of REA Transect Starting and Ending, Maximum Depth and Bottom Substrate of the site were summarized in **Table 3.4**. The average water depth of the transect was about 2.5 to 4 m.

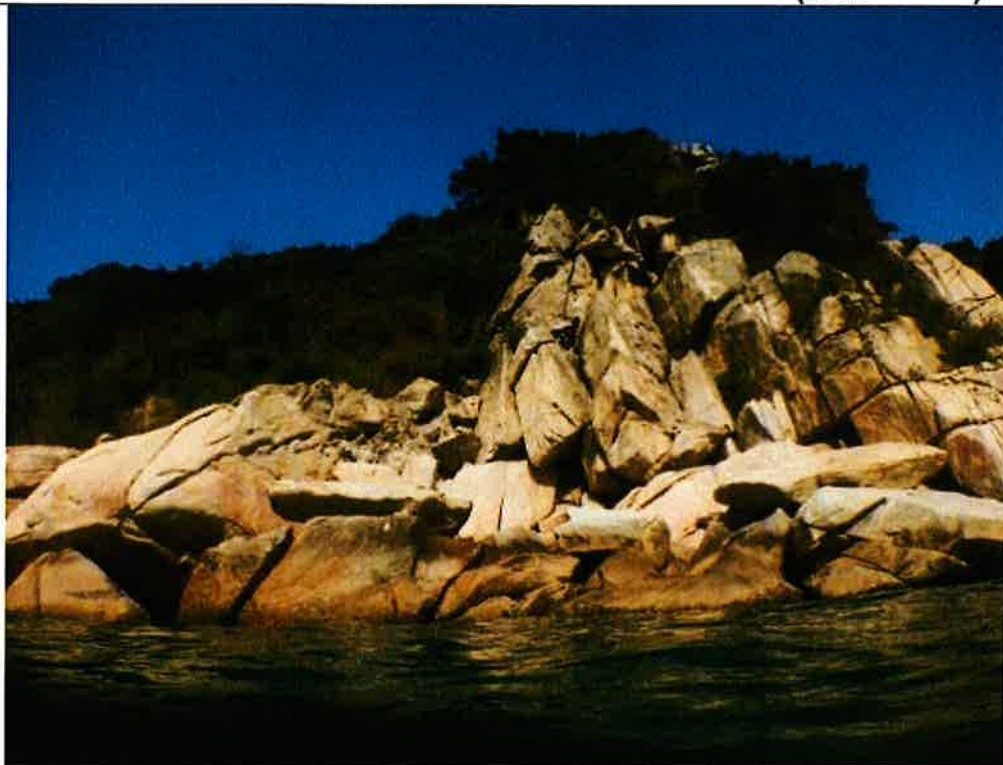
**Photo 1. Bedrock at Shek Kwu Chau**

- 3.1.2. Sixty five (65) coral colonies (**Appendix 1**) were mapped during the survey. All corals recorded during the survey colonized on hard substrates, and Forty-nine were attached to non-movable boulders. Locations of movable and non-movable coral colonies found during the active search surveys are shown in **Figure 2** and **Figure 3** respectively.
- 3.1.3. The mapped corals comprised 6 species, besides the uncommon *Coscinaraea* sp., all common to dominant in Hong Kong (see **Table 3.1** below). All corals were recorded at the water depth range of 2.5 m to 4.5 m. Photos of the site and representative corals are shown in **Photo Plate 1**.

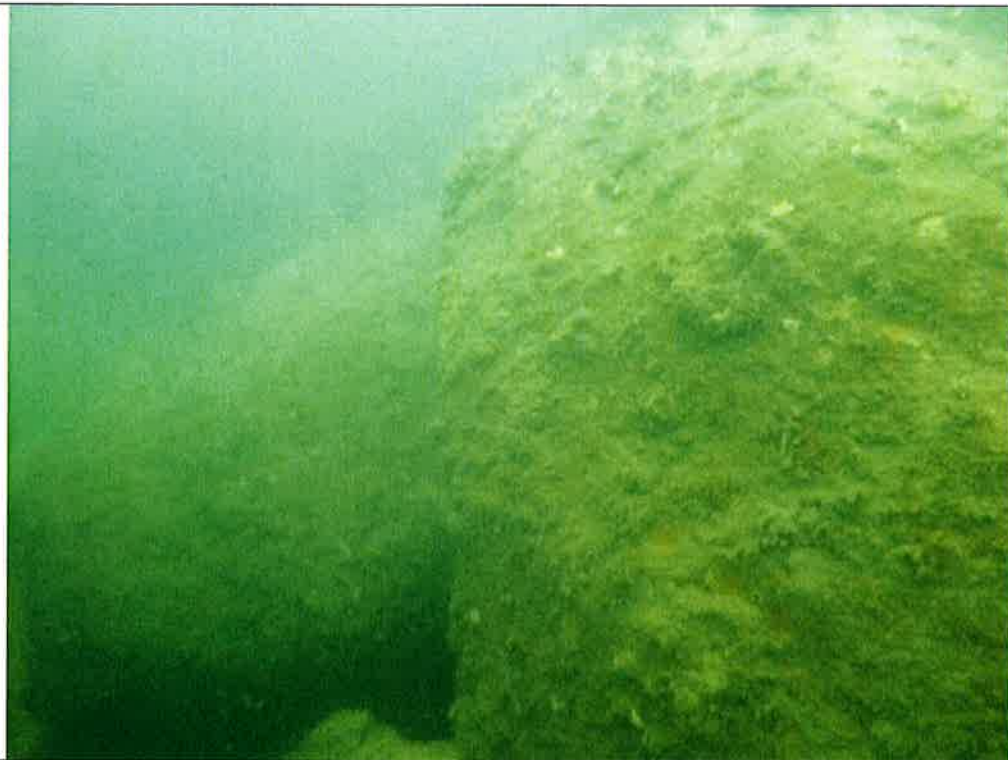
**Photo 2. Boulders at Shek Kwu Chau**

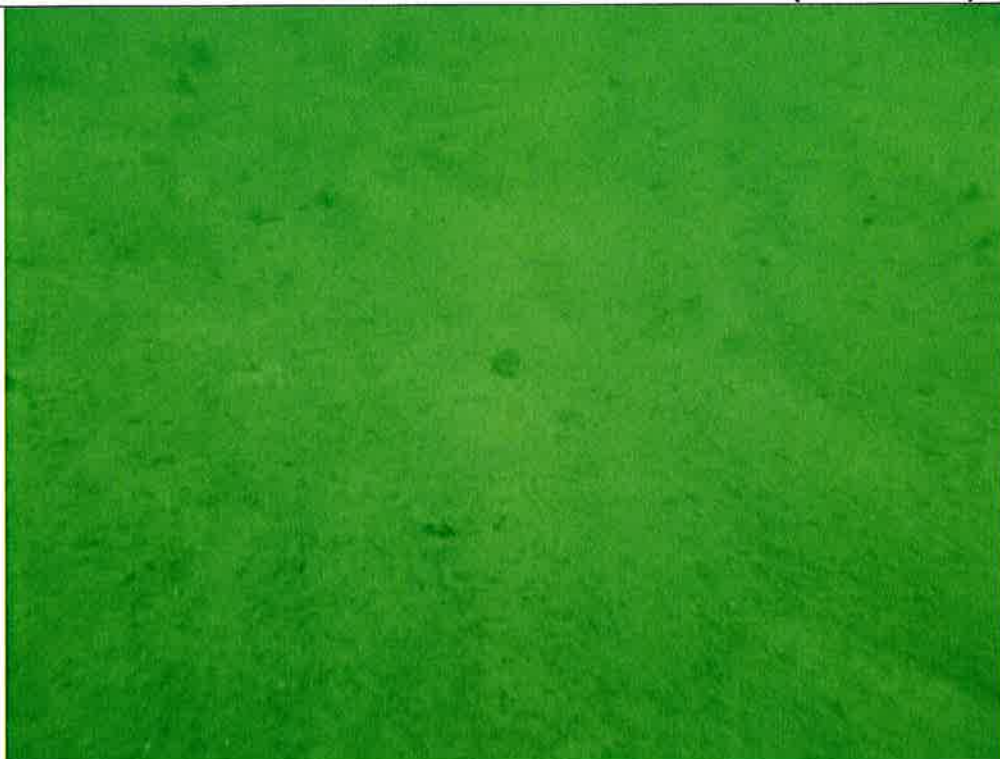
**Photo 3. Sandy Bottom at Shek Kwu Chau**

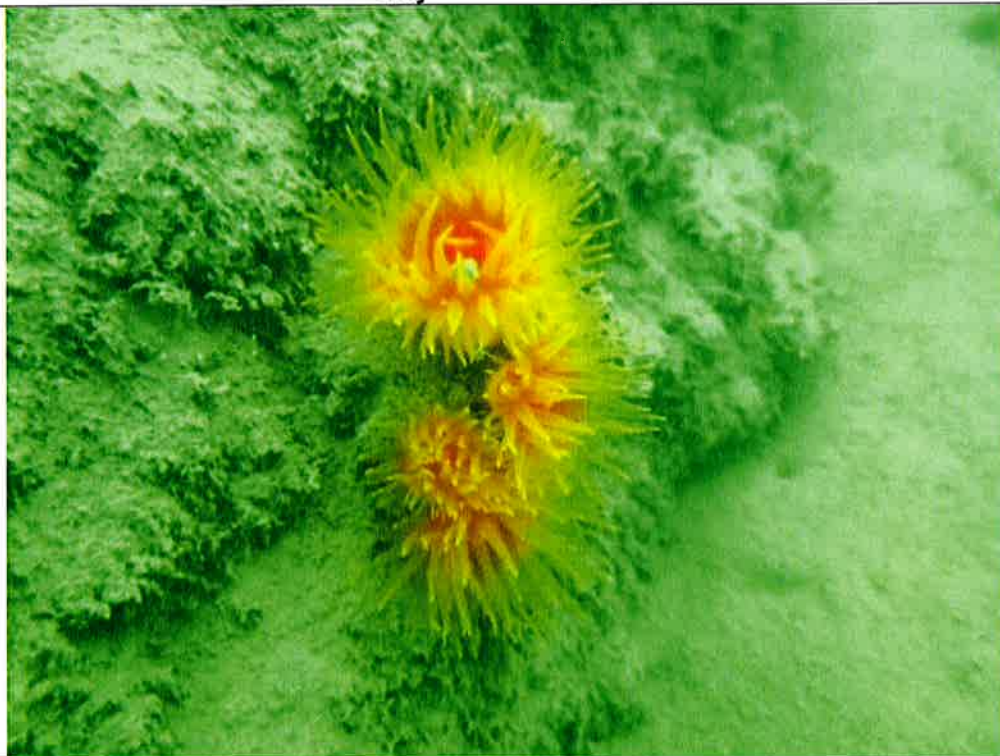
**Photo 4. *Tubastrea* sp. at Shek Kwu Chau**

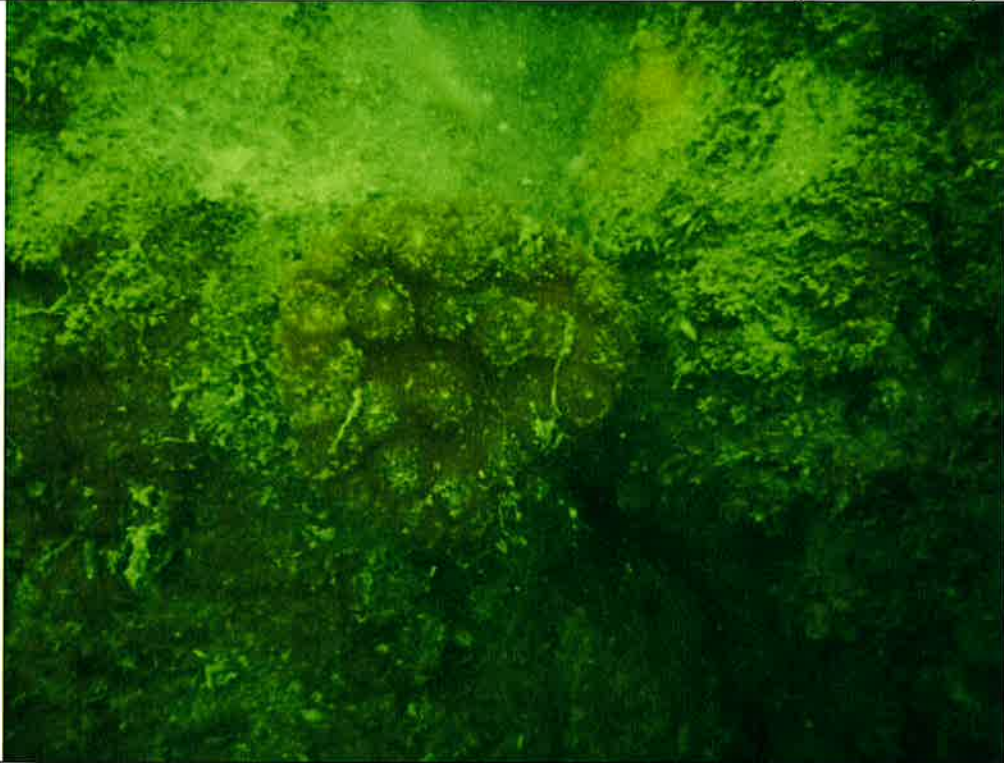
**Photo 5. *Turbinaria peltata* at Shek Kwu Chau**

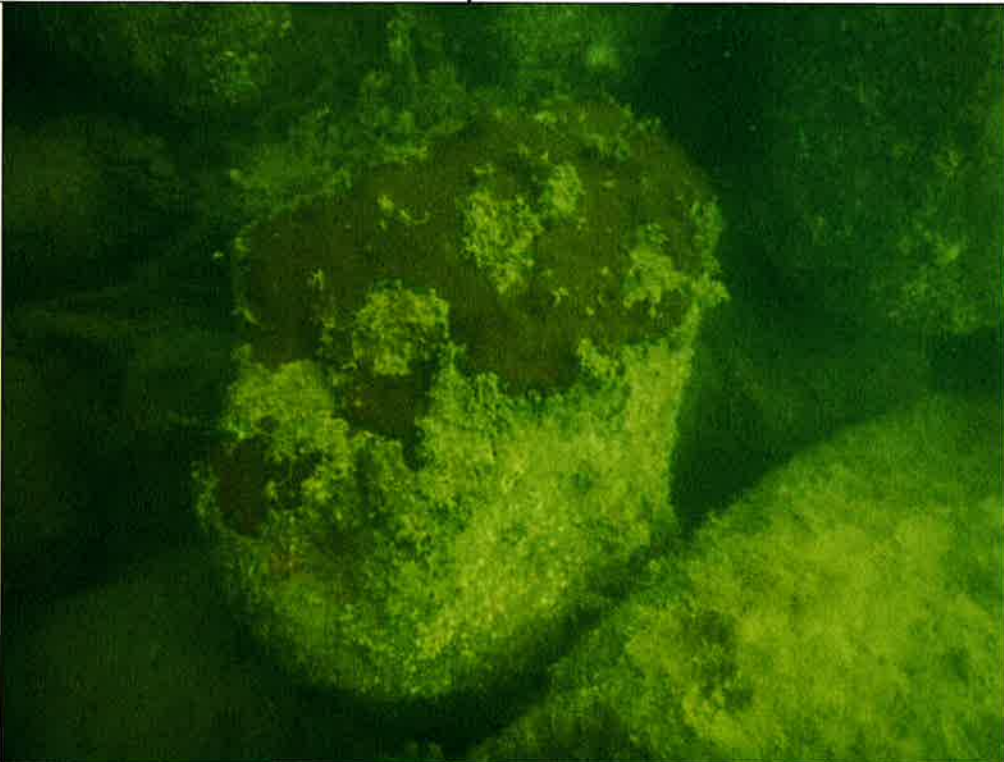
**Photo 6. Movable *Psammocora superficialis* at Shek Kwu Chau**

- 3.1.4. Sixteen (16) coral colonies (**Appendix 1**) are attached to rock less than 50 cm in diameter in which they are feasible to be removed with the rock they attached. Though they are belonged to species common and abundant (except one *Coscinaraea* n sp. colony) in Hong Kong, mitigation measures would still be adopted for these corals. These colonies would need special attention during the translocation process.

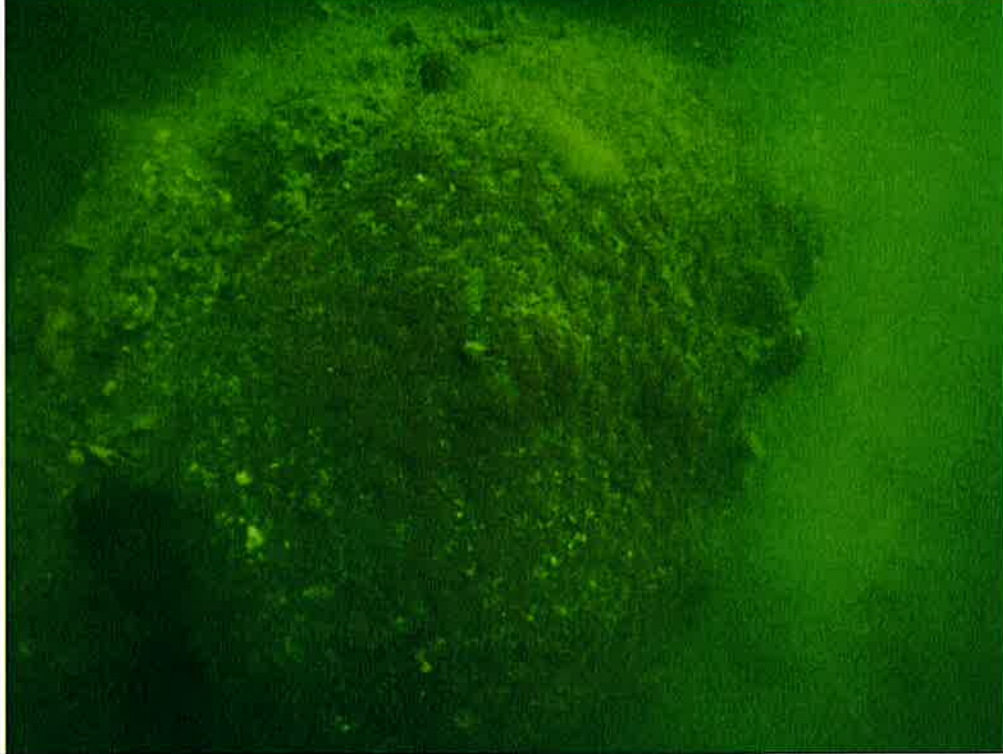
**Photo 7. Movable *Coscinaraea n* sp. at Shek Kwu Chau**

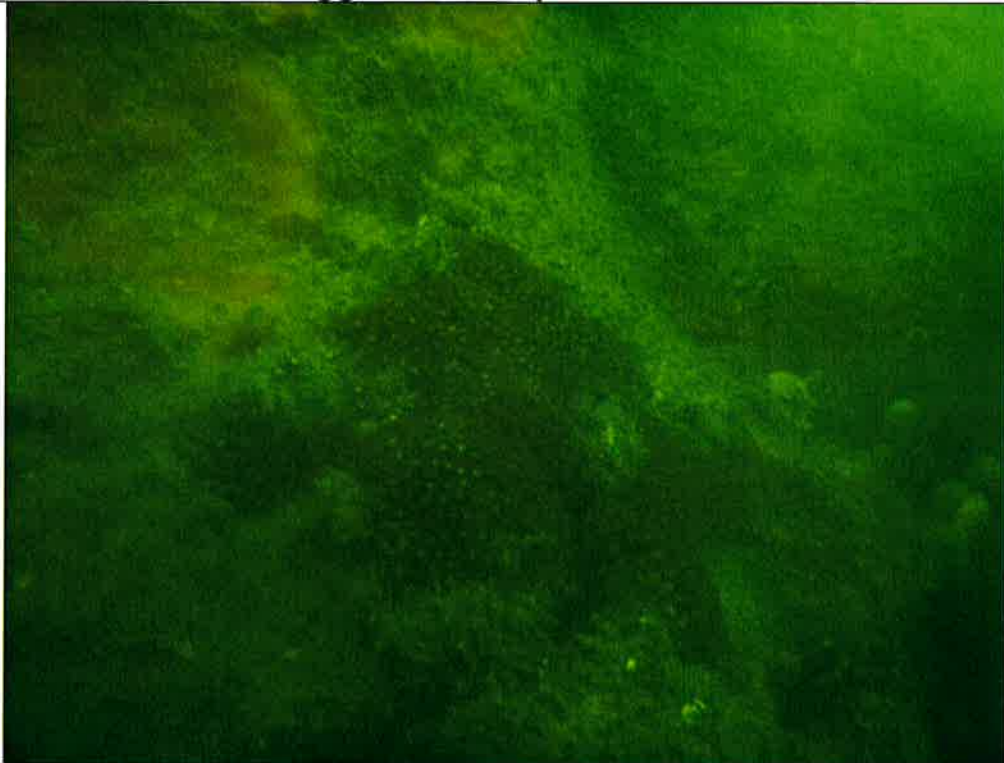
**Photo 8. *Goniopora stutchburyi* at Suggested Recipient Site R3**

3.2.10. This site supported a sparse and patchy cover (~5%) of hard corals. In general, the health conditions of corals are in fair condition. Except for the uncommon coral *Coscinaraea* sp., all the recorded coral colonies grow on the boulders and rocks surfaces. All the recorded coral colonies grow on the boulders and rocks surfaces. Except for the uncommon coral *Coscinaraea* sp., all coral colonies recorded along the transect are common coral species in Hong Kong water. Photos of the site and representative corals are shown in **Photo Plates 2**.

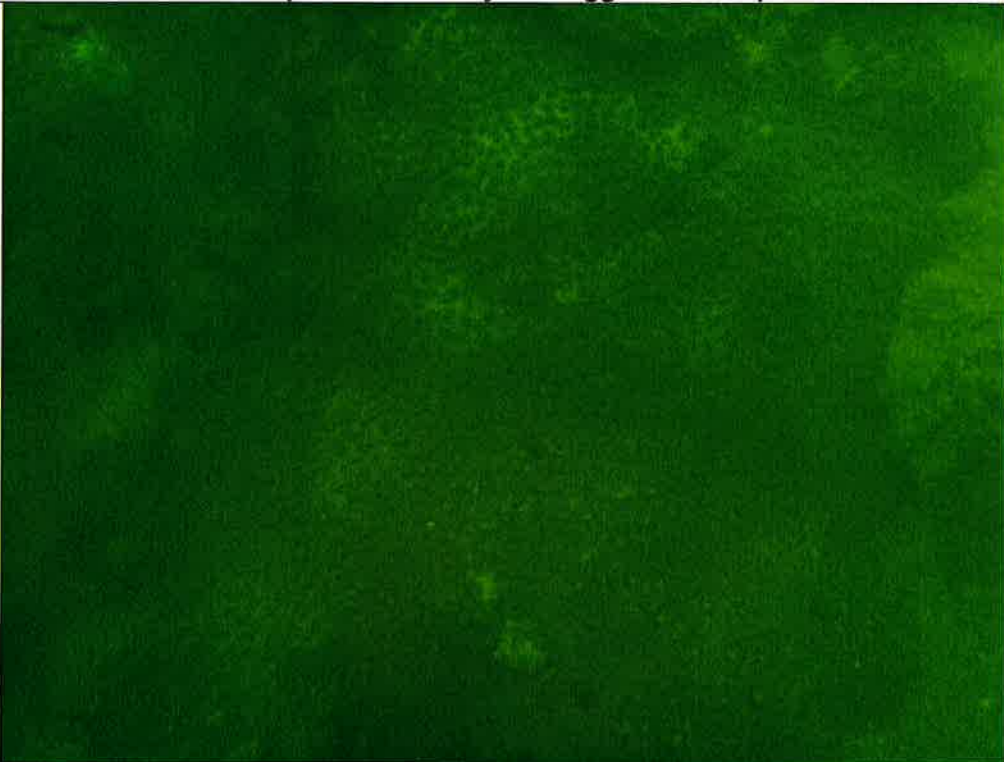
**Photo 9. *Cyphastrea serailia* at Suggested Recipient Site R3**

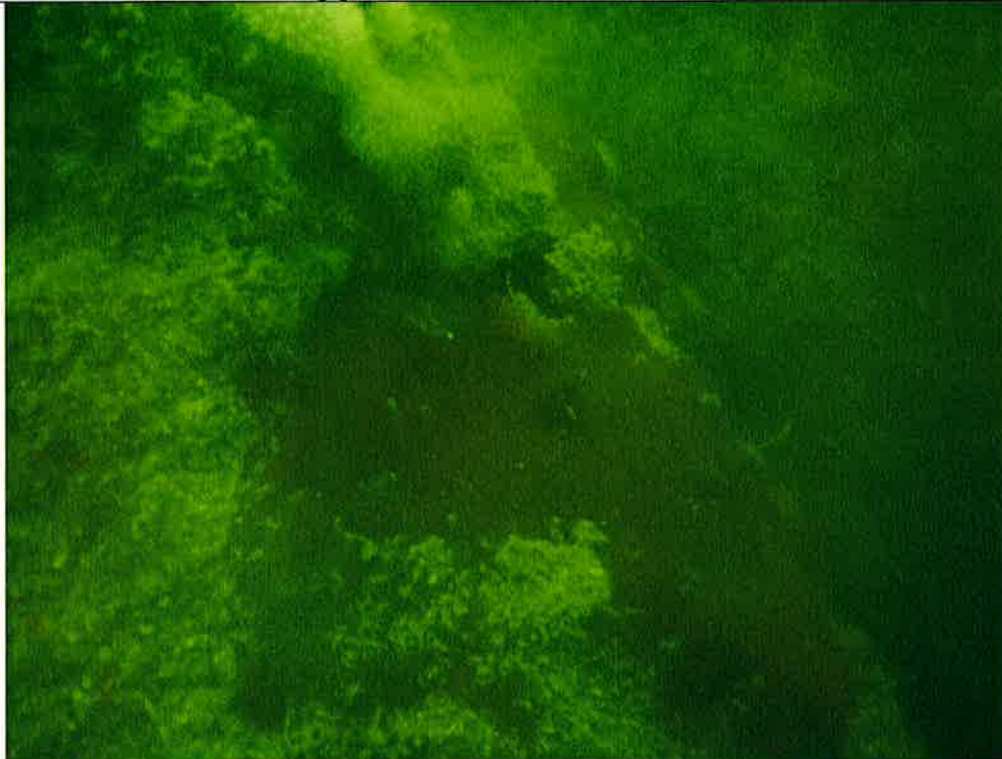
**Photo 10. *Coscinaraea* sp. at Suggested Recipient Site R3**

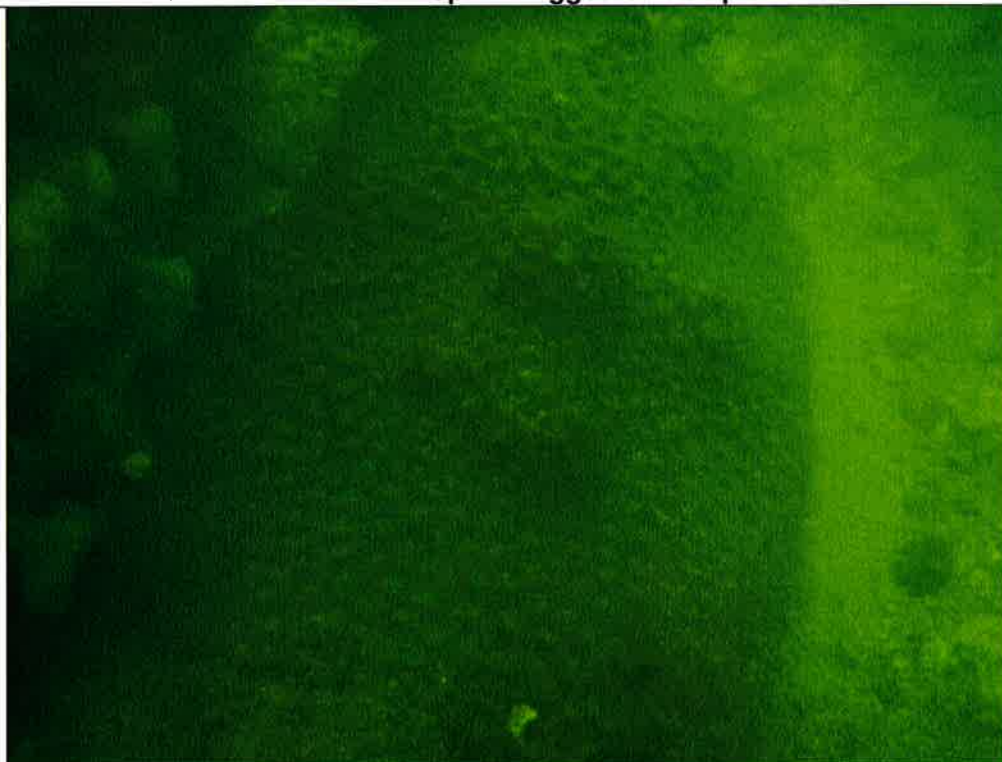
**Photo 11. *Favites chinensis* at Suggested Recipient Site R3**

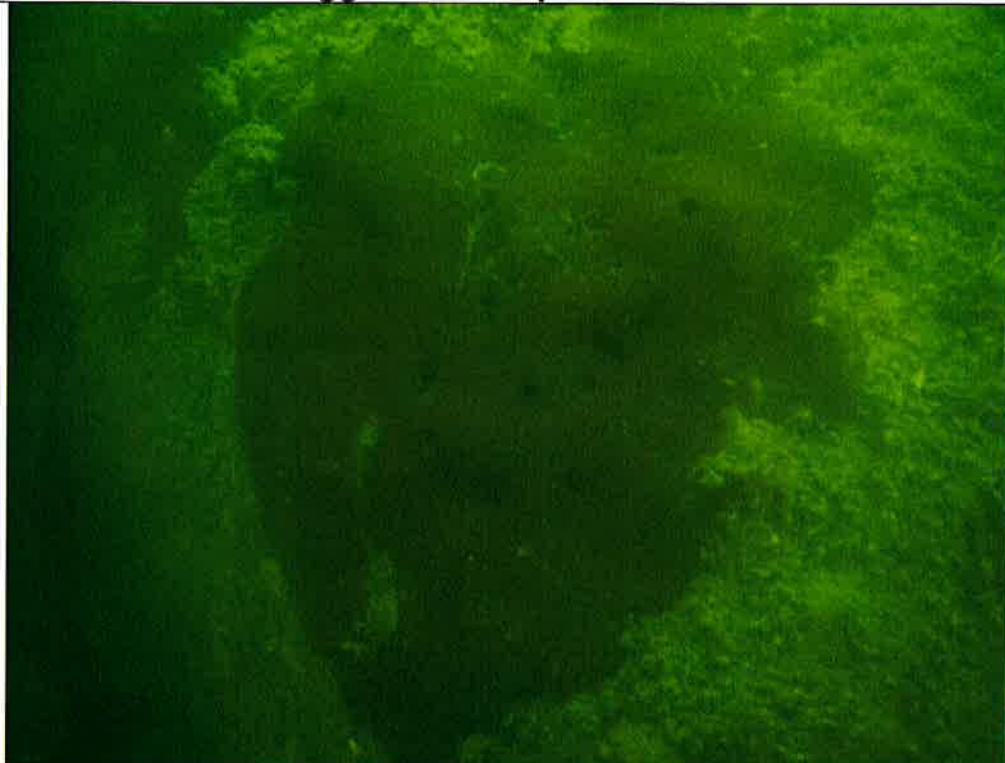
**Photo 12. *Psammocora superficialis* at Suggested Recipient Site R3**

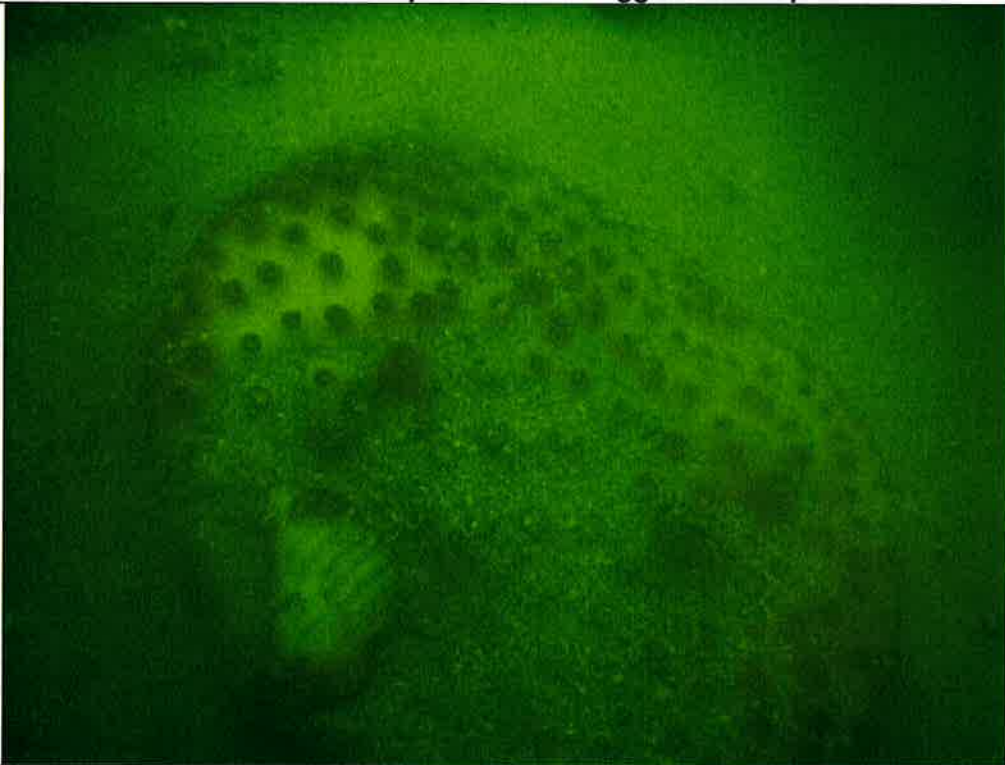
**Photo 13. *Turbinaria peltata* at Suggested Recipient Site R3**
