# Quarterly EM&A Report No.1

## (Period from 28 June to 30 September 2018)

(Clause 3.3, Further Environmental Permit FEP-01/429/2012/A)

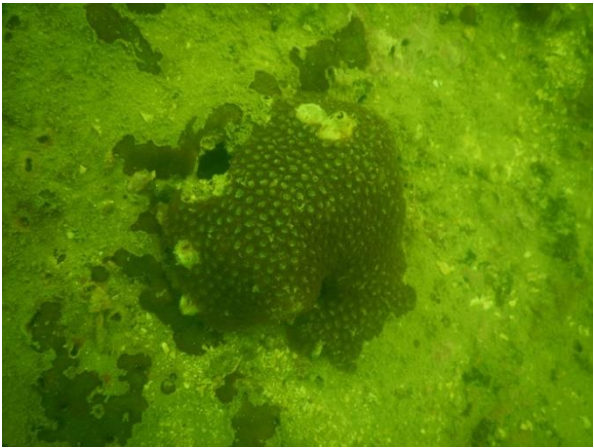
Photo Plate for 2<sup>nd</sup> & 3<sup>rd</sup> Monthly Coral Monitoring at Control Site

- 5.4.7 All remaining tagged coral colonies at Control Site still showed either fair or good health condition during the Third Month Construction Phase Monitoring. Tagged coral #1 and #9 showed 5% of increased mortality of the whole colony, while tagged coral #3 and #6 showed increased sediment coverage of 10% and 5% respectively. There was not increased level of mortality, bleaching and sediment of the tagged colonies #4 and #8 when compared with the baseline results.

- 5.4.8 Since all tagged coral colonies at Indirect Impact Site and 4 tagged coral at Control Site were missing during the third month monitoring, it is suggested to re-tag all the missing corals. The re-tagging activity should be done before the next monitoring survey. As the missing tagged coral colonies were caused by the Super Typhoon Mangkhut, the AL/LL will not be applied at this time.

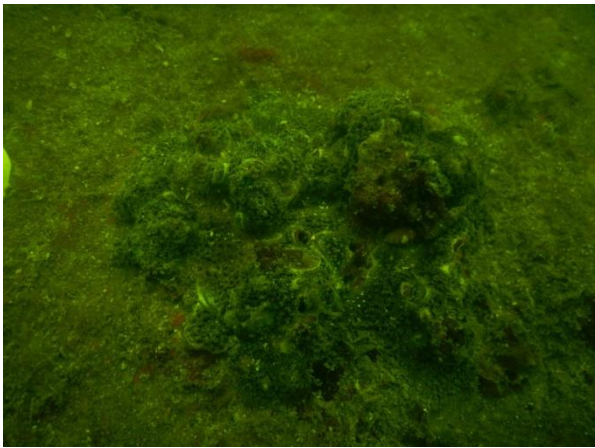
Photo Plate for 2<sup>nd</sup> & 3<sup>rd</sup> Monthly Tagged Coral Monitoring at Indirect Impact Site

- 5.4.6 After the super typhoon Mangkhut hitting Hong Kong on 15<sup>th</sup> and 16<sup>th</sup> September 2018. The whole bottom at the Indirect Impact Site were covered with 1 m thick of sand and mud in which the all ten tagged hard coral colonies were all missing during the third month monitoring. At the control site of Soko Island, most of the rocks at the bottom were turned over by the super typhoon Mangkhut, however only 4 tagged coral colonies were missing during the monitoring survey.

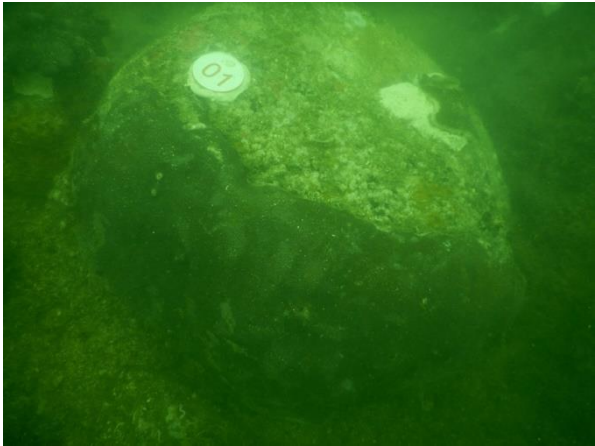
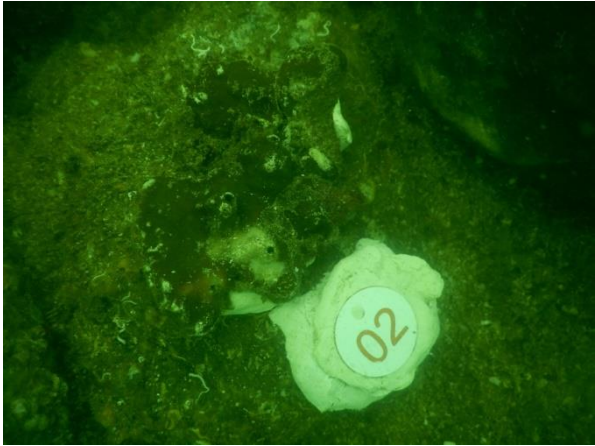
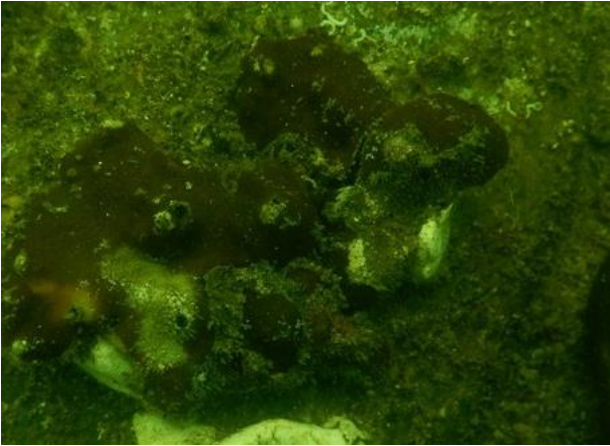
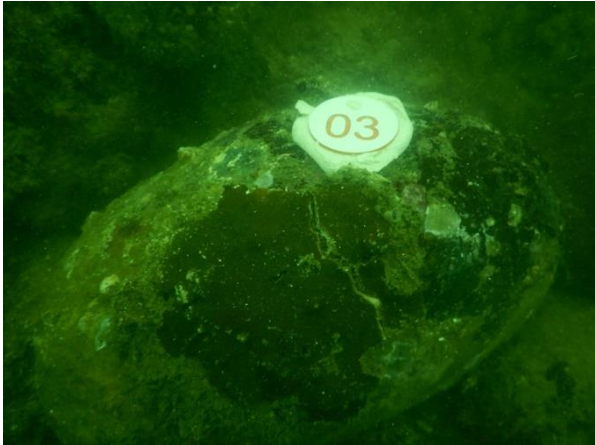
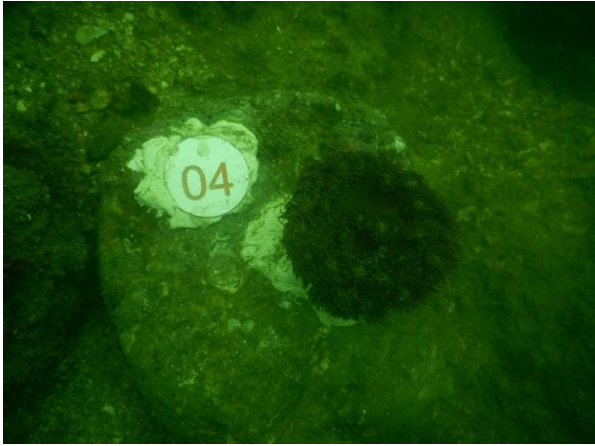
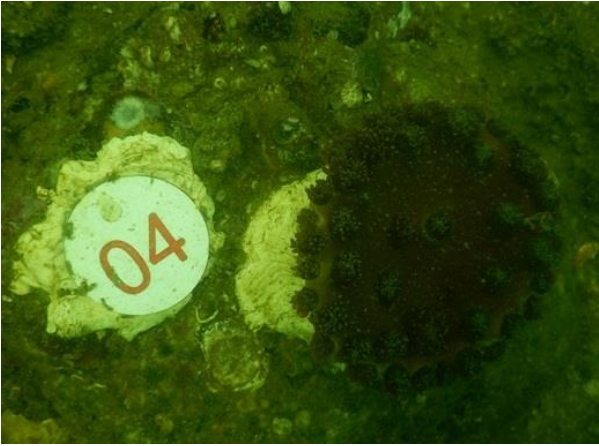
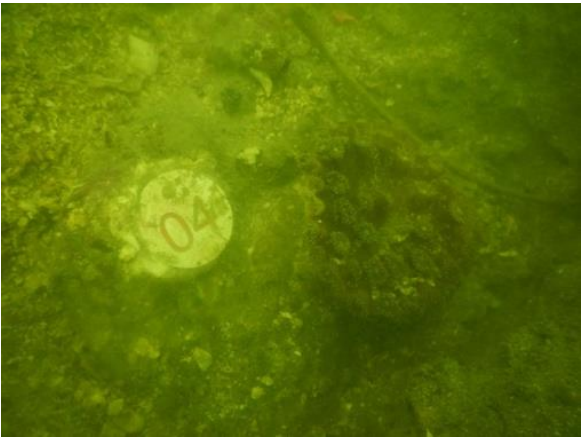
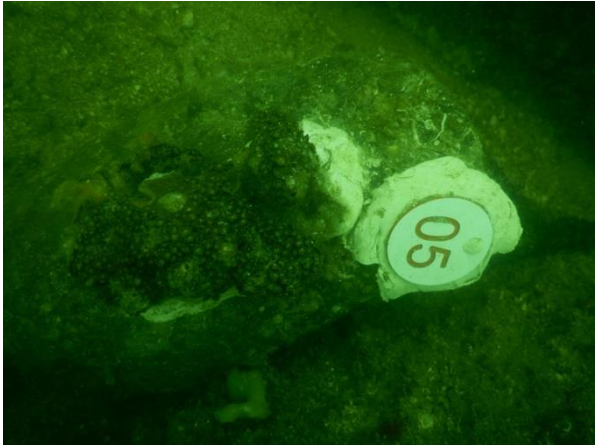
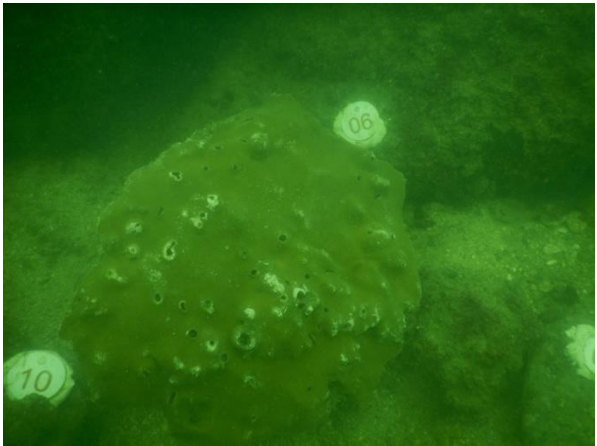
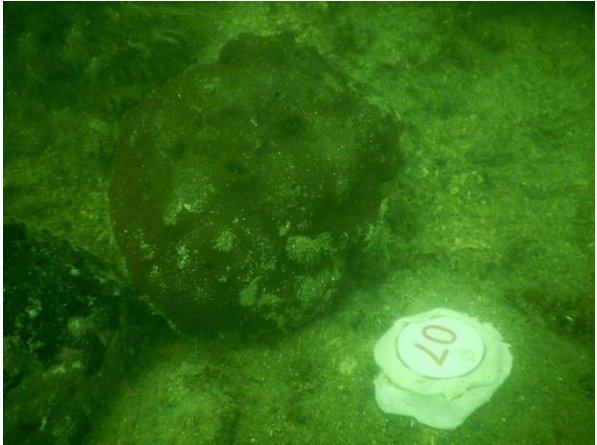
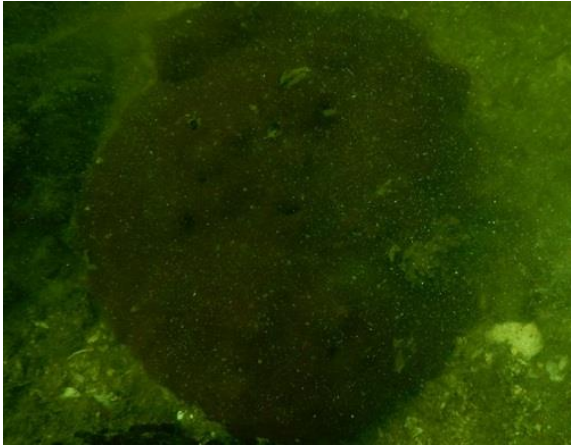
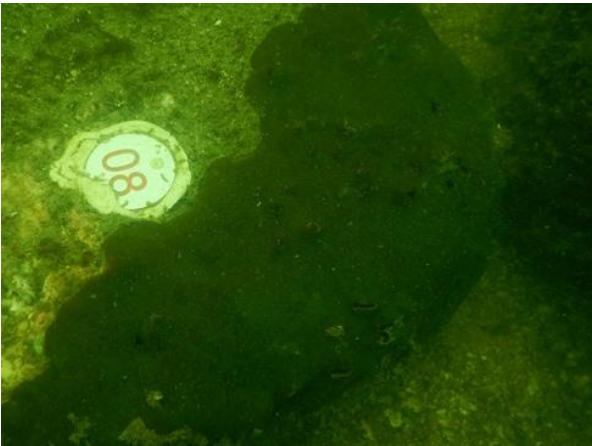
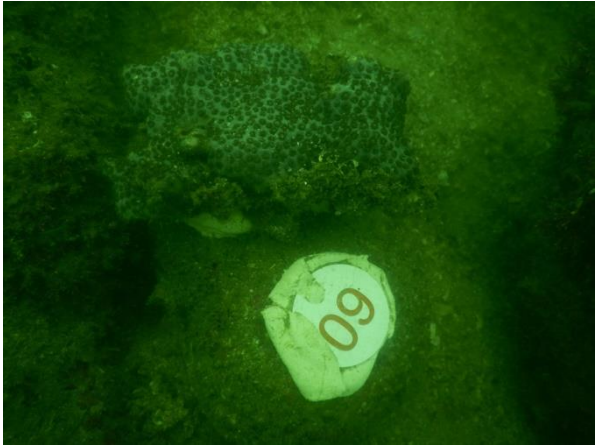
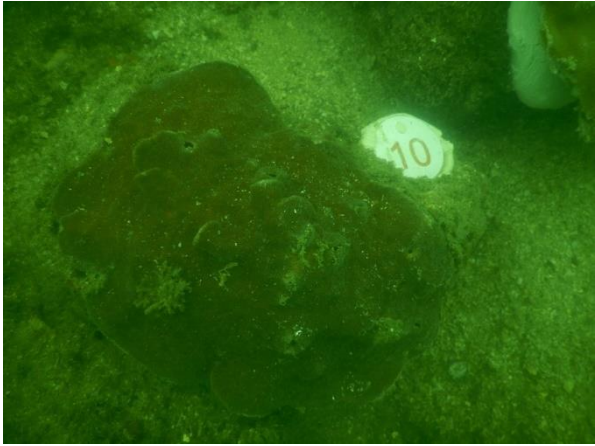
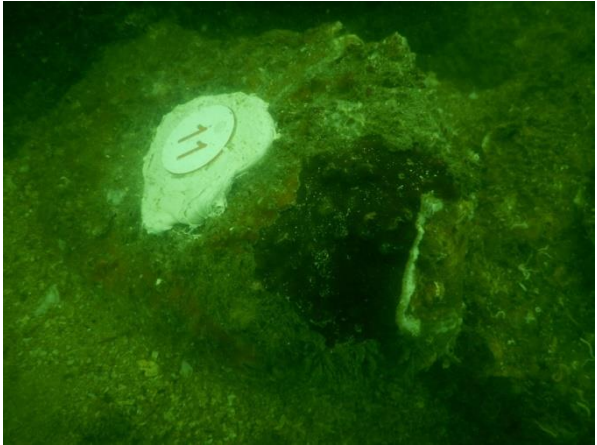
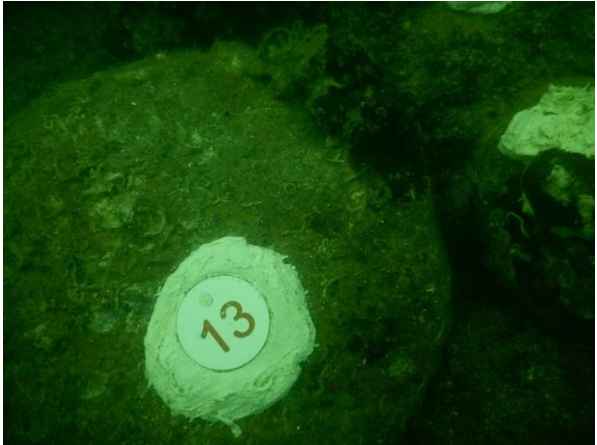
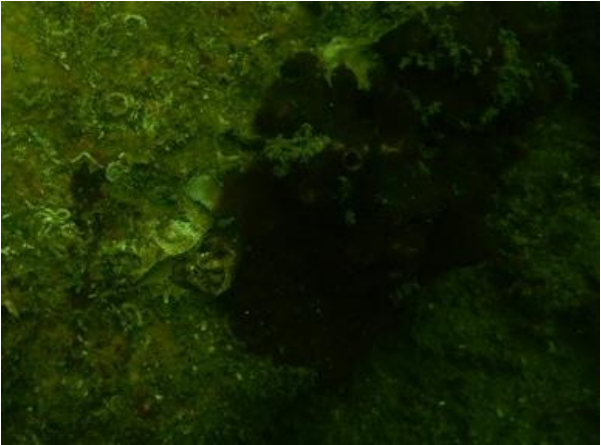
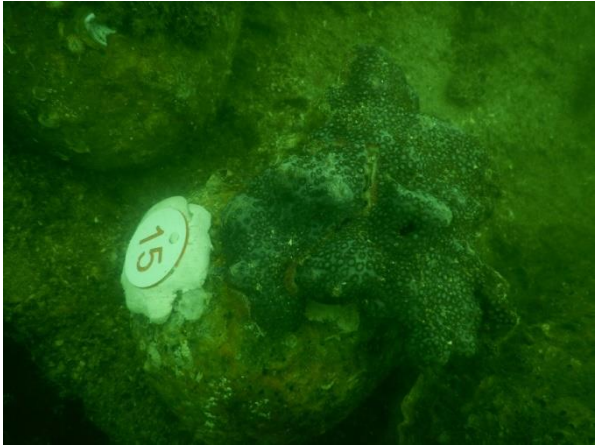
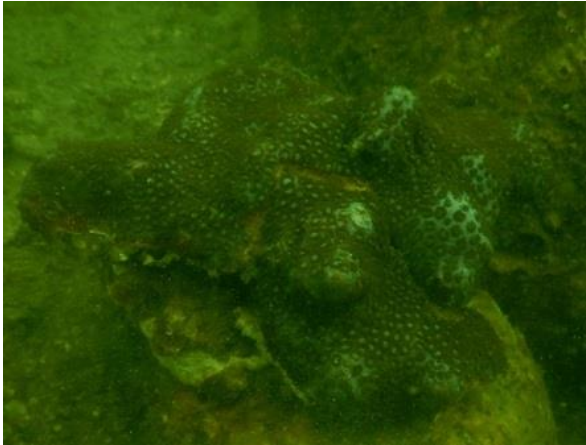
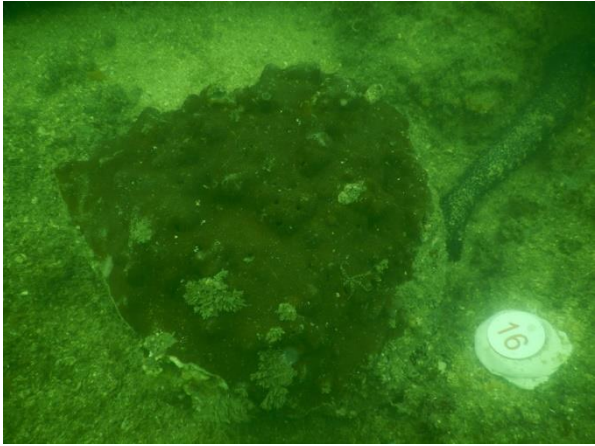
Photo Plate of Translocated Hard Corals at Recipient Site

- 5.4.9 The second post-translocation coral monitoring was carried out on 20 September 2018. Sixteen (16) movable hard coral colonies were monitored at the recipient site R3. However, 9 translocated coral colonies were missing during the second monitoring survey and only 7 left (**Table 5.7**). The remaining translocated coral colonies also showed an increased mortality from 5% to 15% (**Table 5.7**). The missing colonies probably were swept away by the strong wave action caused by the Super Typhoon Mangkhut hitting Hong Kong on 15<sup>th</sup> and 16<sup>th</sup> September 2018.

- 5.4.11 Since all missing tagged coral colonies at the Recipient Site R3 were caused by the Super Typhoon Mangkhut, the AL/LL will not be applied at this time. Post-translocation monitoring survey will be continued to monitor the remaining tagged coral colonies for both translocated coral and natural coral colonies.

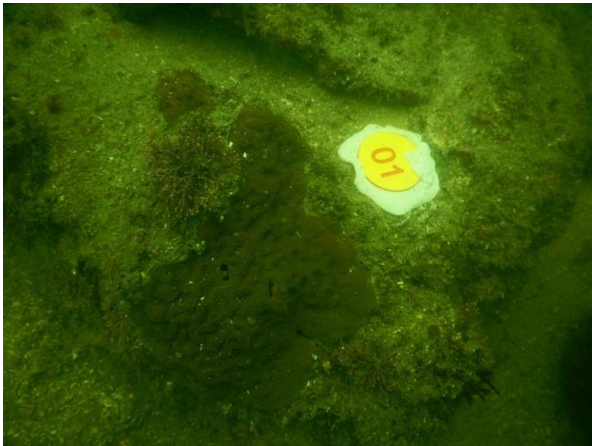
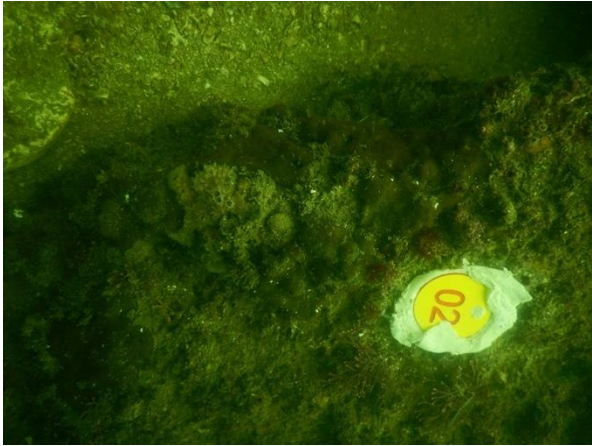
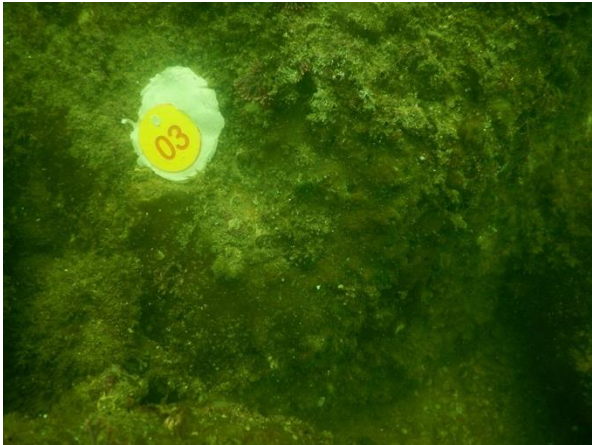
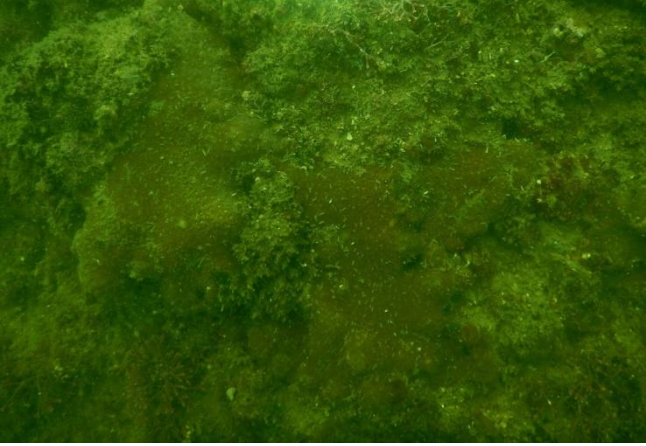
Photo Plate of Natural Hard Corals at Recipient Site

- 5.4.10 Ten (10) natural hard coral colonies were also monitoring at the recipient site as control and 1 coral colony was missing during the monitoring survey (**Table 5.8**). Similar to the translocated coral colonies, the missing tagged coral colony probably was swept away by the strong wave action caused by the Super Typhoon Mangkhut hitting Hong Kong on 15<sup>th</sup> and 16<sup>th</sup> September 2018.
