HONG KONG SECTION OF GUANGZHOU –  
SHENZHEN – HONG KONG EXPRESS RAIL LINK  
(No. EP-349/2009/B)

Remediation Report for  
Kwai Chung Ventilation Building Works Area  
(Site H)

**MTRC Express Rail Link Contract 821  
Shek Yum to Mei Lai Road Tunnels**

**Remediation Report for Kwai Chung  
Ventilation Building Works Area (Site H)**

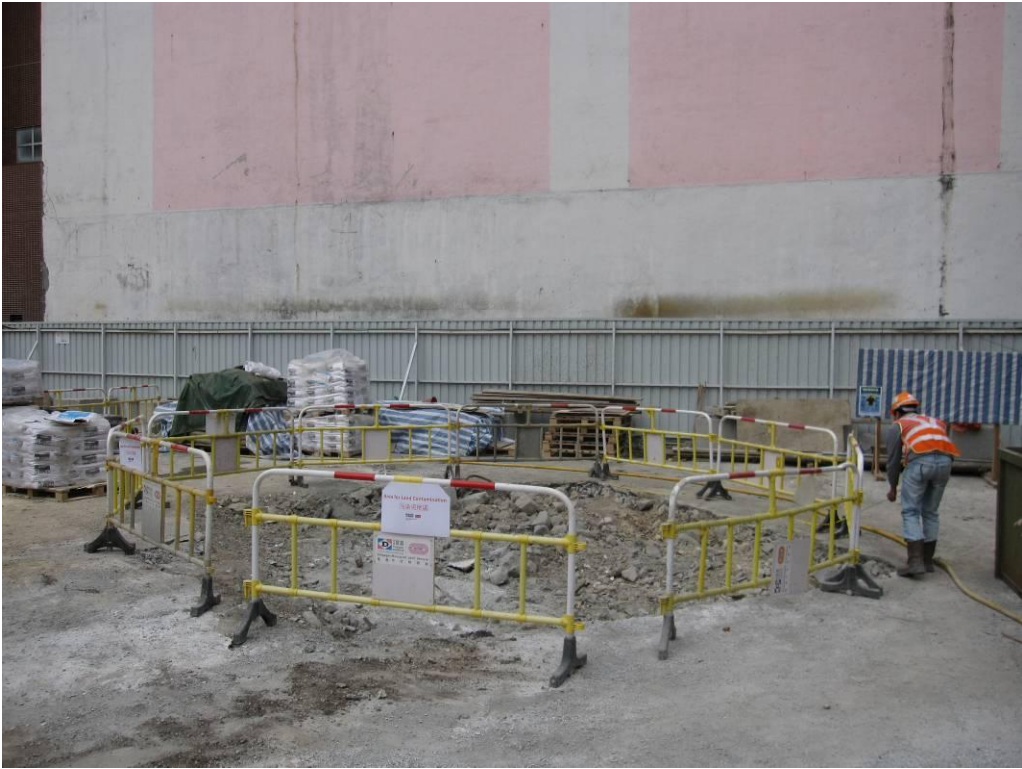
| <b>Photo No.</b><br><b>1</b> | | |

| <b>Description:</b><br><br>Boundaries of contaminated soil extent were set out. | | |

- Boundaries of contaminated soil extent were set out;
- Open cut excavation was undertaken using a backhoe under the supervision of a land contamination professional;
- Excavated soil was stored within a dedicated steel skip within the project Site; and

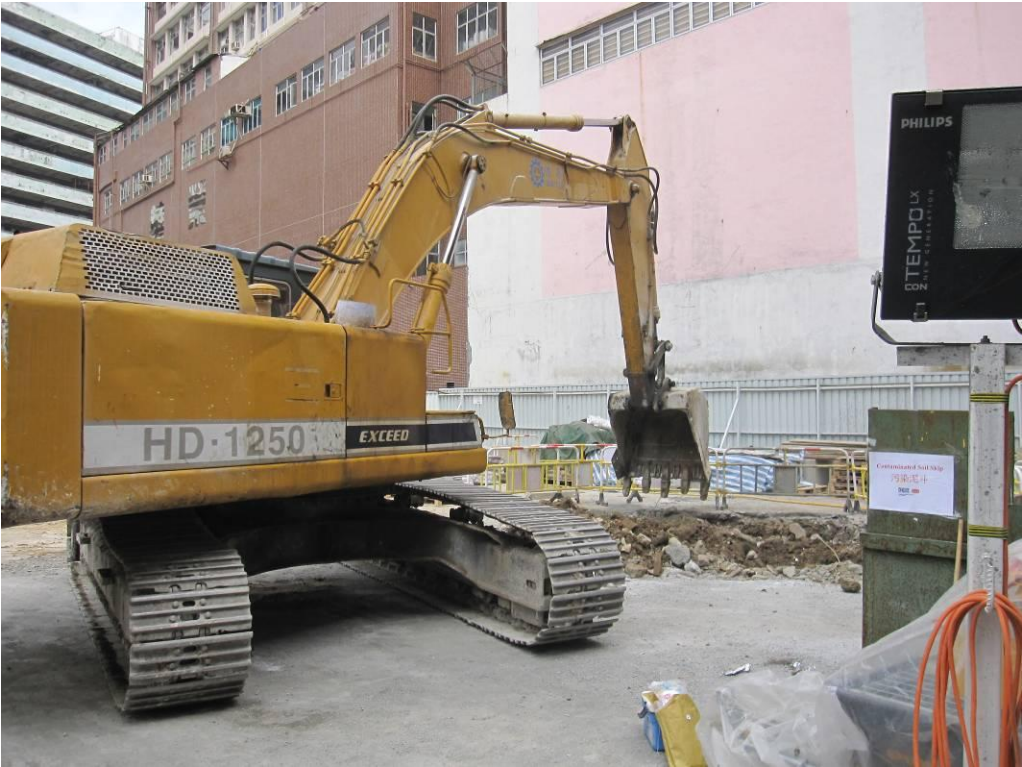
| <b>Photo No.</b><br><b>2</b> | | |

| <b>Description:</b><br><br>Open cut excavation was undertaken using a backhoe. | | |

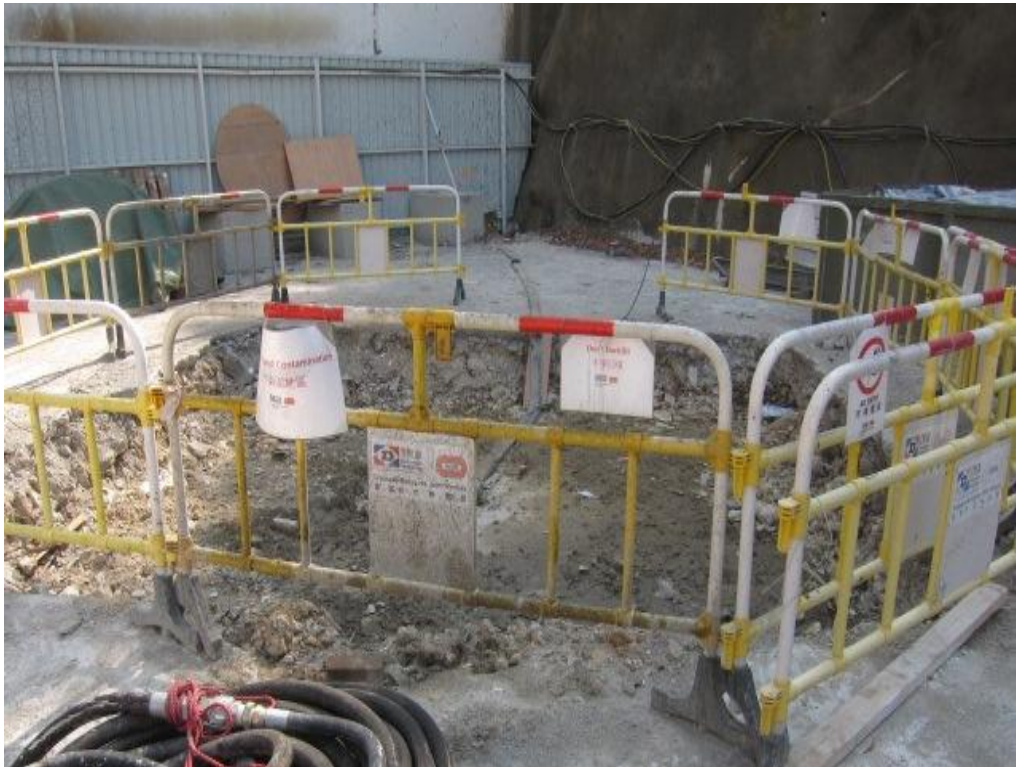
| <b>Photo No.</b><br><b>3</b> | | |

| <b>Description:</b><br>Excavated pit. | | |

- Confirmatory sampling was carried out in the excavation.
- 3.2.2 The excavation work was conducted on 1 February 2011 by DBJV. The horizontal extent of the excavation was 25m<sup>2</sup> with depth of 0.7m BBC.

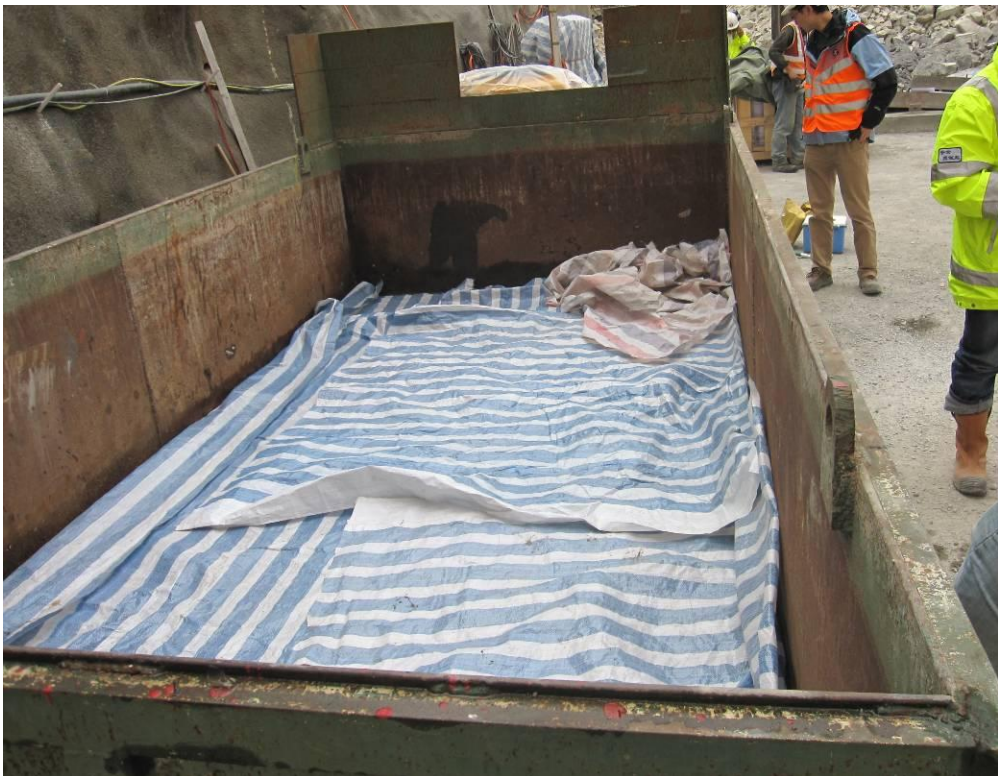
| <b>Photo No.</b><br><b>4</b> | | |

| <b>Description:</b><br>An empty steel skip was covered with impermeable sheets at the bottom. The skip would then be filled with contaminated soil for biopiling. | | |

- 4.2.3 The excavated soil was placed into a steel skip within the works area and covered with impermeable sheeting to prevent fugitive emissions and rain ingress. Biopile formation was supervised by a land contamination specialist. Photographs are presented in **Appendix C**.

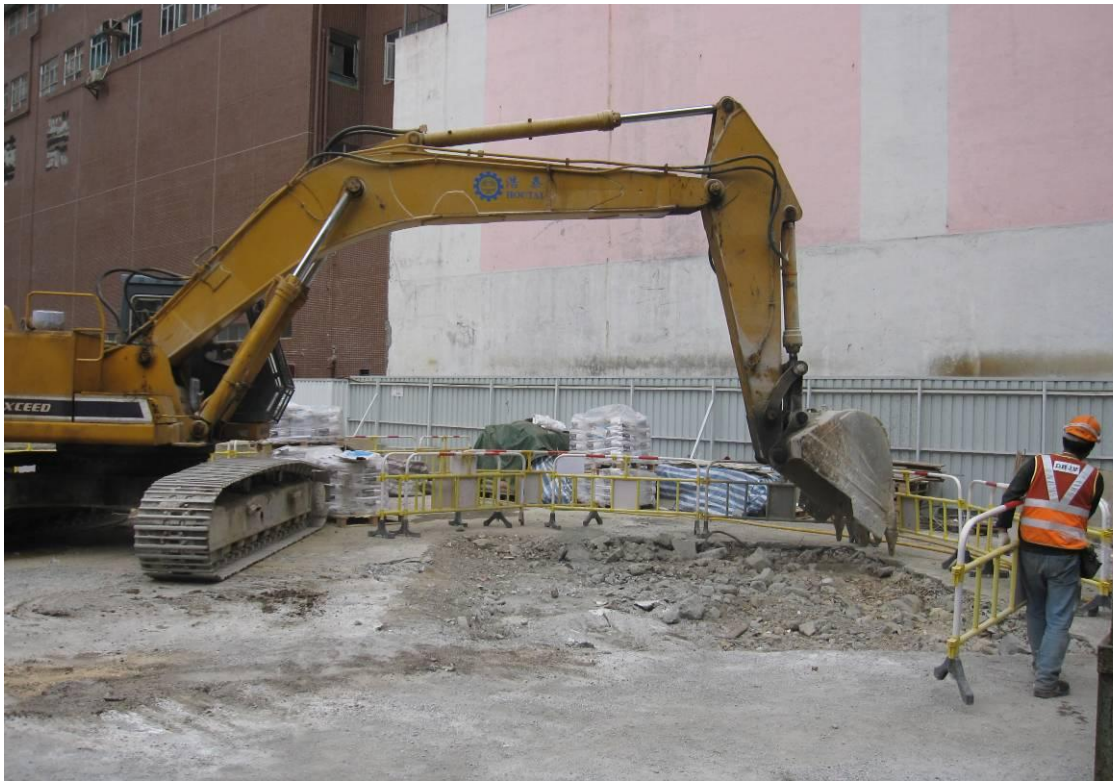
| <b>Photo No.</b><br><b>5</b> | |

| <b>Description:</b><br><br>Open cut excavation was being undertaken using a backhoe | |

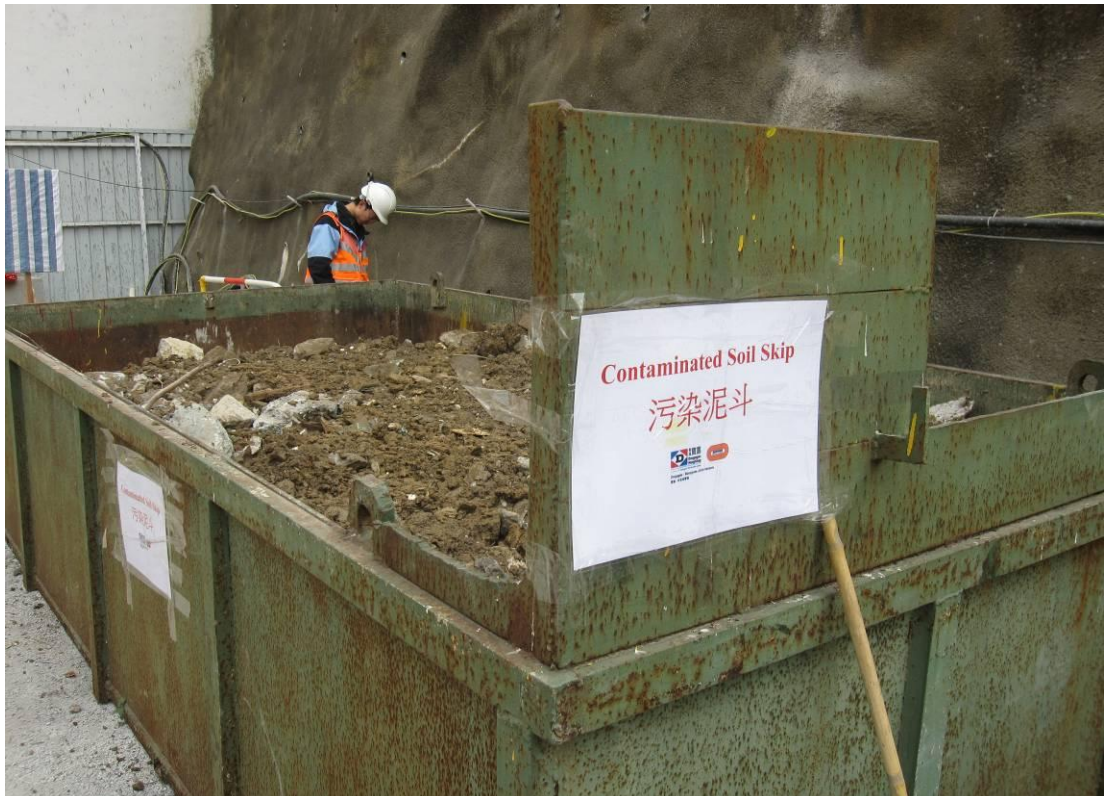
| <b>Photo No.</b><br><b>6</b> | |

| <b>Description:</b><br><br>The skip was filled with contaminated soil. | |

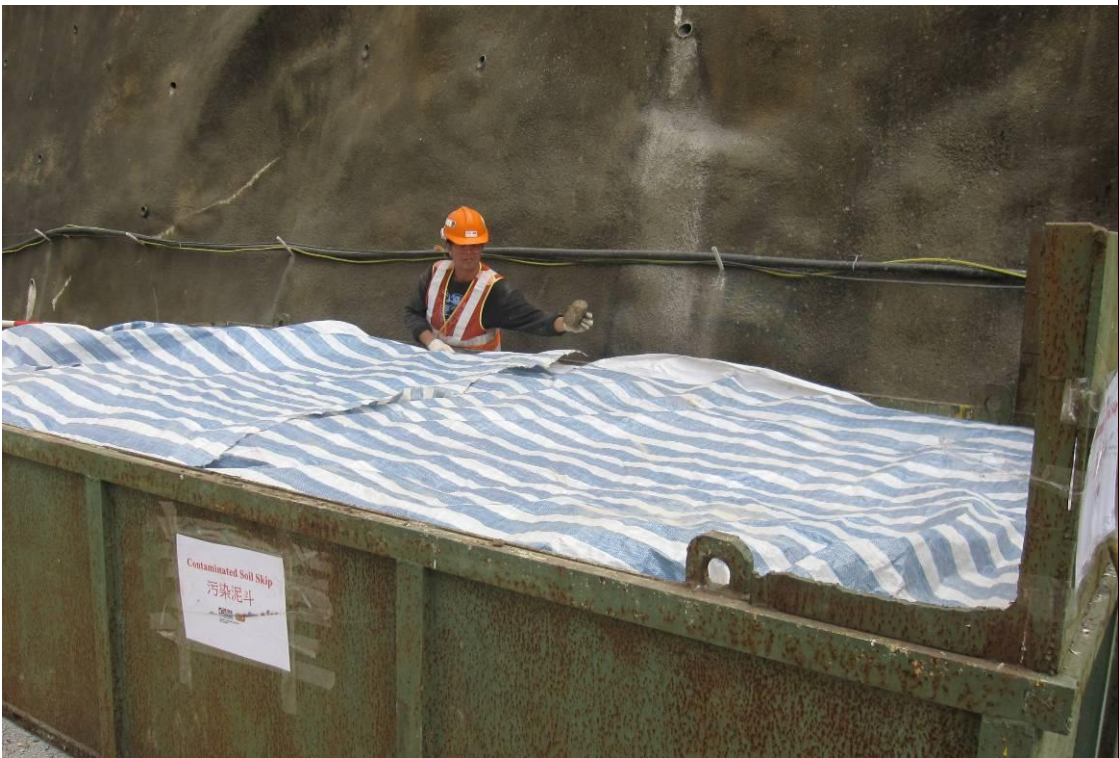
| <b>Photo No.</b><br>7 | |

| <b>Description:</b><br>The filled skip is covered by impermeable sheets. | |

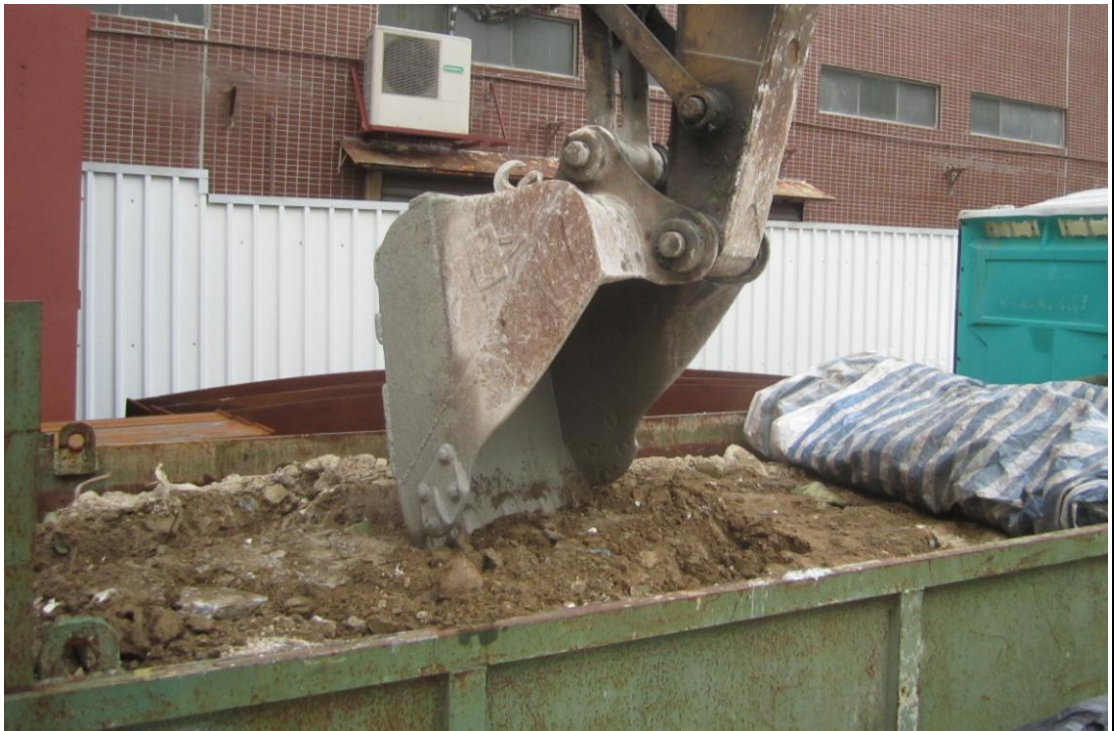
| <b>Photo No.</b><br>8 | |

| <b>Description:</b><br>During remediation, the soil was turned regularly. | |

- 4.2.4 The biopile was operated statically however soils were turned regularly using a backhoe excavator to enhance aerobic conditions. Based on the approved supp. CAR/RAP, soil samples were collected for analysis of bis-(2-Ethylhexyl)phthalate concentrations in order to monitor the progress of contaminant cleanup. One soil sample was proposed to be collected per 10 m<sup>3</sup> of contaminated soil; therefore, two soil samples were collected randomly at different location within the biopile on 29 June, 2011.
