**CONTRACT NO. 1/WSD/19 & 6/WSD/21**

**IN-SITU REPROVISIONING OF SHA TIN WATER  
TREATMENT WORKS (SOUTH WORKS) – WATER TREATMENT WORKS AND  
ANCILLARY FACILITIES  
Environmental Permit EP-494/2015**

**In-Situ Reprovisioning of Sha Tin Water Treatment Works (South Works) – Water  
Treatment Works and Ancillary Facilities  
Environmental Permit EP-494/2015  
Submission of 97<sup>th</sup> monthly EM&A Report**

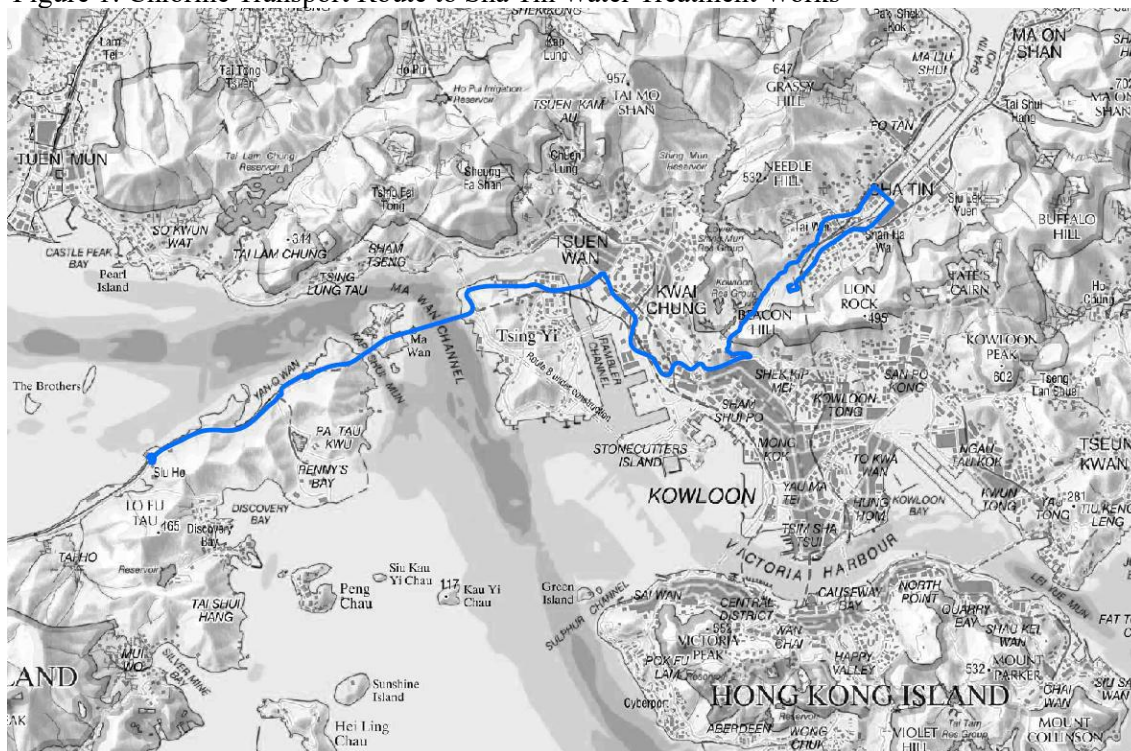
Figure 1: Chlorine Transport Route to Sha Tin Water Treatment Works

- 2.7.1 Chlorine is delivered to Sha Tin WTW in batches of up to 6×1-tonne drums. The transport route from Sham Shui Kok dock on North Lantau is shown in **Figure 1**. The route passes along the North Lantau Expressway, around the northern edge of Tsing Yi, through Tsuen Wan and along Tai Po Road (Piper's Hill) to Sha Tin (Table 2-15).

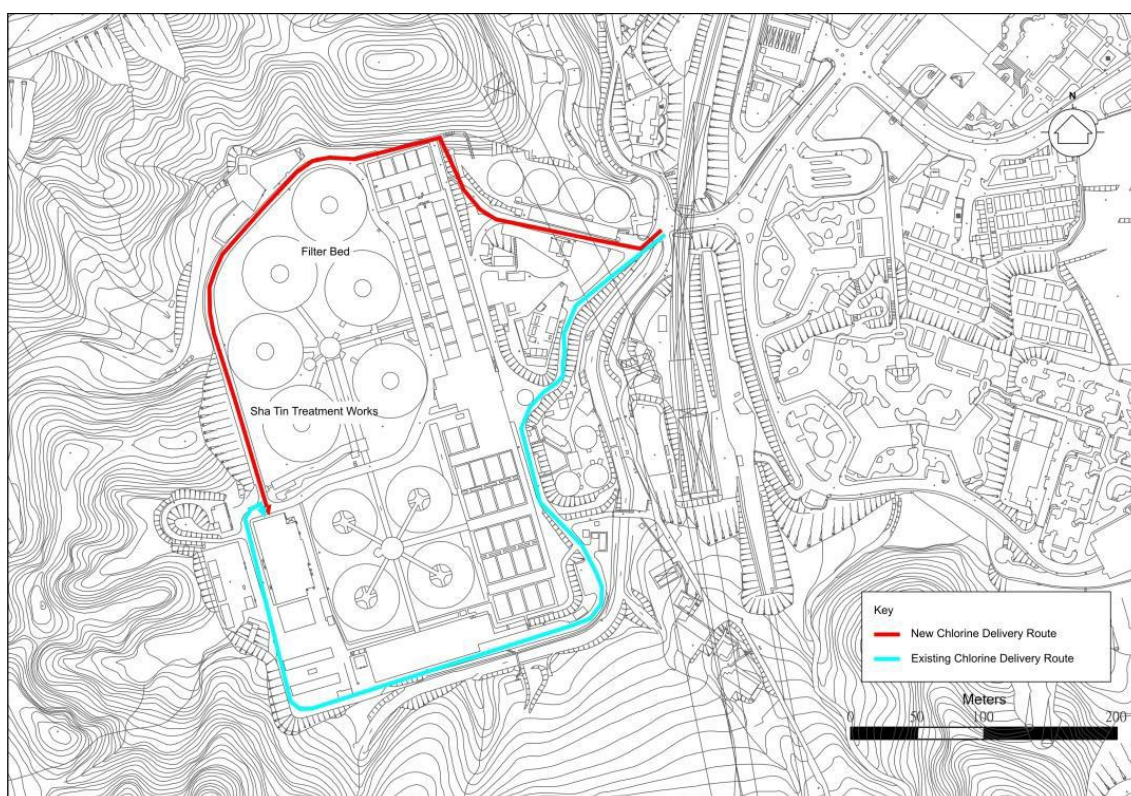
Figure 2: Chlorine Delivery Route at Sha Tin WTW

2.7.3 The on-site chlorine delivery route is shown in **Figure 2**.

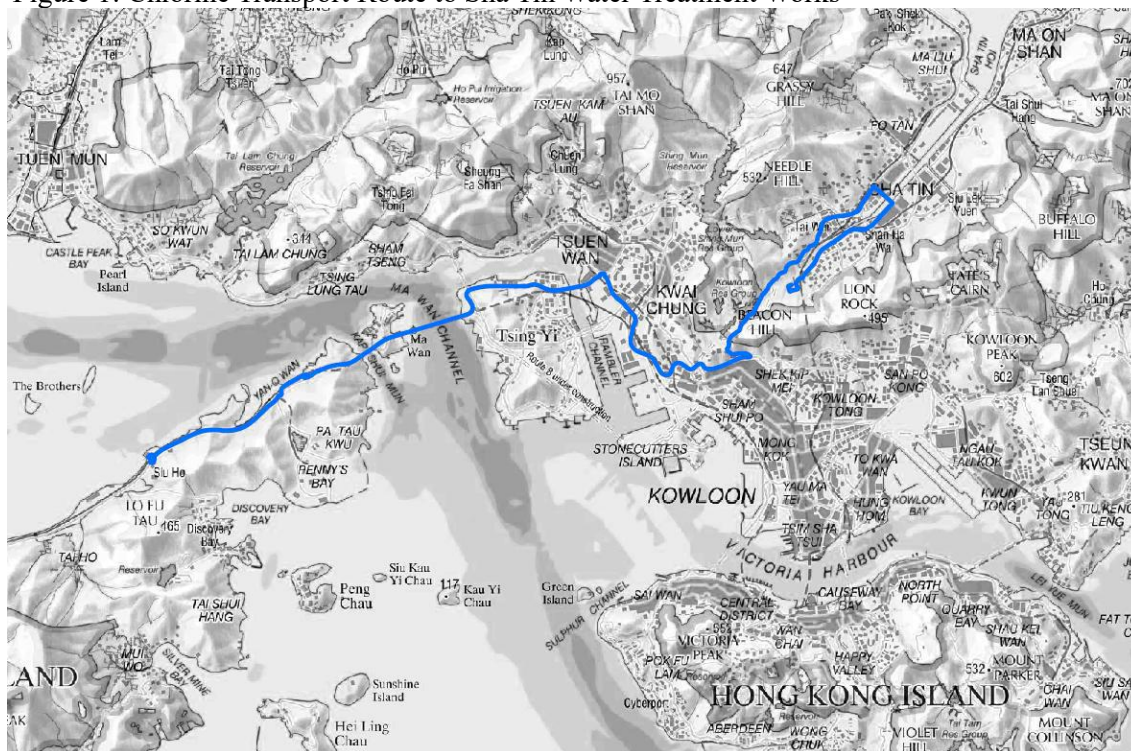
Figure 1: Chlorine Transport Route to Sha Tin Water Treatment Works

- 2.7.1 Chlorine is delivered to Sha Tin WTW in batches of up to 6×1-tonne drums. The transport route from Sham Shui Kok dock on North Lantau is shown in **Figure 1**. The route passes along the North Lantau Expressway, around the northern edge of Tsing Yi, through Tsuen Wan and along Tai Po Road (Piper's Hill) to Sha Tin (Table 2-15).

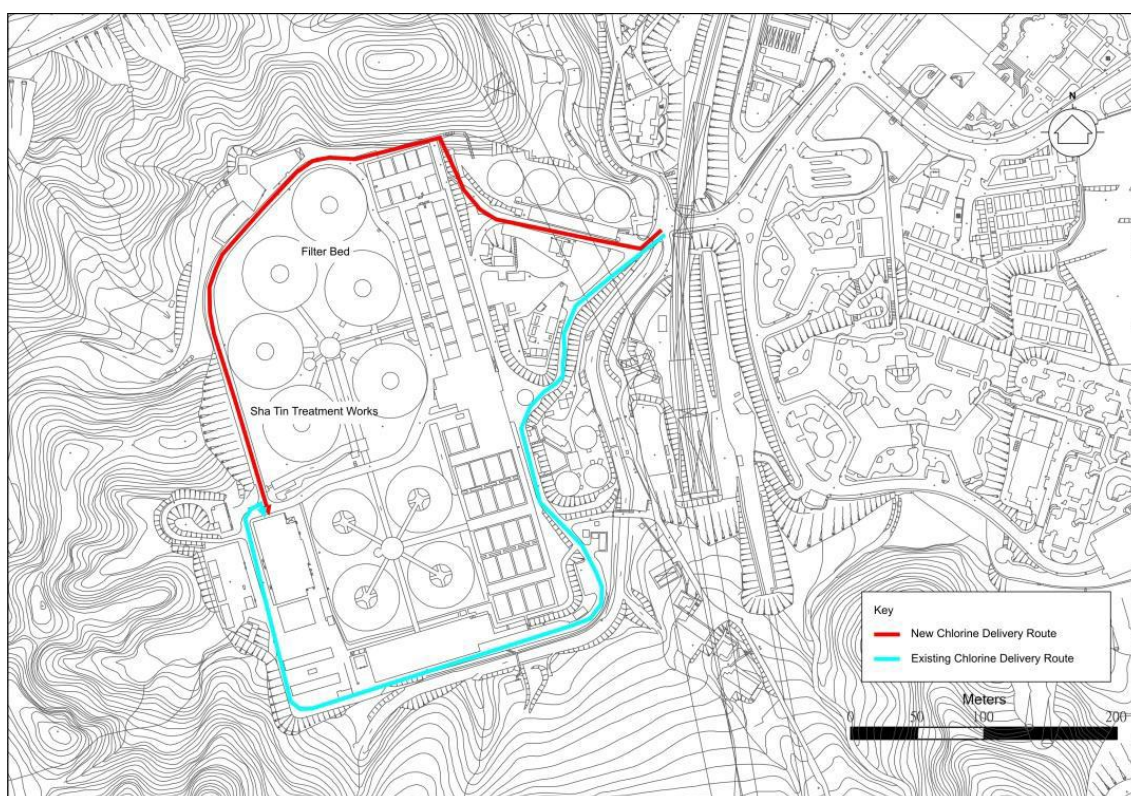
Figure 2: Chlorine Delivery Route at Sha Tin WTW

2.7.3 The on-site chlorine delivery route is shown in **Figure 2**.

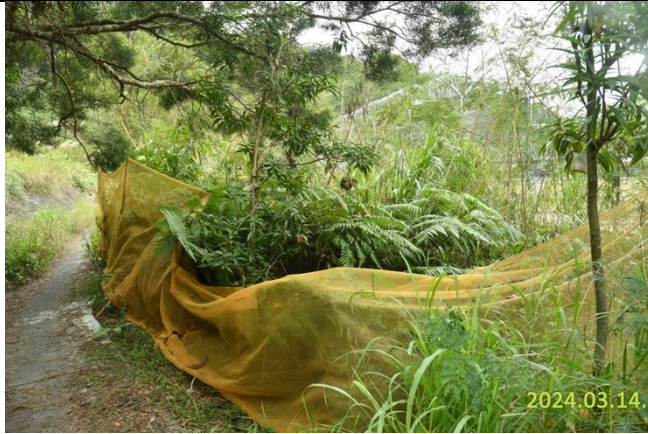
Photo 1. Collapsed protection zone of *Cibotium barometz* shall be rectified.

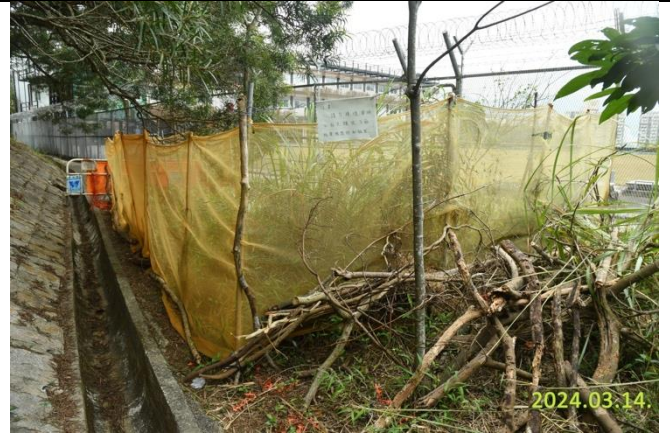
- 2.5.8 Signs of ploughed soil by wild boar(s) at the two groups of transplanted *Cibotium barometz* were reported in previous monitoring. A robust fencing was recently installed to protect the group of *Cibotium barometz* from further damage caused by wild boars.

Photo 2. A protective fence for another patch of *Cibotium barometz*.

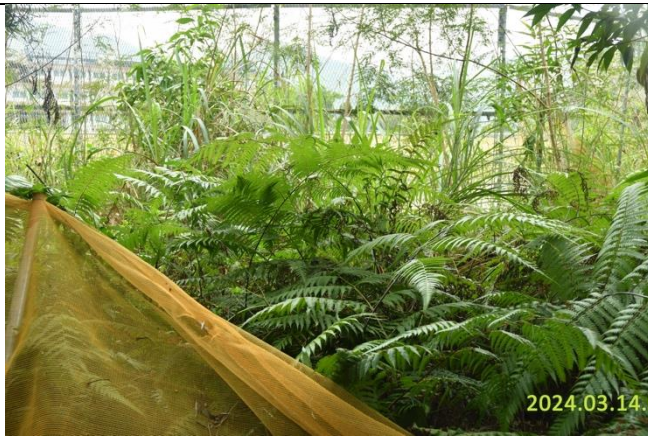
Photo 3. *Cibotium barometz* in good condition

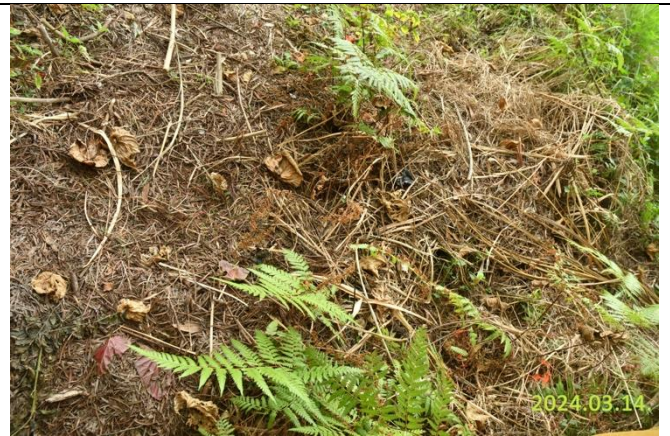
Photo 4. *Cibotium barometz* at the second patch were smaller in size the site is more exposed under direct sunlight.

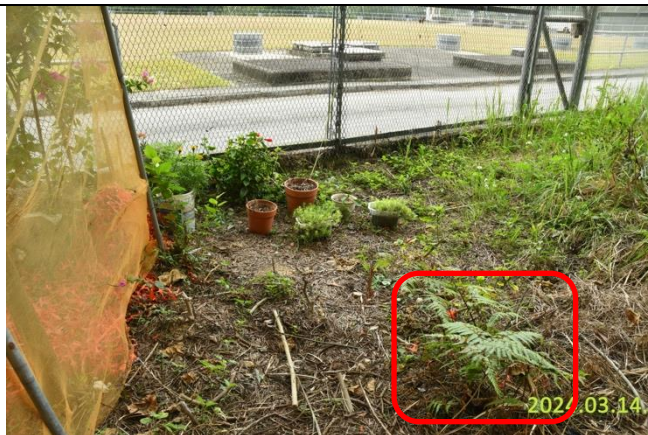
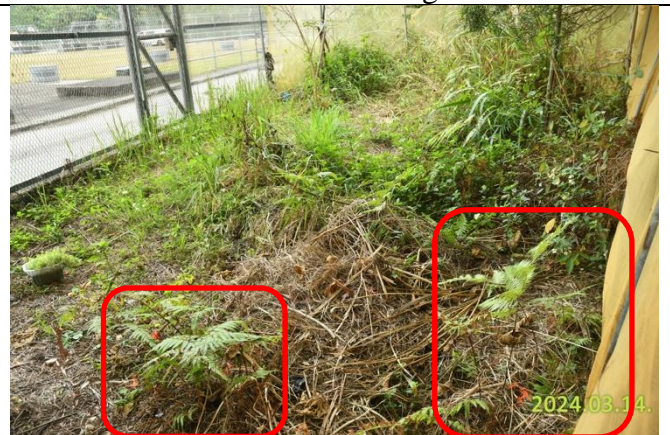
Photo 5 & 6. Weeds and climbers were observed occupying growing space particularly at the second patch (in red), which may deplete their health/ growth condition.

- 2.5.6 Weeding by hand held tools within protection zone of *Cibotium barometz* is urgently needed.
- 2.5.7 Root ball of TA572 and TA327 tree should be kept moisture especially during dry and non-raining day.

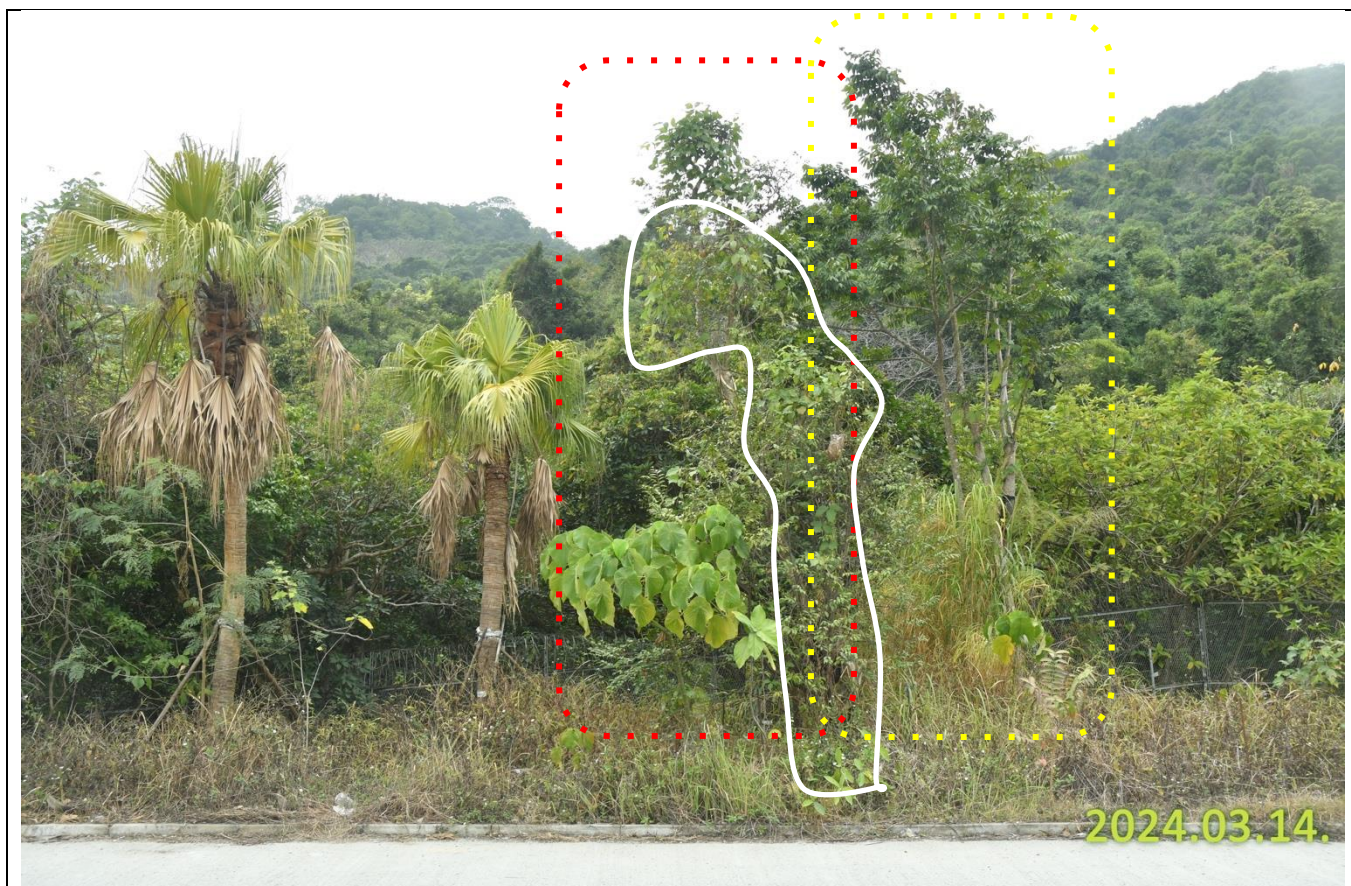
- 2.5.1 The condition of TA572 was observed in fair health despite in poor form. TA327 was in fair condition; while already dead TA326 collapsed under Signal No. 10 typhoon Mangkhut in September 2018. Tree guying cables have been installed to provide external support to the two remaining transplanted trees. Climbing vines on TA327 should be removed, including the roots, to reduce rapid colonization covering the canopy.

Photo 7. Transplanted Incense Tree (*Aquilaria sinensis*) – TA327 (red); and Ailanthus (*Ailanthus fordii*) – TA572 (yellow). Climber (white) should be removed, including the roots, to relieve the canopy

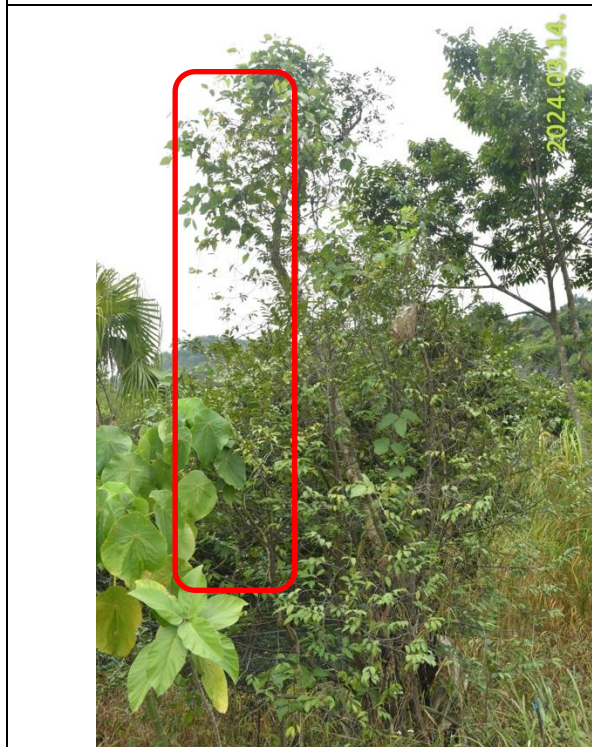
Photo 8. Sprouts at lower trunk of TA327 (*Aquilaria sinensis*). Climber (red) should be removed, including the roots, to relieve the

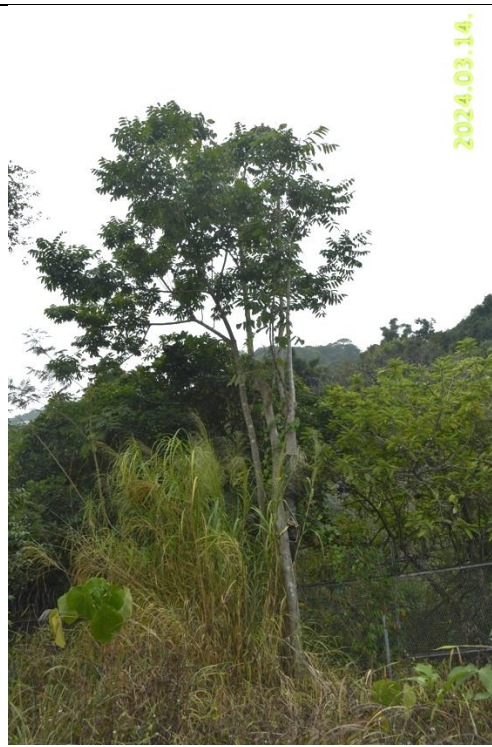
Photo 9. TA572 (*Ailanthus fordii*) was found vigorous and in generally good condition. Surrounding weeds/ grass should be removed

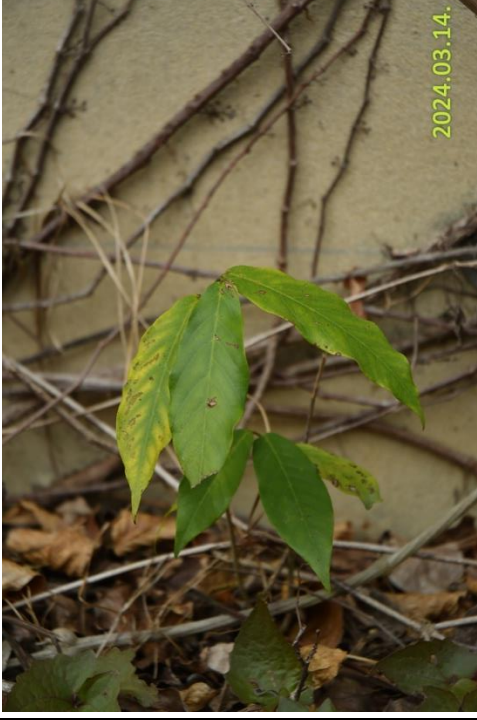
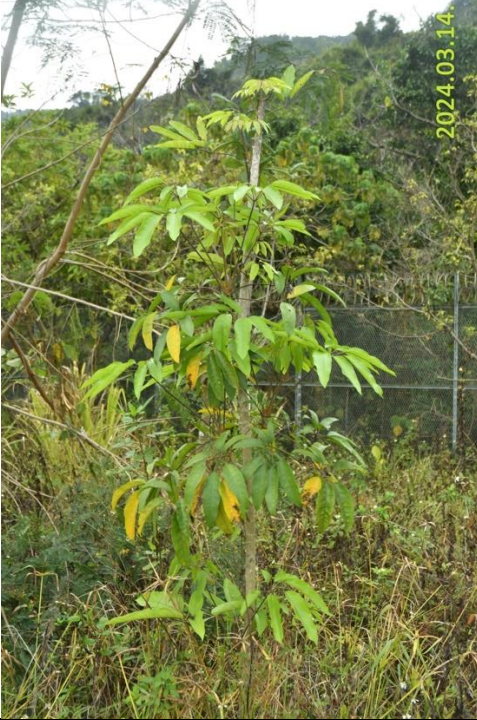
- 2.5.4 New small sprouts keep emerging from the two *Desmos chinensis* that have been reported dead previously. Construction materials was also found too close to the planter. An eye-catching protective fence shall be set up as a protection zone. No construction materials shall be placed near/ within the protection zone.

<p>Photo 10. New sprouts of the <i>Desmos chinensis</i> that reported dead previously. Sign of dehydration detected.</p>	<p>Photo 11. <i>Schefflera heptaphylla</i> as compensatory planting of TA326.</p>

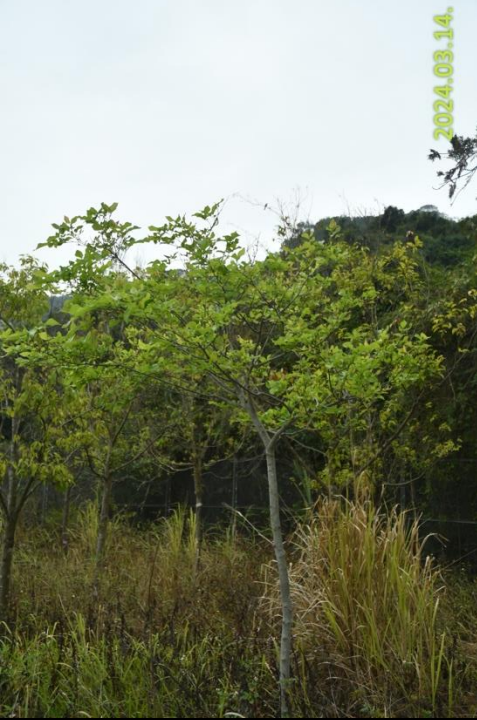
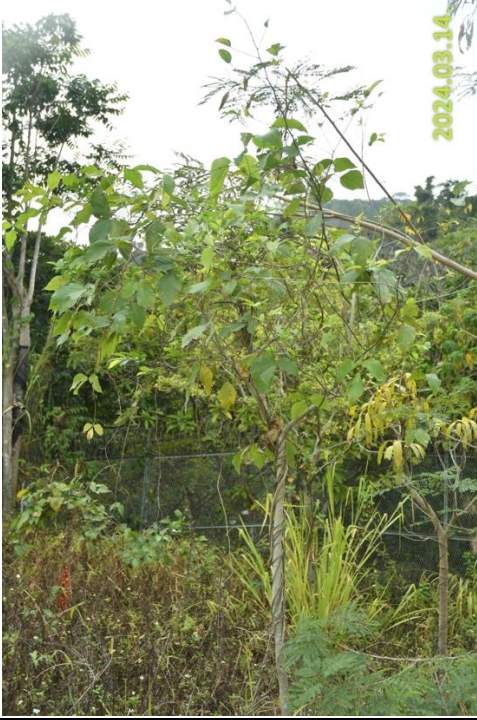
- 2.5.2 Compensatory planting of TA326 has been completed on 25 March 2020 by planting two *Syzygium levinei* and one *Schefflera heptaphylla*. However, the two native *Syzygium levinei* were mis-planted by two exotic *Syzygium jambos*, which has been replaced by another native tree species *Celtis sinensis* on 31 May 2021. Climbing vines on one of the *Celtis sinensis* should be removed, including the roots, to reduce rapid colonization covering the canopy.

<p>Photo 12 and 13. The two exotic <i>Syzygium jambos</i> (mis-treated as the native <i>Syzygium levinei</i>) are replaced by another native tree <i>Celtis sinensis</i> (due to market availability) as compensatory planting of TA326. Note: <i>Celtis sinensis</i> is a deciduous species.</p> <p>Fast-growing climber was observed in one of the <i>Celtis sinensis</i> (right; compared to the left). The climber should be removed immediately otherwise it will affect the health of the tree. Root removal is necessary when recolonization of weeds is fast after recent routine maintenance work.</p>
