Expansion of Hong Kong International Airport into a Three-Runway System

Construction Phase Quarterly EM&A Report No.4
(1 October to 31 December 2016)

February 2017

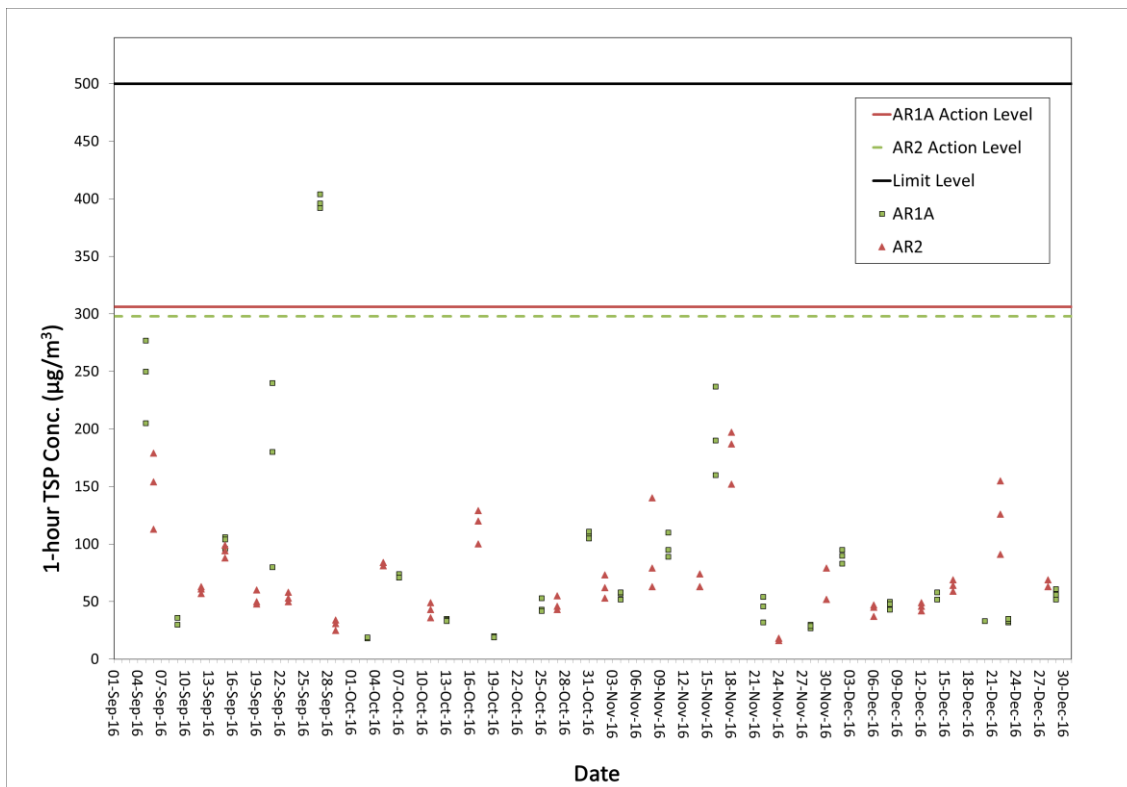
Graph 1: Graphical Plot of 1-hour TSP concentration at AR1A and AR2 during the Reporting Period

No exceedance of the Action and Limit Level was recorded at AR1 and AR2 in the reporting period.

The weather varied from sunny to rainy in the reporting quarter. Wind direction was mainly north or northwest in the reporting quarter.

The active construction site is around 3 km away from the nearest air sensitive receiver in Tung Chung. The major dust sources during the reporting period were observed to be local air pollution and nearby traffic emissions. It is considered that the monitoring work in the reporting period was effective and there was no adverse impact attributable to the works of the Project.

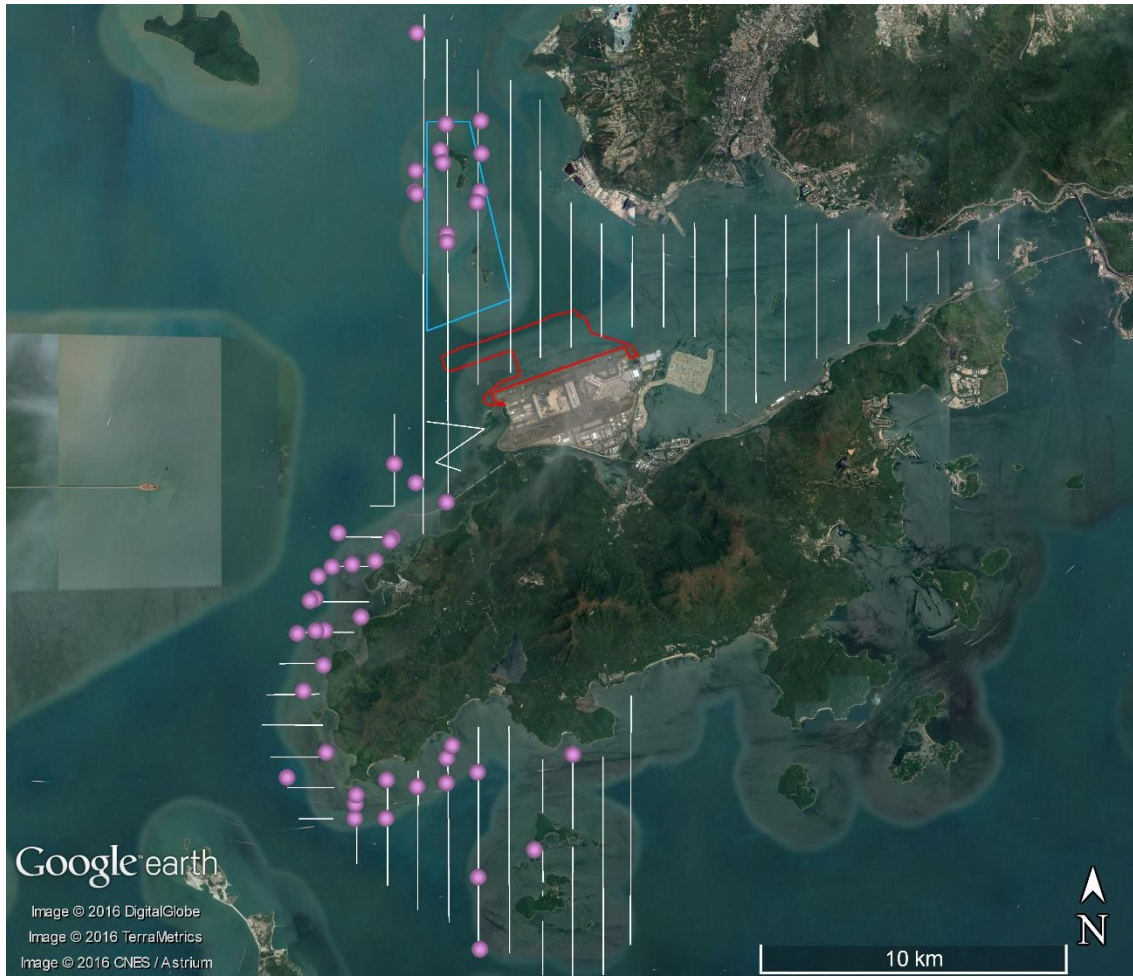
Figure 2.5: Sightings Distribution of Chinese White Dolphins

Distribution of CWD sightings recorded from October to December 2016 during on-effort search under favourable weather condition are illustrated in **Figure 2.5**. CWD sightings were relatively more frequent in WL than in NWL and SWL. In NWL, sightings were mainly recorded around Lung Kwu Chau. Two sightings were recorded in the southwestern corner of NWL survey area close to the Hong Kong-Zhuhai-Macao Bridge Hong Kong Link Road alignment. No sightings of CWDs were recorded within or in close vicinity of the 3RS land-formation footprint. CWD sightings in WL were evenly distributed in both coastal and off-shore areas near Tai O. In SWL waters, CWDs were most frequently sighted along the coast from Fan Lau to Lo Kei Wan, with a few scattered sightings around Soko Islands. Details of the sighting data were presented in **Appendix E**.

[Pink circle: Sighting locations of CWD, White line: Vessel survey transects, Blue polygon: Sha Chau and Lung Kwu Chau Marine Park (SCLKCMP), Red polygon: 3RS land-formation footprint]

Note: Only on-effort sightings under Beaufort 3 or below were presented in the figure.

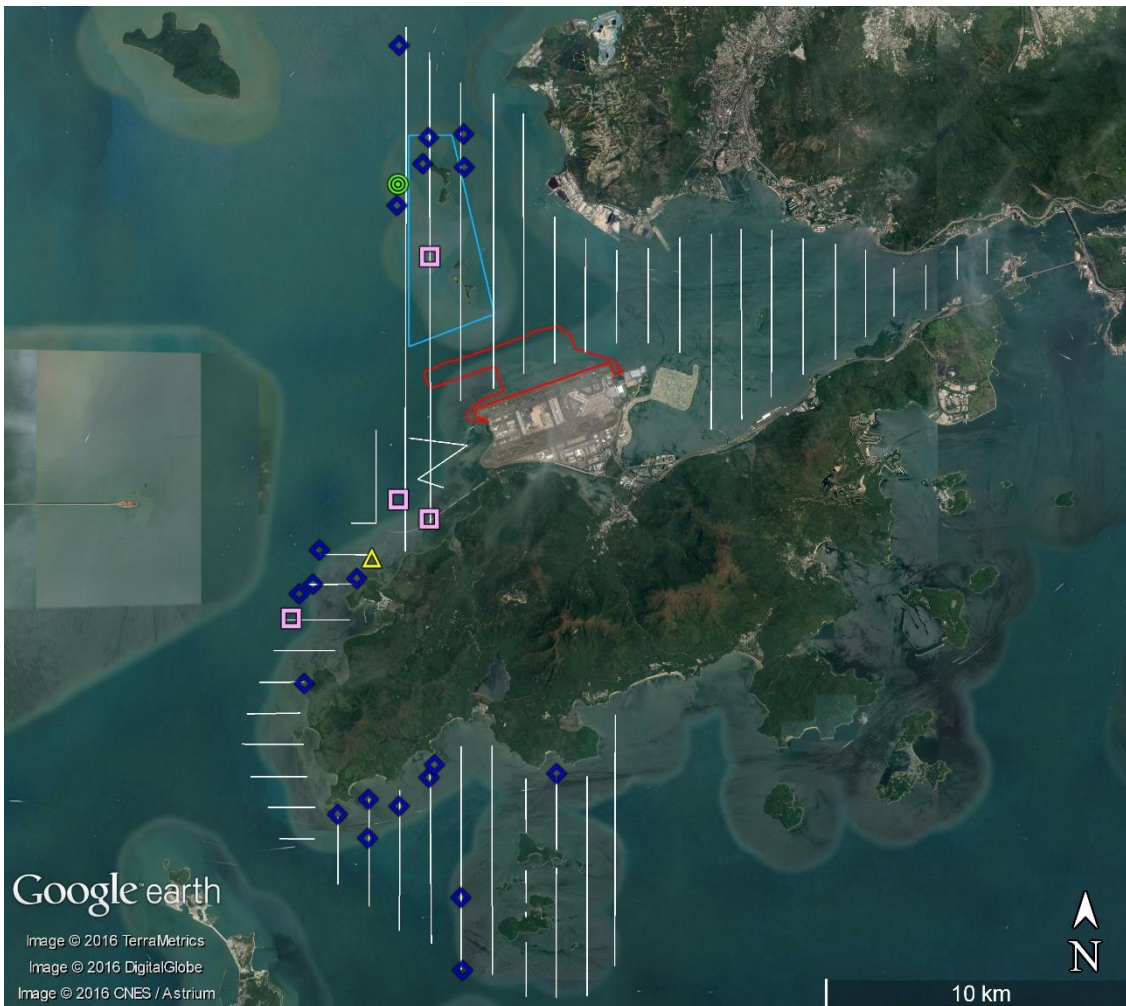
Figure 2.7: Sighting Locations of Chinese White Dolphins Engaged in Different Behaviours

During October to December 2016, 20 groups of CWDs were sighted with feeding activities. Amongst these 20 groups of feeding CWDs, one group was observed in association with operating pair trawlers at southwestern corner of Soko Islands close to the boundary of Hong Kong waters, two groups were sighted in association with operating purse seiners in NWL and SWL. In NWL waters, the majority of the feeding activities of CWDs were observed north to Lung Kwu Chau. In WL, CWDs were mainly being observed feeding in waters around Tai O. In SWL, more feeding sightings of CWDs were recorded along the coast from Fan Lau to Tai Long Wan Campgroup. The sighting locations of CWDs engaged in different behaviours during the reporting quarter were illustrated in **Figure 2.7**.

[Indigo rhombus: Foraging, Green circle: Socializing, Pink square: Resting, Yellow triangle: Travelling, White line: Vessel survey transects, Blue polygon: SCLKCMP, Red polygon: 3RS land-formation footprint]

Note: Only on-effort sightings under Beaufort 3 or below were presented in the figure.

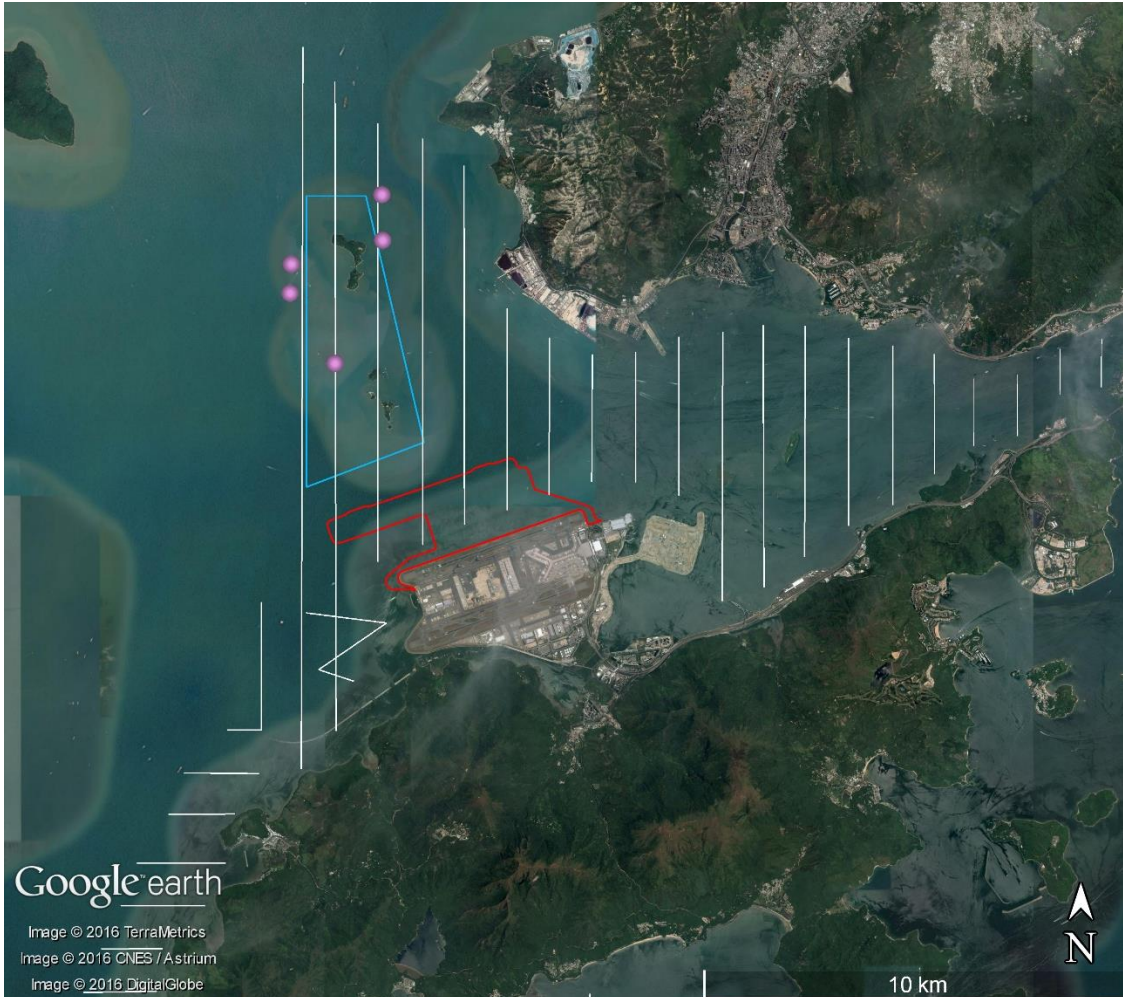
Figure 2.8: Sighting Locations of Mother-calf Pairs

[Pink circle: Sighting locations of mother-calf pairs, White line: Vessel survey transects, Blue polygon: Sha Chau and Lung Kwu Chau Marine Park (SCLKCMP), Red polygon: 3RS land-formation footprint]

Note: Only on-effort sightings under Beaufort 3 or below were presented in the figure.
