Expansion of Hong Kong International Airport into a Three-Runway System

Construction Phase Quarterly EM&A Report No.7
(1 July to 30 September 2017)

December 2017

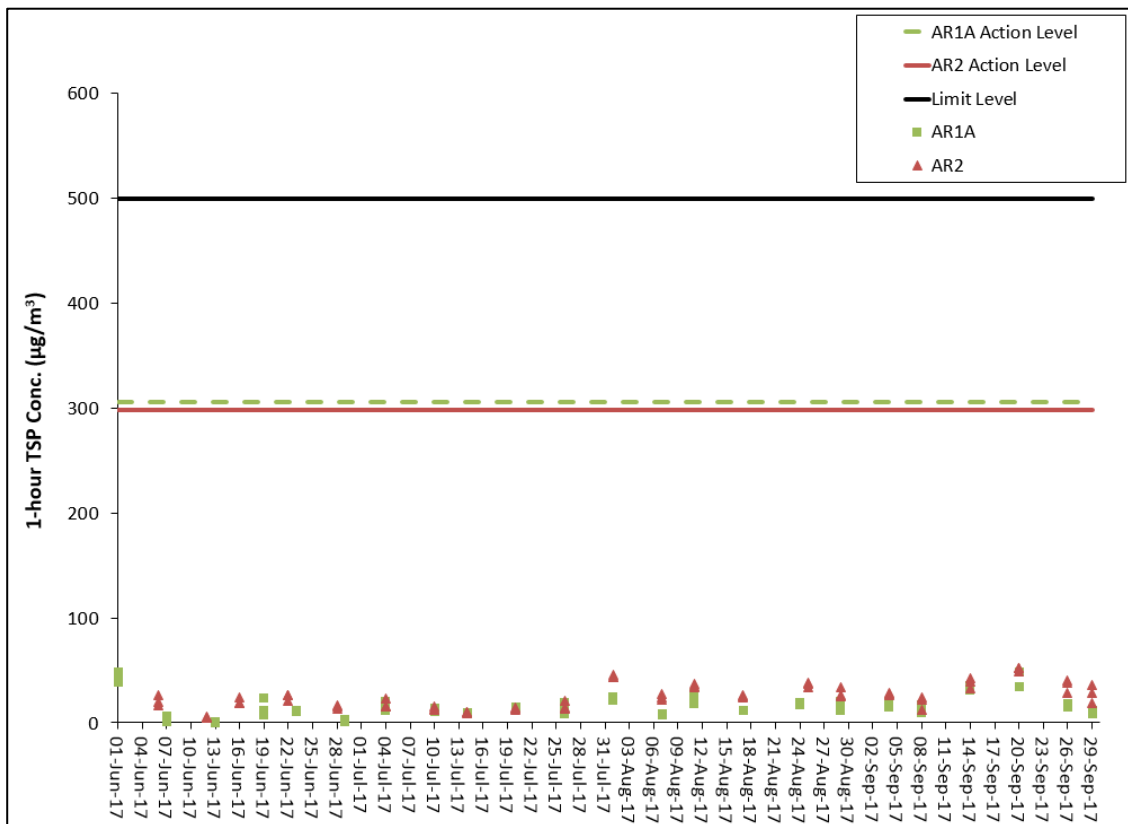
Graph 1: Graphical Plot of 1-hour TSP concentration at AR1A and AR2 during the Reporting Period

No exceedance of Action or Limit Level was recorded at all monitoring stations in the reporting period.

The weather varied from sunny to rainy during the reporting period. Wind direction was mainly south or southwest in the reporting period.

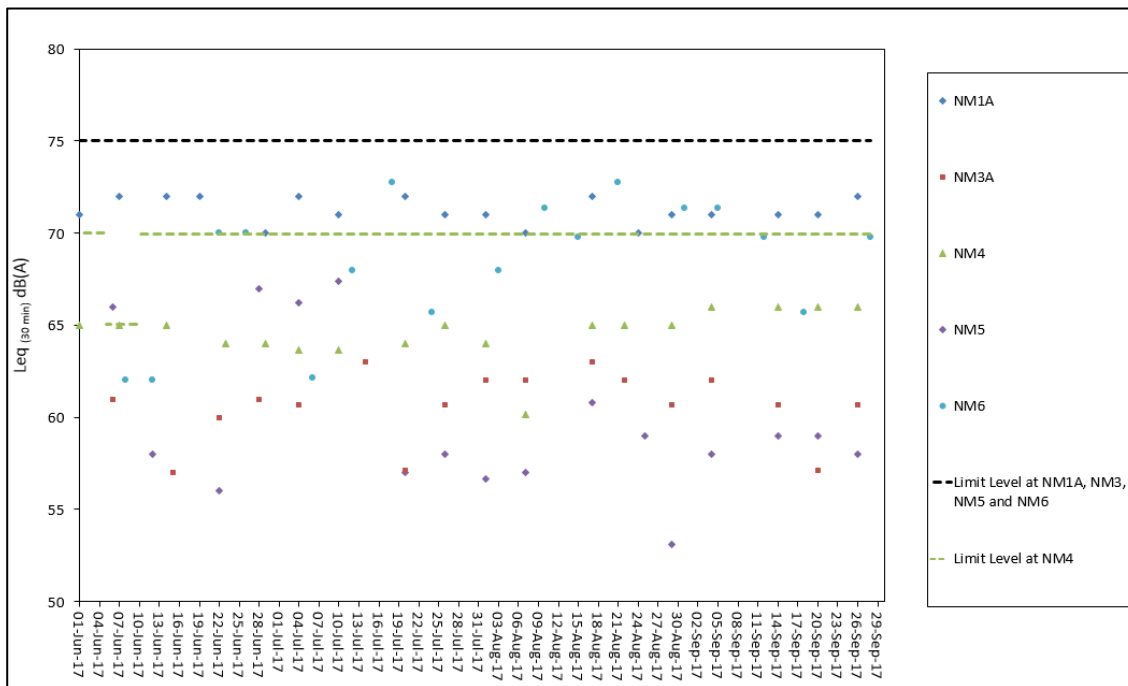
Graph 2: Graphical Plot of Leq (30min) at NM1A, NM3A, NM4, NM5 and NM6 during the Reporting Period

No exceedance of the Action and Limit Level was recorded at all monitoring stations in the reporting period.

The key activities of the Project carried out in the reporting period are summarised in **Section 1.5**. The active construction work is around 900 m away from the nearest noise sensitive receivers in the villages in North Lantau. The major noise sources during the reporting period were observed to be road traffic and helicopters at NM1A, aircrafts and helicopters at NM3A, helicopters and construction activities from a nearby school at NM4, aircrafts and helicopters at NM5, and aircrafts, helicopters, and marine vessels at NM6. It is considered that the monitoring work in the reporting period was effective and there was no adverse impact attributable to the works of the Project.

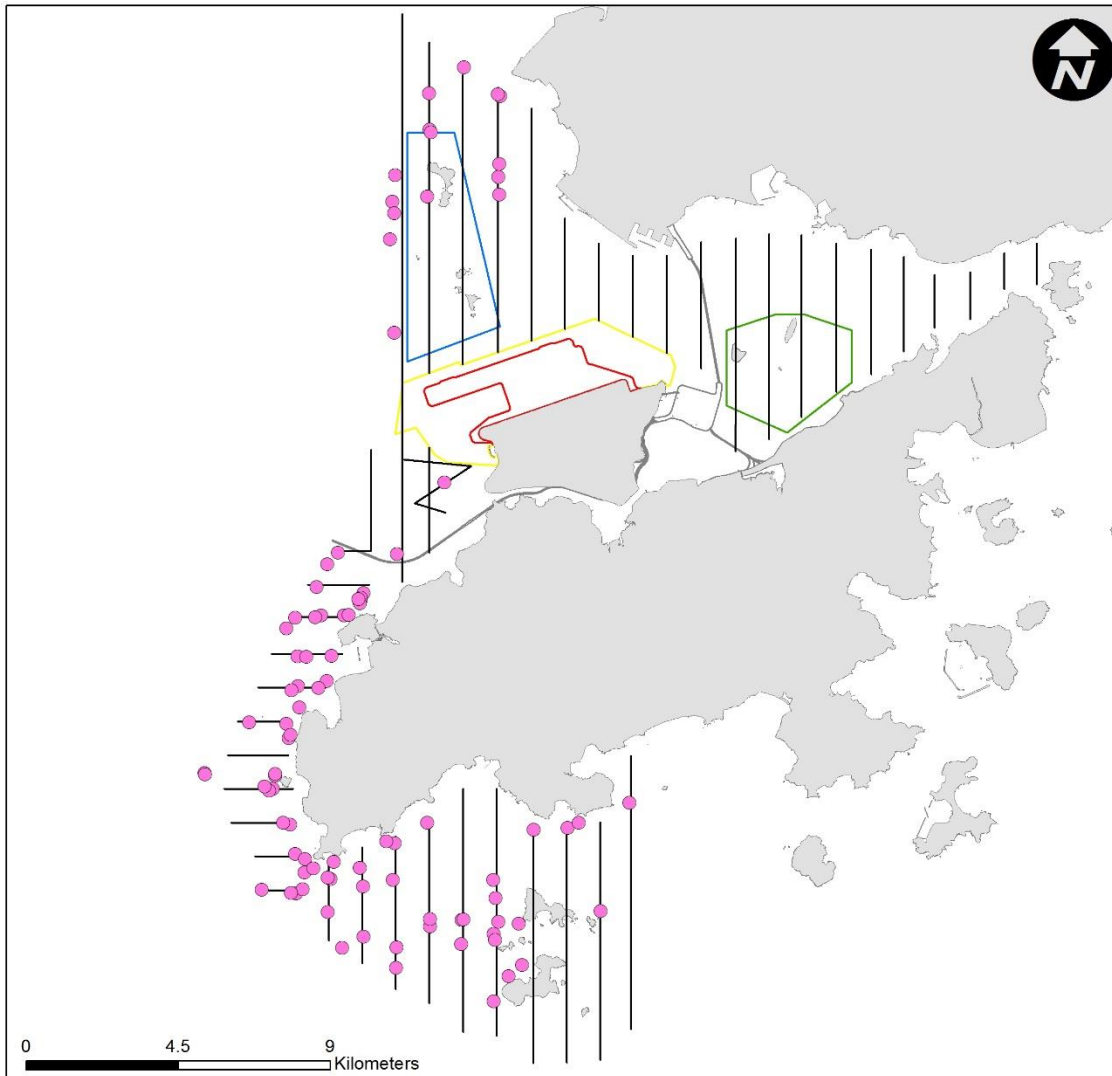
Figure 2.5: Sightings Distribution of Chinese White Dolphins

[Pink circle: Sighting locations of CWD, Black line: Vessel survey transects, Blue polygon: Sha Chau and Lung Kwu Chau Marine Park (SCLKCMP); Green polygon: Brothers Marine Park (BMP); Red polygon: 3RS land-formation footprint; Yellow line: 3RS temporary works area boundary]

Remarks: Please note that there are 93 pink circles on the map indicating the sighting locations of CWD. Some of them were very close to each other and therefore appear overlapped on this sighting distribution map.

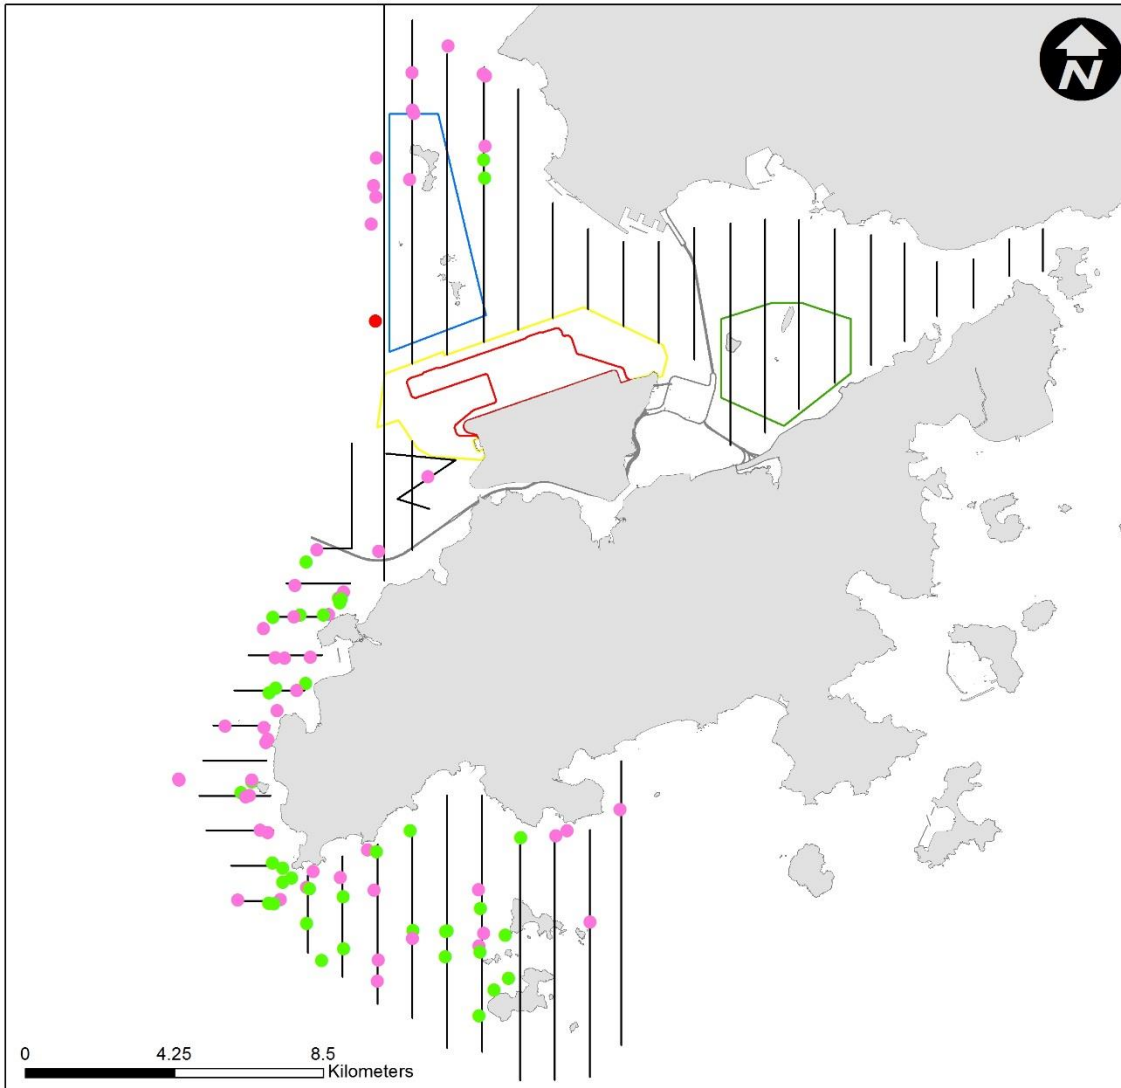
Figure 2.6: Sighting Locations of Chinese White Dolphins with Different Group Sizes

[Pink circle: Sighting locations of CWD with group size from 1 to 2 individuals; Green circle: Sighting locations of CWD with group size from 3 to 9 individuals; Red circle: Sighting locations of CWD with group size of 10 or above; Black line: Vessel survey transects; Blue polygon: Sha Chau and Lung Kwu Chau Marine Park (SCLKCMP); Green polygon: Brothers Marine Park (BMP); Red polygon: 3RS land-formation footprint; Yellow line: 3RS temporary works area boundary

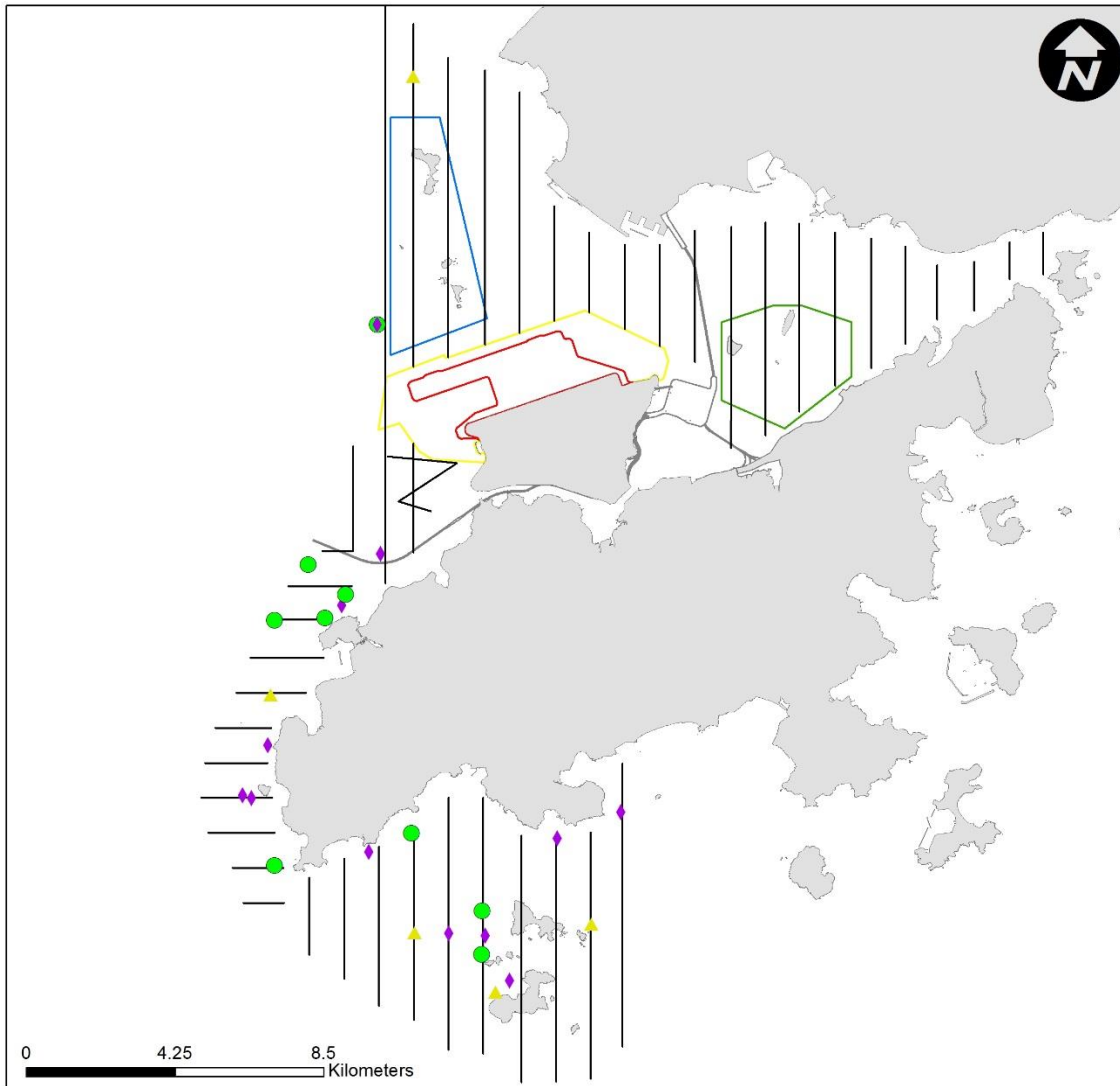
Figure 2.7: Sighting Locations of Chinese White Dolphins Engaged in Different Behaviours

During July to September 2017, 12 groups of CWDs were sighted with feeding activities. Amongst these 12 groups of feeding CWDs, two groups were observed in association with operating fishing boat (gill netter) in SWL. The sighting locations of CWDs engaged in different behaviours during the reporting period are illustrated in Figure 2.7.

[Indigo rhombus: Foraging; Green circle: Socializing; Yellow triangle: Travelling; Black line: Vessel survey transects; Blue polygon: Sha Chau and Lung Kwu Chau Marine Park (SCLKCMP); Green polygon: Brothers Marine Park (BMP); Red polygon: 3RS land-formation footprint; Yellow line: 3RS temporary works area boundary]

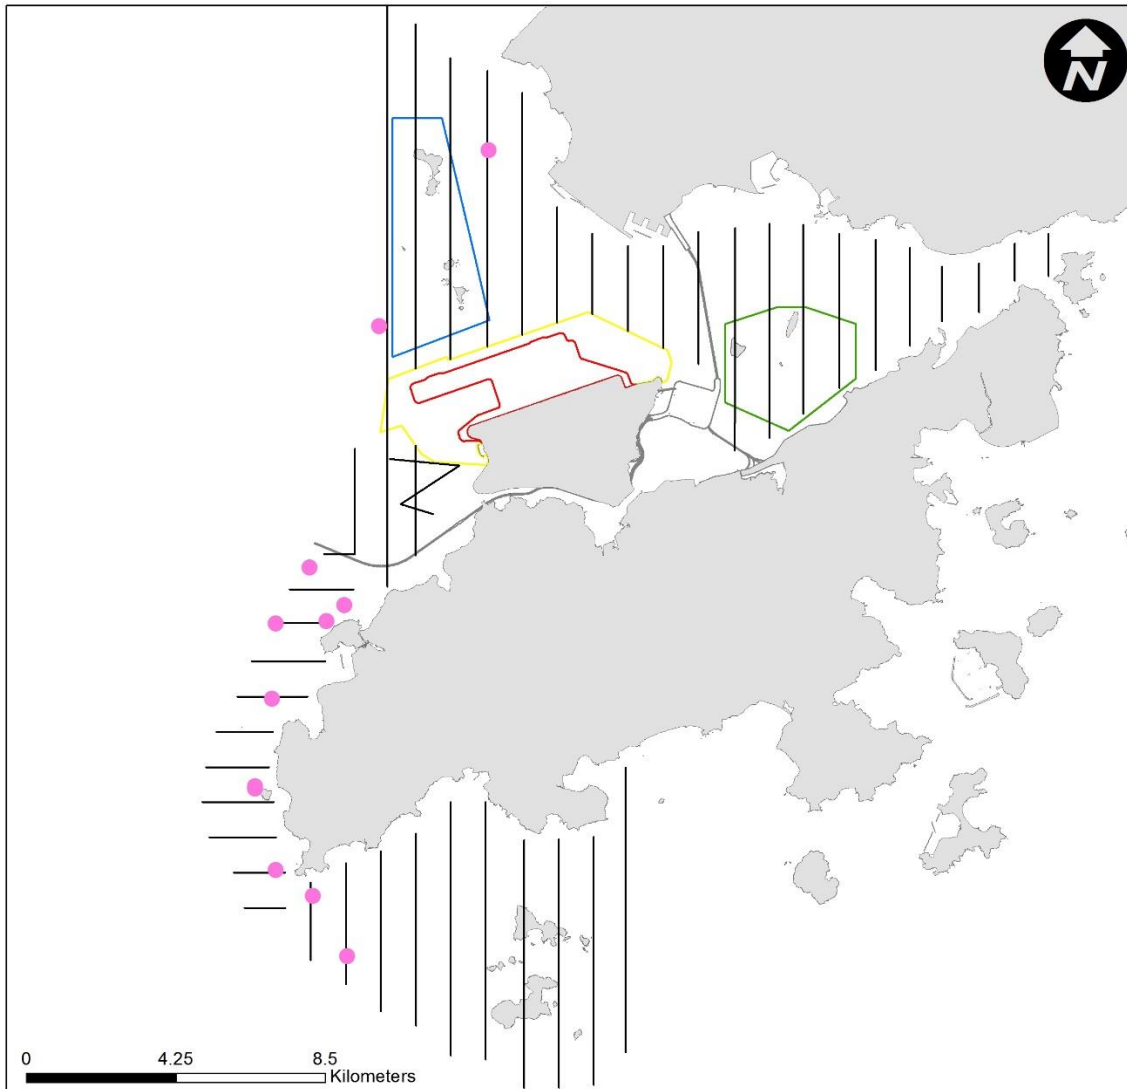
Figure 2.8: Sighting Locations of Mother-calf Pairs

From July to September 2017, 12 sightings of CWDs were recorded with the presence of mother-and-calf, mother-and-unspotted juvenile and/or mother-and-spotted juvenile pairs. Two-thirds of these mother-calf pairs were sighted in WL. The sighting locations of mother-calf pairs are shown in **Figure 2.8**.

[Pink circle: Sighting locations of mother-calf pairs; Black line: Vessel survey transects; Blue polygon: Sha Chau and Lung Kwu Chau Marine Park (SCLKCMP); Green polygon: Brothers Marine Park (BMP); Red polygon: 3RS land-formation footprint; Yellow line: 3RS temporary works area boundary]

Remarks: Please note that there are 12 pink circles on the map indicating the locations of the sightings with the presences of mother-and-calf, mother-and-unspotted juvenile and/or mother-and-spotted juvenile pairs. Some of them were very close to each other and therefore appear overlapped on this sighting distribution map.

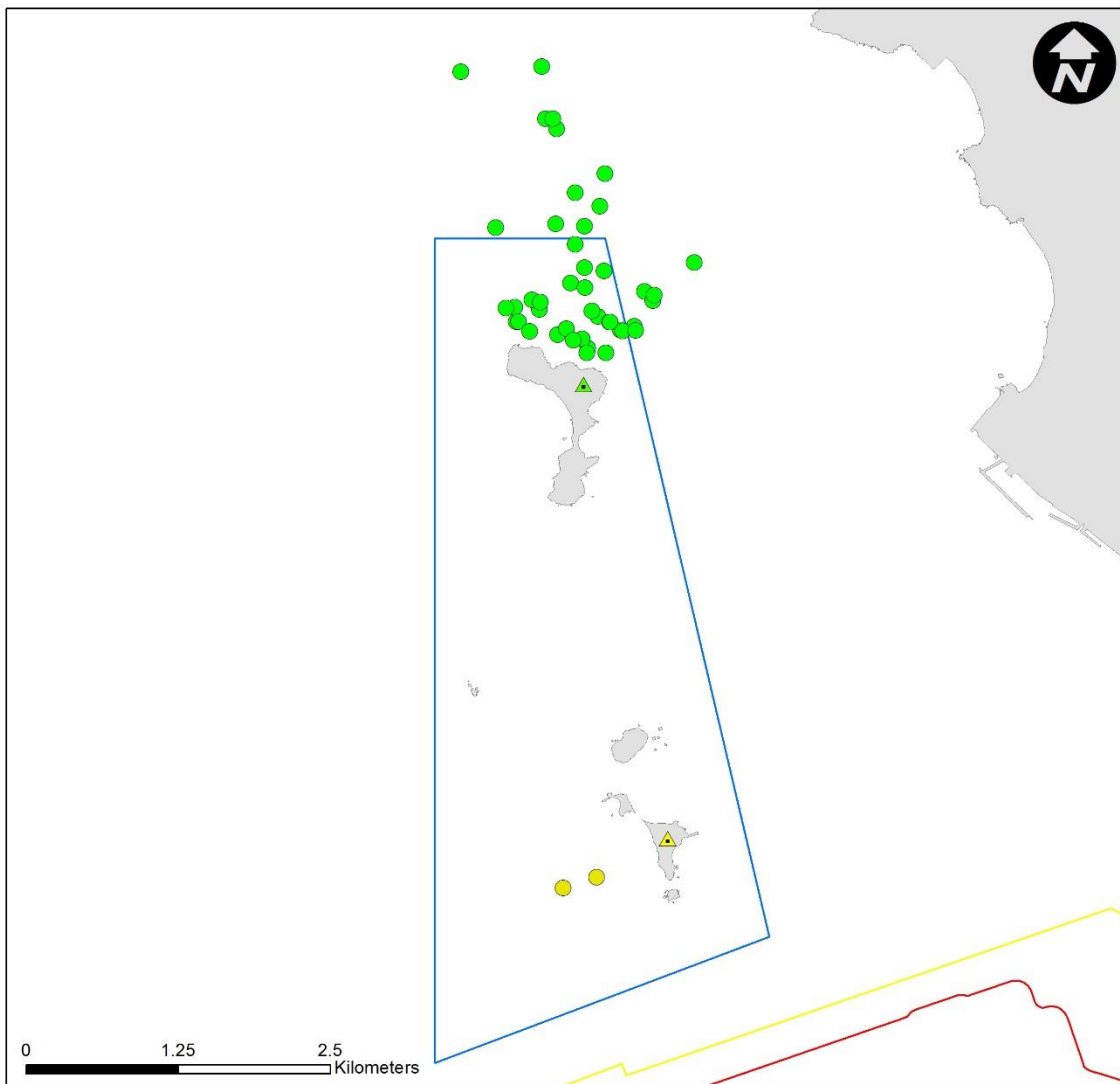
Figure 2.9: Plots of First Sightings of All CWD Groups from Land-based Stations

[Green triangle: LKC station; Yellow triangle: SC station; Green circle: CWD group off LKC; Yellow circle: CWD group off SC; Blue line: SCLKCMP boundary; Yellow line: 3RS temporary works area; Red line: 3RS land-formation footprint]

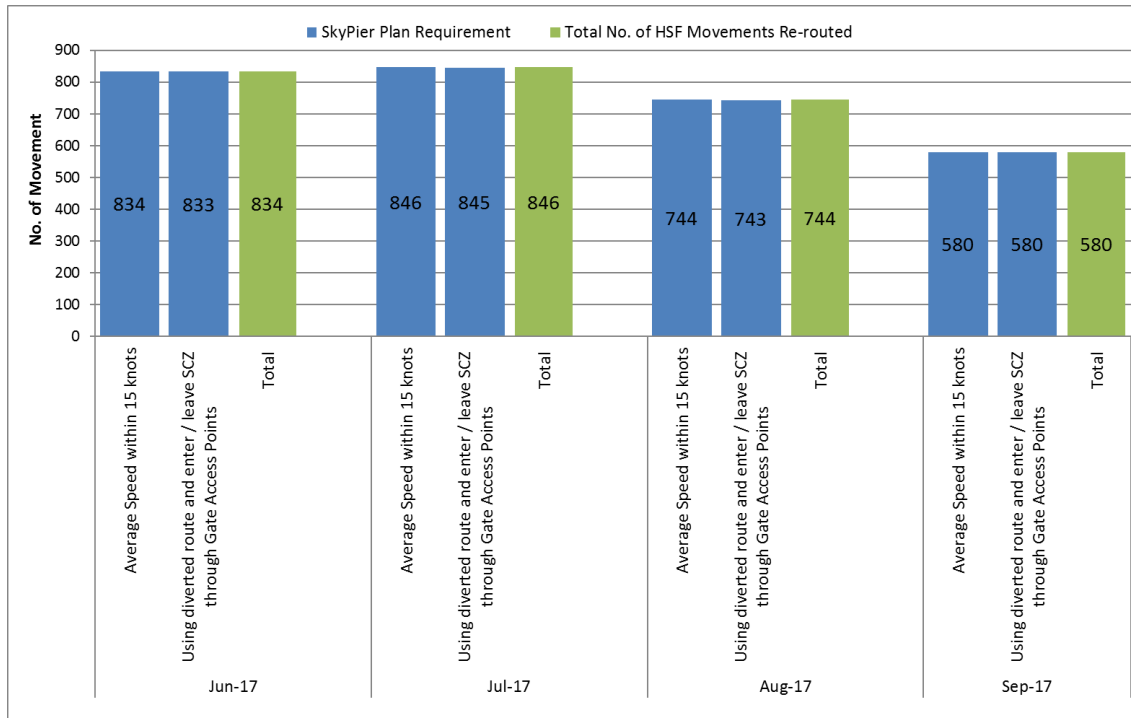
Graph 3: Summary of SkyPier Plan Monitoring Results (July 2017 to September 2017)

the AIS transponders. Vessel captains were requested to provide the radar track photos which indicated the vessel entered the SCZ through the gate access points and there was no speeding in the SCZ. FO's explanation has been accepted.

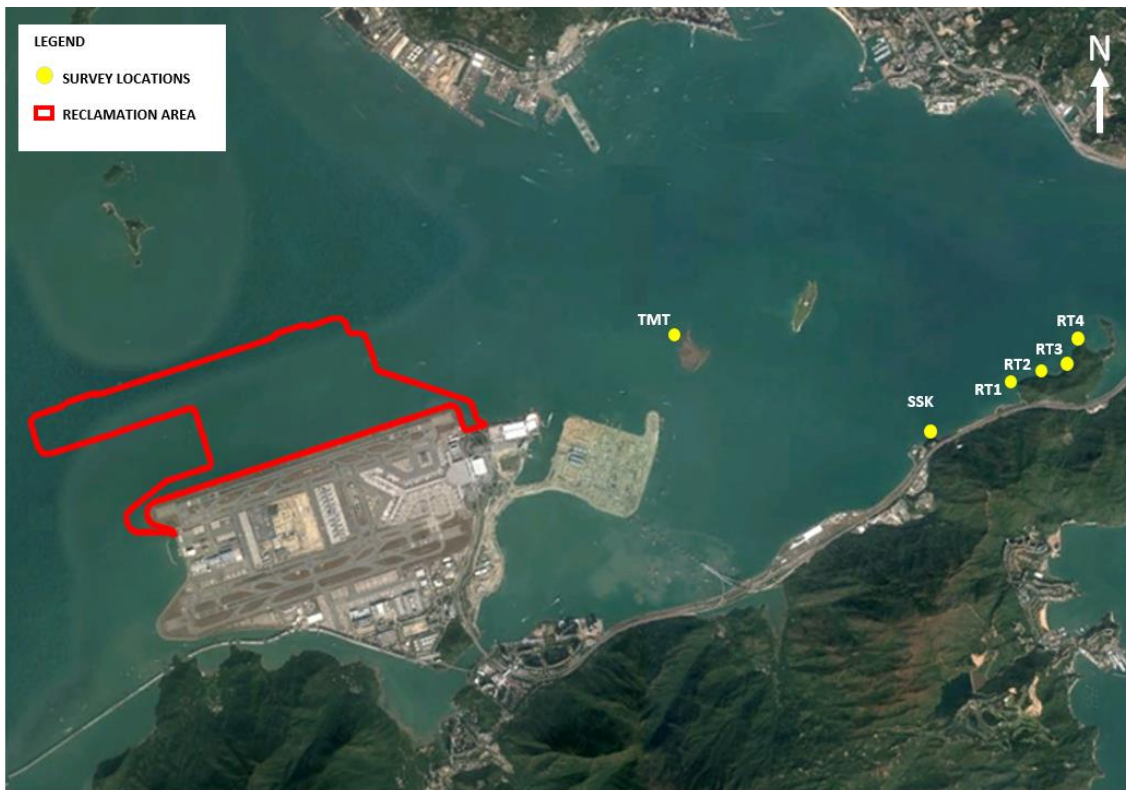
Figure 2.11: Locations of Six Coral Dive Survey Sites

In addition to the ad-hoc surveys at the recipient site in YTW (RT2), natural coral monitoring was also conducted at three other locations in YTW (namely, RT1, RT3 and RT4), Tai Mo To (TMT) and Sham Shui Kok (SSK), each with 20 tagged coral colonies, in June, July and September 2017 for comparison with the survey findings at the recipient site. The locations of all the survey sites are as illustrated in **Figure 2.11**. The monitoring results of these five localities are compared with those of the control (natural) corals at the recipient site RT2, as summarized in **Table 2.25** and presented graphically in **Graph 4**. It can be seen from the comparison that while the two survey locations at TMT and SSK are much closer to the 3RS project site than the four locations at YTW (RT1, RT2, RT3 and RT4), the average PM levels of natural corals (tagged) at TMT and SSK are generally lower than those at the four YTW locations. Hence, it is evident from the comparison of findings that the relatively high PM levels at YTW not likely to be related to the 3RS marine works activities but, rather, seem to have been a discrete incident.

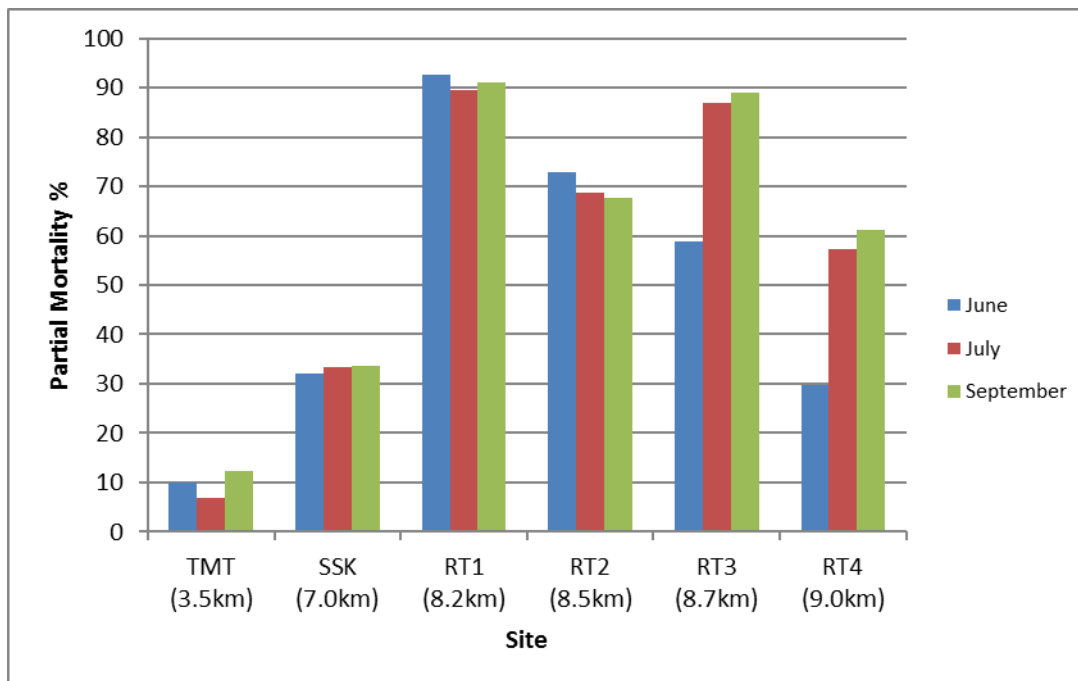
Graph 4: Comparison of Average Partial Mortality of Tagged Natural Corals at Six Survey Sites

TMT	SSK	RT1	RT2 (recipient site)	RT3	RT4
Distance from 3RS project site boundary	3.5km	7.0km	8.2km	8.5km	8.7km	9.0km
Average Partial Mortality						
June 2017	10.0%	32.1%	92.8%	73.5%	58.8%	29.8%
July 2017	6.8%	33.3%	89.5%	68.8%	87.0%	57.3%
September 2017	12.3%	33.8%	91.0%	67.8%	89.0%	61.3%
Average Health Condition						
June 2017	4.8	3.7	0.9	2.1	3.2	4.0
July 2017	4.7	4.5	1.2	2.9	3.0	3.5
September 2017	3.2	1.8	1.2	2.7	1.4	2.3

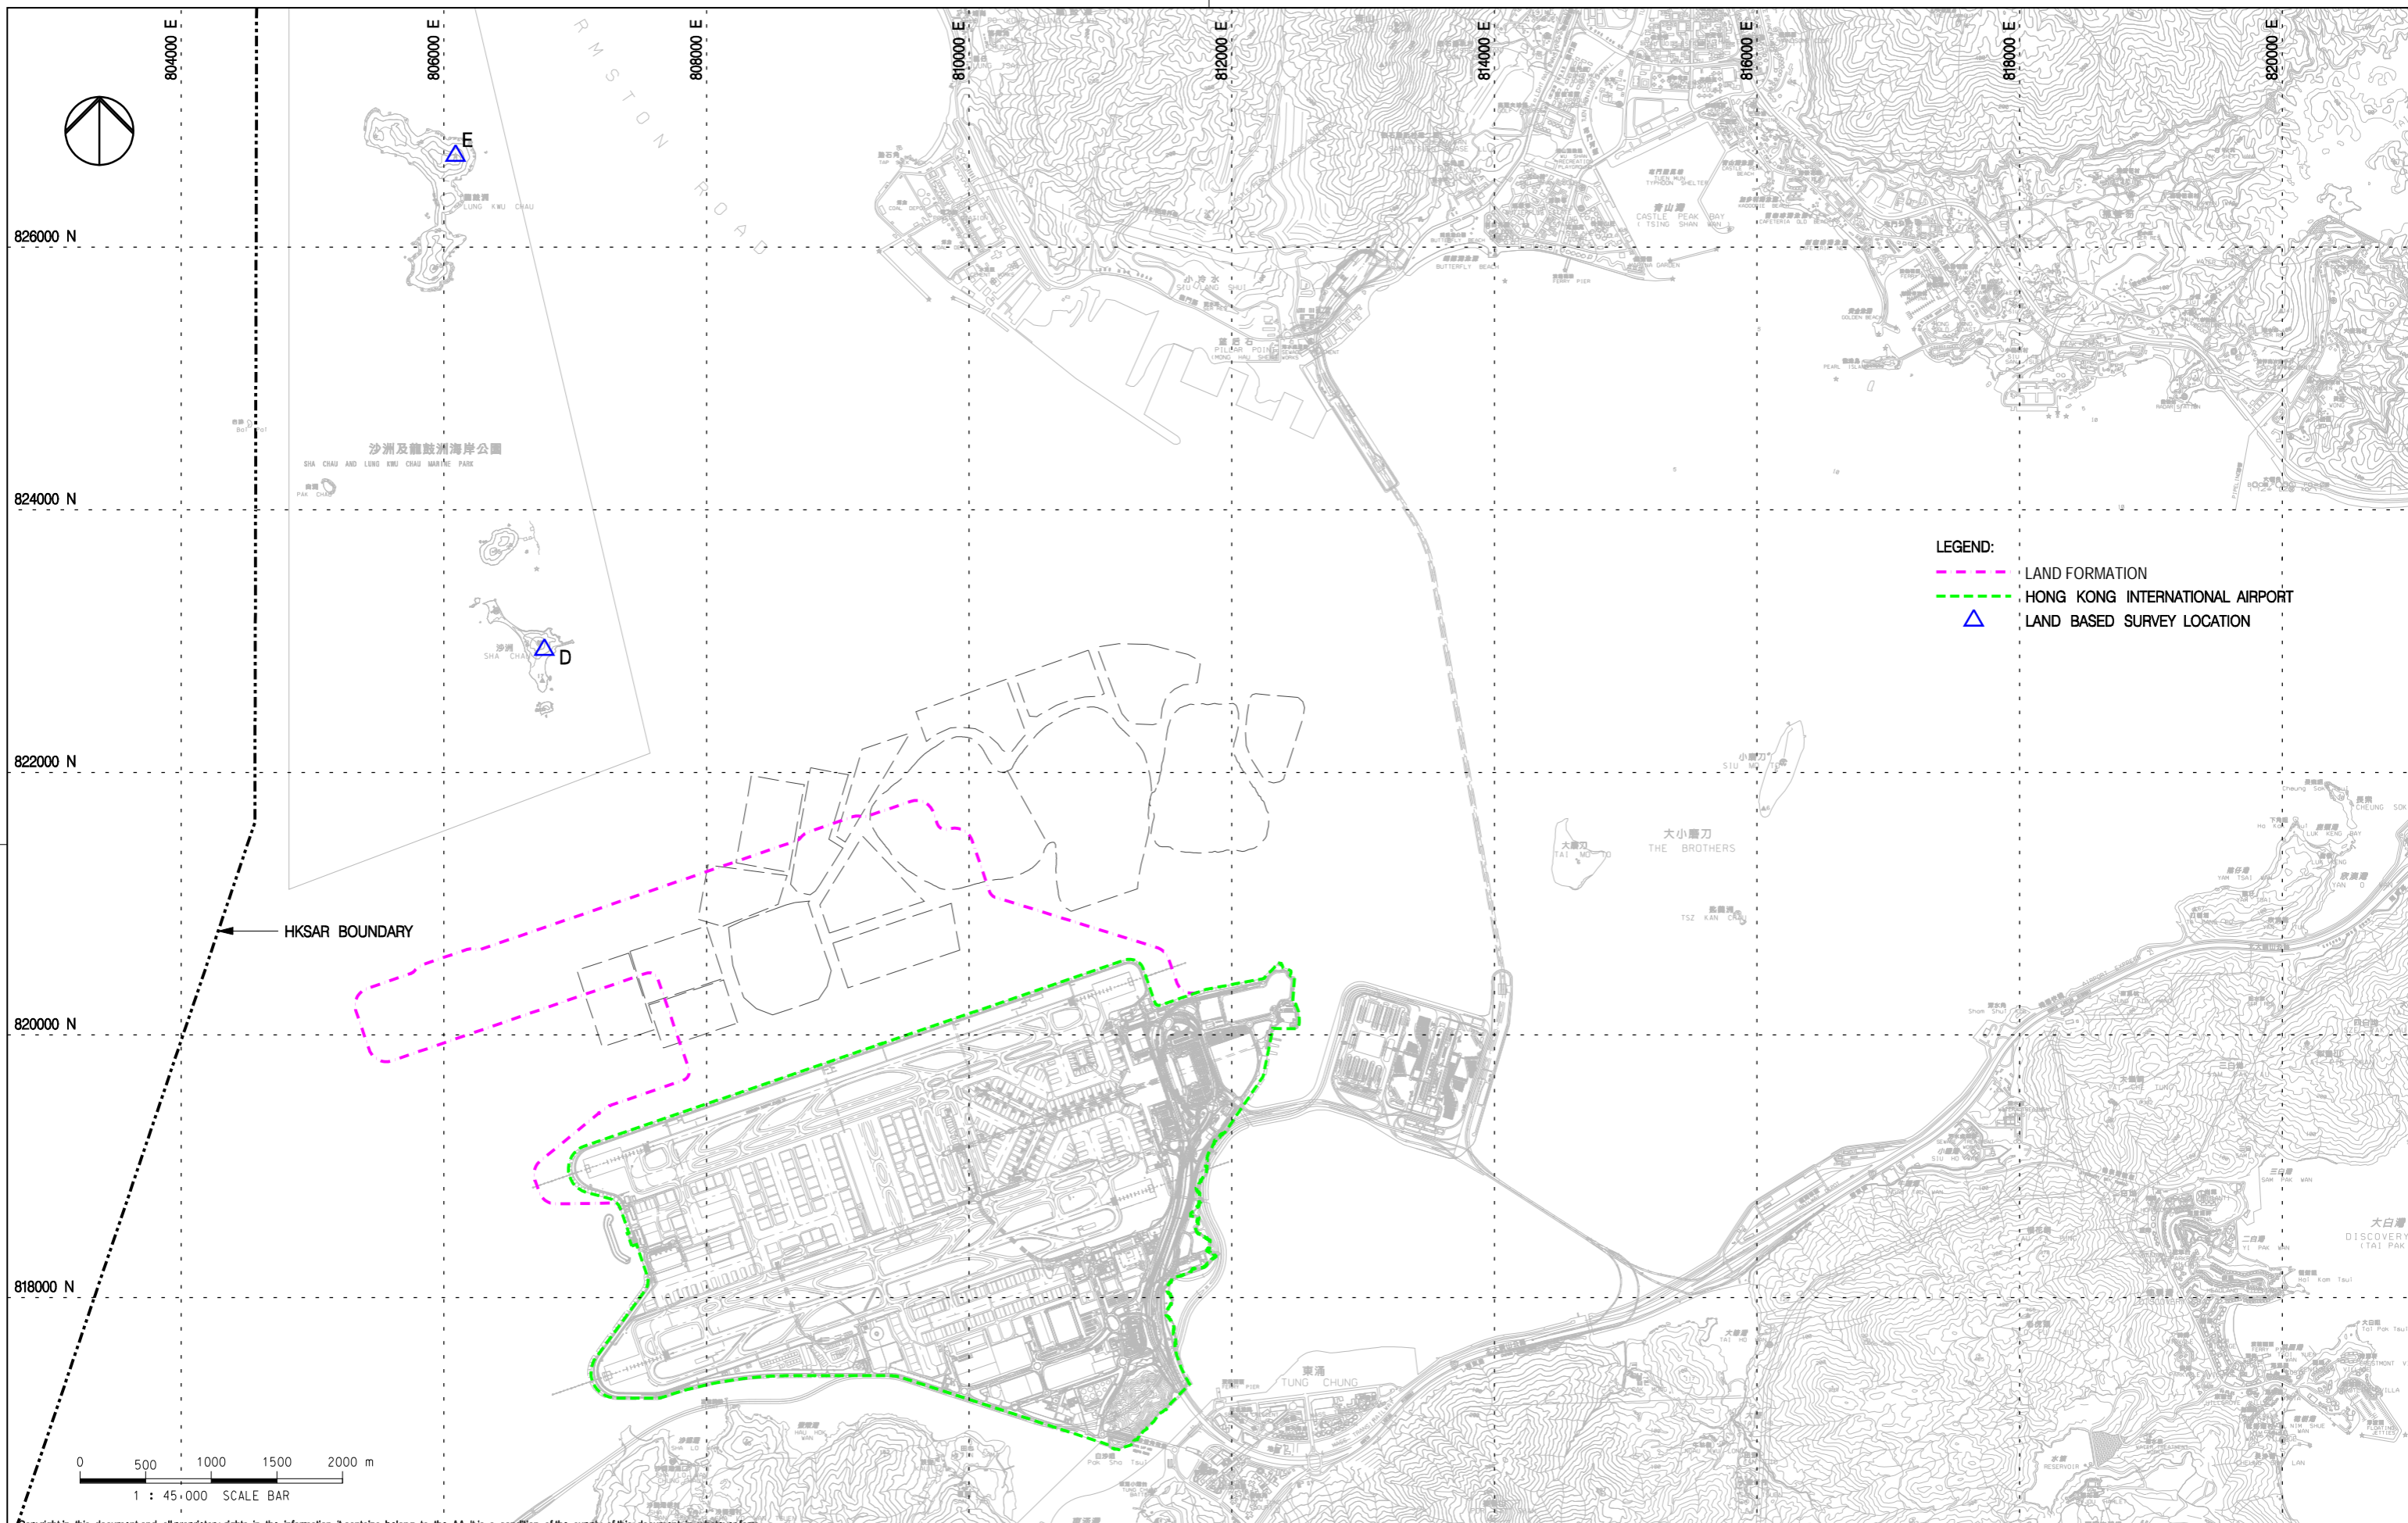
EXPANSION OF HONG KONG INTERNATIONAL AIRPORT INTO A THREE-RUNWAY SYSTEM		Scale at A3
Drawing No.	FIGURE 2.3	1 : 125000
Rev.	D

Remarks: Transects for operation phase monitoring subject to refinement based on the actual boundaries for the extension of Hong Kong International Airport Approach Areas (HKIAAA) and 3RS Marine Park

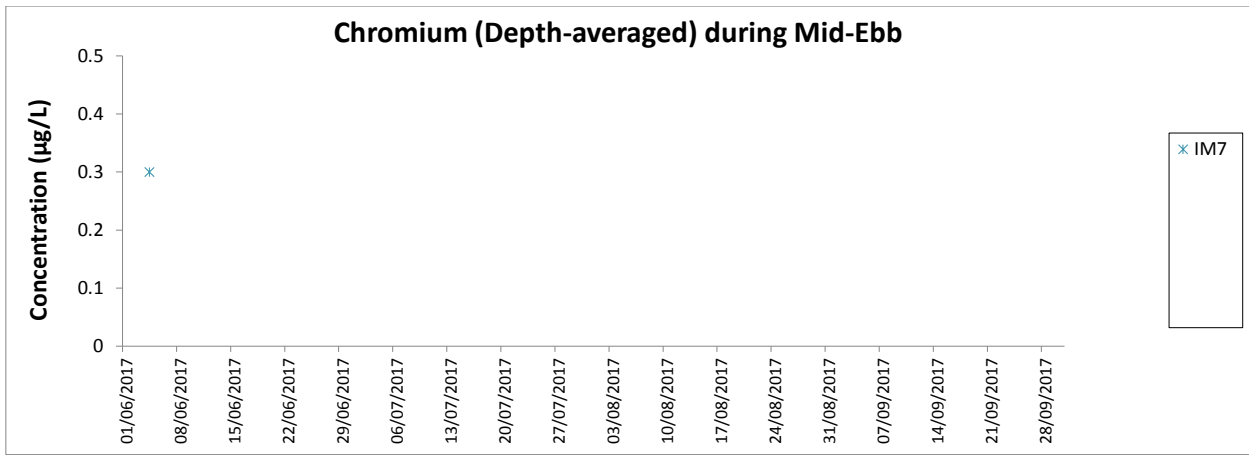
Note: The Action and Limit Levels of chromium can be referred to Table 2.4 of the Quarterly EM&A Report.
 The monitoring results of chromium at all other monitoring stations during mid-ebb tide were below the reporting limit 0.2 µg/L
 The monitoring results of chromium at all monitoring stations during mid-flood tide were below the reporting limit 0.2 µg/L

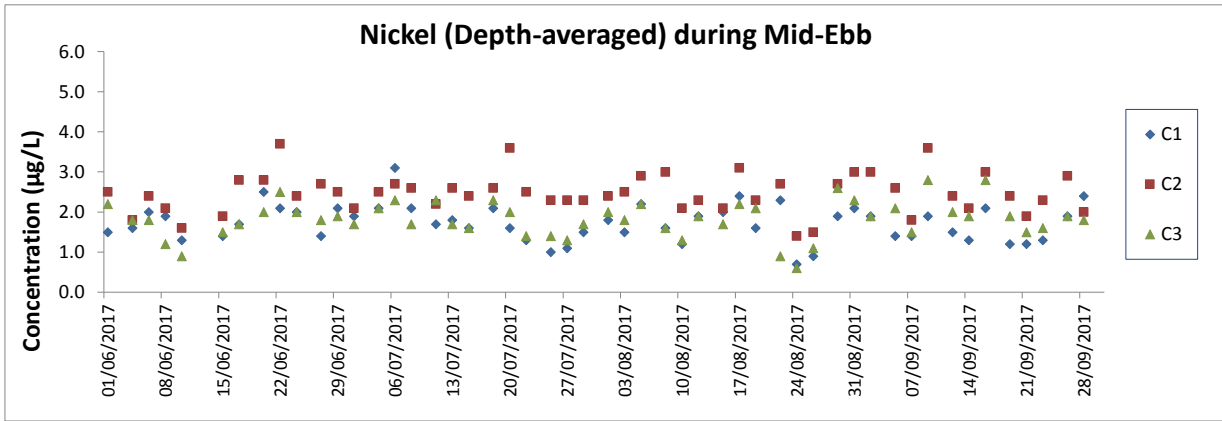
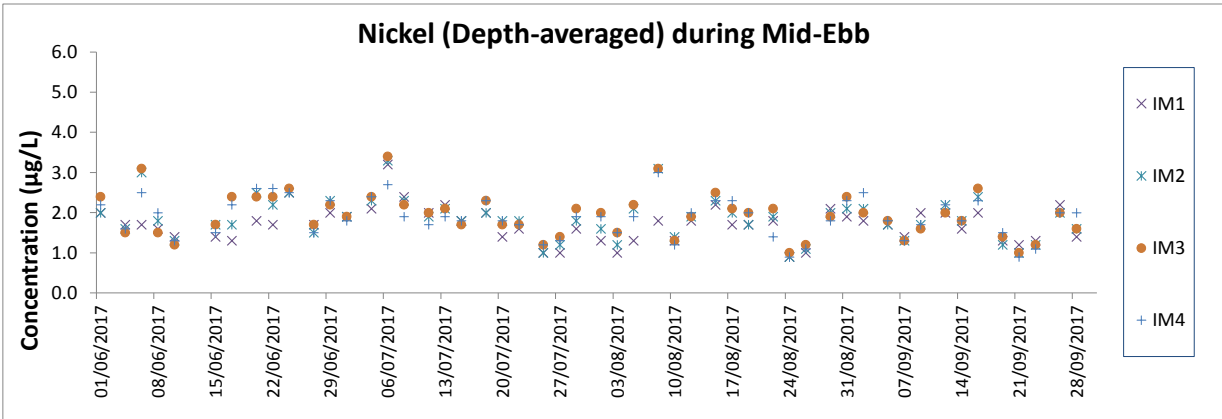
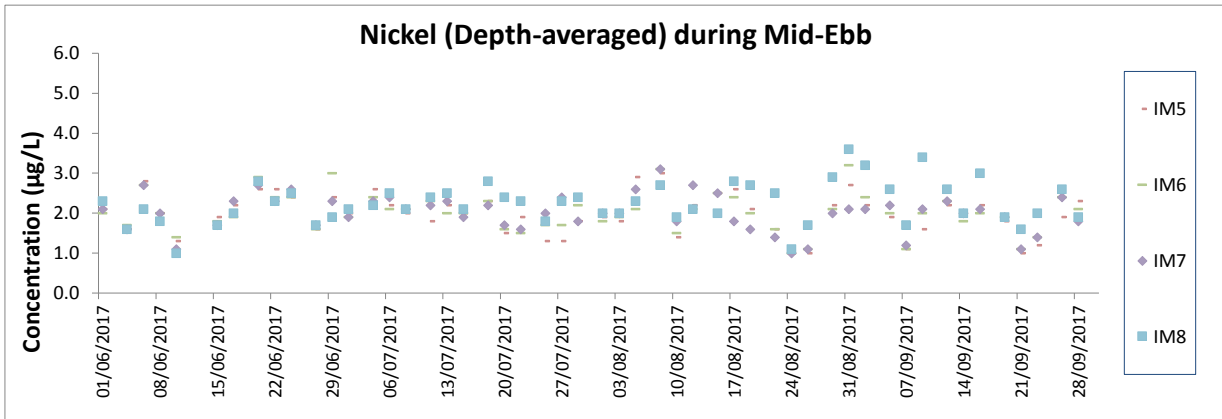
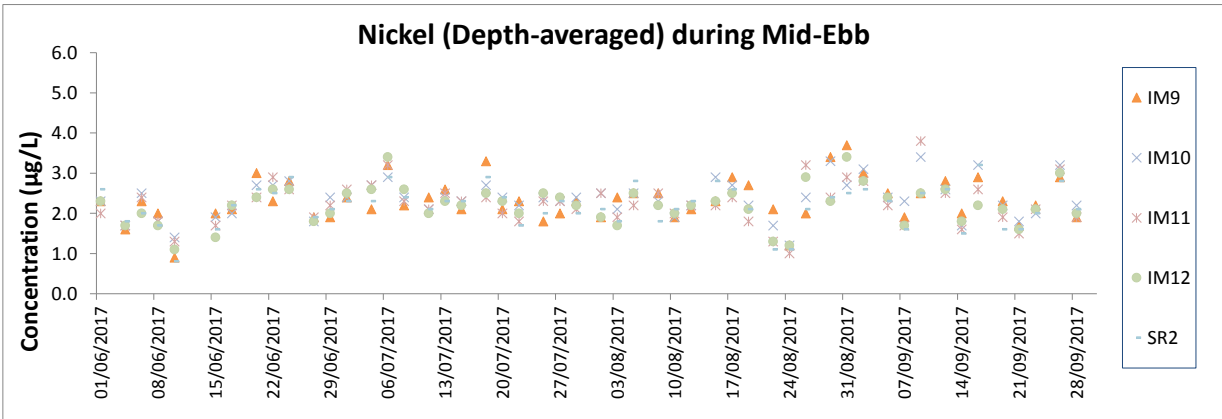
Note: The Action and Limit Levels of nickel can be referred to Table 2.4 of the Quarterly EM&A Report.

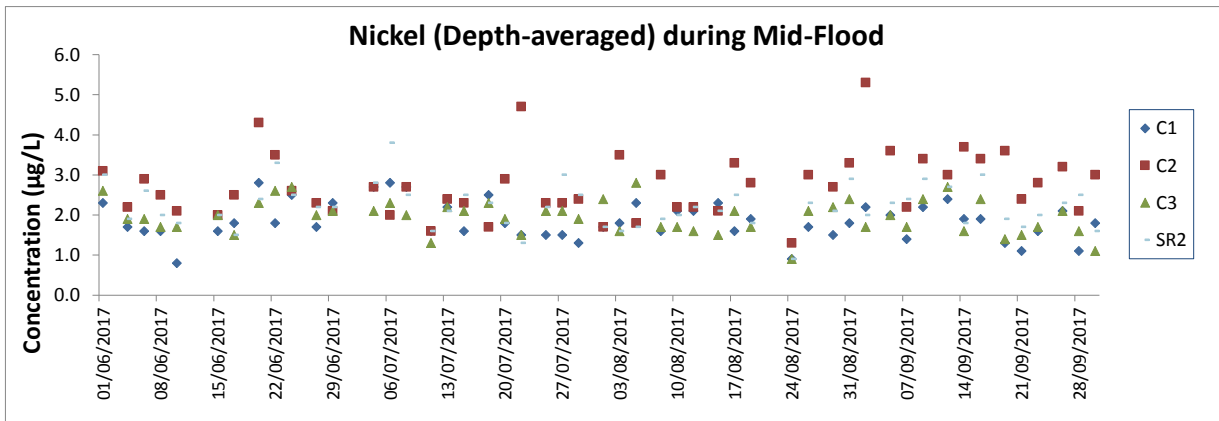
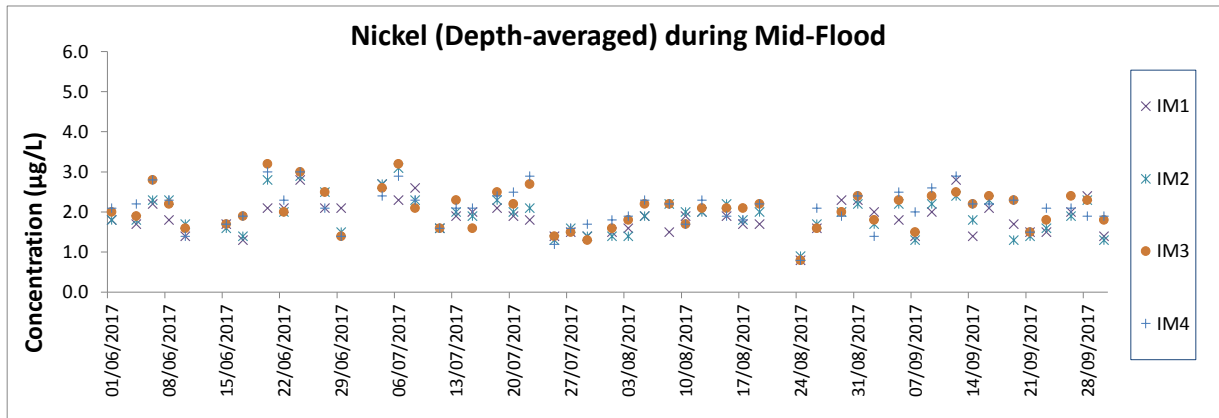
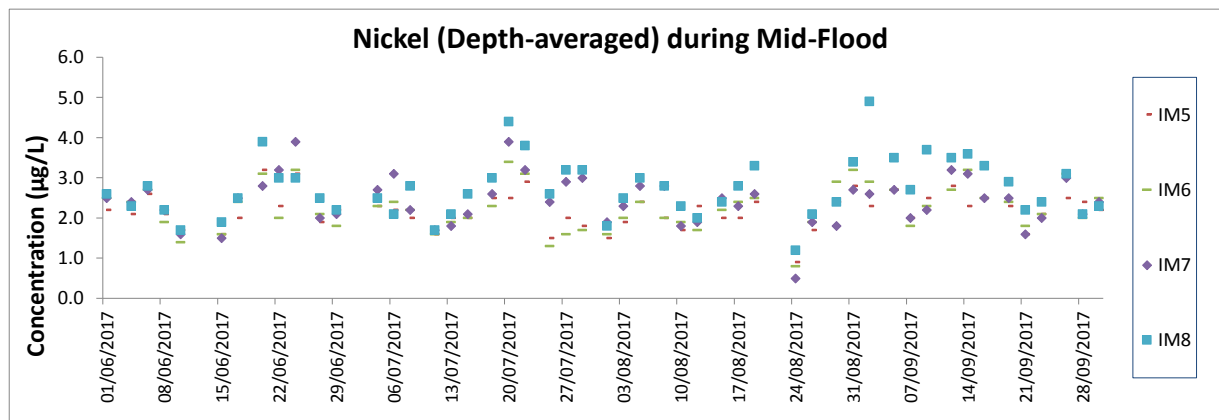
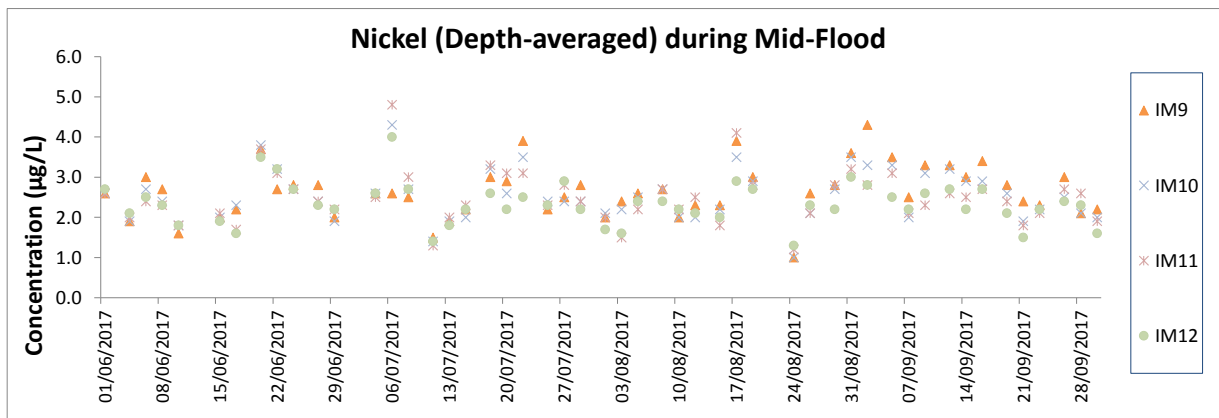
Note: The Action and Limit Levels of nickel can be referred to Table 2.4 of the Quarterly EM&A Report.

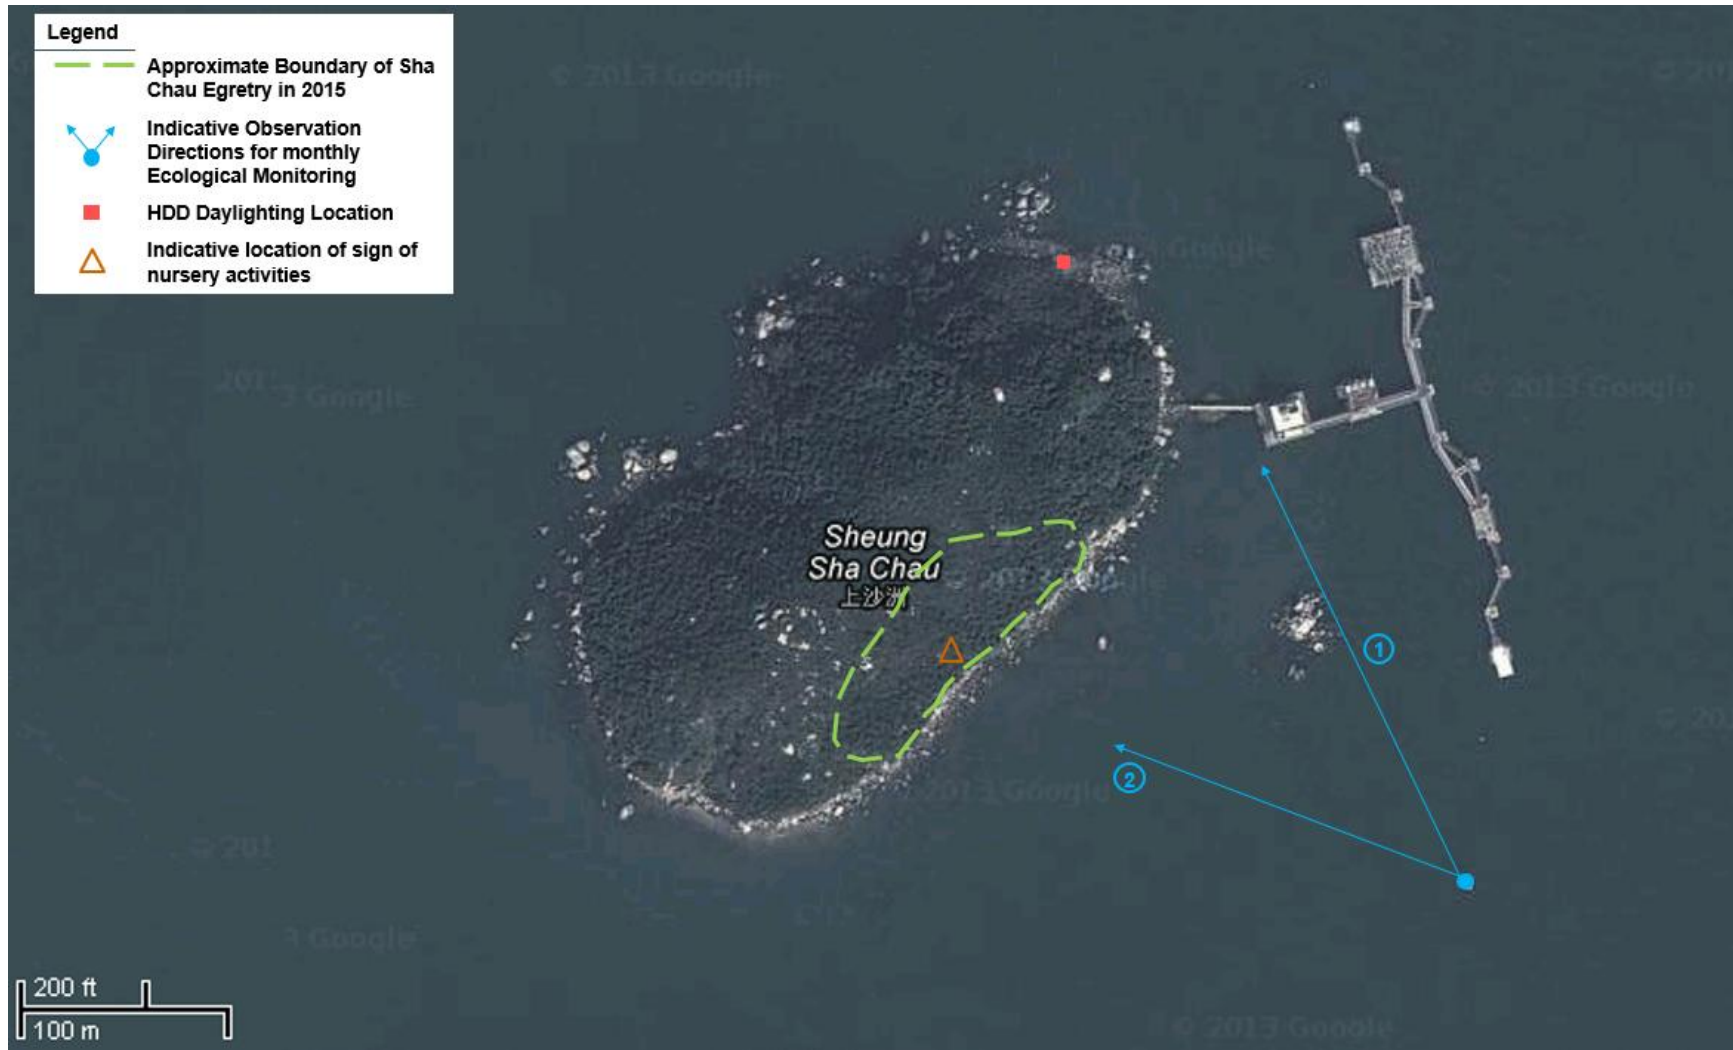
Ecological Monitoring – site photos and location map regarding the monthly ecological monitoring for the egret area on Sheung Sha Chau and the HDD works
