# **Expansion of Hong Kong International Airport into a Three-Runway System**

Construction Phase Quarterly EM&A Report  
No.21 (1 January to 31 March 2021)

June 2021

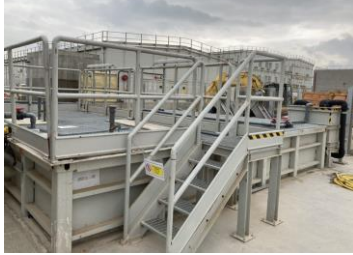
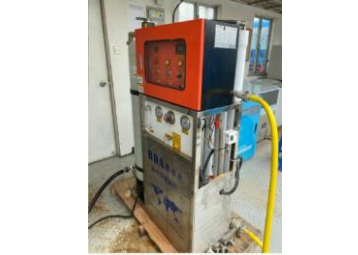
**Snapshots of Good Environmental Practices in the Reporting Period**

<p>Water browsers were installed in vehicles equipped with GPS for tracking of water spraying on haul roads</p>	<p>Operation of on-site wastewater treatment facility</p>	<p>Use of desalinated seawater for construction operations</p>

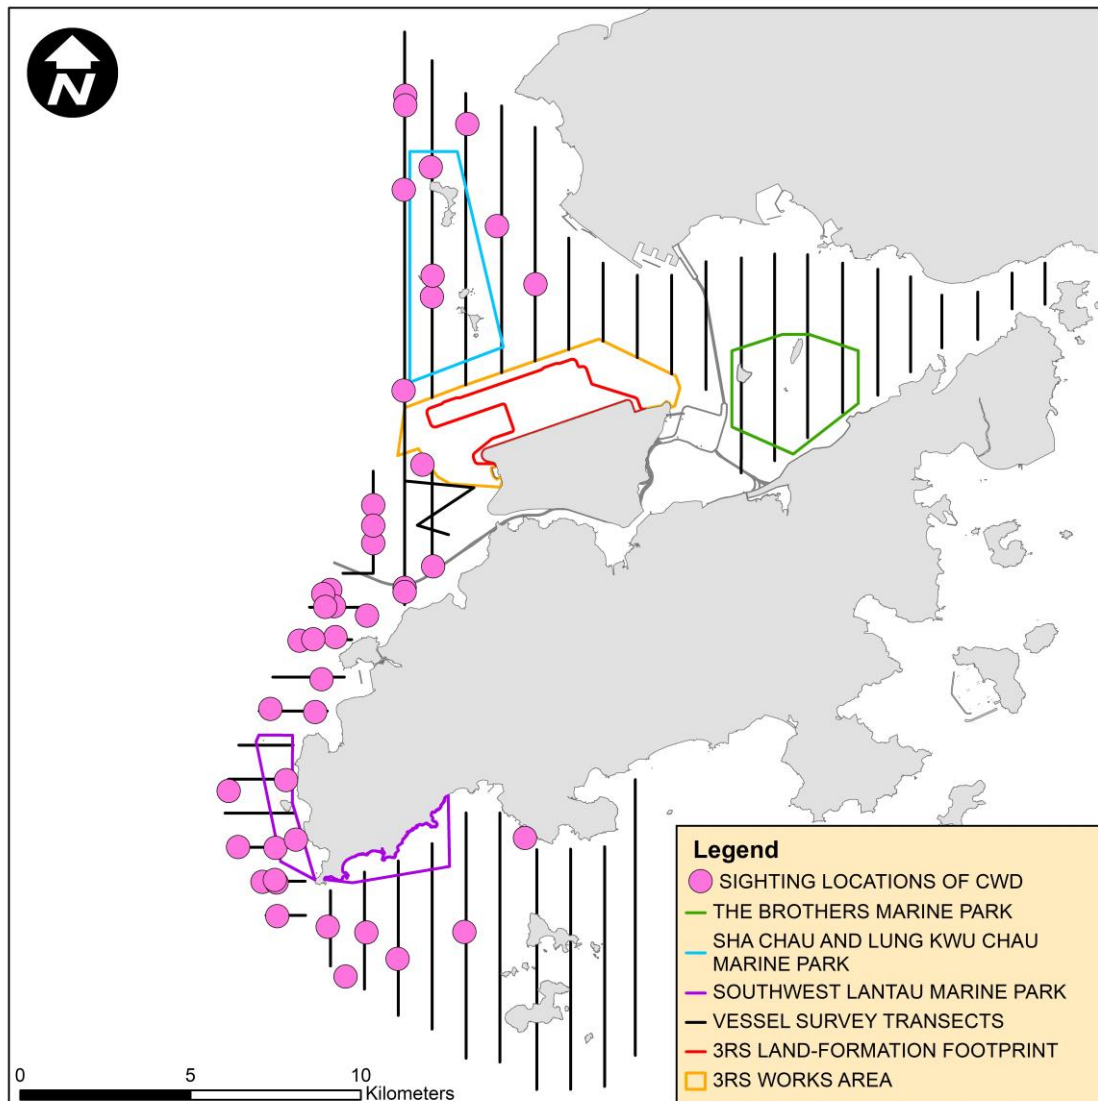
**Figure 2.5: Sightings Distribution of Chinese White Dolphins from January to March 2021**

The distribution of CWD sightings recorded from January to March 2021 is illustrated in **Figure 2.5**. In NWL (including AW transects), the majority of the CWD sightings were recorded within and around SCLKCMP, with a few sightings located at the southwestern corner of the survey area, close to Hong Kong-Zhuhai-Macao Bridge Hong Kong Link Road. In WL, CWD sightings were scattered throughout the survey area with the majority clustered near Tai O and scattered from Peaked Hill to Fan Lau. In SWL, dolphin sightings were recorded in the relatively offshore waters between Fan Lau and Soko Islands. No CWD sightings were recorded in NEL survey area. Details of the sighting data are presented in **Appendix C**.

Remarks: (1) Please note that there are 43 pink circles on the map indicating the sighting locations of CWD. Some of them were very close to each other and therefore appear overlapped on this sighting distribution map. (2) Marine park excludes land area and the landward boundary generally follows the high water mark along the coastline.

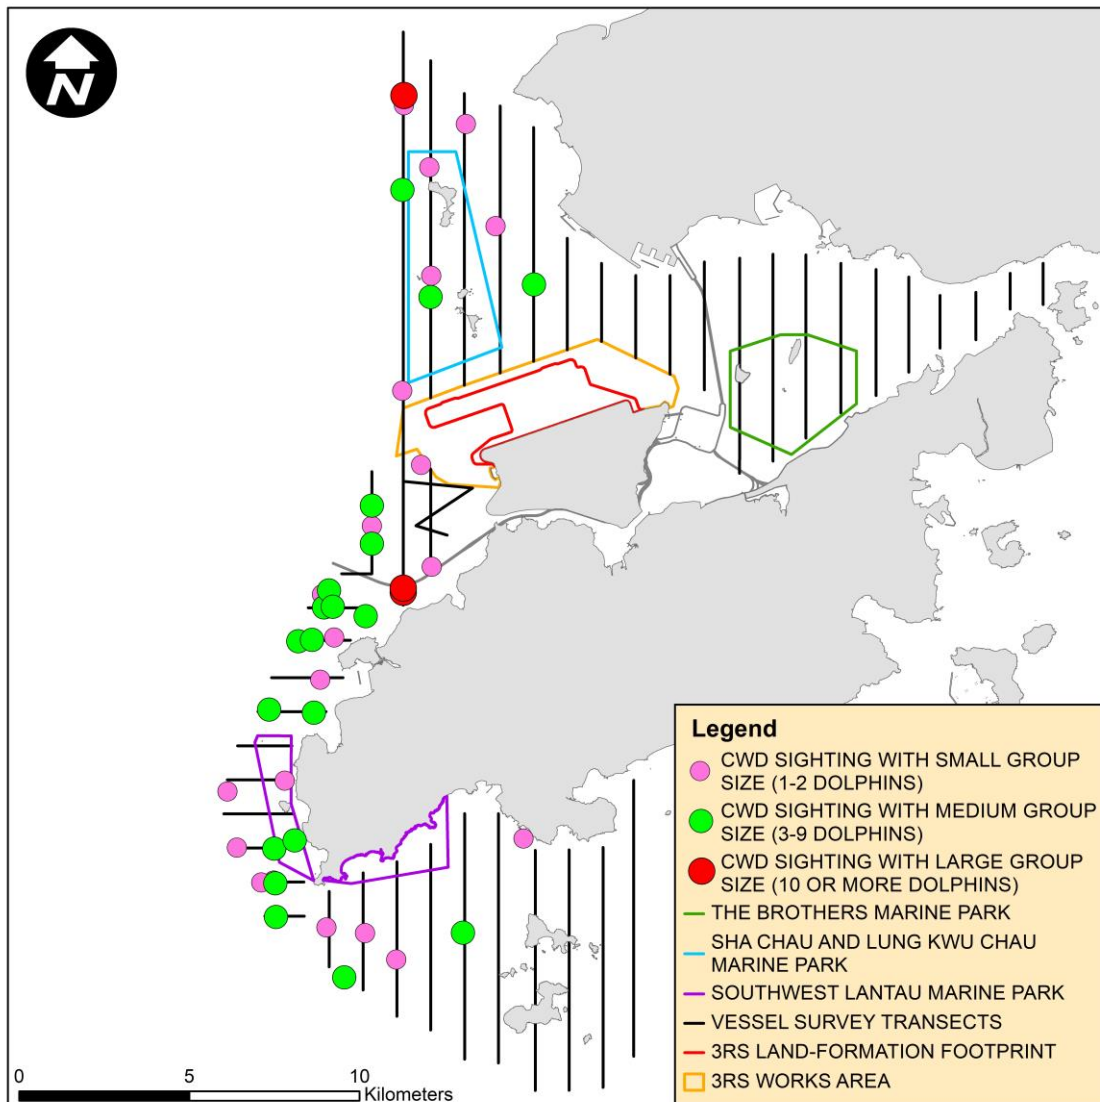
**Figure 2.6: Sighting Locations of Chinese White Dolphins with Different Group Sizes**

There are no observable difference in the distribution pattern between small-sized and medium-sized dolphin groups as they all scattered amongst NWL, WL and SWL survey areas. However, all the three sighting with large group size were exclusively recorded in NWL survey area only. Sighting locations of CWD groups with different group sizes are depicted in **Figure 2.6**.

Remarks: (1) Please note that there are 43 circles on the map indicating the sighting locations of CWD. Some of them were very close to each other and therefore appear overlapped on this sighting distribution map. (2) Marine park excludes land area and the landward boundary generally follows the high water mark along the coastline.

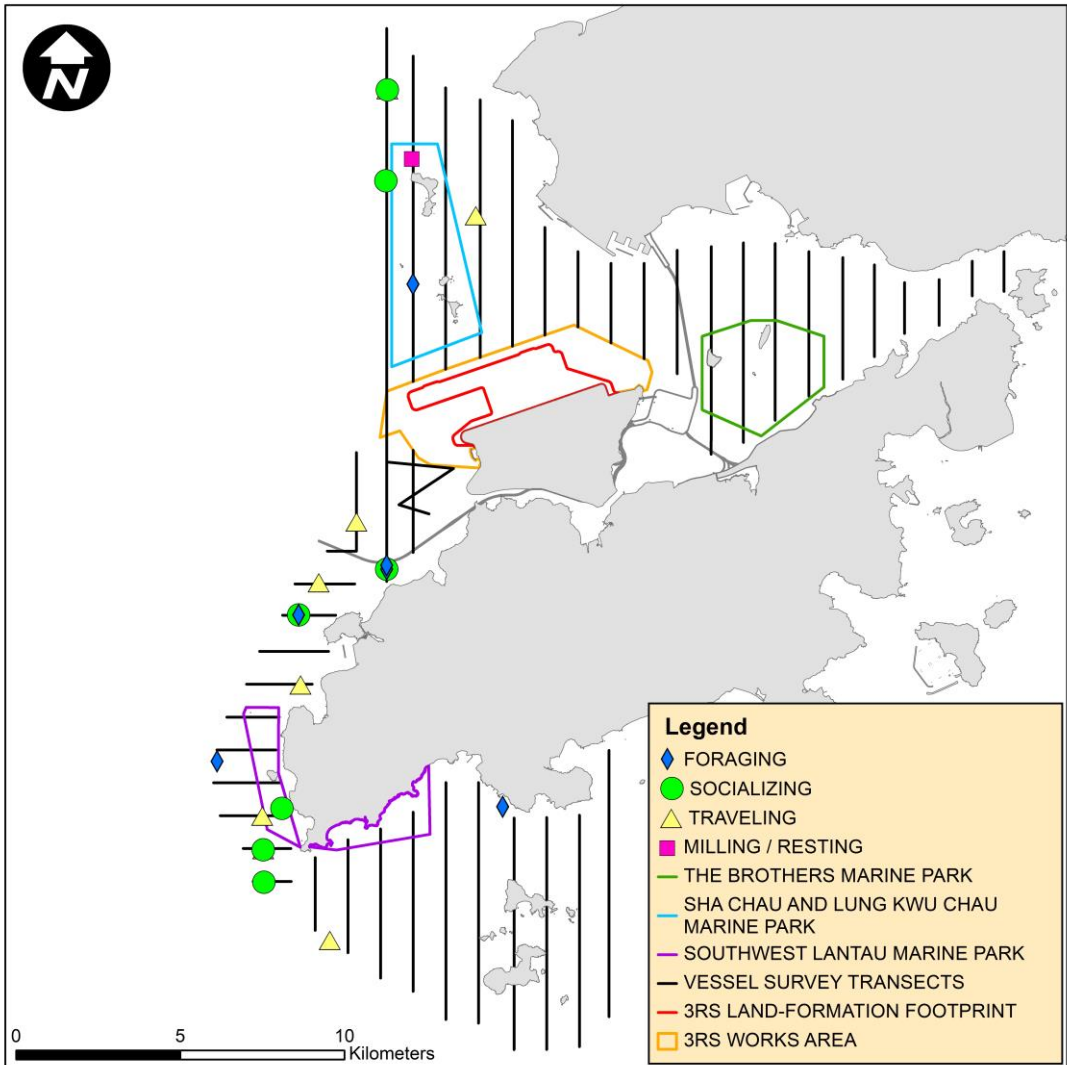
**Figure 2.7: Sighting Locations of Chinese White Dolphins Engaged in Different Behaviours**

The sighting locations of CWDs engaged in different behaviours during the current reporting period are illustrated in **Figure 2.7**.

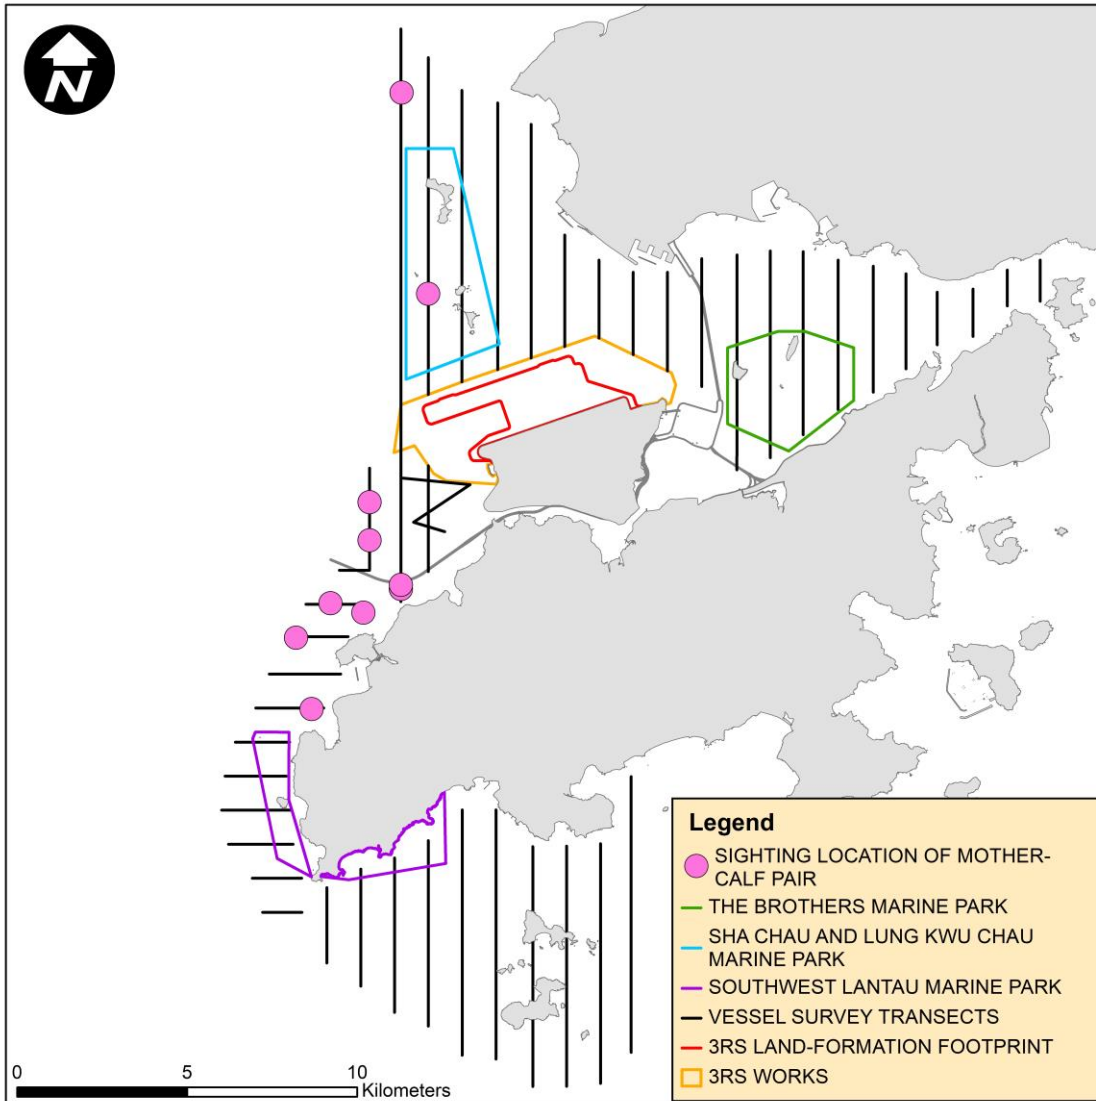
**Figure 2.8: Sighting Locations of Mother-calf Pairs**

The locations of CWD sightings with the presence of mother-and-unspotted juvenile pairs are shown in **Figure 2.8**.

Remarks: (1) Please note that there are seven circles on the map indicating the sighting locations of Mother-Calf pair. (2) Marine park excludes land area and the landward boundary generally follows the high water mark along the coastline.

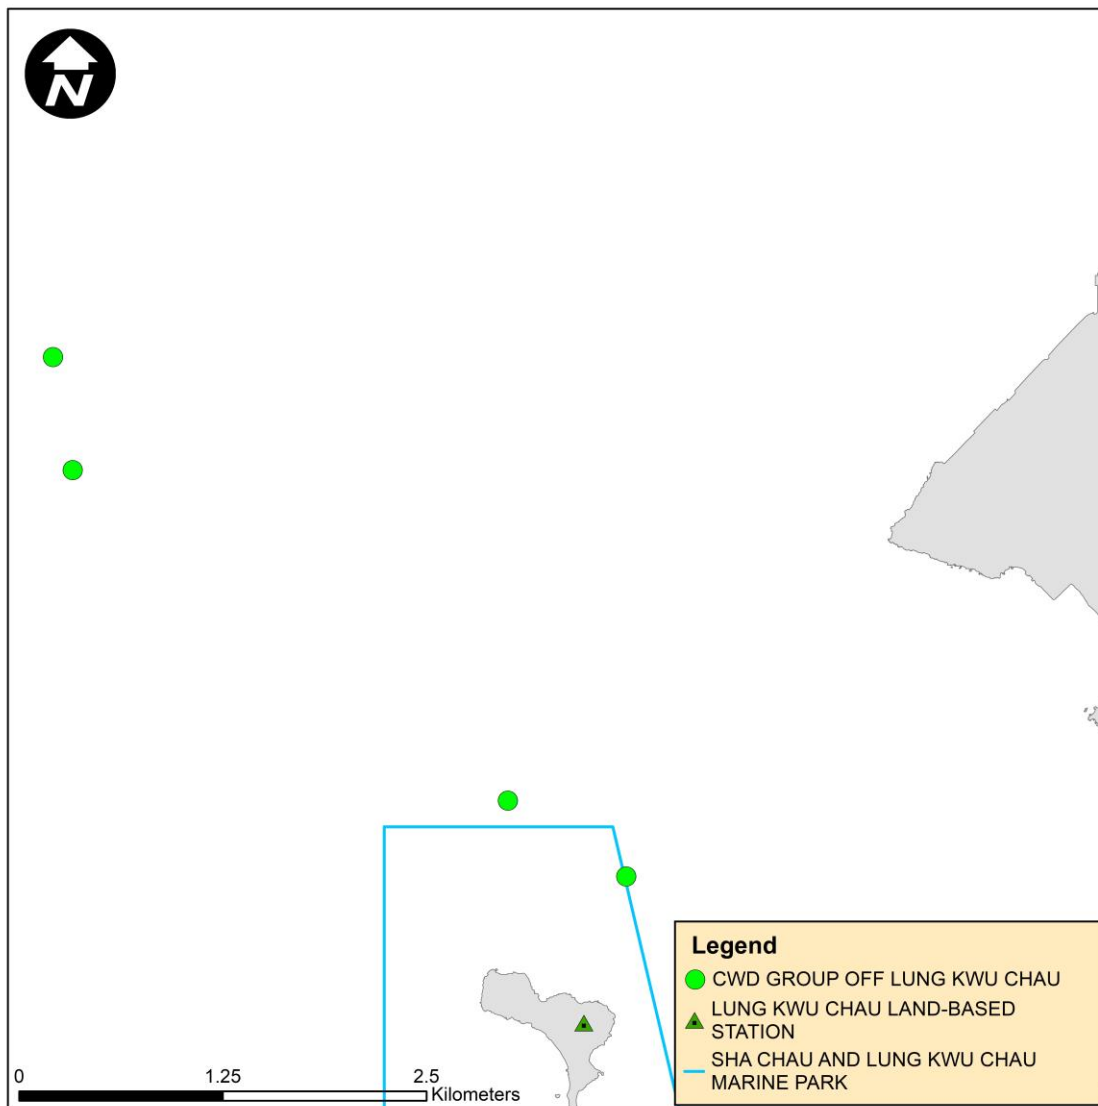
Figure 2.9: Plots of First Sightings of All CWD Groups from Land-based Stations

Remark: Marine park excludes land area and the landward boundary generally follows the high water mark along the coastline.

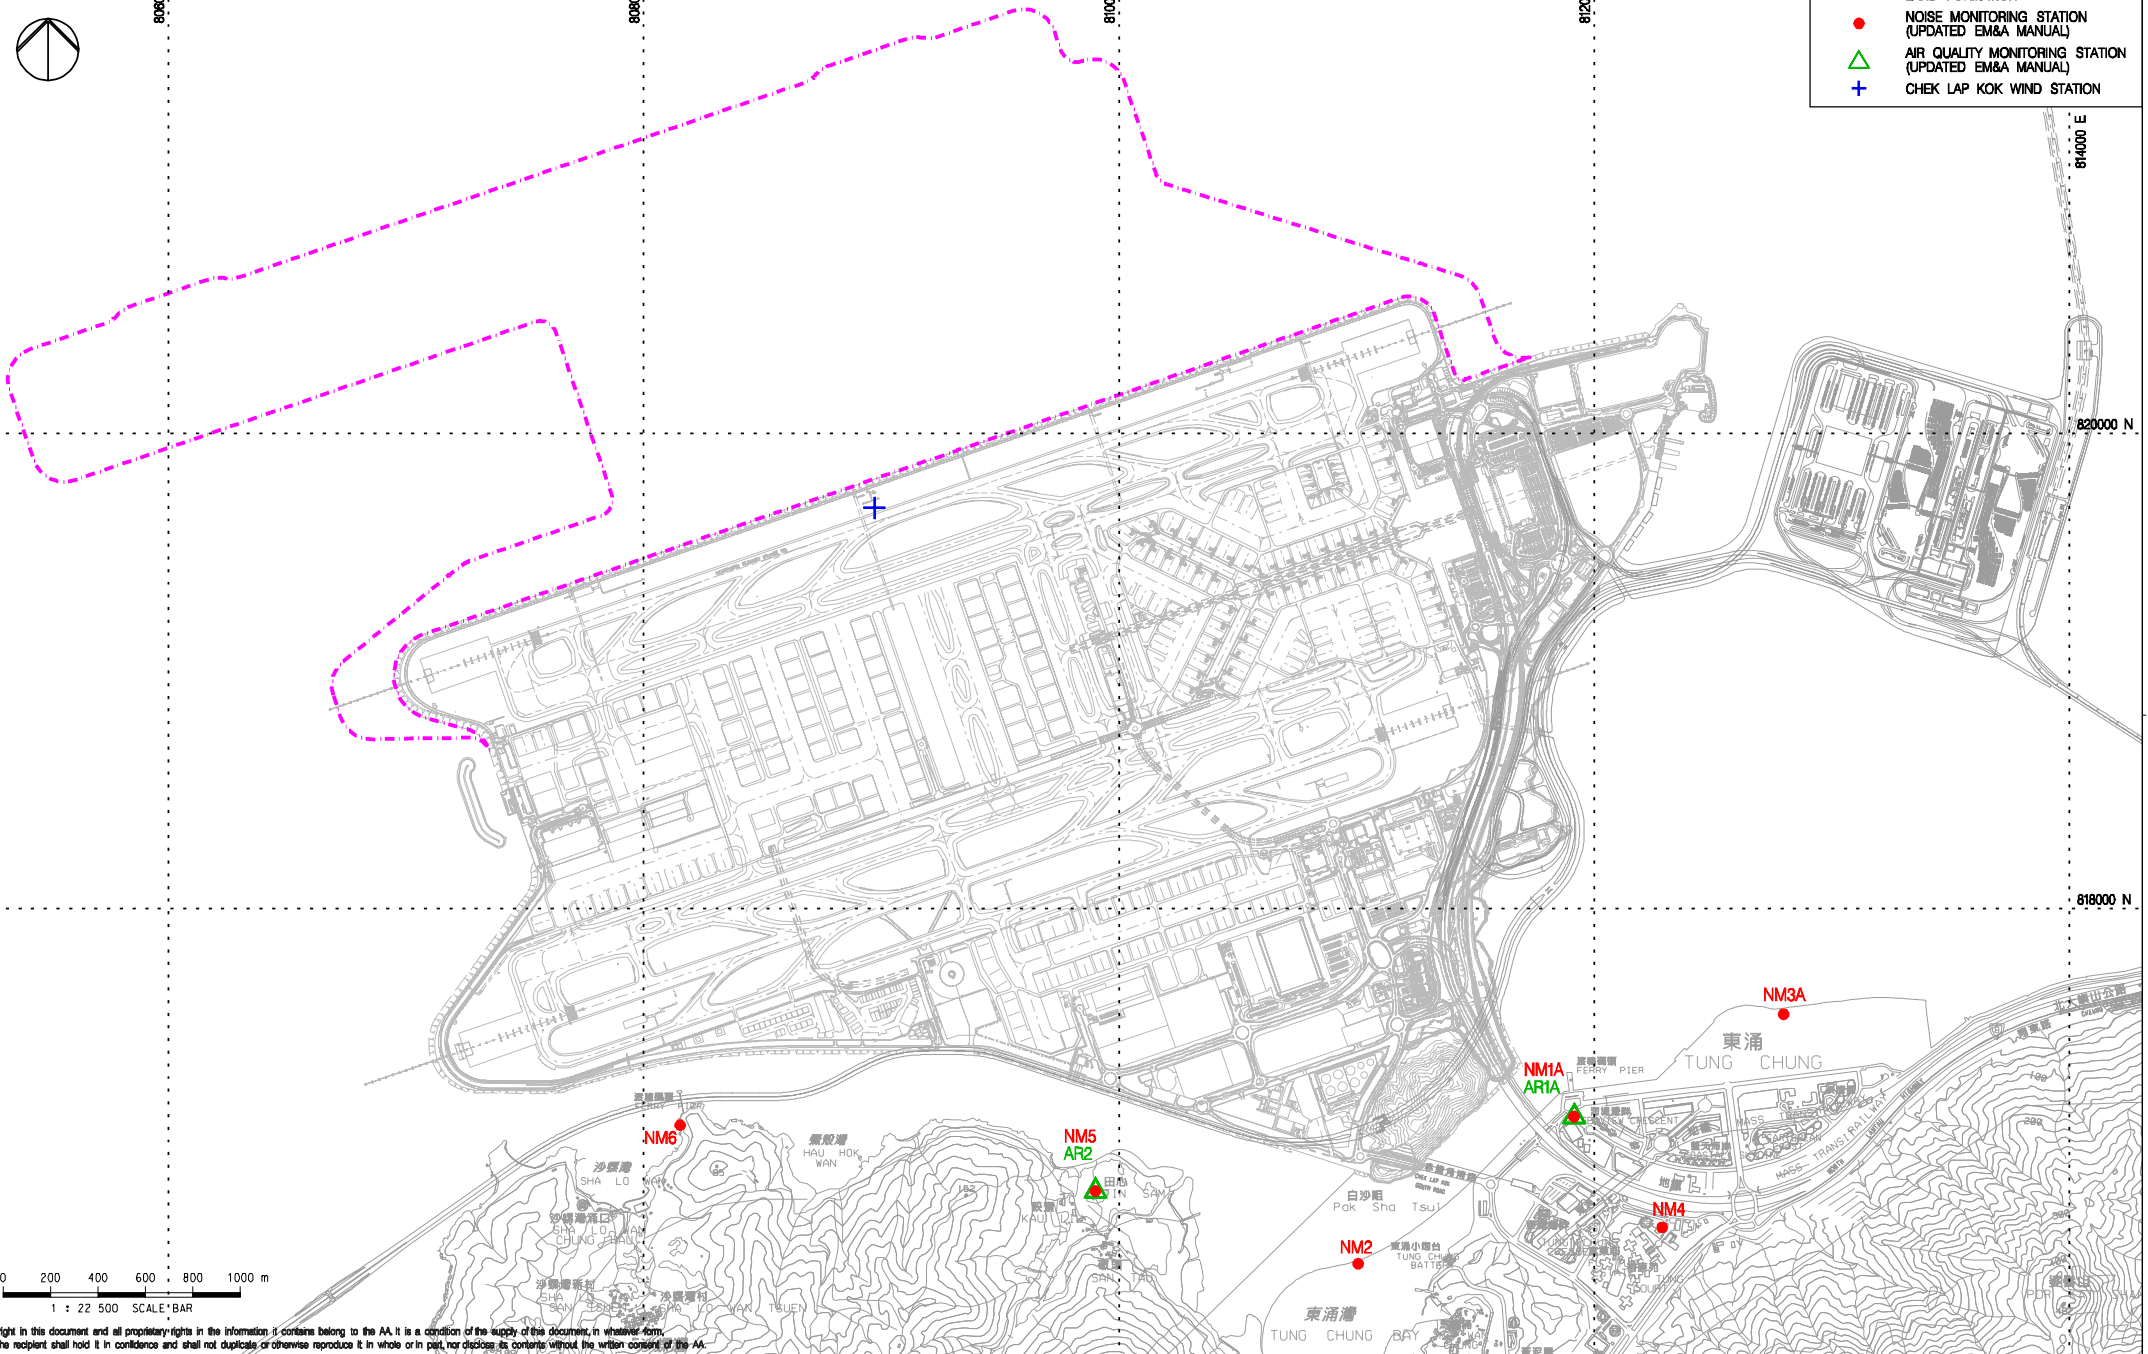
- LEGEND:
- - - LAND FORMATION
  - NOISE MONITORING STATION (UPDATED EM&A MANUAL)
  - ▲ AIR QUALITY MONITORING STATION (UPDATED EM&A MANUAL)
  - + CHEK LAP KOK WIND STATION

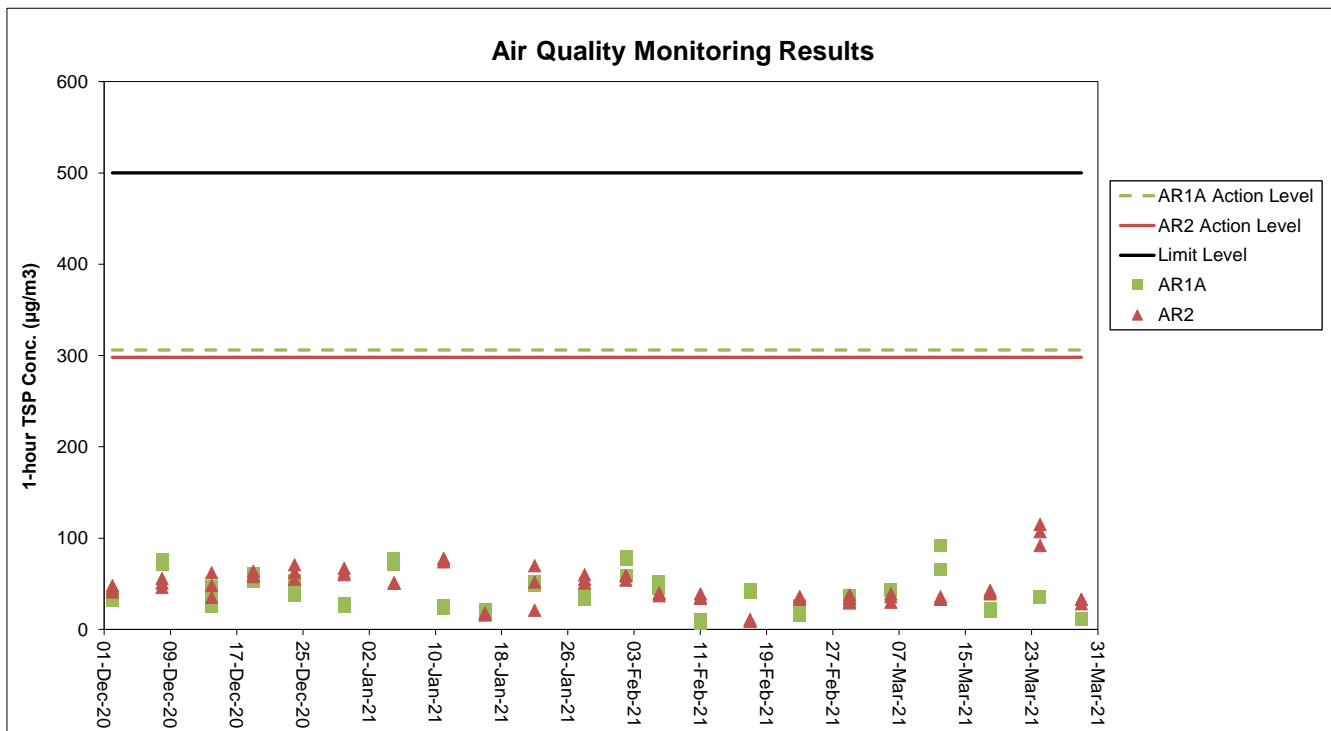
# **Air Quality Monitoring Results**

1. The key activities of the Project carried out in the reporting period included reclamation works and land-based works. Works in the reclamation areas included DCM works, marine filling, seawall and facilities construction, together with runway and associated works such as bored piling for approach lights. Land-based works on existing airport island involved mainly airfield works, foundation and substructure work for Terminal 2 expansion, modification and tunnel work for APM and BHS systems, and preparation work for utilities, with activities include site establishment, site office construction, road and drainage works, cable ducting, demolition of existing facilities, piling, and excavation works.

4. QA/ QC requirements as stipulated in the EM&A Manual were carried out during measurement.

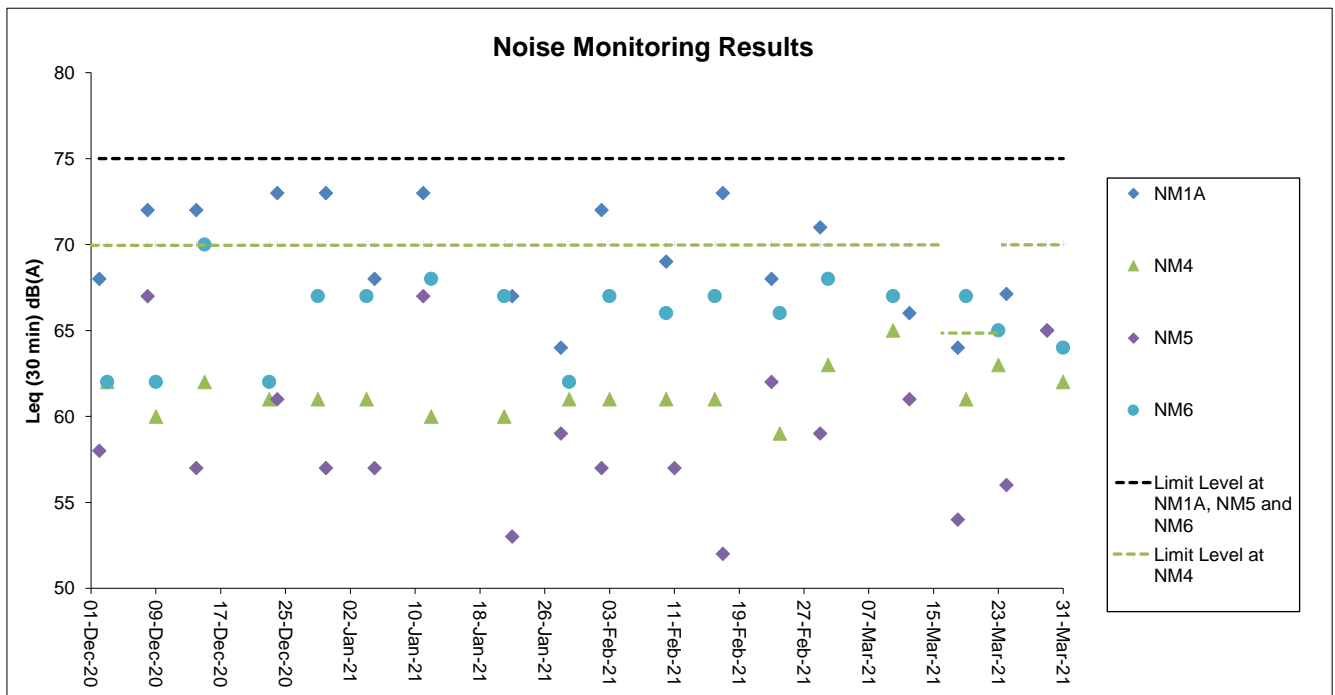
# Noise Monitoring Results

1. The Limit Level is reduced to 70dB(A) for school and 65dB(A) during school examination period at NM4. School examination took place from 18 to 24 March 2021 during this reporting period.

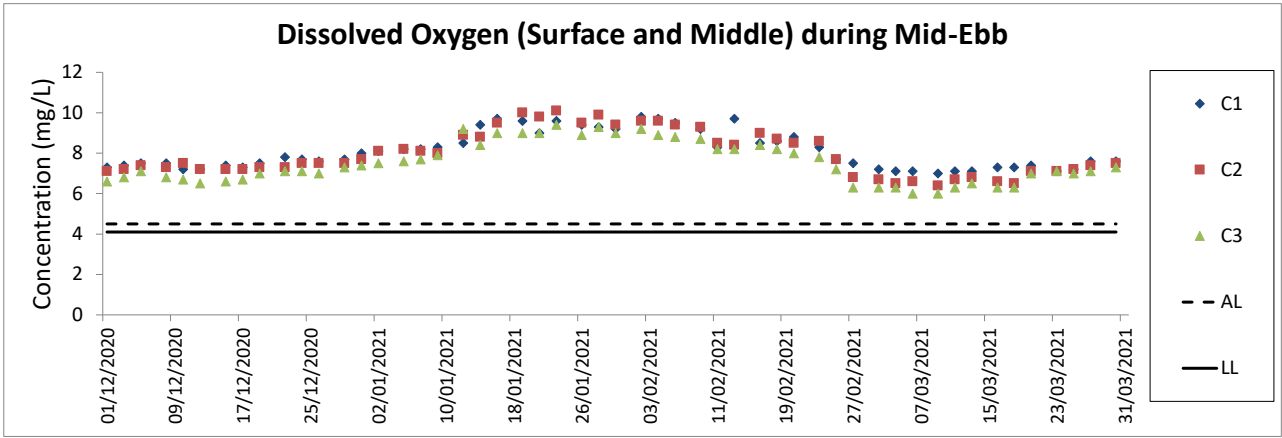
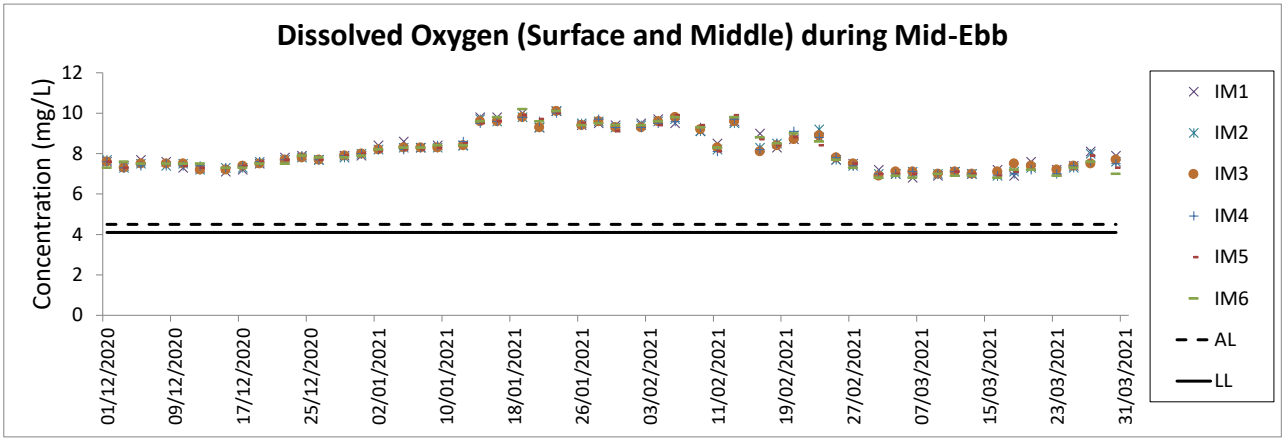
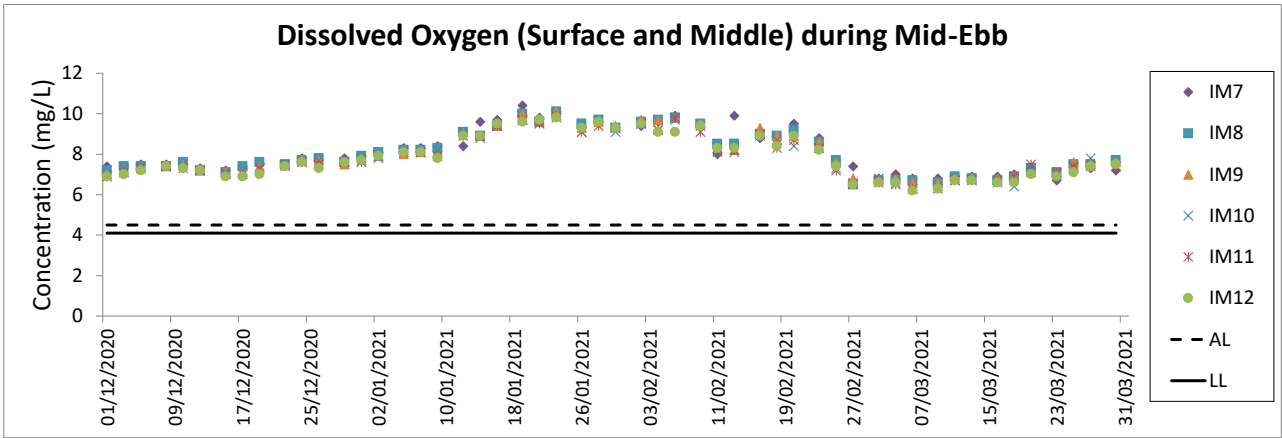
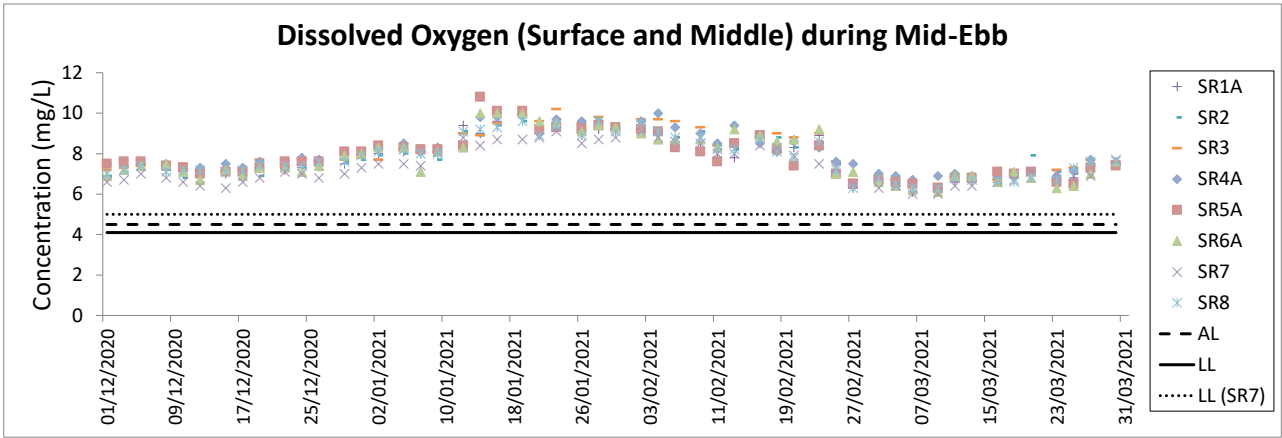
# **Water Quality Monitoring Results**

- Notes:
1. The key marine works activities of the Project during monitoring included deep cement mixing (DCM) works, marine filling, seawall and facilities construction, together with runway and associated works such as bored piling for approach lights.
  2. General weather condition during monitoring ranged from sunny to rainy, with sea condition ranged from calm to rough. Detailed meteorological conditions can be referred to Table 2.11 of this Report and corresponding Monthly EM&A Reports.
  3. QA/QC requirements as stipulated in the EM&A Manual were carried out during measurement.

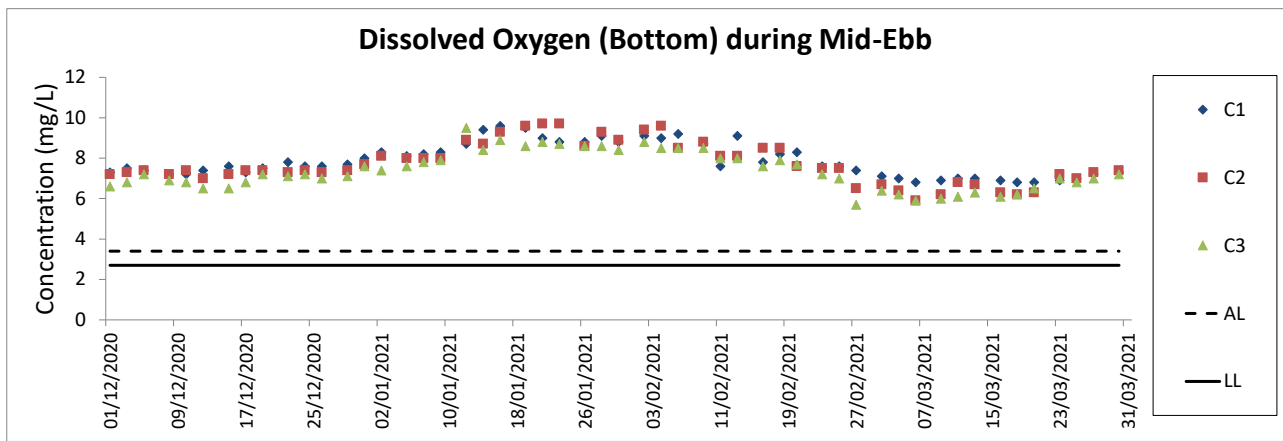
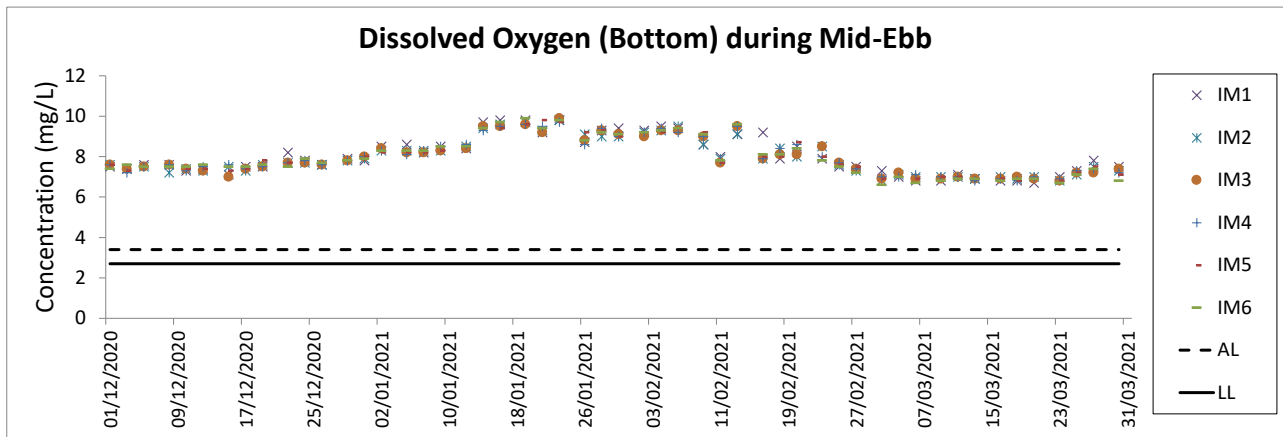
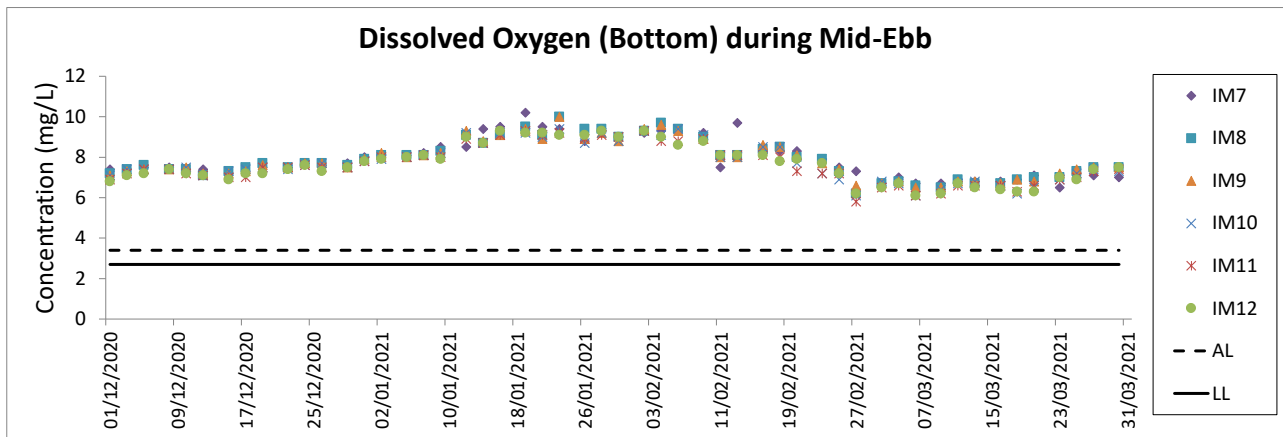
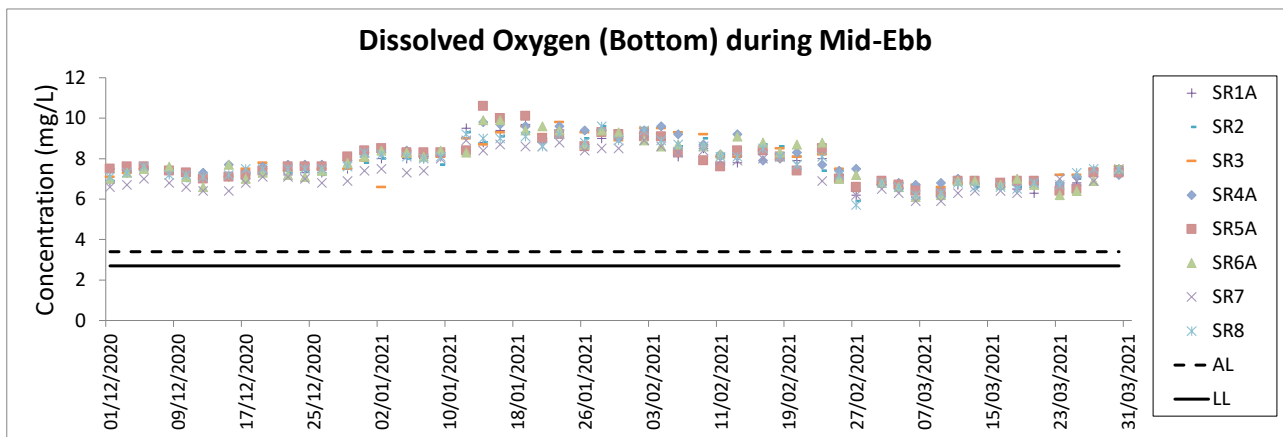
1. The key marine works activities of the Project during monitoring included deep cement mixing (DCM) works, marine filling, seawall and facilities construction, together with runway and associated works such as bored piling for approach lights.
2. General weather condition during monitoring ranged from sunny to rainy, with sea condition ranged from calm to rough. Detailed meteorological conditions can be referred to Table 2.11 of this Report and corresponding Monthly EM&A Reports.
3. QA/ QC requirements as stipulated in the EM&A Manual were carried out during measurement.

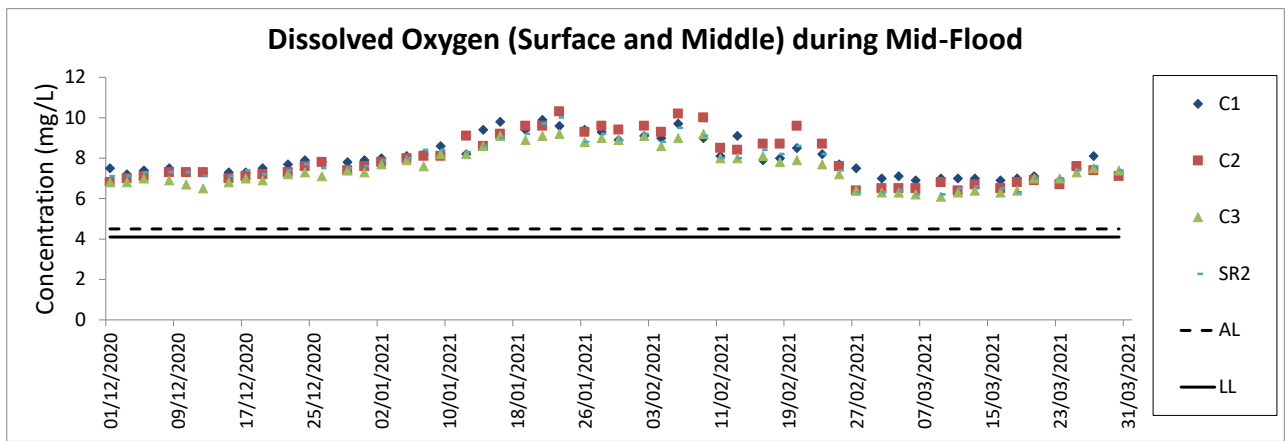
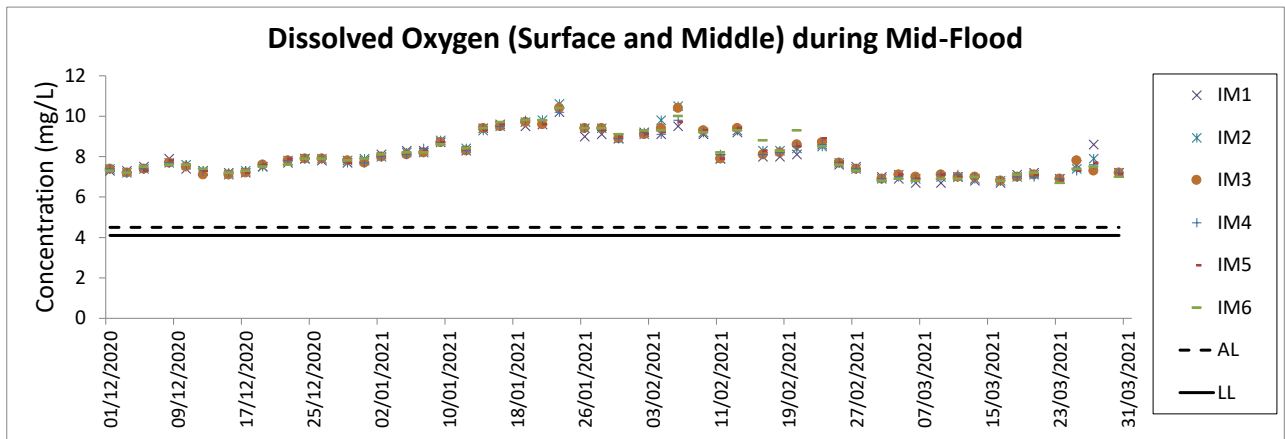
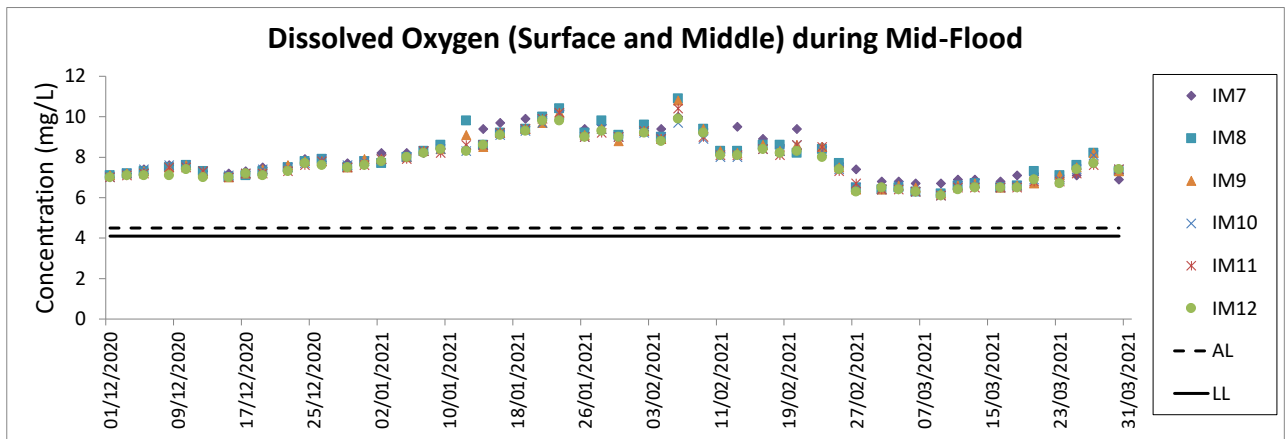
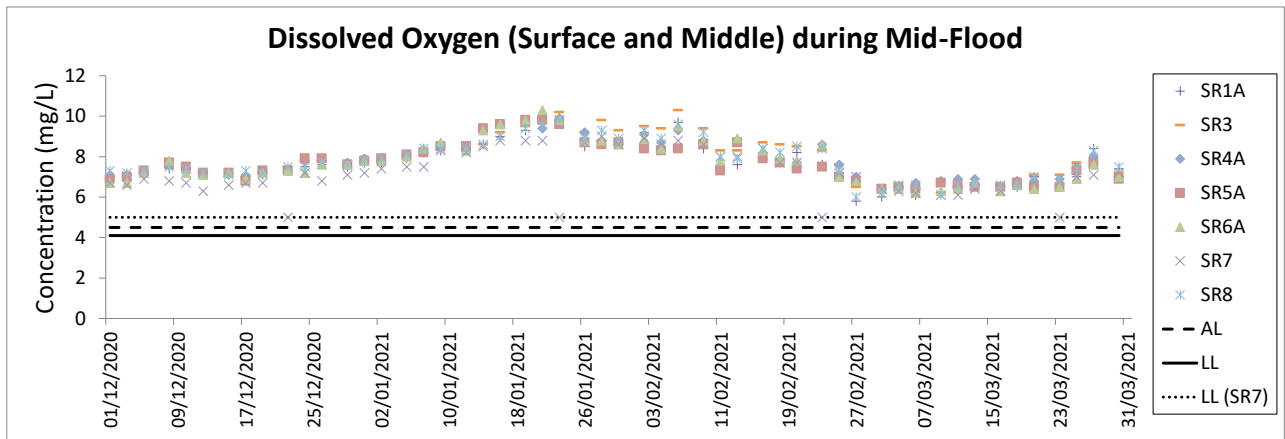
- Notes:
1. The key marine works activities of the Project during monitoring included deep cement mixing (DCM) works, marine filling, seawall and facilities construction, together with runway and associated works such as bored piling for approach lights.
  2. General weather condition during monitoring ranged from sunny to rainy, with sea condition ranged from calm to rough. Detailed meteorological conditions can be referred to Table 2.11 of this Report and corresponding Monthly EM&A Reports.
  3. QA/QC requirements as stipulated in the EM&A Manual were carried out during measurement.

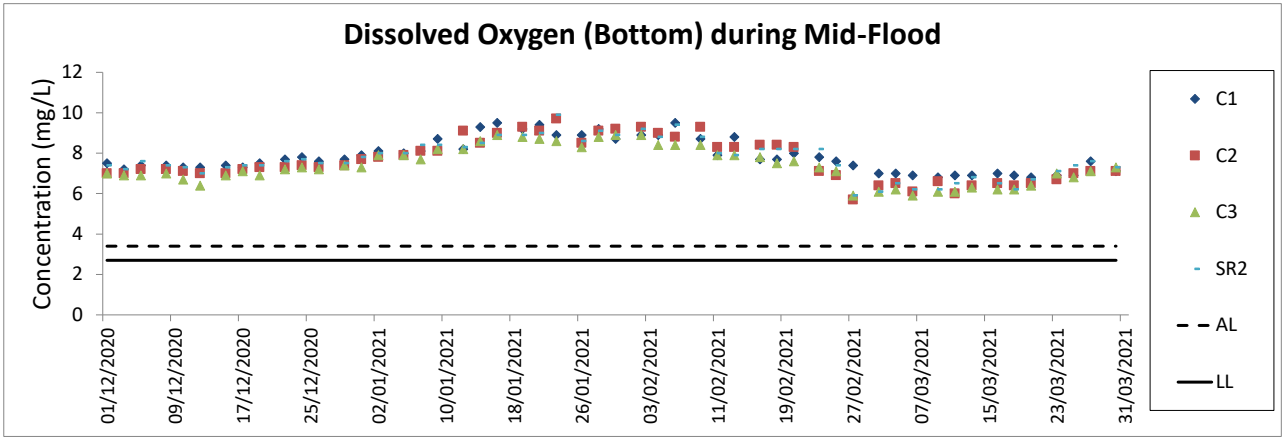
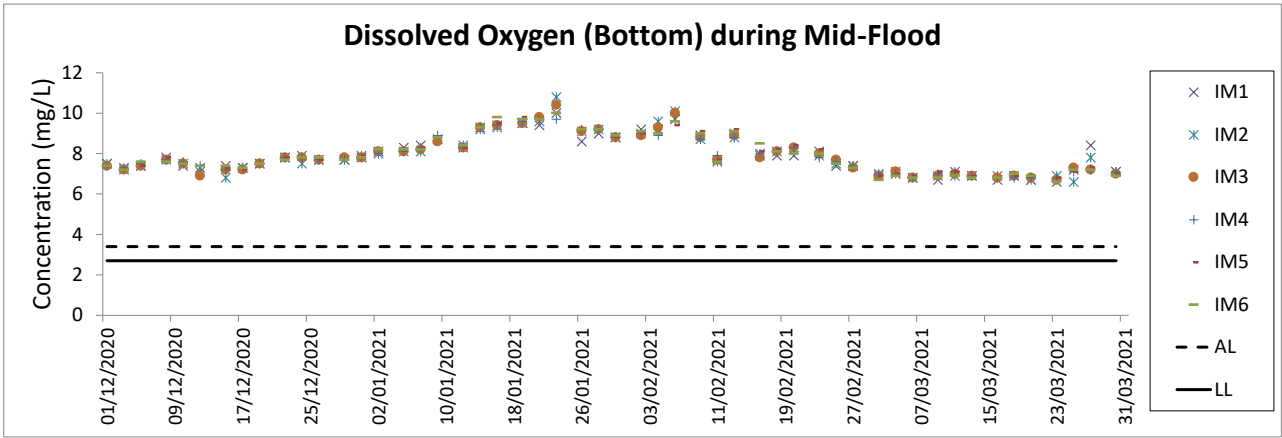
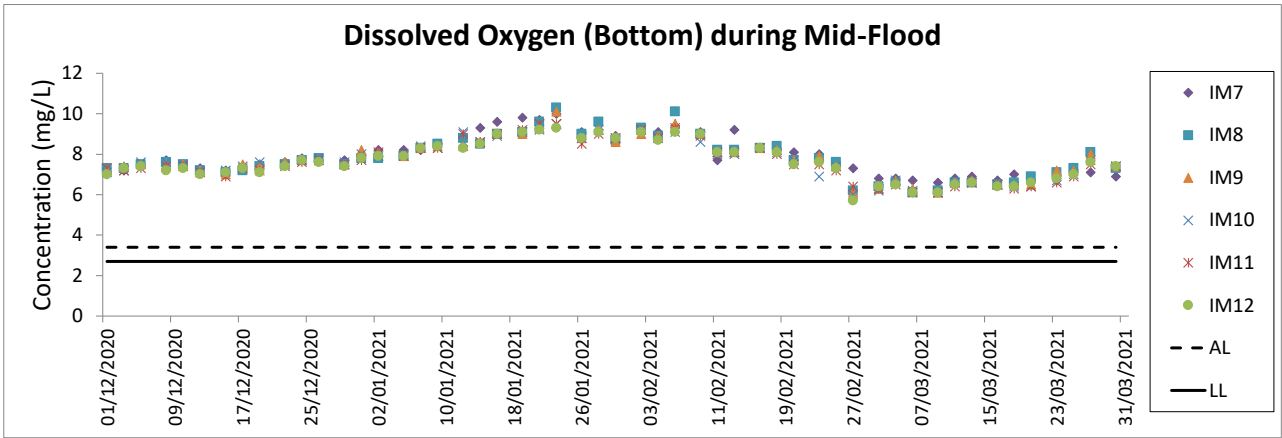
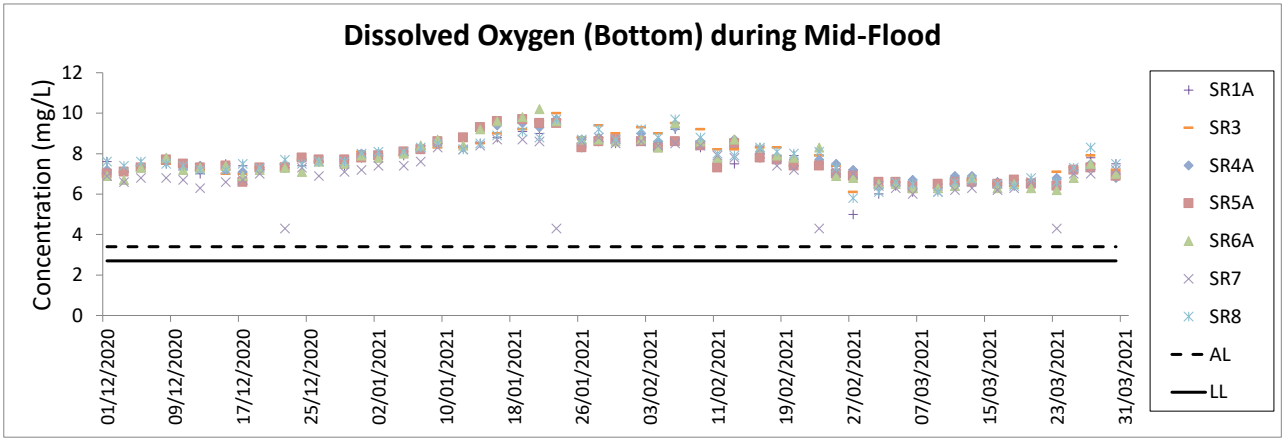
1. The key marine works activities of the Project during monitoring included deep cement mixing (DCM) works, marine filling, seawall and facilities construction, together with runway and associated works such as bored piling for approach lights.
2. General weather condition during monitoring ranged from sunny to rainy, with sea condition ranged from calm to rough. Detailed meteorological conditions can be referred to Table 2.11 of this Report and corresponding Monthly EM&A Reports.
3. QA/ QC requirements as stipulated in the EM&A Manual were carried out during measurement.
