# **Expansion of Hong Kong International Airport into a Three-Runway System**

Construction Phase Quarterly EM&A Report  
No.21 (1 January to 31 March 2021)

June 2021

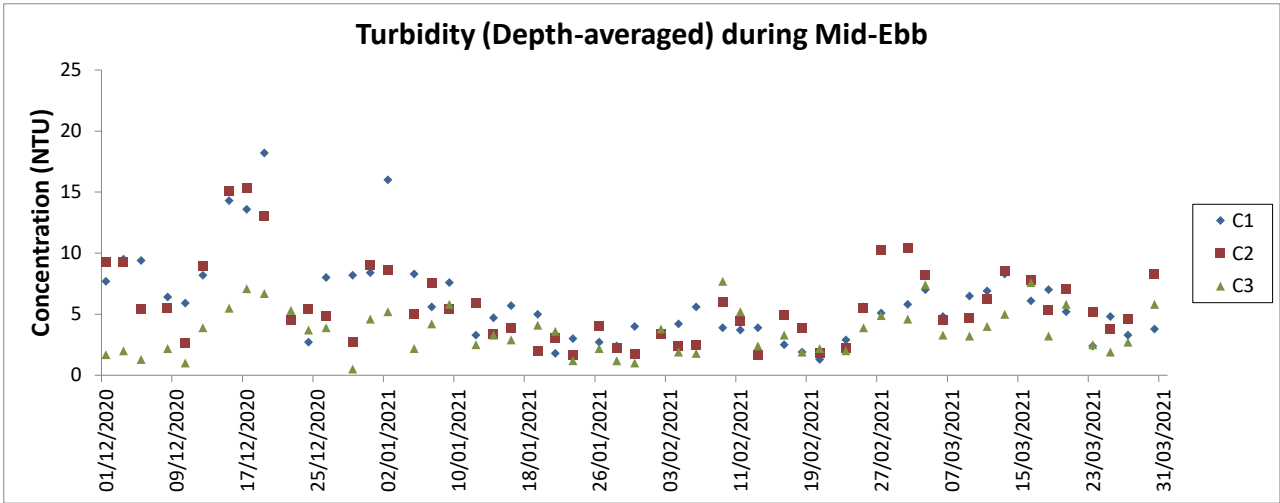
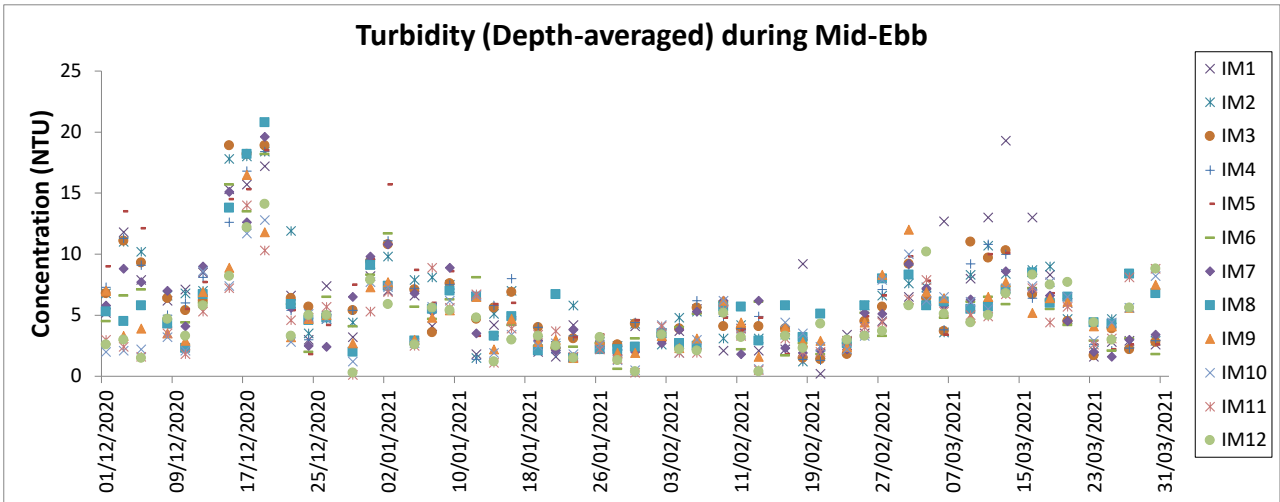
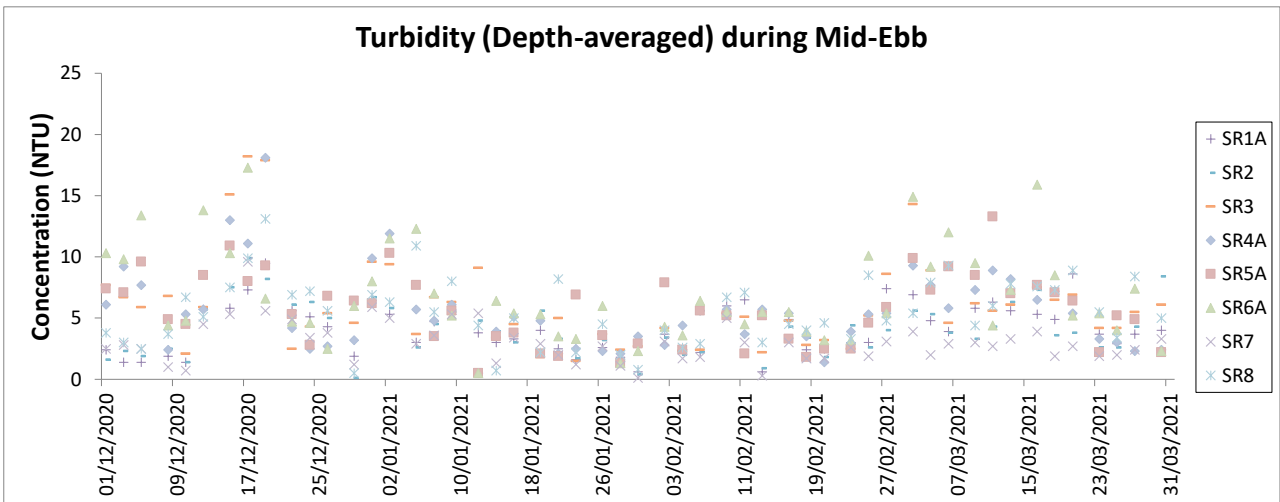
- Notes:
1. The Action and Limit Levels can be referred to Table 2.8 of this Report.
  2. The key marine works activities of the Project during monitoring included deep cement mixing (DCM) works, marine filling, seawall and facilities construction, together with runway and associated works such as bored piling for approach lights.
  3. General weather condition during monitoring ranged from sunny to rainy, with sea condition ranged from calm to rough. Detailed meteorological conditions can be referred to Table 2.11 of this Report and corresponding Monthly EM&A Reports.
  4. QA/ QC requirements as stipulated in the EM&A Manual were carried out during measurement.

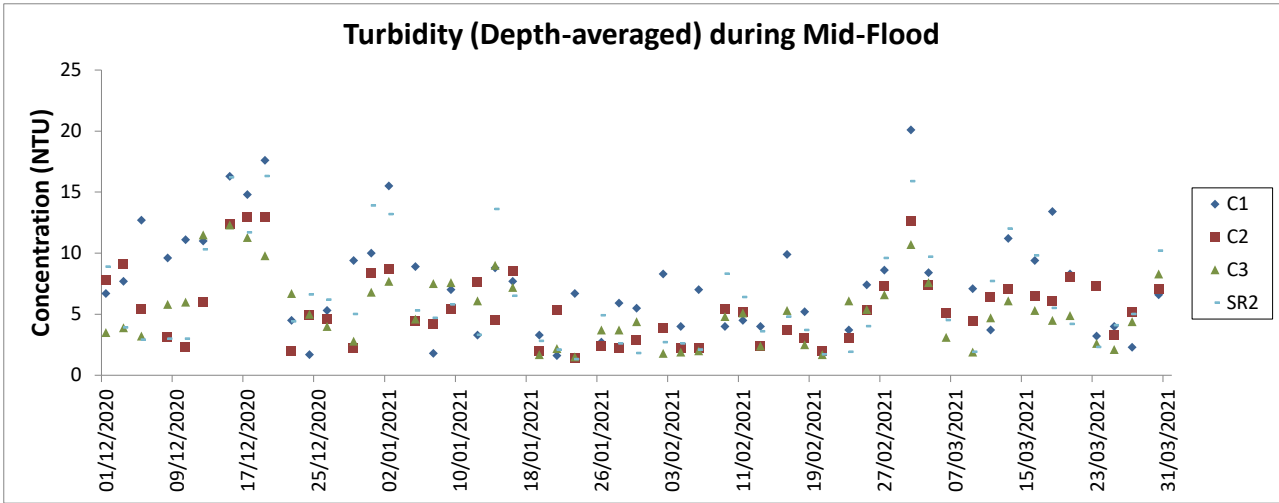
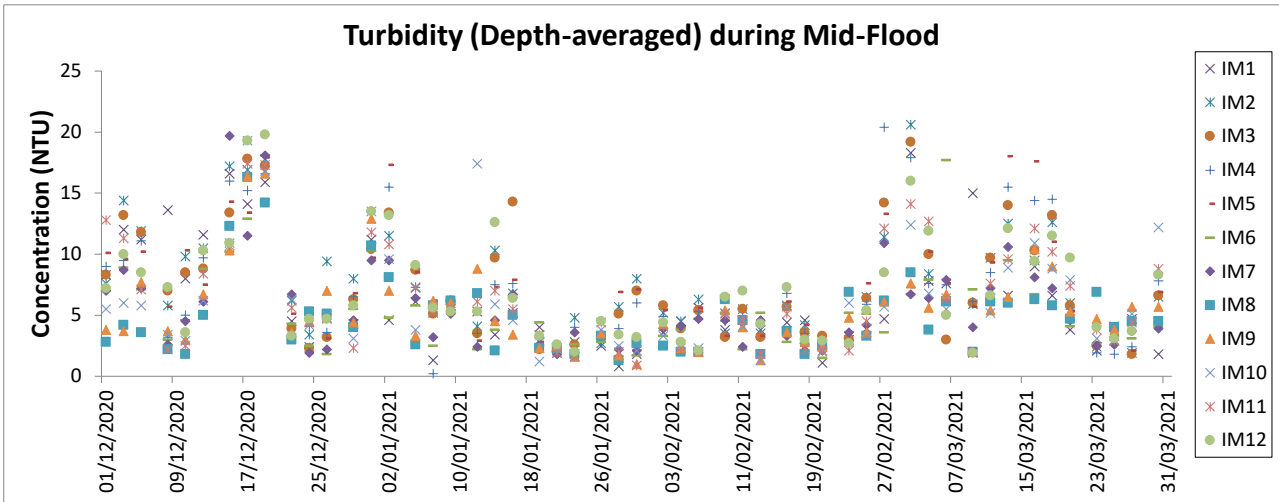
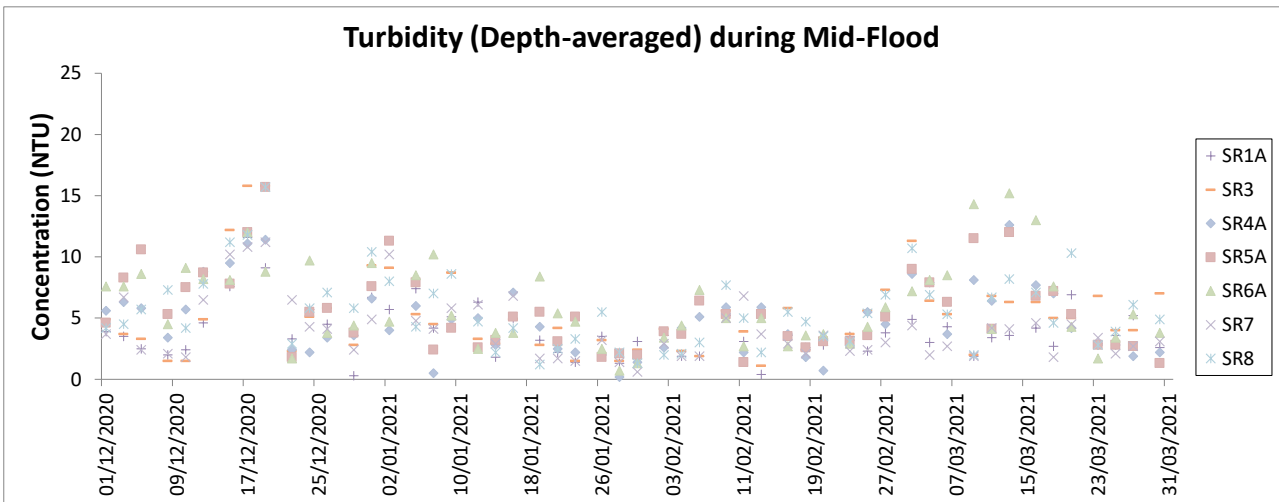
- Notes:
1. The Action and Limit Levels can be referred to Table 2.8 of this Report.
  2. The key marine works activities of the Project during monitoring included deep cement mixing (DCM) works, marine filling, seawall and facilities construction, together with runway and associated works such as bored piling for approach lights.
  3. General weather condition during monitoring ranged from sunny to rainy, with sea condition ranged from calm to rough. Detailed meteorological conditions can be referred to Table 2.11 of this Report and corresponding Monthly EM&A Reports.
  4. QA/ QC requirements as stipulated in the EM&A Manual were carried out during measurement.

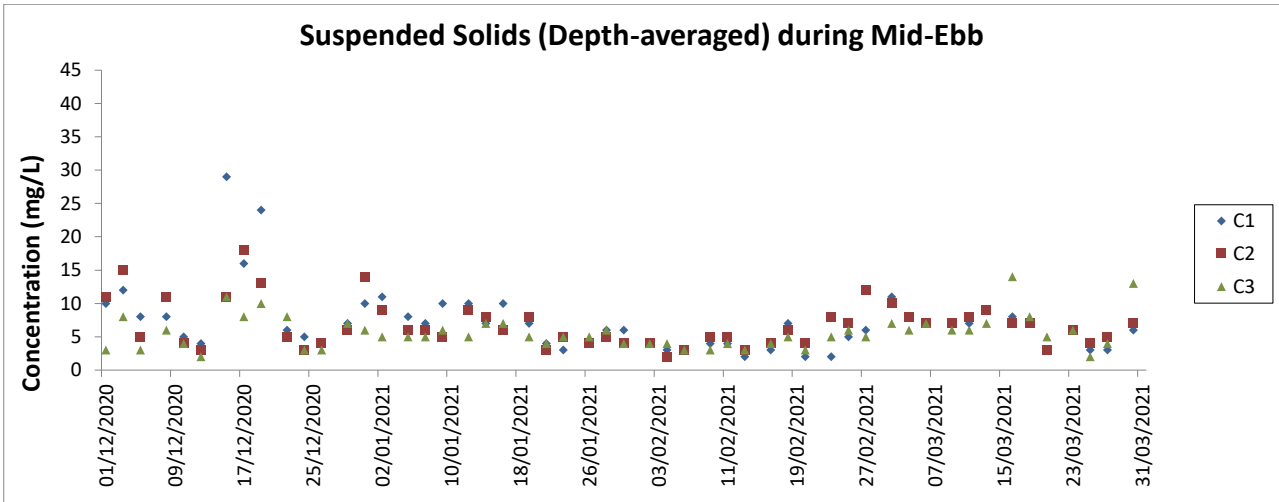
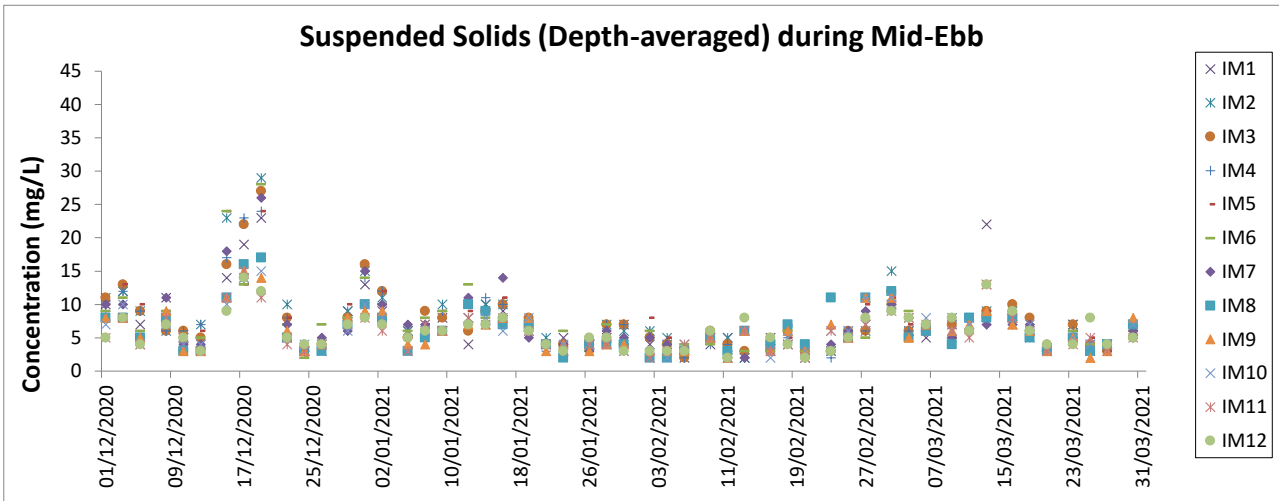
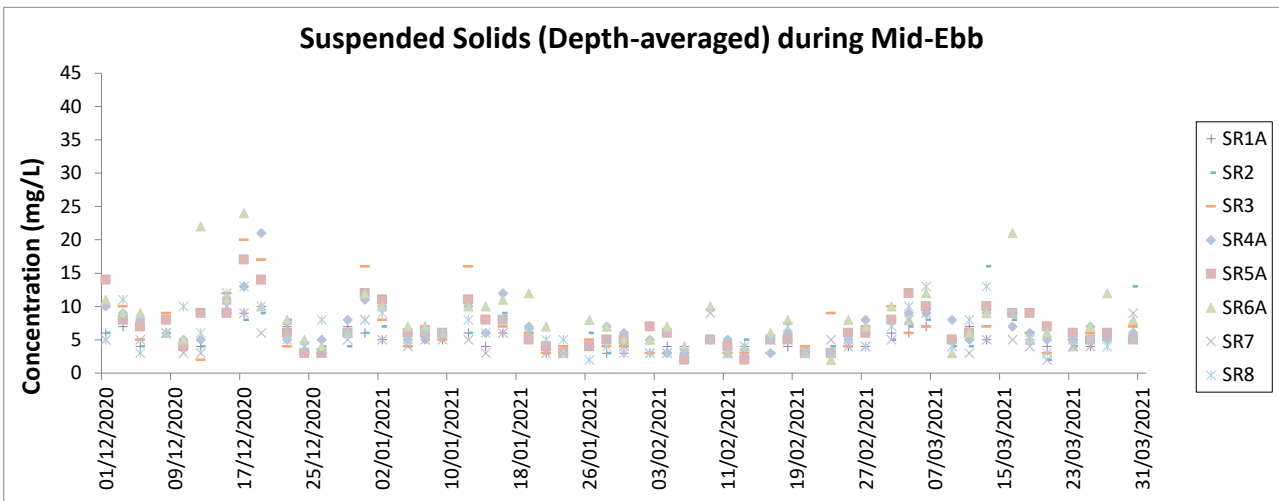
- Notes:
1. The Action and Limit Levels can be referred to Table 2.8 of this Report.
  2. The key marine works activities of the Project during monitoring included deep cement mixing (DCM) works, marine filling, seawall and facilities construction, together with runway and associated works such as bored piling for approach lights.
  3. General weather condition during monitoring ranged from sunny to rainy, with sea condition ranged from calm to rough. Detailed meteorological conditions can be referred to Table 2.11 of this Report and corresponding Monthly EM&A Reports.
  4. QA/ QC requirements as stipulated in the EM&A Manual were carried out during measurement.

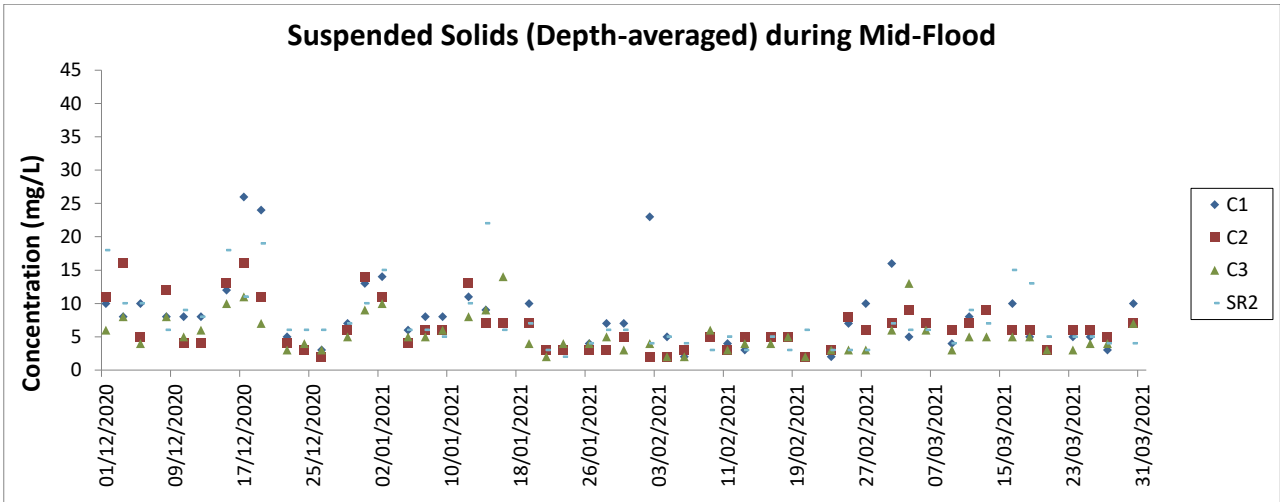
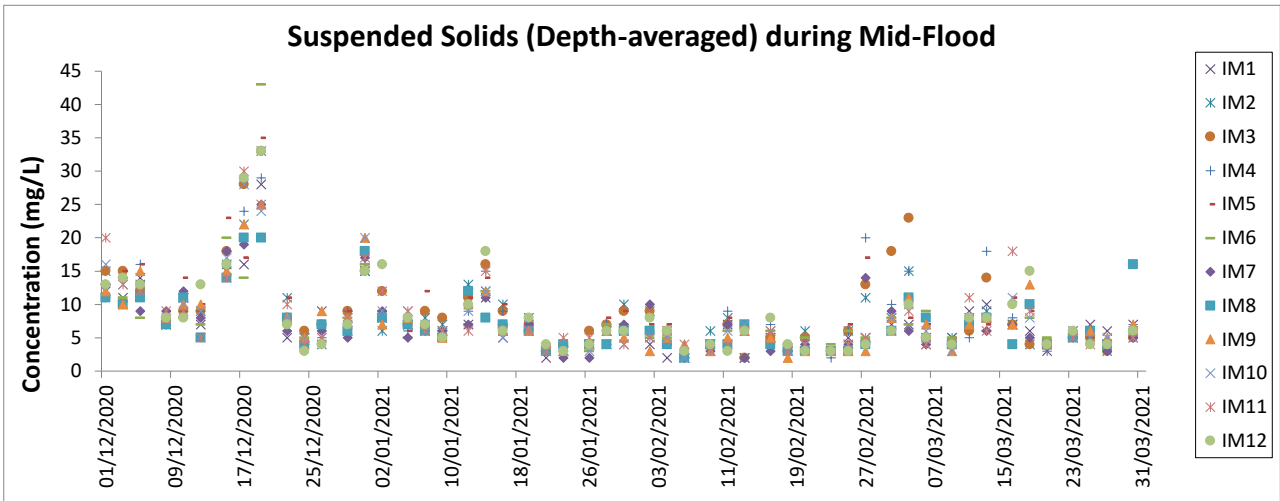
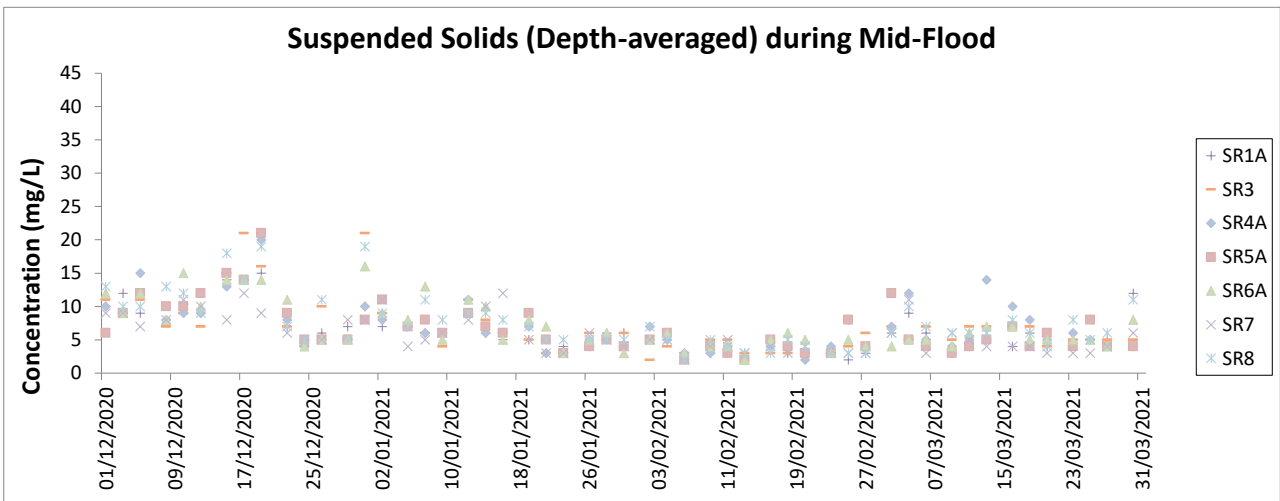
- Notes:
1. The Action and Limit Levels can be referred to Table 2.8 of this Report.
  2. The key marine works activities of the Project during monitoring included deep cement mixing (DCM) works, marine filling, seawall and facilities construction, together with runway and associated works such as bored piling for approach lights.
  3. General weather condition during monitoring ranged from sunny to rainy, with sea condition ranged from calm to rough. Detailed meteorological conditions can be referred to Table 2.11 of this Report and corresponding Monthly EM&A Reports.
  4. QA/ QC requirements as stipulated in the EM&A Manual were carried out during measurement.

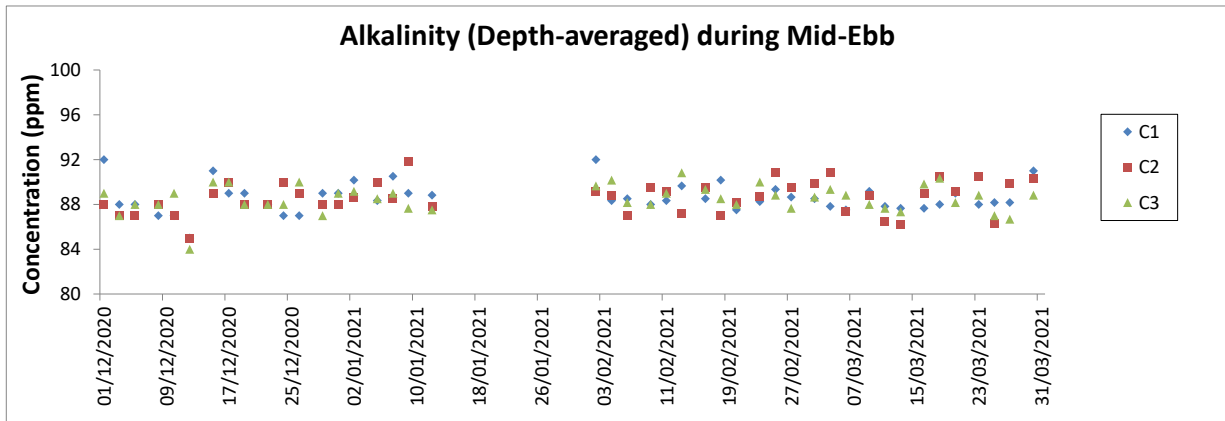
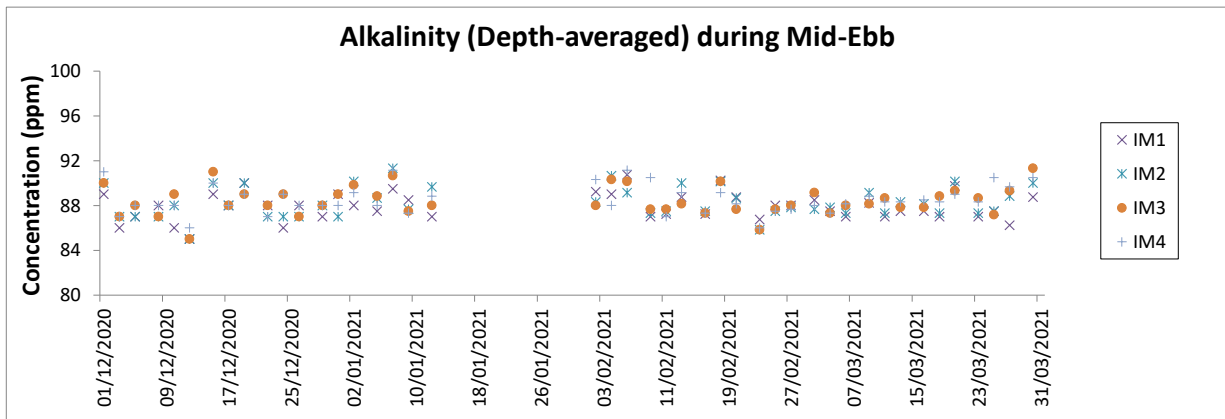
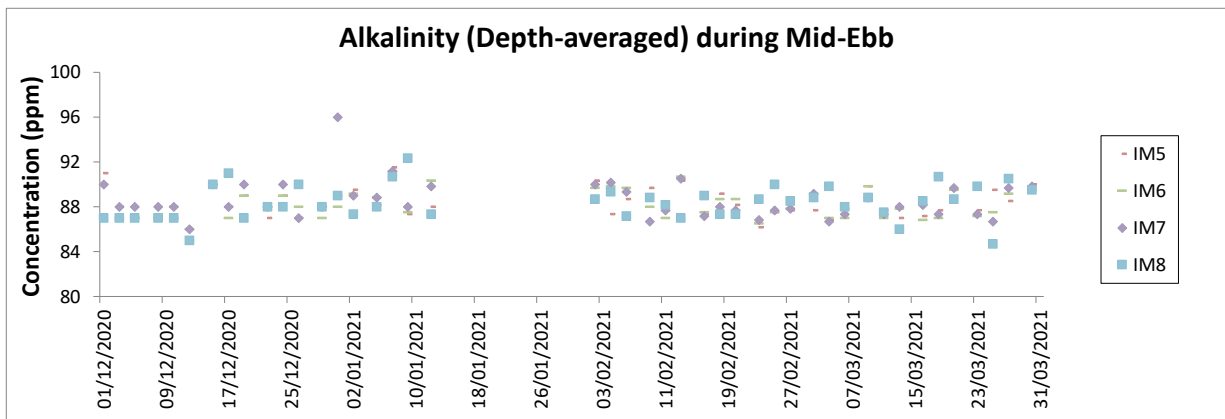
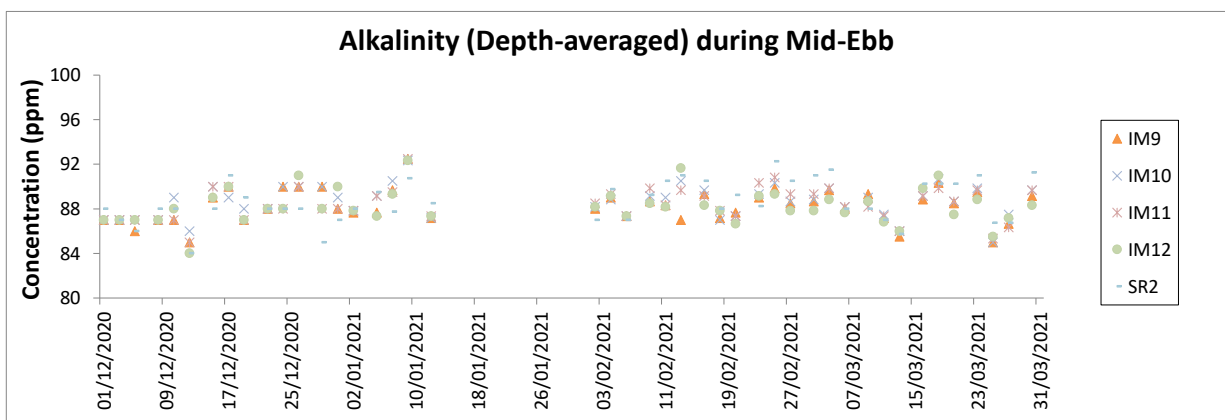
1. The Action and Limit Levels can be referred to Table 2.8 of this Report.
2. The key marine works activities of the Project during monitoring included deep cement mixing (DCM) works, marine filling, seawall and facilities construction, together with runway and associated works such as bored piling for approach lights.
3. General weather condition during monitoring ranged from sunny to rainy, with sea condition ranged from calm to rough. Detailed meteorological conditions can be referred to Table 2.11 of this Report and corresponding Monthly EM&A Reports.
4. QA/ QC requirements as stipulated in the EM&A Manual were carried out during measurement.
5. In view of the construction programme for marine-based DCM works, regular DCM monitoring, which was ceased since 14 January 2021, was resumed at all monitoring stations starting from 2 February 2021.

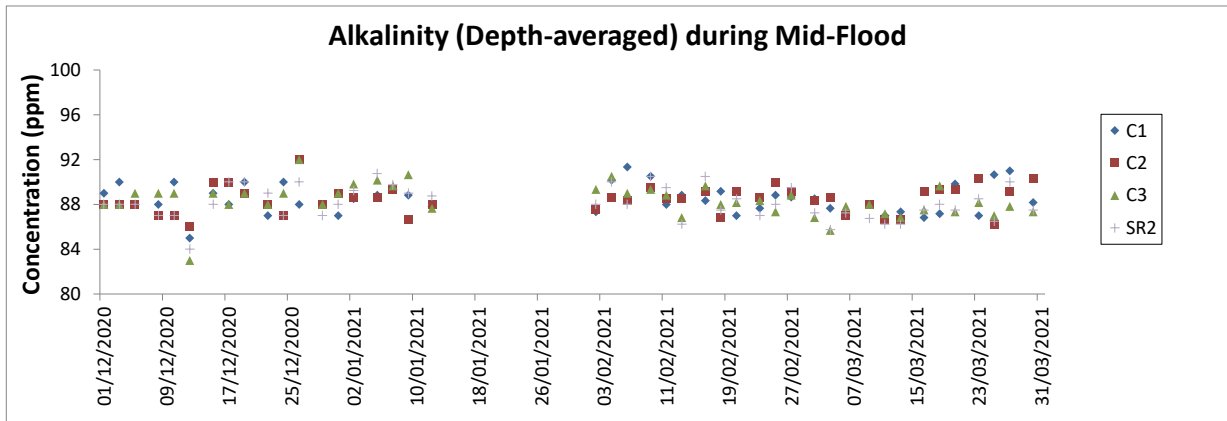
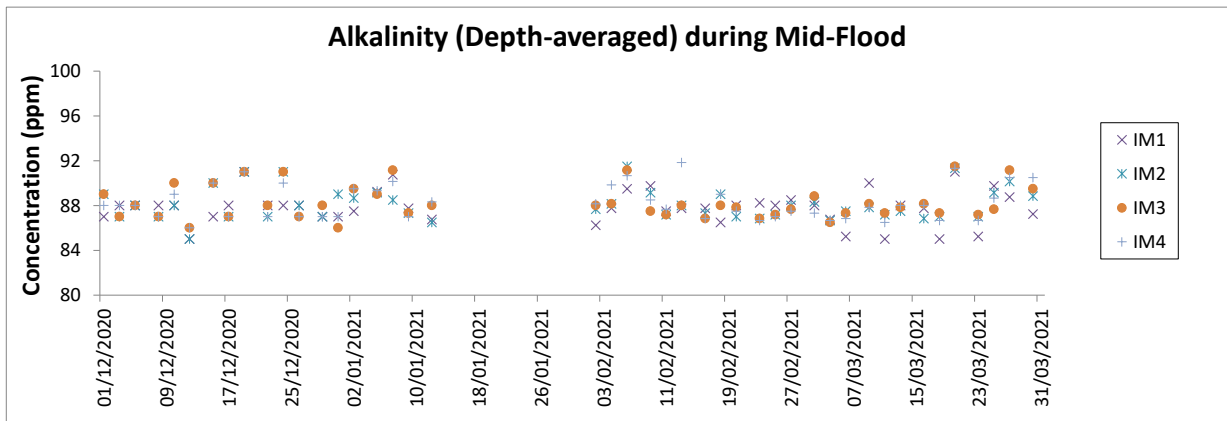
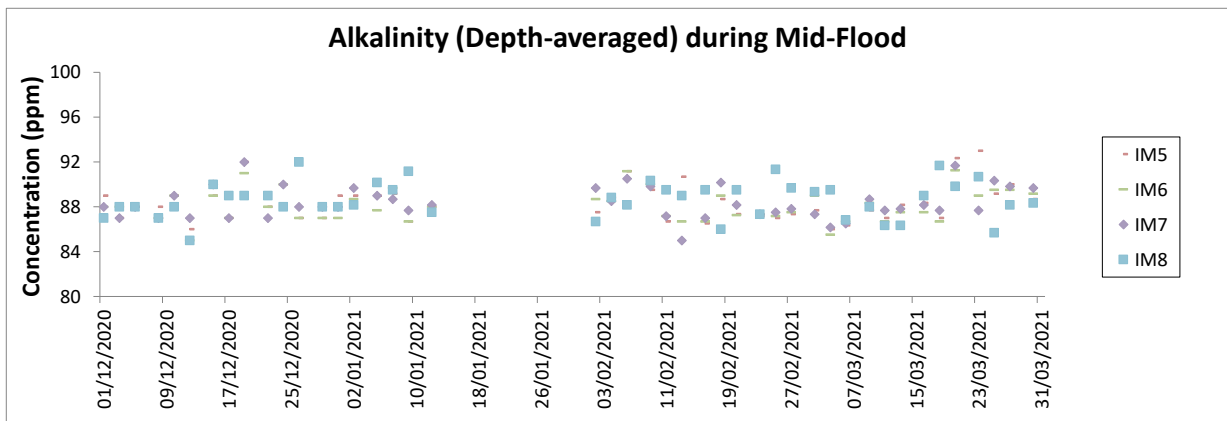
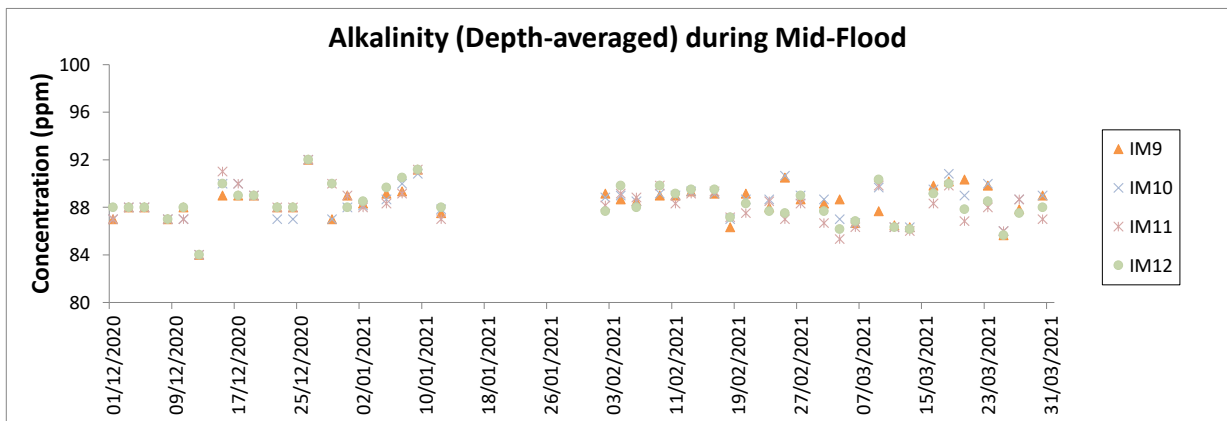
1. The Action and Limit Levels can be referred to Table 2.8 of this Report.
2. The key marine works activities of the Project during monitoring included deep cement mixing (DCM) works, marine filling, seawall and facilities construction, together with runway and associated works such as bored piling for approach lights.
3. General weather condition during monitoring ranged from sunny to rainy, with sea condition ranged from calm to rough. Detailed meteorological conditions can be referred to Table 2.11 of this Report and corresponding Monthly EM&A Reports.
4. QA/ QC requirements as stipulated in the EM&A Manual were carried out during measurement.
5. In view of the construction programme for marine-based DCM works, regular DCM monitoring, which was ceased since 14 January 2021, was resumed at all monitoring stations starting from 2 February 2021.

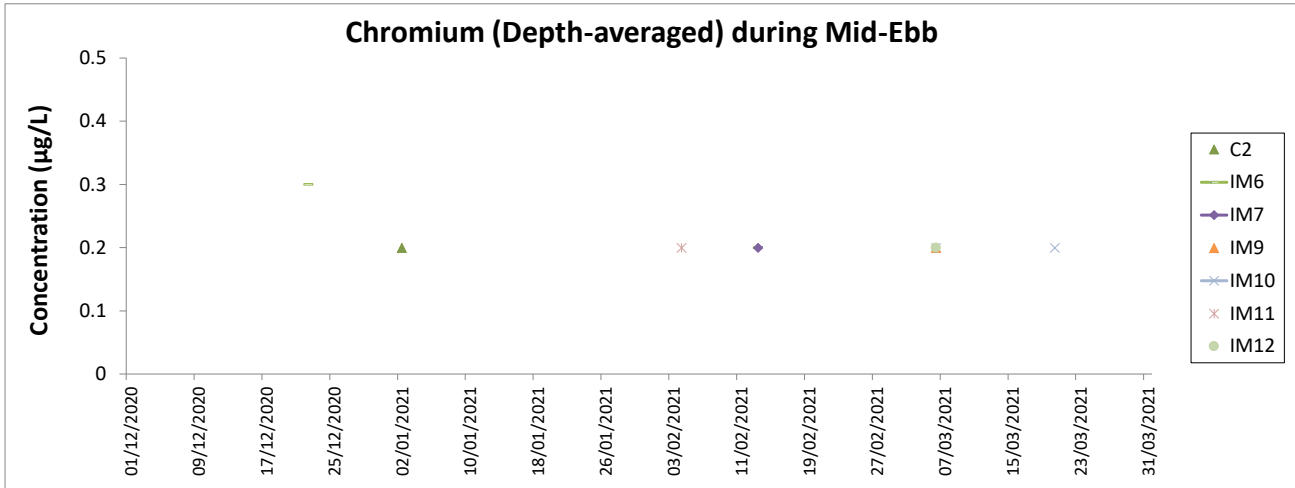
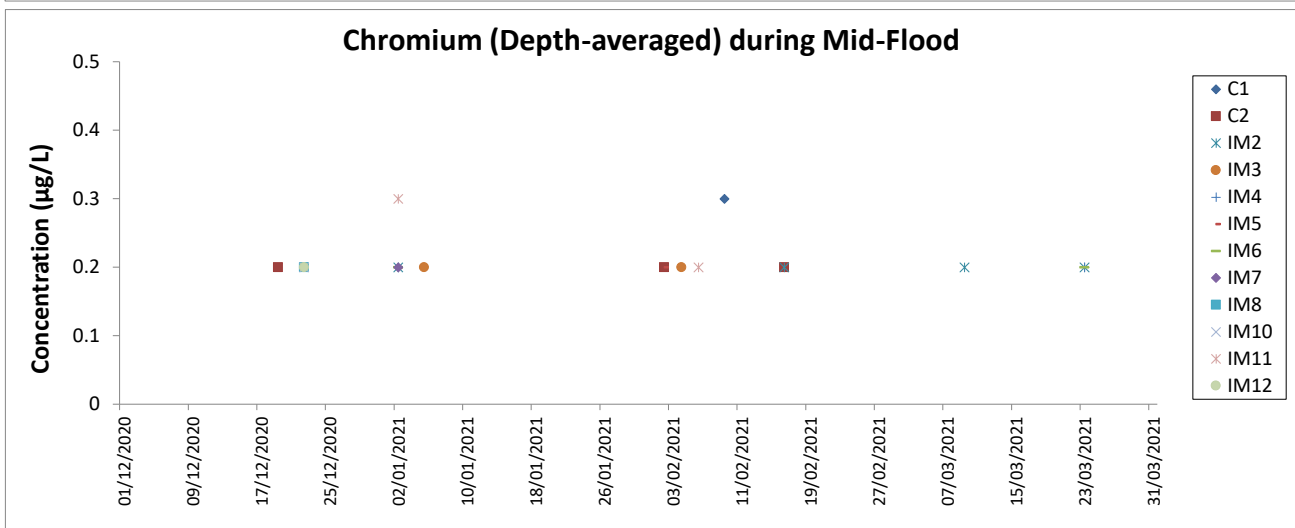
1. The Action and Limit Levels can be referred to Table 2.8 of this Report.
2. The monitoring results of chromium not presented above were below the reporting limit of 0.2 µg/L.

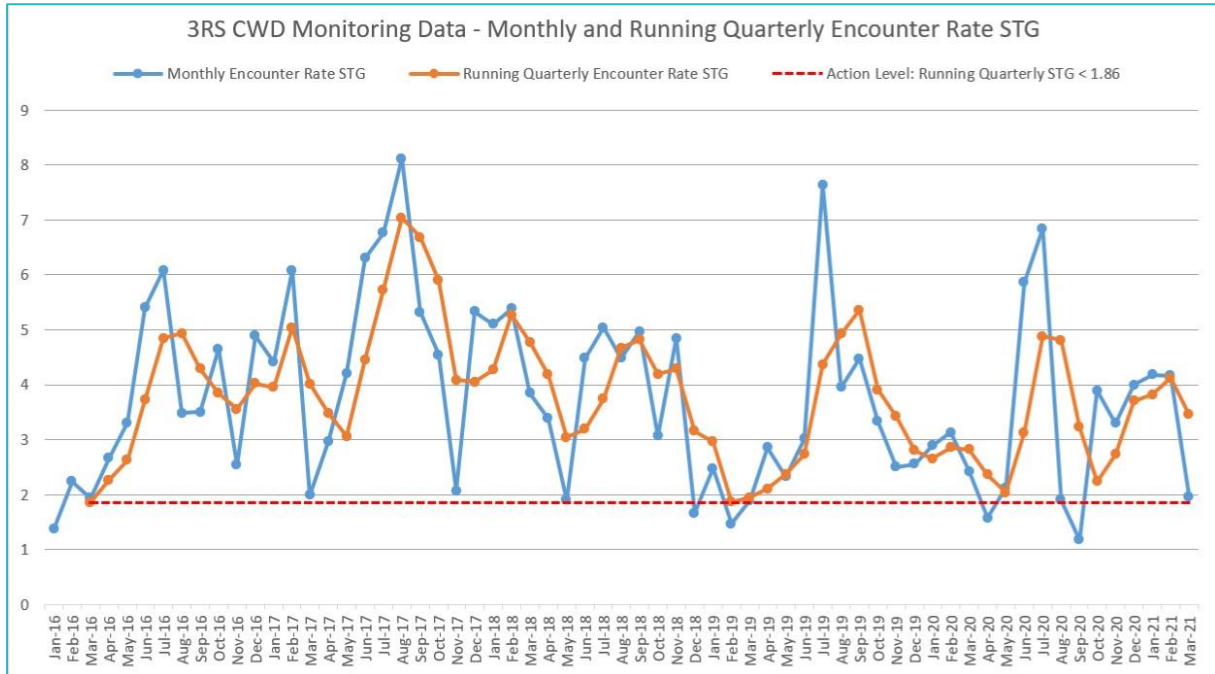
**Encounter Rate STG:**

**Graphical Presentation of Monthly and Running Quarterly Encounter Rates for the entire monitoring period**
