# **Expansion of Hong Kong International Airport into a Three-Runway System**

Construction Phase Quarterly EM&A Report  
No.26 (1 April to 30 June 2022)

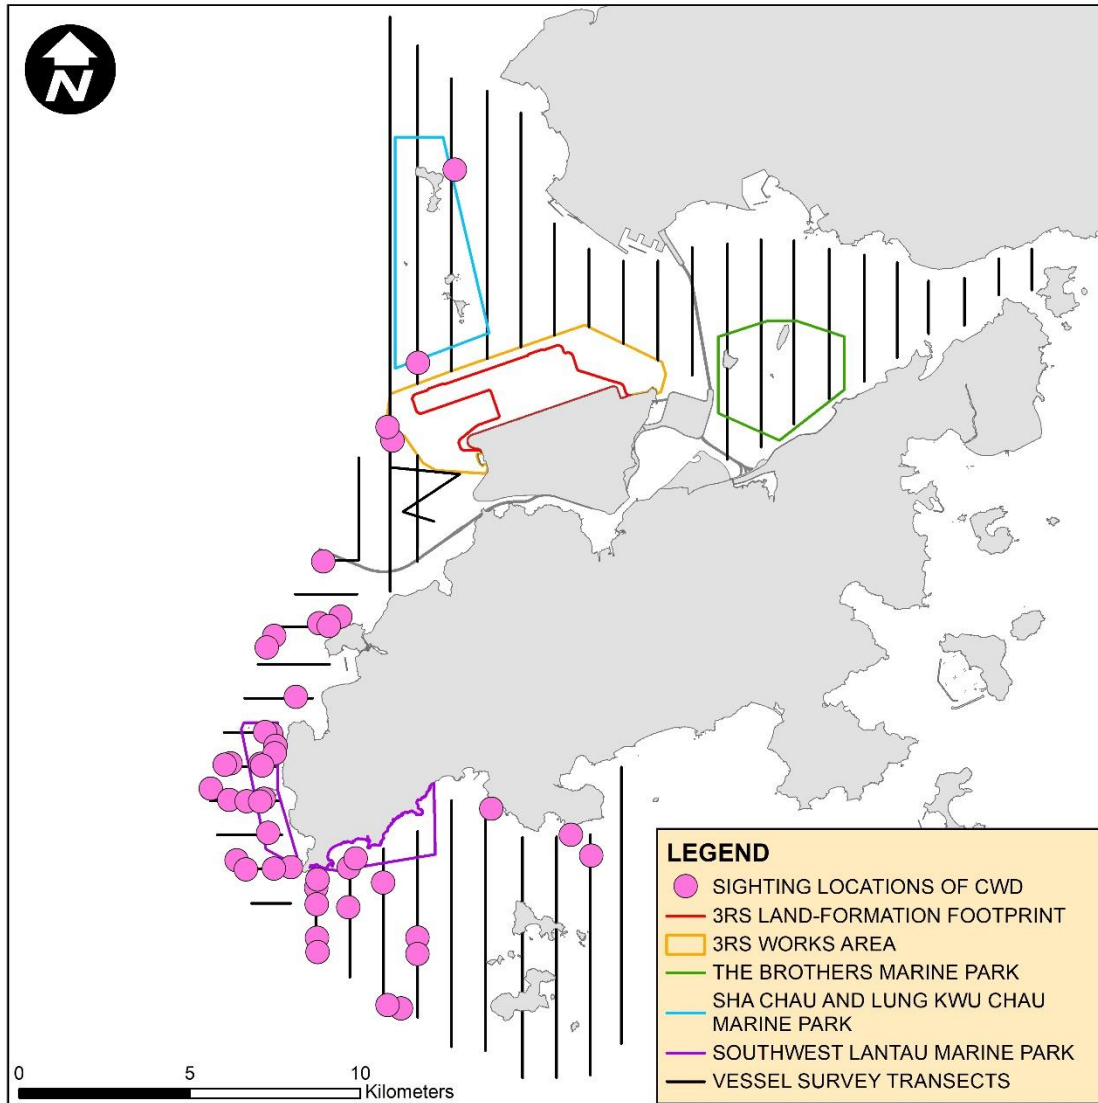
**Figure 2.5: Sightings Distribution of Chinese White Dolphins from April to June 2022**

The distribution of CWD sightings recorded from April to June 2022 is illustrated in **Figure 2.5**. In NWL, there were CWD sightings recorded near SCLKCMP, as well as waters to the west of 3RS area. In WL, CWD sightings were scattered amongst the entire survey area from North of Tai O to Fan Lau, with relatively more sightings clustered around Peaked Hill. In SWL, CWD sightings were mostly recorded in the northwestern part of the survey area around Fan Lau, with few sightings located to the west of the Soko Islands and around Lo Kei Wan. No CWD sightings were recorded in NEL survey area during the reporting period. Details of the sighting data are presented in **Appendix C**.

Remarks: (1) Please note that there are 45 pink circles on the map indicating the sighting locations of CWD. Some of them were very close to each other and therefore appear overlapped on this sighting distribution map. (2) Marine park excludes land area and the landward boundary generally follows the high water mark along the coastline.

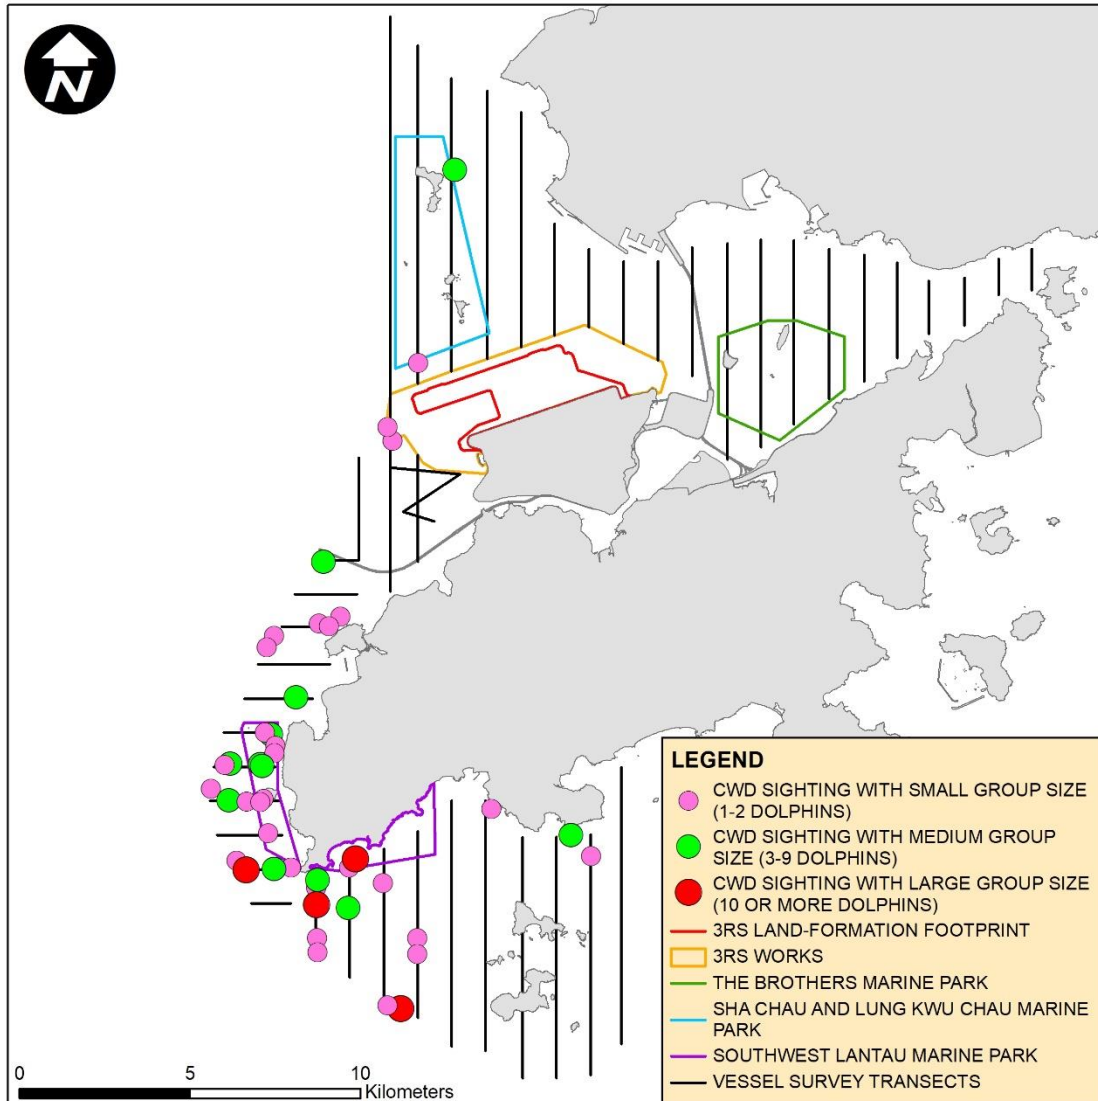
**Figure 2.6: Sighting Locations of Chinese White Dolphins with Different Group Sizes**

There are no observable differences in the distribution pattern between small-sized and medium-sized dolphin groups in WL and SWL as they all scattered. In NWL, small-sized dolphin groups appeared to distribute closer to the 3RS area. Sighting locations of CWD groups with different group sizes are depicted in **Figure 2.6**.

Remarks: (1) Please note that there are 45 circles on the map indicating the sighting locations of CWD. Some of them were very close to each other and therefore appear overlapped on this sighting distribution map. (2) Marine park excludes land area and the landward boundary generally follows the high water mark along the coastline.

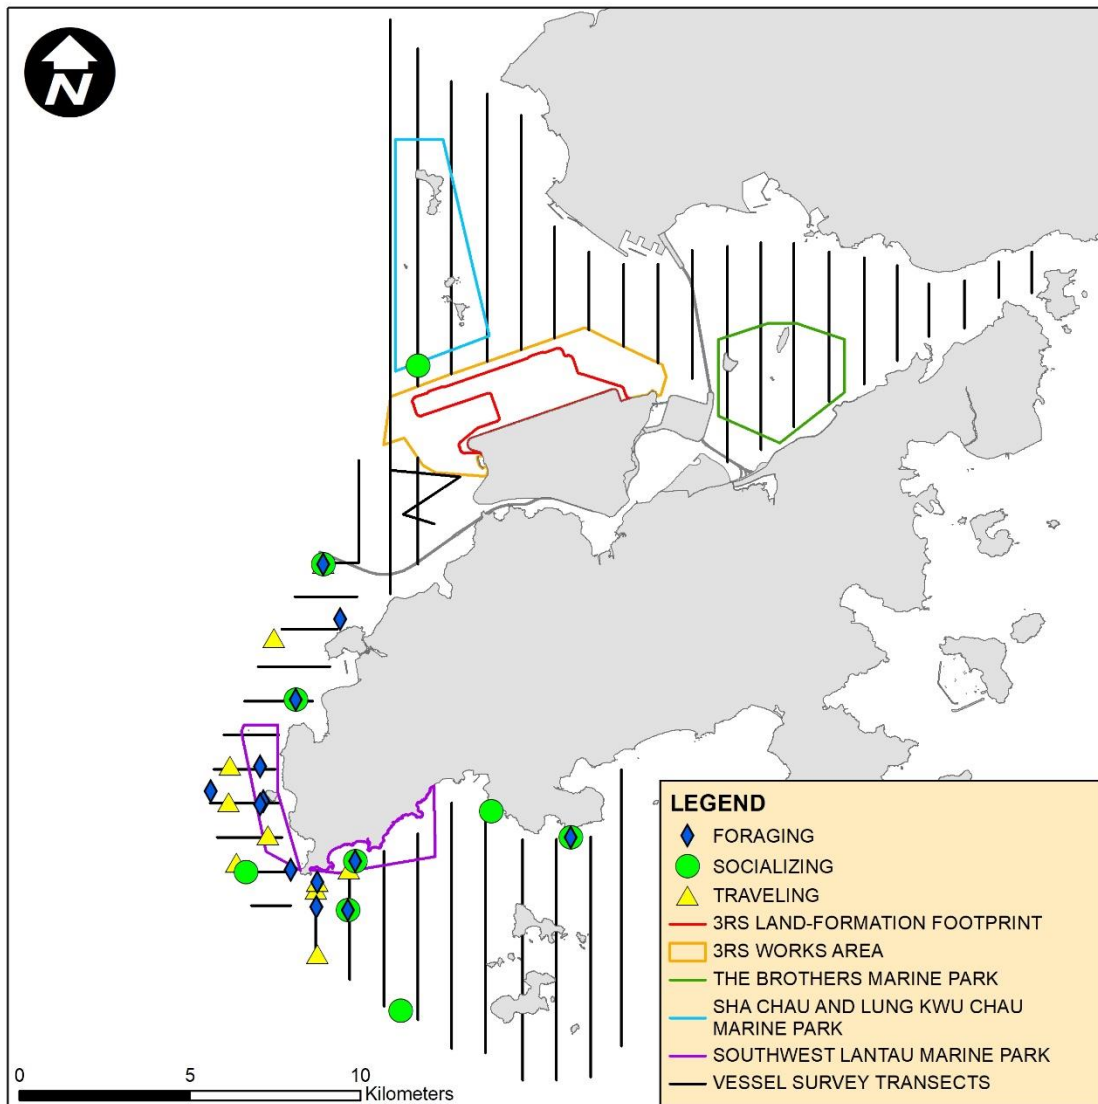
**Figure 2.7: Sighting Locations of Chinese White Dolphins Engaged in Different Behaviours**

The sighting locations of CWDs engaged in different behaviours during the current reporting period are illustrated in **Figure 2.7**.

Remarks: Marine park excludes land area and the landward boundary generally follows the high water mark along the coastline.

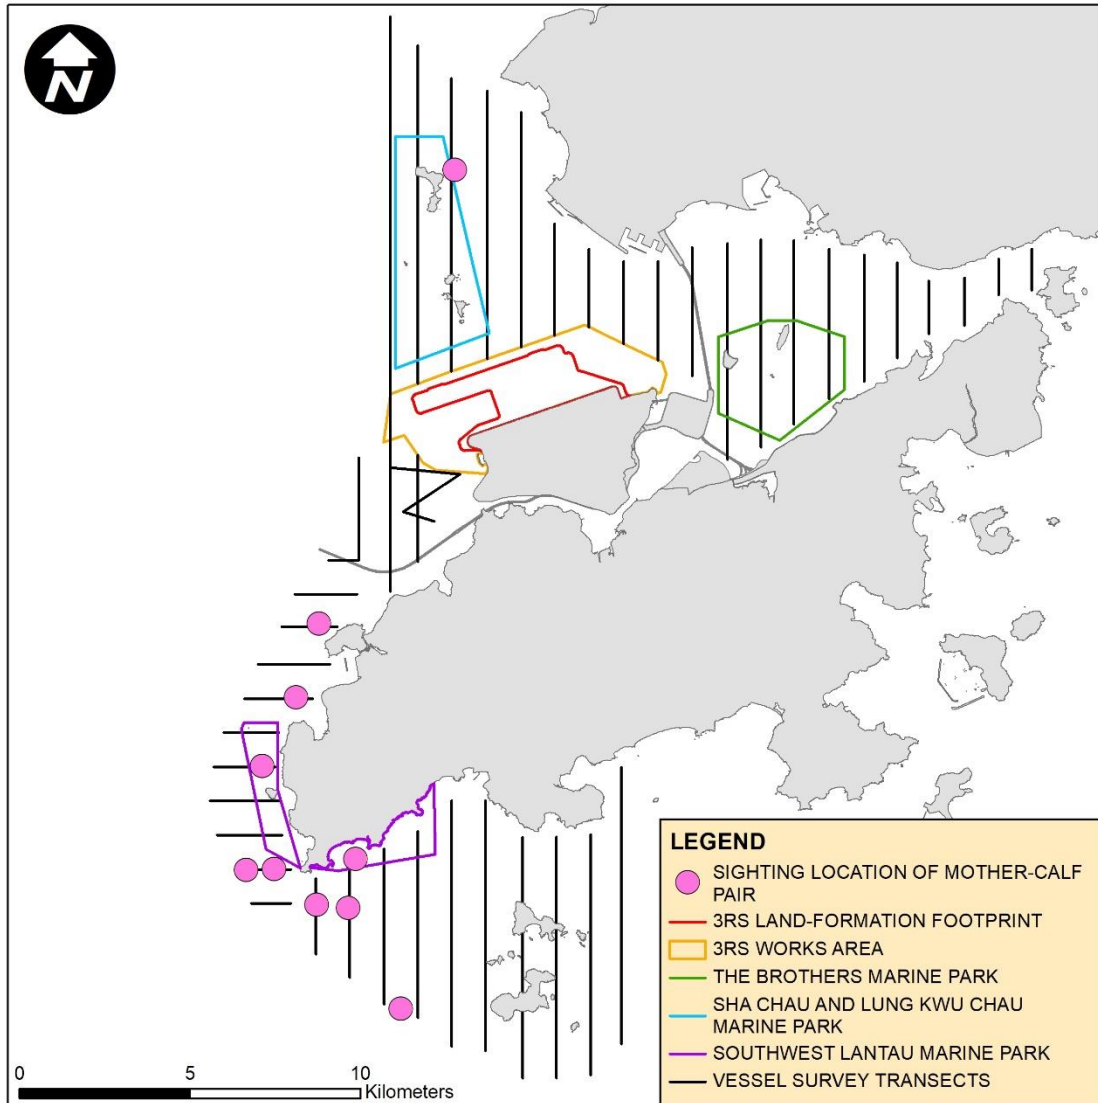
**Figure 2.8: Sighting Locations of Mother-calf Pairs**

From April to June 2022, 10 sightings of CWD were recorded with the presence of mother-and-unspotted juvenile pairs and/or mother-and-unspotted calf pairs observed, which is slightly higher than that recorded in the previous reporting quarter (i.e. nine sightings between January and March 2022). The number of CWD sightings with the presence of mother-calf pairs is also higher than that recorded in the same quarter of last year (i.e. six sightings between April and June 2021). These 10 sightings were recorded in NWL, WL and SWL survey areas, including a sighting in SWL with four mother-and-unspotted juvenile pairs observed.

The locations of CWD sightings with the presence of mother-calf pairs are shown in **Figure 2.8**.

Remarks: (1) Please note that there are 10 circles on the map indicating the sighting locations of Mother-Calf pairs. (2) Marine park excludes land area and the landward boundary generally follows the high water mark along the coastline.

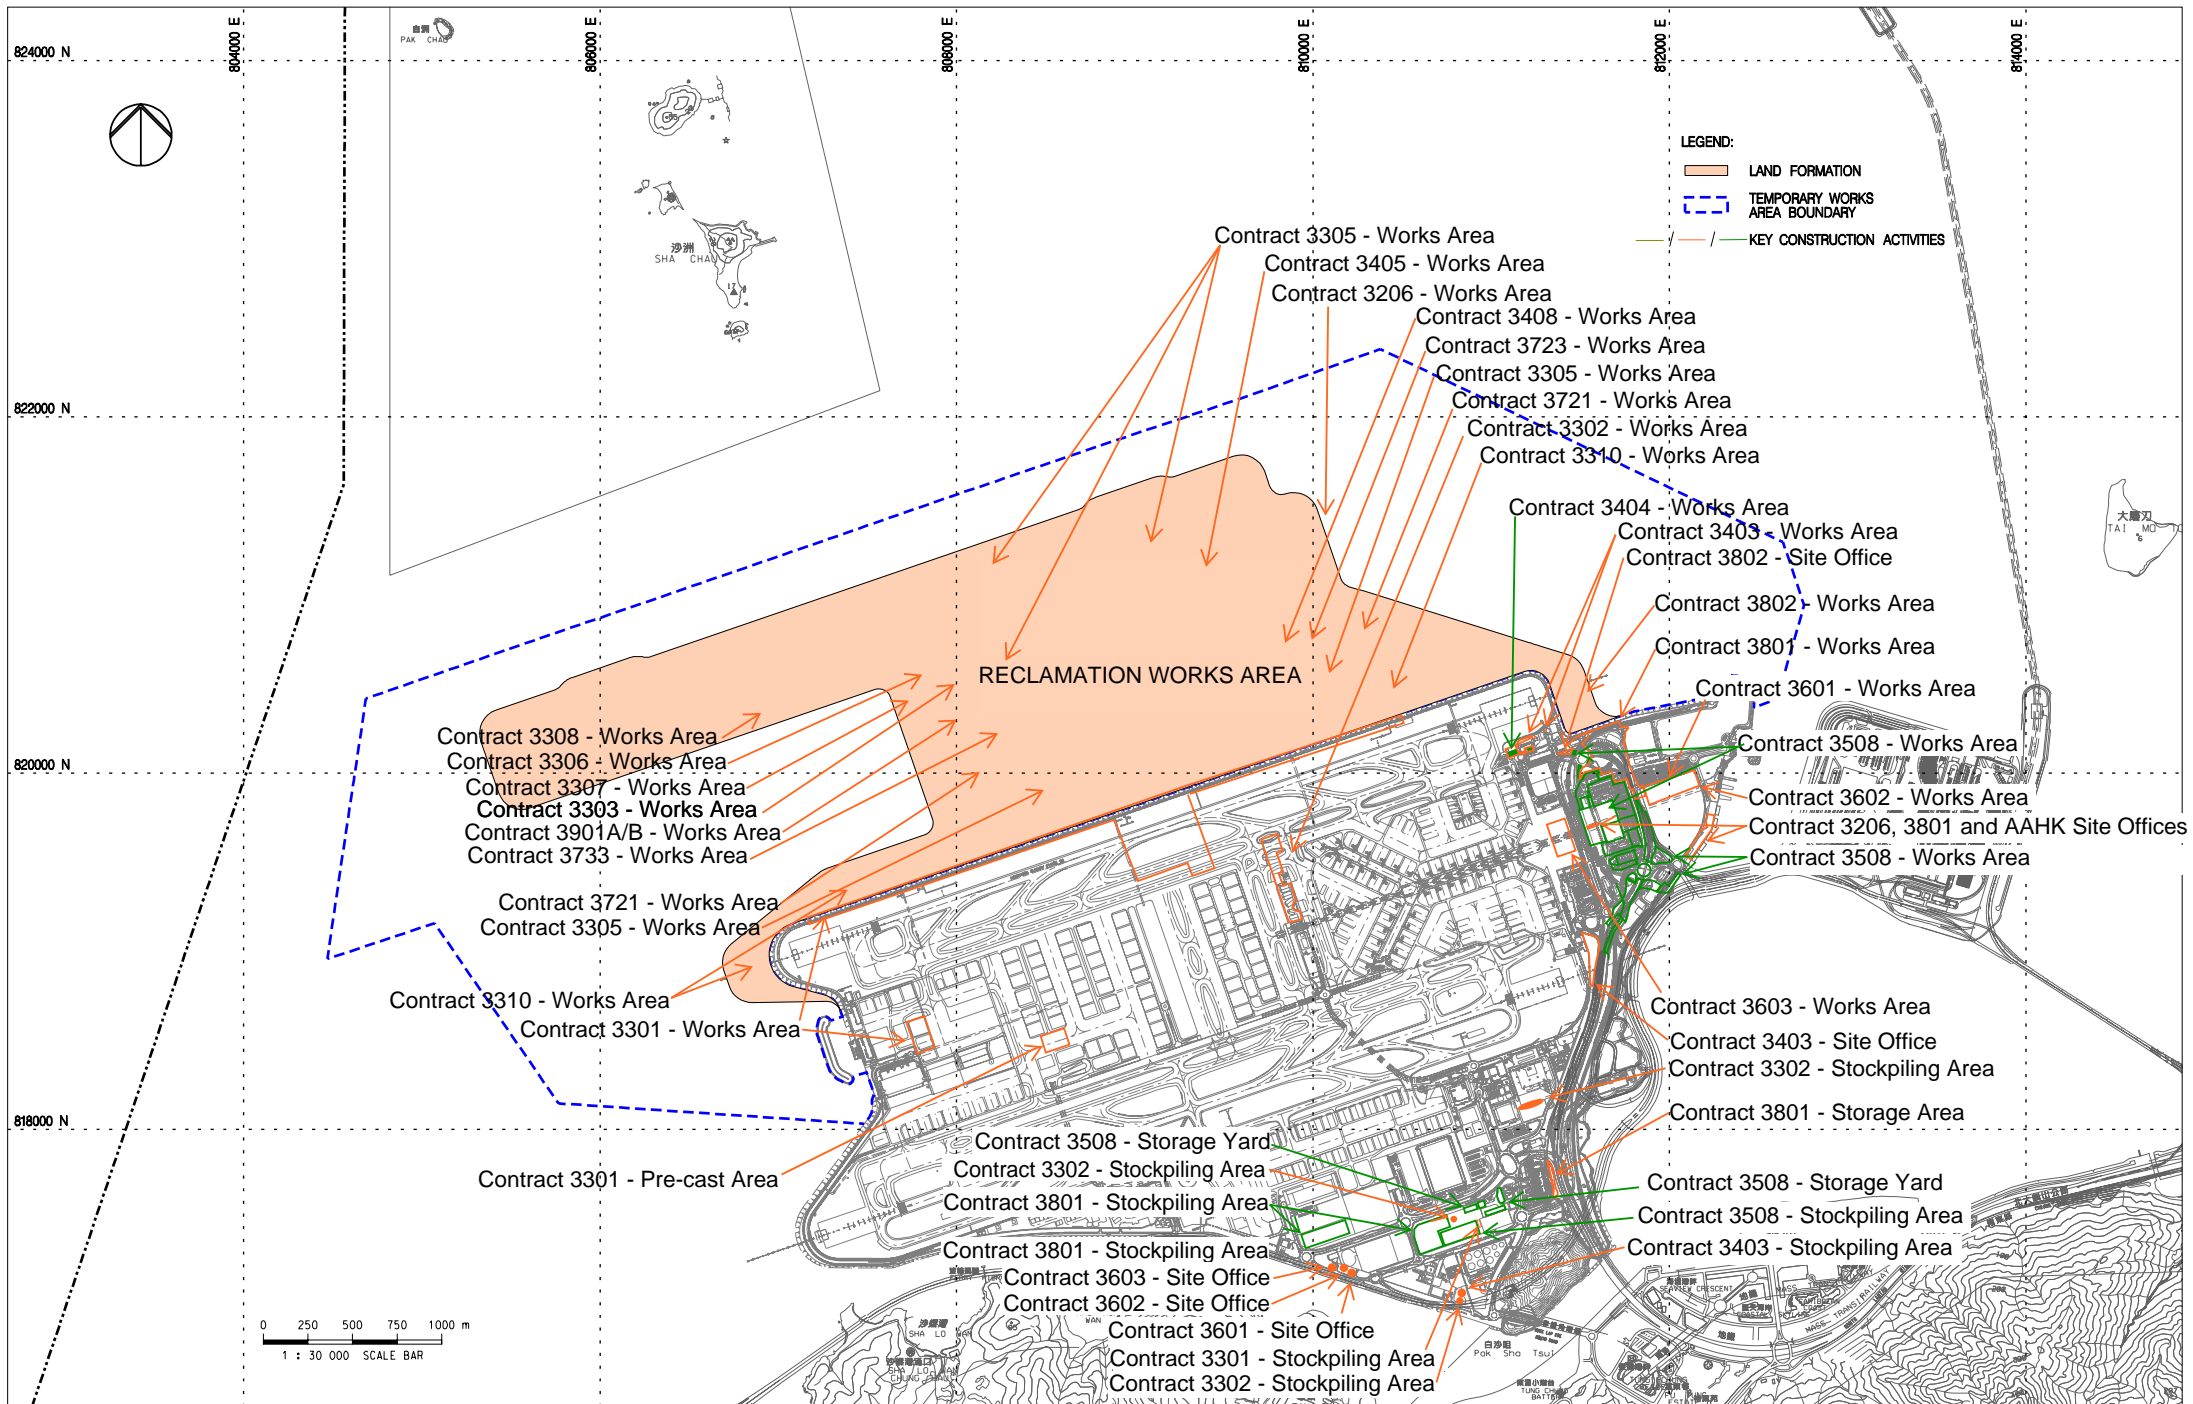
FIGURE 1.1 LOCATIONS OF KEY CONSTRUCTION ACTIVITIES

Note: The locations are for indicative purpose. The actual construction work locations are in accordance with the construction work programme.
