EP-510/2016 – Police Facilities in Kong Nga Po

**Service Contract No. NDO 07/2019
Environmental Team for Site Formation and
Infrastructure Works for Police Facilities in
Kong Nga Po**

**Monthly Environmental Monitoring and
Audit Report for February 2024
(Version 1.0)**

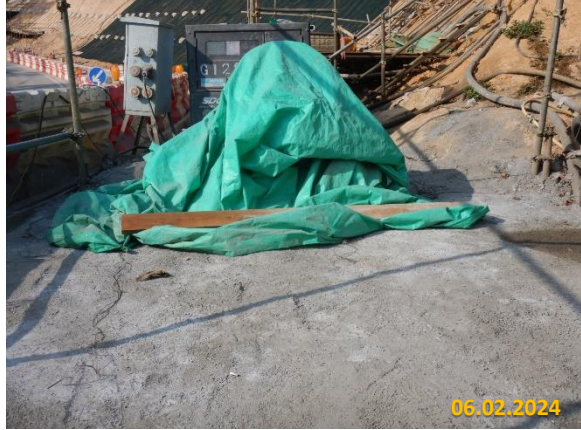
Ref*	Proposed Construction Method**	Location/Working Period	Anticipated Major Impacts	Recommended Mitigation Measures	Photo Records (Partial)
EIA 3.91; EM&A Log 2.2	Slope Upgrading Works	Kong Nga Po Main Site Kong Nga Po Road	Dust impact from soil nail works	<ul style="list-style-type: none"> • Three side enclosure with top shelter for cement mixing works • Water spraying on soil nailing works • Dusty materials exceeding 20 bags shall be stored in area sheltered on top and the three sides or covered entirely by impervious sheeting

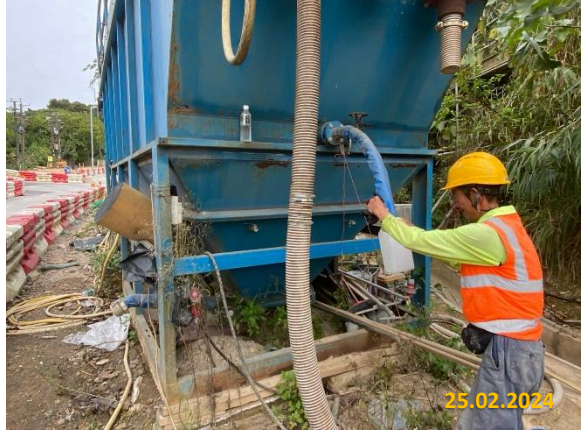
<p>By main contractor at KNP Road</p>

<p>By sub-contractor at KNP Road</p>
EIA 5.6.1.2; EM&A Log 4.2			Water	<ul style="list-style-type: none"> • Deploy desilting/sedimentation devices for wastewater treatment prior to discharge • Establish soil berm with retention pit to control water outflow

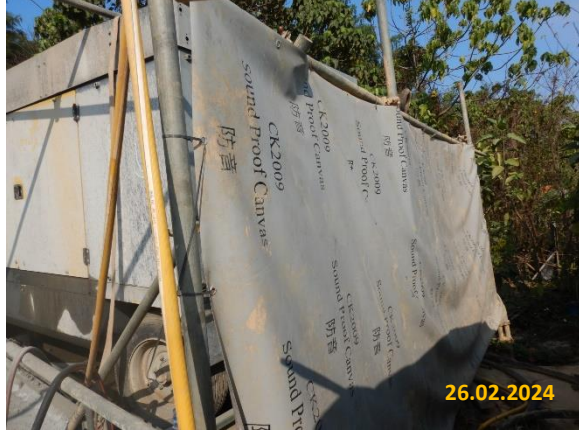
<p>By sub-contractor at KNP Road</p>

<p>By main contractor at KNP Road</p>
EIA 4.4.6; EM&A Log 3.2			Noise	<ul style="list-style-type: none"> Regular inspection and maintenance of plant and equipment in good condition Provide noise barriers for soil nailing works where near the sensitive receiver

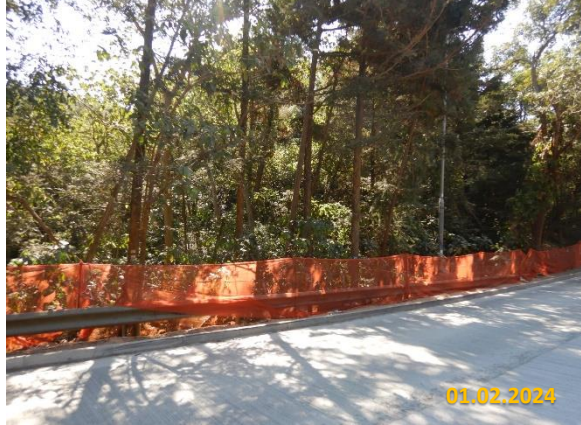
<p>By main contractor at KNP Road</p>

<p>By main contractor at KNP Main Site</p>
EIA Table 10.11 EM&A Table 9.1			Landscape and visual impact	<ul style="list-style-type: none"> • Properly fenced off the conservative species • Preservation of existing trees will be undertaken in accordance with DEVB TC(W) 7/2015 and Guidelines for Tree Risk Assessment and Management Arrangement

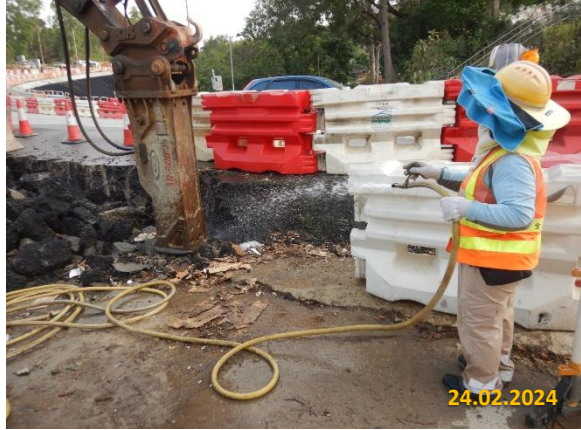
Ref*	Proposed Construction Method**	Location/Working Period	Anticipated Major Impacts	Recommended Mitigation Measures	Photo Records (Partial)
EIA 3.91; EM&A Log 2.2	Road and Associated Works	Kong Nga Po Main Site Kong Nga Po Road	Air Dust impact from excavation activities and earth moving	<ul style="list-style-type: none"> • Use of regular water spraying (once every 1.25 hours or 8 times per day) at all active works area exposed site surfaces and unpaved roads, particularly during dry weather • Regular inspection and maintenance of plant and equipment in good condition • Regularly clean up stockpiles and debris to avoid accumulation of materials

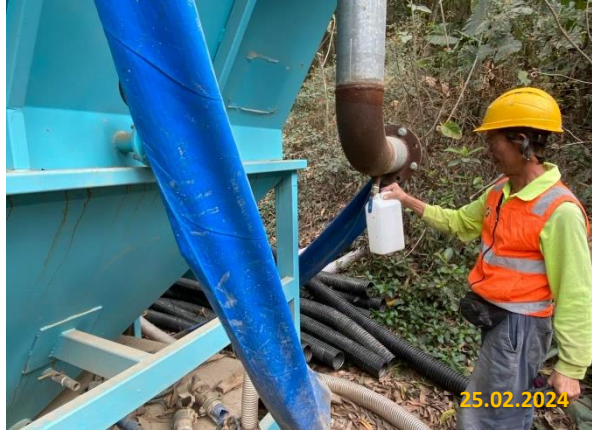
<p>By main contractor at KNP Road</p>

<p>By sub-contractor at KNP Road</p>
EIA 5.6.1.2; EM&A Log 4.2			Water	<ul style="list-style-type: none"> • Provide desilting/sedimentation devices for wastewater treatment before discharge

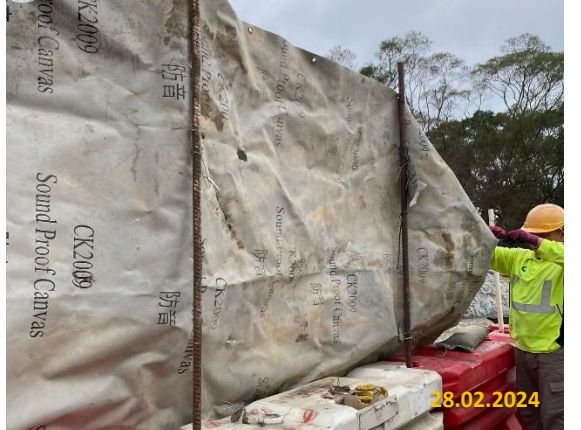
<p>By sub-contractor at KNP Road</p>

<p>By main contractor at KNP Road</p>
EIA 4.4.6; EM&A Log 3.2			Noise from roadworks	<ul style="list-style-type: none"> Enclose the noisy part of machineries with noise isolating mats during hard surface breaking / for operating plants
