**EP-510/2016 – Police Facilities in Kong Nga Po**

**Service Contract No. NDO 07/2019  
Environmental Team for Site Formation and  
Infrastructure Works for Police Facilities in  
Kong Nga Po**

**Monthly Environmental Monitoring and  
Audit Report for March 2024  
(Version 1.0)**

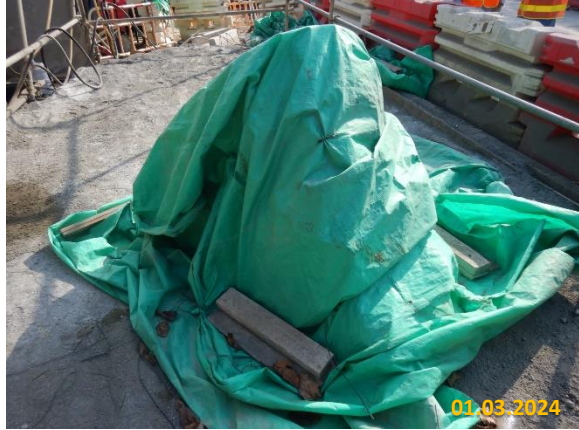
Ref*	Proposed Construction Method**	Location/Working Period	Anticipated Major Impacts	Recommended Mitigation Measures	Photo Records (Partial)
EIA 3.91; EM&A Log 2.2	Slope Upgrading Works	Kong Nga Po Main Site Kong Nga Po Road	Dust impact from soil nail works	<ul style="list-style-type: none"> <li>• Three side enclosure with top shelter for cement mixing works</li> <li>• Water spraying on soil nailing works</li> <li>• Dusty materials exceeding 20 bags shall be stored in area sheltered on top and the three sides or covered entirely by impervious sheeting</li> </ul>

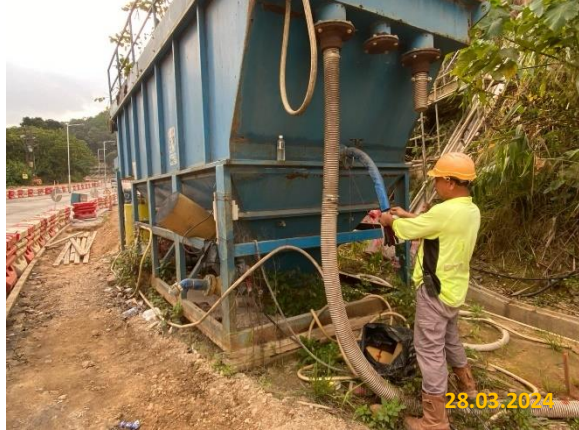
<p>01.03.2024</p> <p>By sub-contractor at KNP Road</p>
EIA 5.6.1.2; EM&A Log 4.2			Water	<ul style="list-style-type: none"> <li>• Deploy desilting/sedimentation devices for wastewater treatment prior to discharge</li> <li>• Establish soil berm with retention pit to control water outflow</li> </ul>

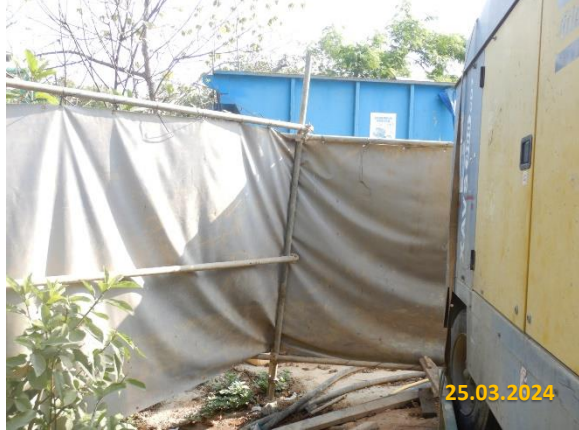
<p>By main contractor at KNP Road</p>
EIA 4.4.6; EM&A Log 3.2			Noise	<ul style="list-style-type: none"> <li>Regular inspection and maintenance of plant and equipment in good condition</li> <li>Provide noise barriers for soil nailing works where near the sensitive receiver</li> </ul>

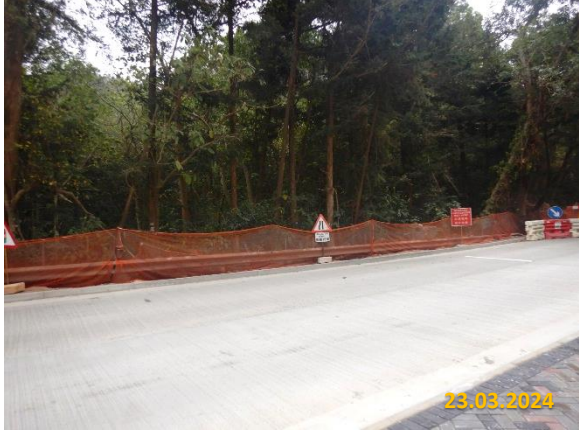
<p data-bbox="1453 869 1899 901">By main contractor at KNP Main Site</p>
EIA Table 10.11 EM&A Table 9.1			Landscape and visual impact	<ul style="list-style-type: none"> <li>• Properly fenced off the conservative species</li> <li>• Preservation of existing trees will be undertaken in accordance with DEVB TC(W) 7/2015 and Guidelines for Tree Risk Assessment and Management Arrangement</li> </ul>

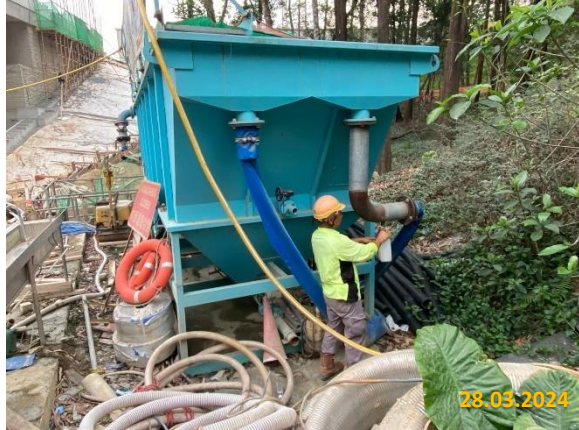
<p data-bbox="1451 869 1825 901">By sub-contractor at KNP Road</p>
EIA 5.6.1.2; EM&A Log 4.2			Water	<ul style="list-style-type: none"> <li>• Provide desilting/sedimentation devices for wastewater treatment before discharge</li> </ul>

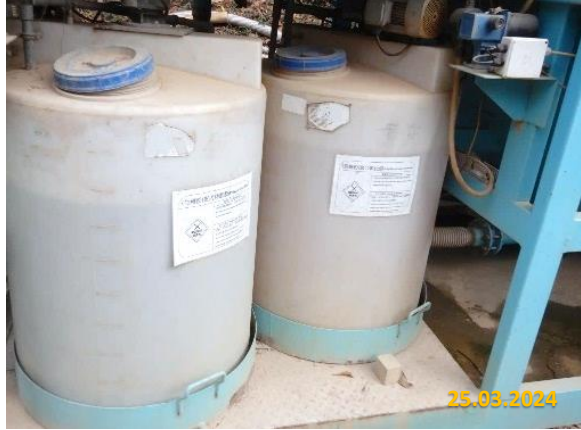
Ref*	Proposed Construction Method**	Location/Working Period	Anticipated Major Impacts	Recommended Mitigation Measures	Photo Records (Partial)
EIA 7.5.1.4; EM&A Log 6.2	(Con't) Road and Associated Works	(Con't) Kong Nga Po Main Site Kong Nga Po Road	Chemical Waste	<ul style="list-style-type: none"> <li>Drip tray and chemical spillage kit shall be provided on site</li> </ul>
