EP-510/2016 – Police Facilities in Kong Nga Po

**Service Contract No. NDO 07/2019
Environmental Team for Site Formation and
Infrastructure Works for Police Facilities in
Kong Nga Po**

**Quarterly Environmental Monitoring and
Audit Report for April to June 2024
(Version 1.0)**

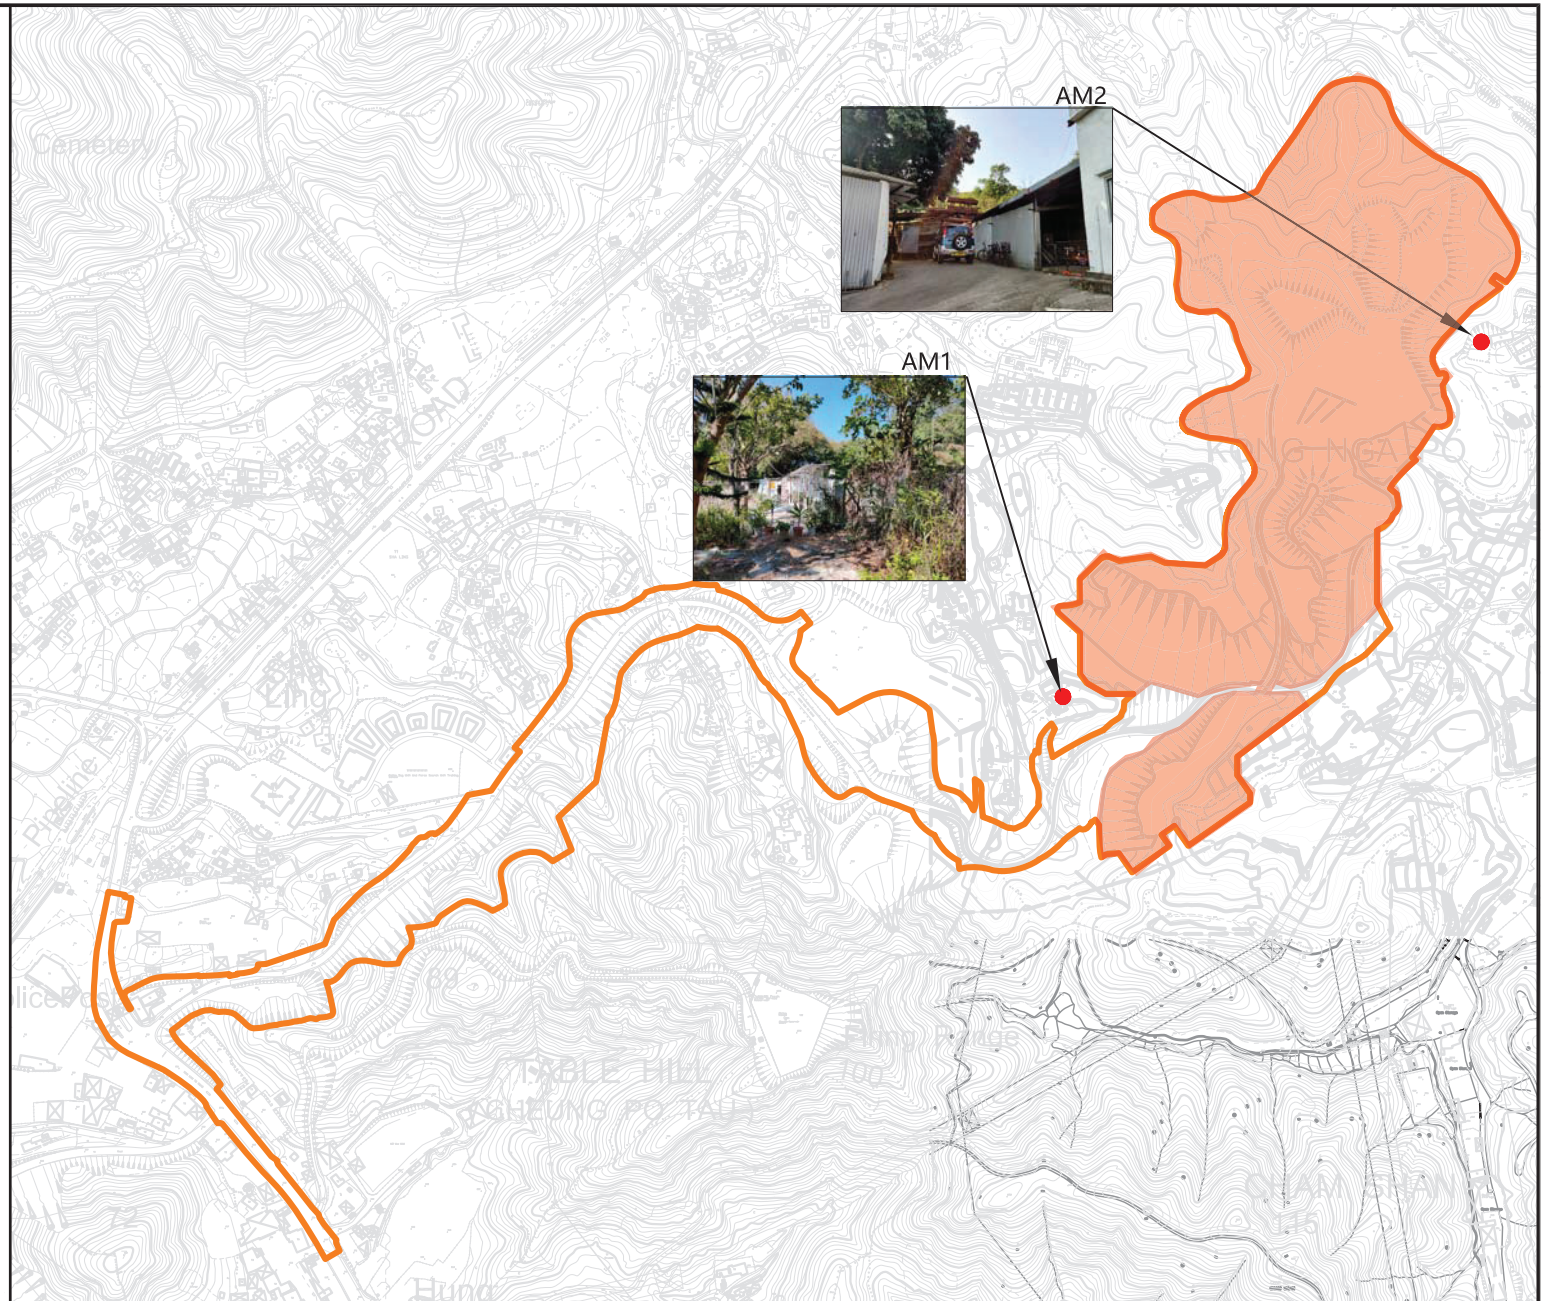
Air Quality Monitoring Stations	
ID	Description
AM1	Village House, Kong Nga Po
AM2	Village House, Kong Nga Po

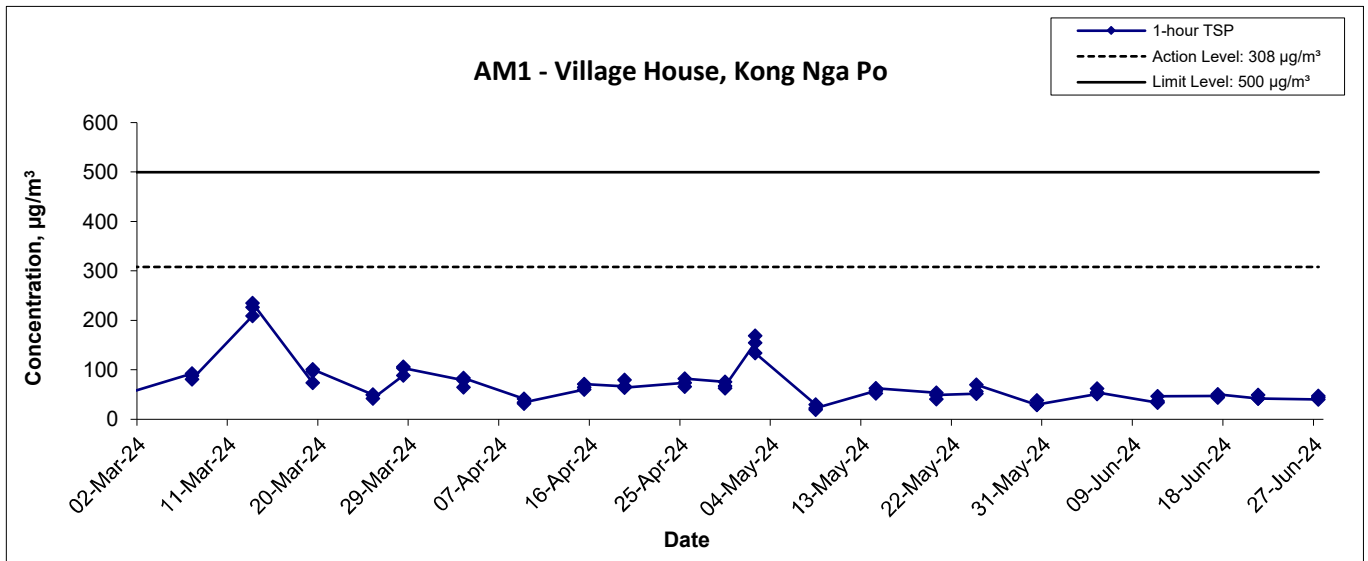
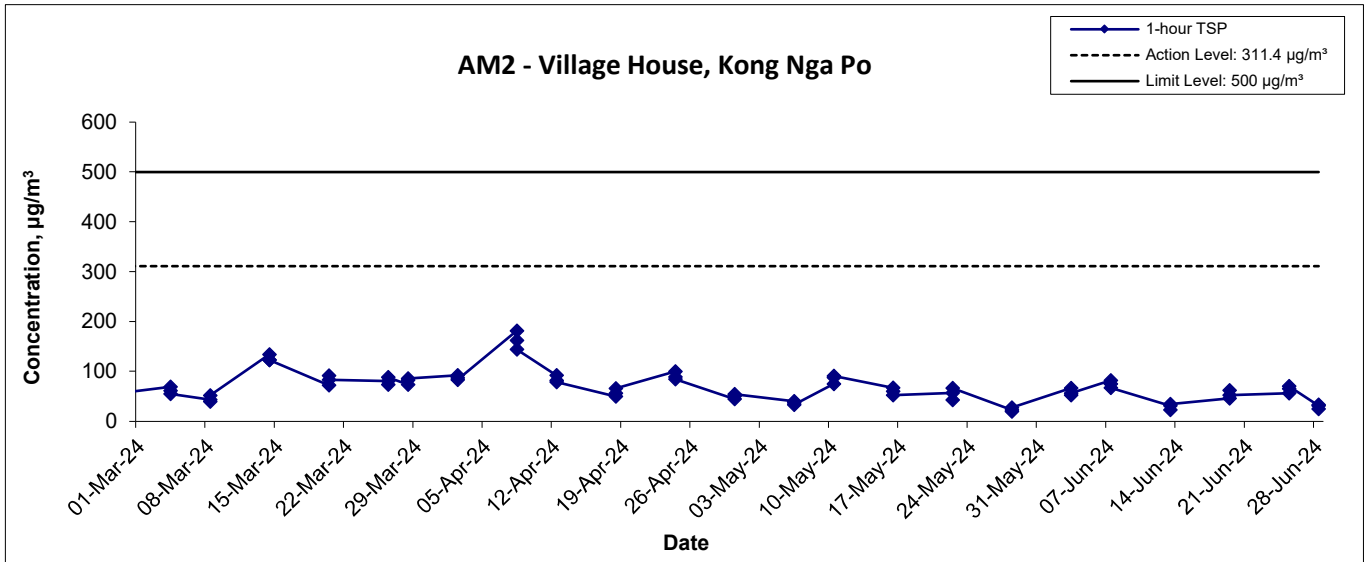
1-hr TSP Concentration Levels

Title Service Contract No. NDO 07/2019 Environmental Team for Site Formation and Infrastructure Works for Police Facilities in Kong Nga Po Graphical Presentation of 1-hour TSP Monitoring Results	Scale N.T.S	Project No. WMA20001

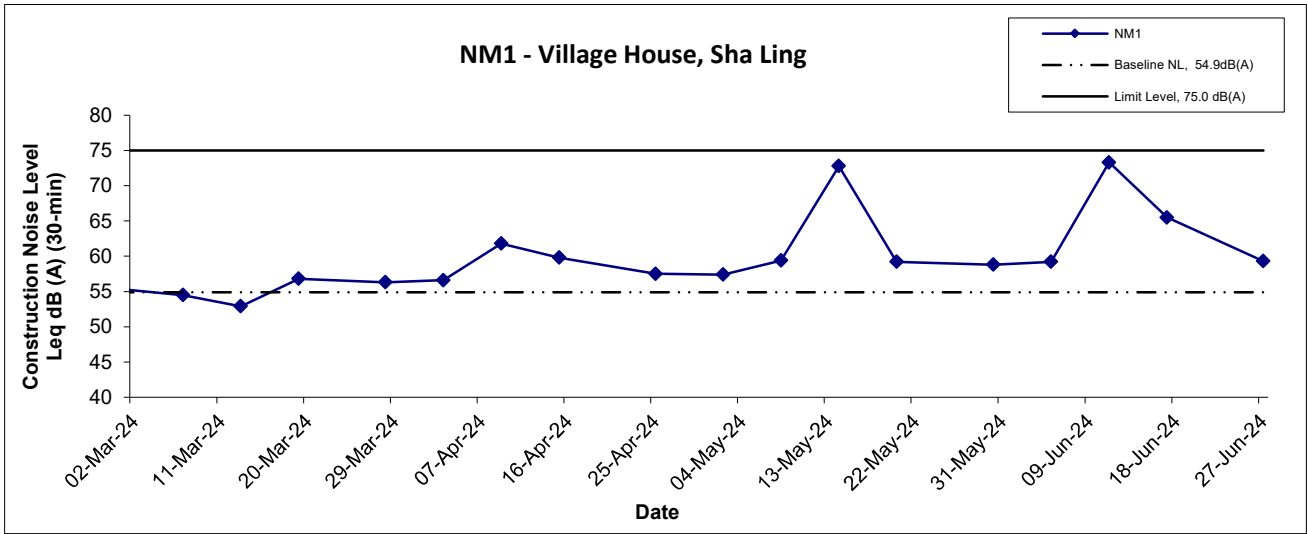
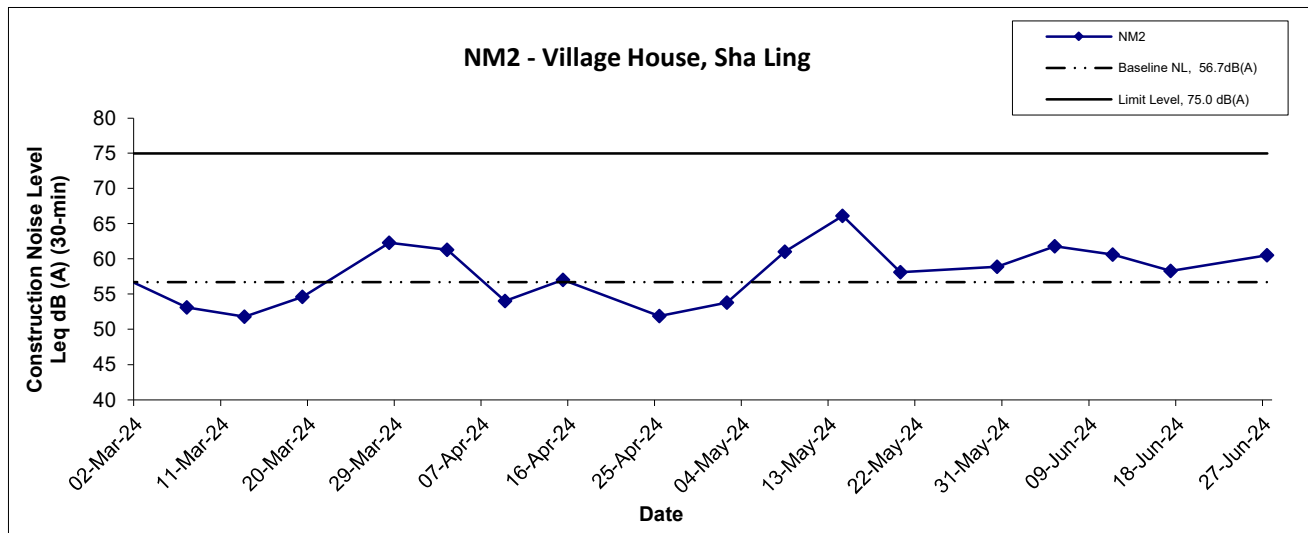
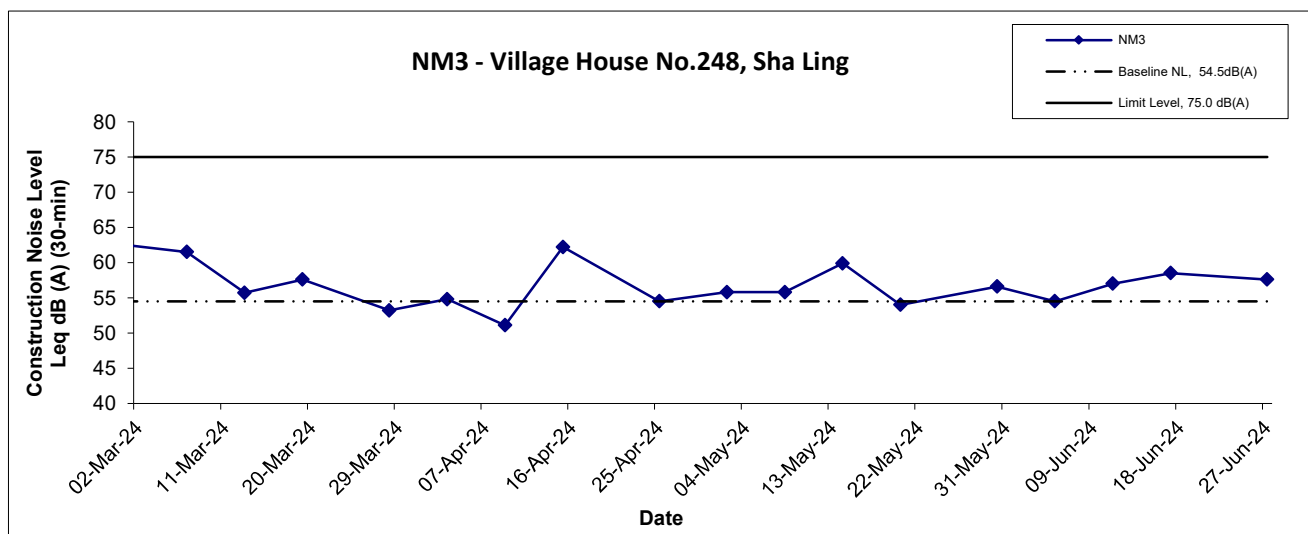
Noise Levels

Title Service Contract No. NDO 07/2019 Environmental Team for Site Formation and Infrastructure Works for Police Facilities in Kong Nga Po Graphical Presentation of Construction Noise Monitoring Results	Scale N.T.S	Project No. WMA20001	consulting . testing . research
	Date Jun 24	Appendix C

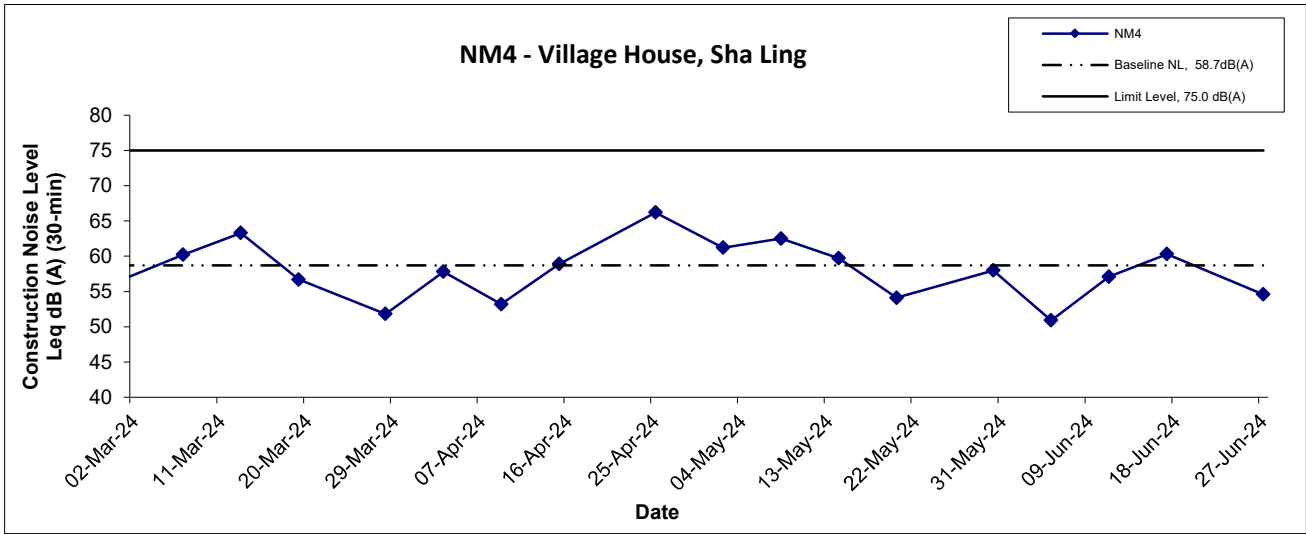
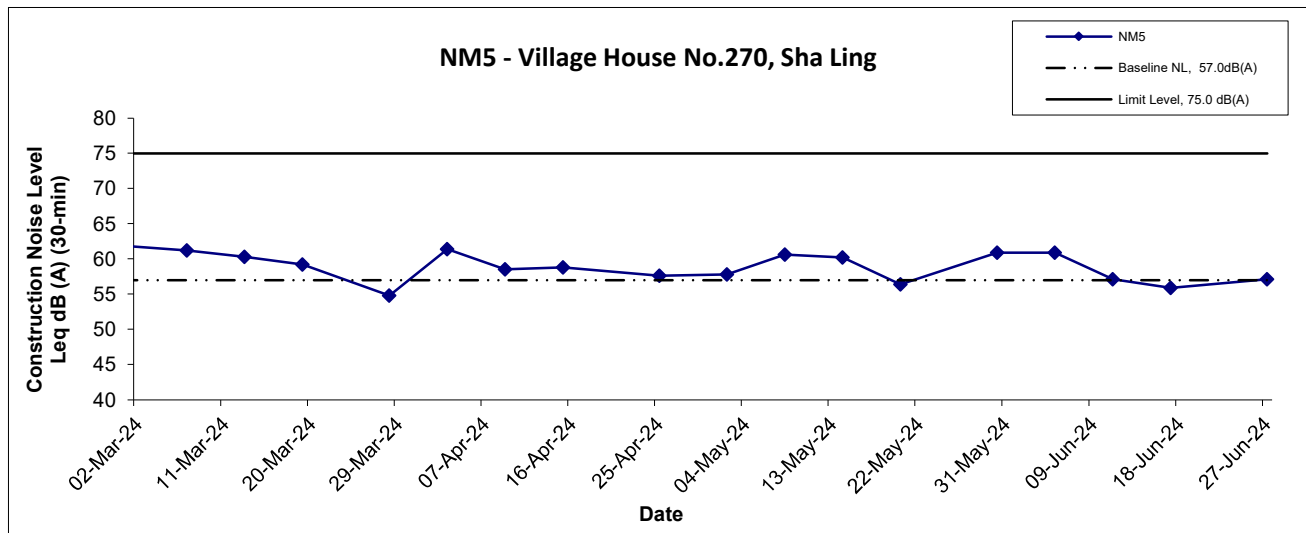
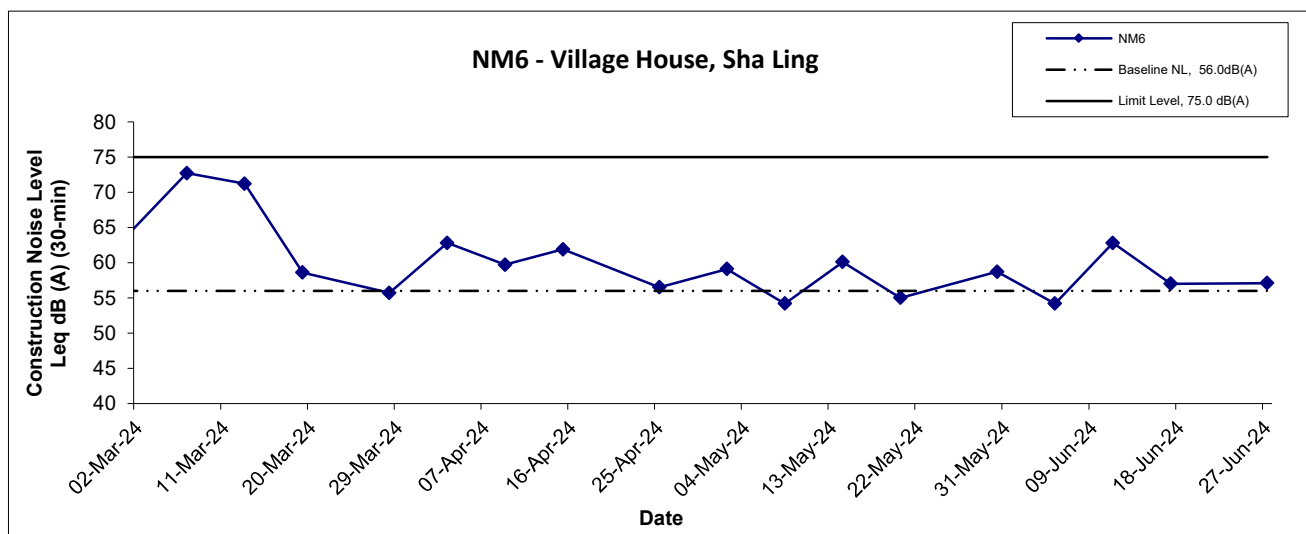
Noise Levels

Title Service Contract No. NDO 07/2019 Environmental Team for Site Formation and Infrastructure Works for Police Facilities in Kong Nga Po Graphical Presentation of Construction Noise Monitoring Results	Scale N.T.S	Project No. WMA20001	consulting . testing . research
	Date Jun 24	Appendix C

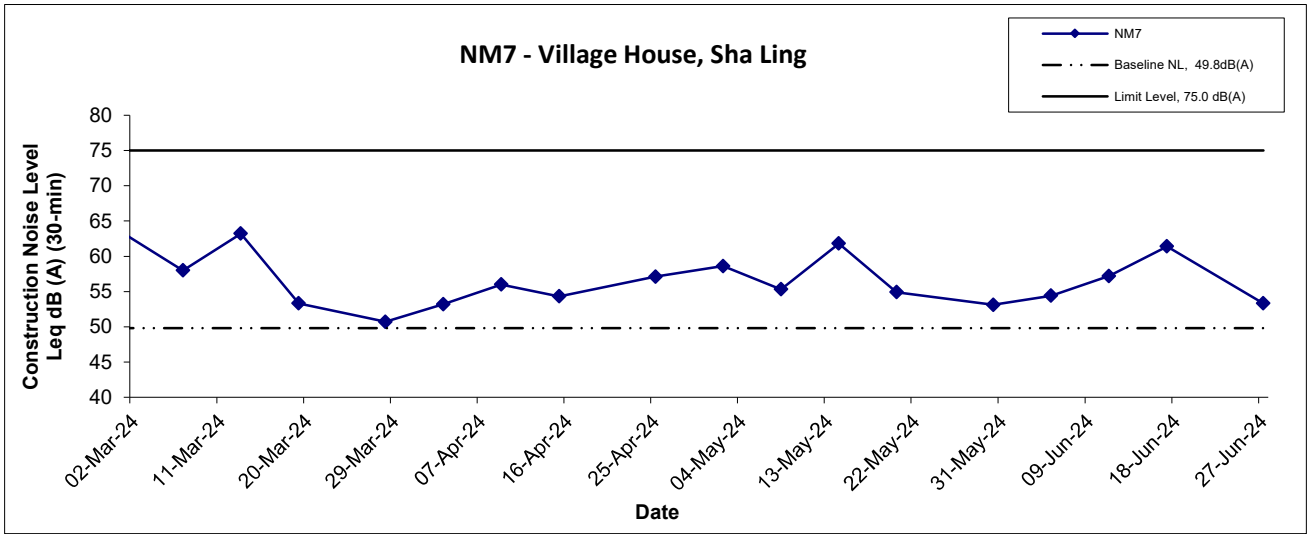
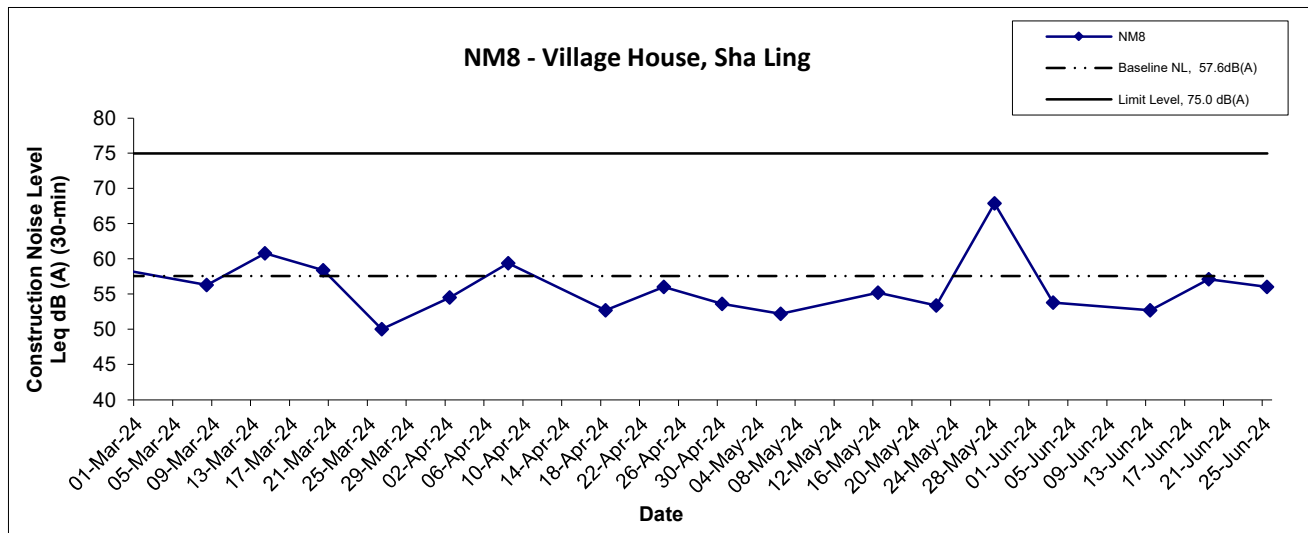
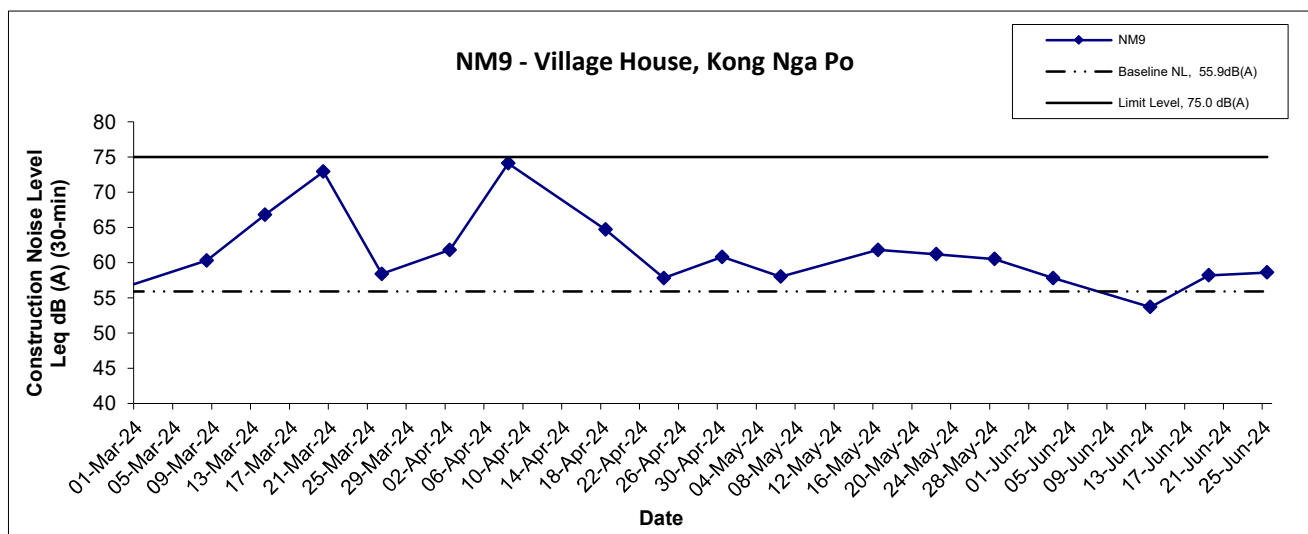
Noise Levels

Title Service Contract No. NDO 07/2019 Environmental Team for Site Formation and Infrastructure Works for Police Facilities in Kong Nga Po Graphical Presentation of Construction Noise Monitoring Results	Scale	Project No.	consulting . testing . research
	N.T.S	WMA20001	
	Date	Appendix	
	Jun 24	C

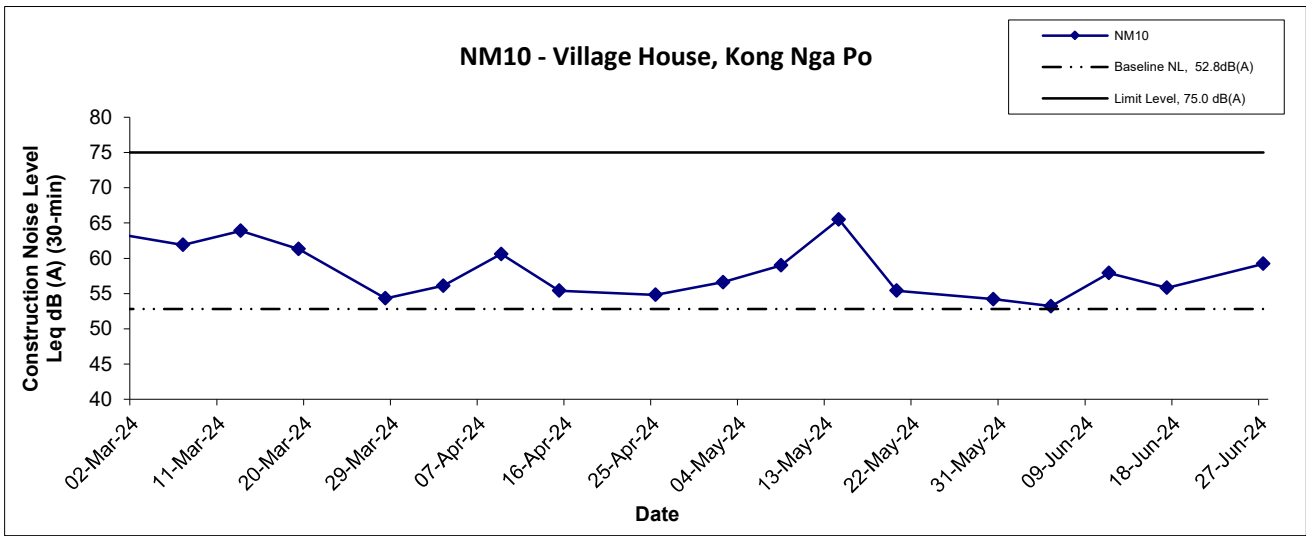
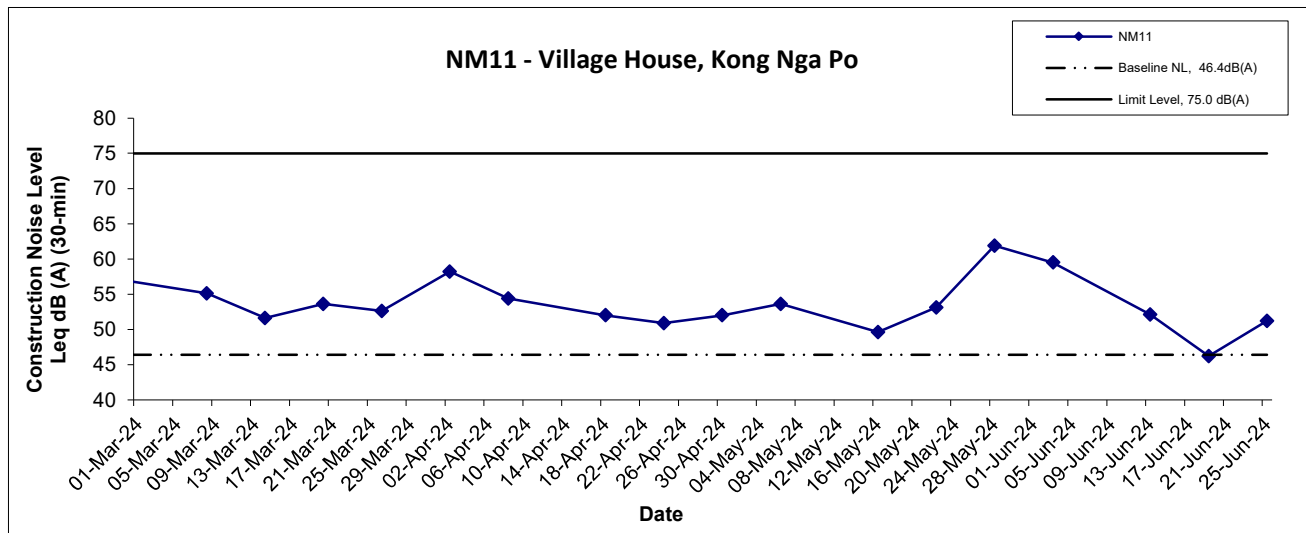
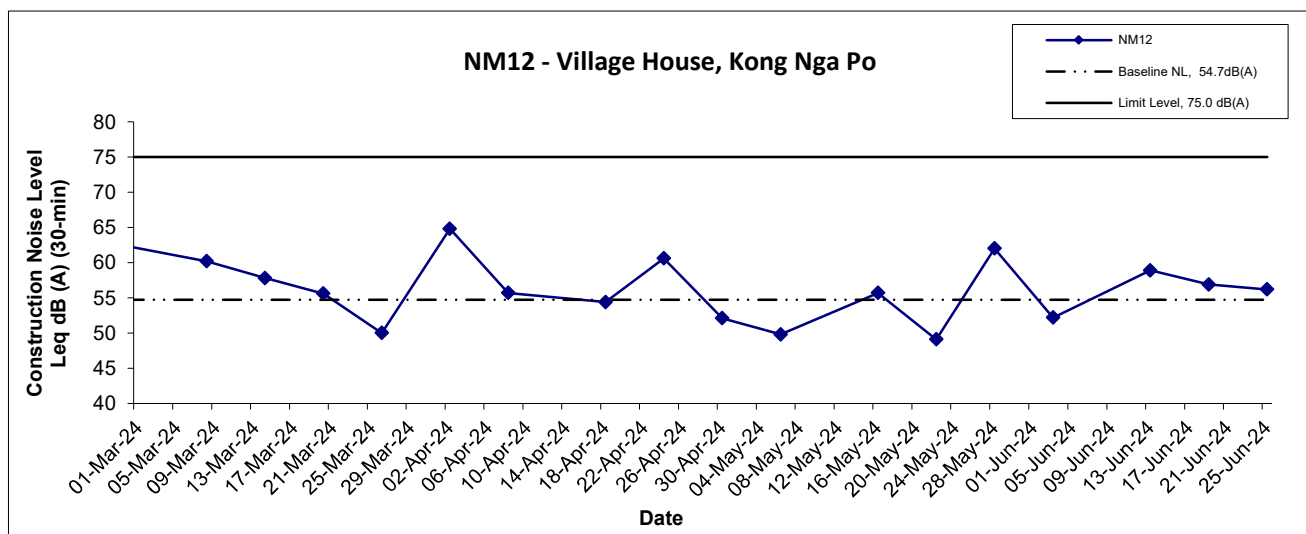
Noise Levels

Title Service Contract No. NDO 07/2019 Environmental Team for Site Formation and Infrastructure Works for Police Facilities in Kong Nga Po Graphical Presentation of Construction Noise Monitoring Results	Scale N.T.S	Project No. WMA20001	consulting . testing . research
	Date Jun 24	Appendix C

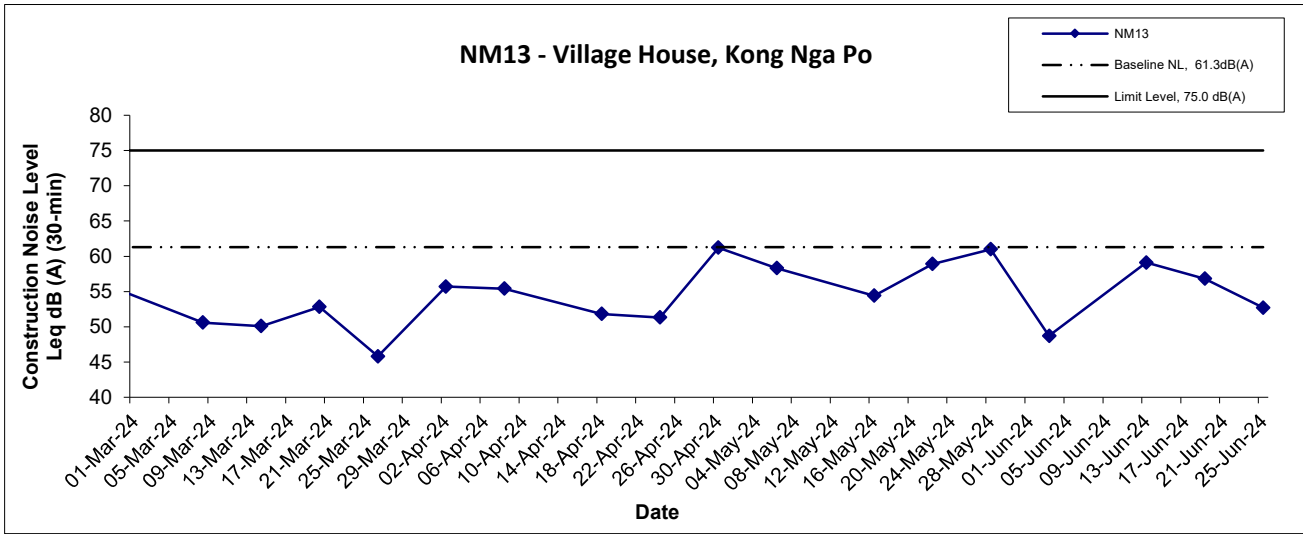
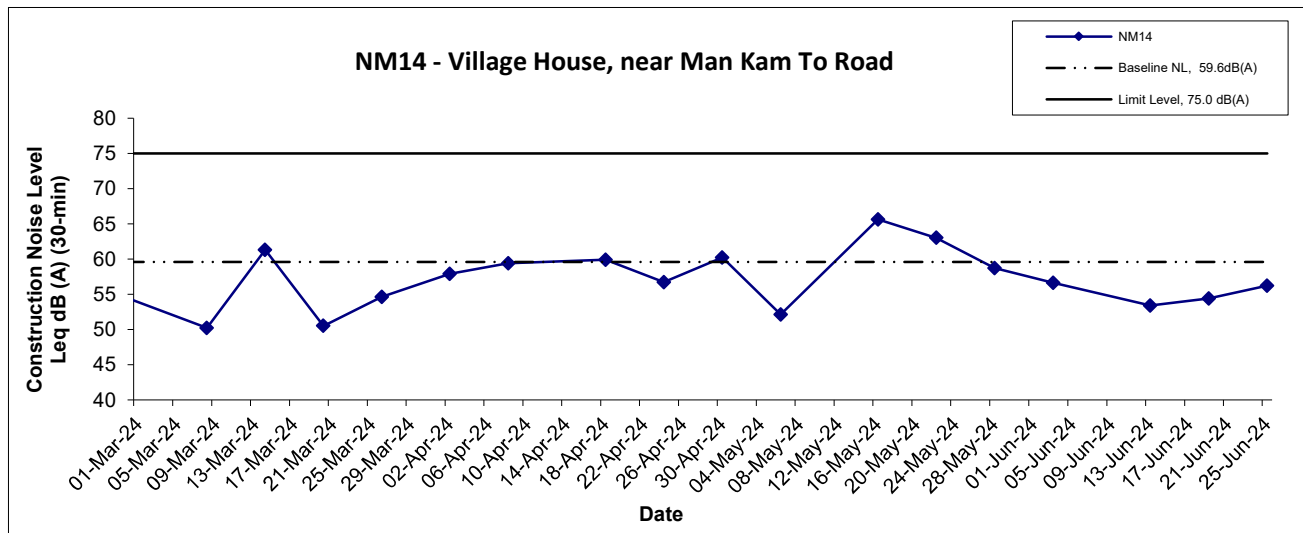
Noise Levels

Title Service Contract No. NDO 07/2019 Environmental Team for Site Formation and Infrastructure Works for Police Facilities in Kong Nga Po Graphical Presentation of Construction Noise Monitoring Results	Scale	N.T.S	Project No.	WMA20001
	Date	Jun 24	Appendix	C
