**Provision of Independent Environmental Checker Consultancy for Design
and Construction of Kong Nga Po Police Training Facilities
Verification of Monthly EM&A Report (January 2025)**

**Provision of Environmental Team consultancy
for Design and Construction of Kong Nga Po Police
Training Facilities (Programme No. 279LP)**

**Monthly Environmental Monitoring and
Audit Report for January 2025
(Version 3)**

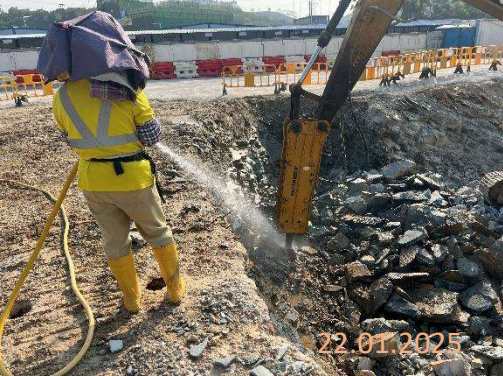
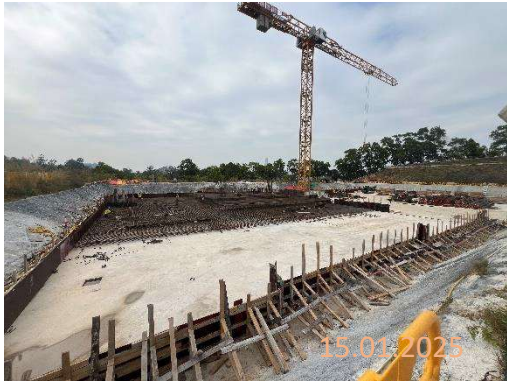
Ref*	Proposed Construction Method	Location/Working Period	Anticipated Major Impacts	Recommended Mitigation Measures	Photo Records (Partial)
EIA 3.9.1; EM&A Log 2.2	Open cut excavation	Kong Nga Po Site	Dust impact	<ul style="list-style-type: none"> • Manual water spraying for dust suppression • Regular inspection and maintenance of plant and equipment in good condition • Cover stockpile with impervious sheets or grout • Provide wheel washing facility at site entrance

<p>By subcontractor at KNP site</p>

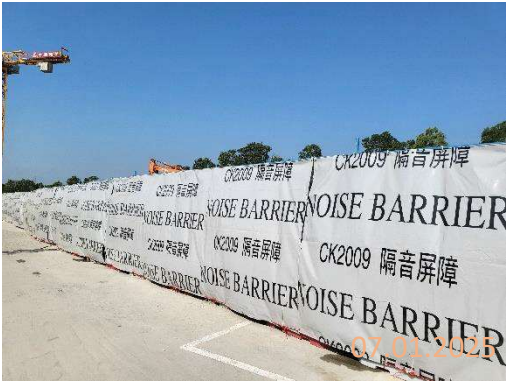
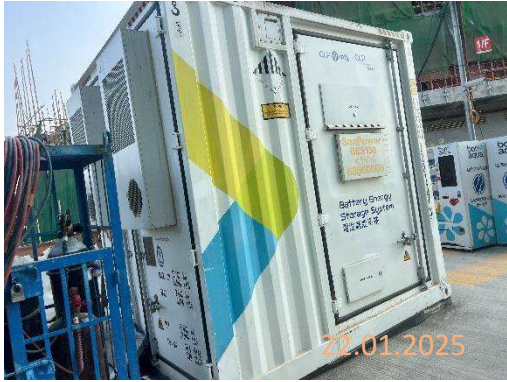
<p>15.01.2025</p> <p>By subcontractor at KNP site</p>
<p>EIA 4.4.6; EM&A Log 3.2</p>			<p>Noise</p>	<ul style="list-style-type: none"> • Regular inspection and maintenance of plant & equipment in good condition • Deploy Quality Powered Mechanical Equipment (QPME) if possible • Valid construction noise permit should be displayed at site entrance.

<p>By main contractor at KNP site</p>

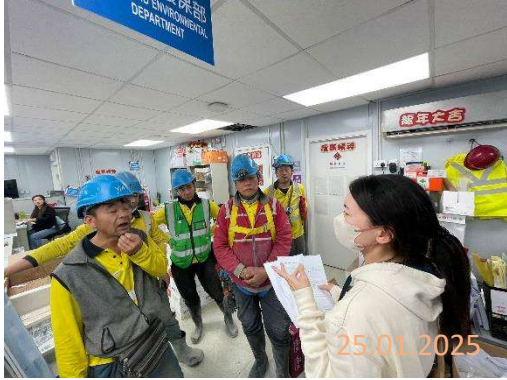
<p>By main contractor at KNP site</p>
<p>EIA 9.7.1 and EM&A Log 8.3</p>			<p>Ecology Concern</p>	<ul style="list-style-type: none"> • Provide training to workers about the conservative species • Provision of protective fence for the conservative species • Regular inspection for concerned vegetation and conservative species

<p>By main contractor at KNP site</p>

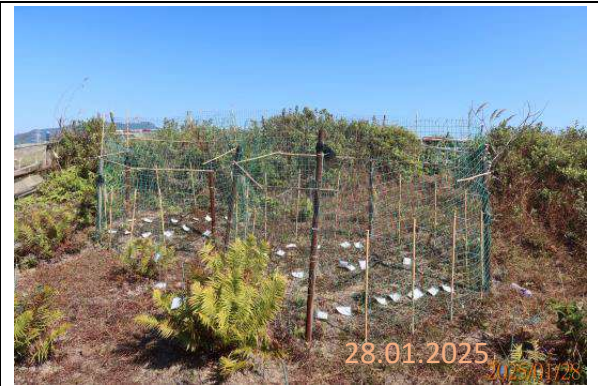
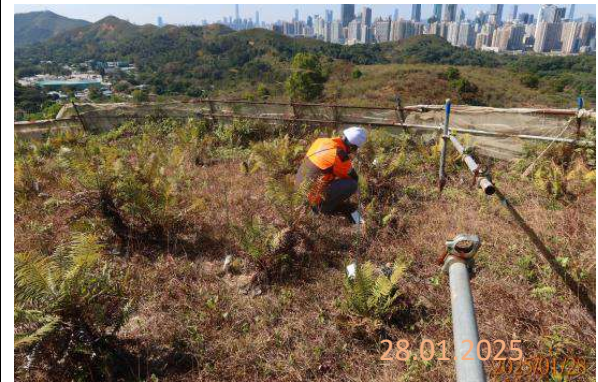
By subcontractor at KNP site

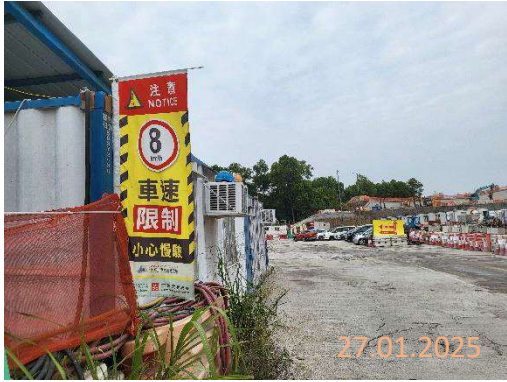
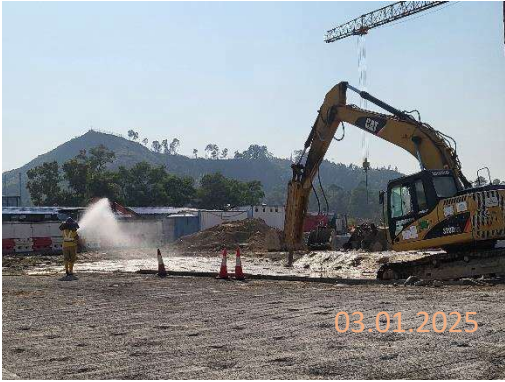
<p>EIA 3.9.1; EM&A Log 2.2</p>	<p>Soil Removal</p>	<p>Kong Nga Po Site</p>	<p>Air</p>	<ul style="list-style-type: none"> • Deploy water bowser for regular water spraying to enhance dust suppression • Cover dusty materials with impervious sheets • Exposed slopes covered with waterproof layers such as tarpaulin sheets or grout to reduce the potential for sediment laden runoff entering the drainage system. • The speed of the trucks within the site should be controlled to about 10km/hour in order to reduce adverse dust impacts and secure the safe movement around the site.

<p>By main contractor at KNP site</p>

<p>By main contractor at KNP site</p>
--	---------------------	-------------------------	------------	--	--

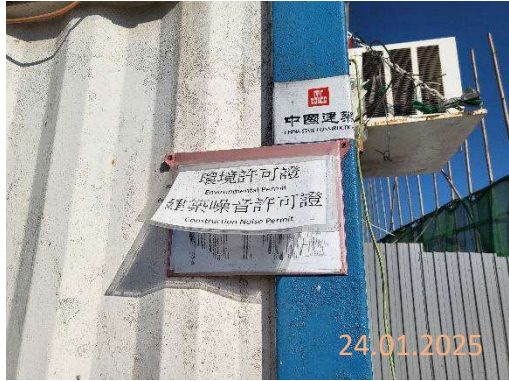
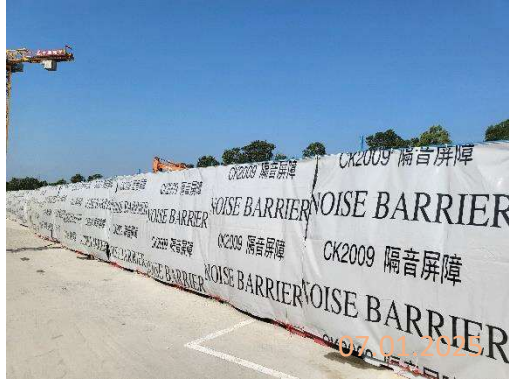
<p>By main contractor at KNP site</p>
<p>EIA 4.4.6; EM&A Log 3.2</p>			<p>Noise</p>	<ul style="list-style-type: none"> • Regular inspection and maintenance of plant & equipment in good condition • Deploy Quality Powered Mechanical Equipment (QPME) if possible

<p>By main contractor at KNP site</p>

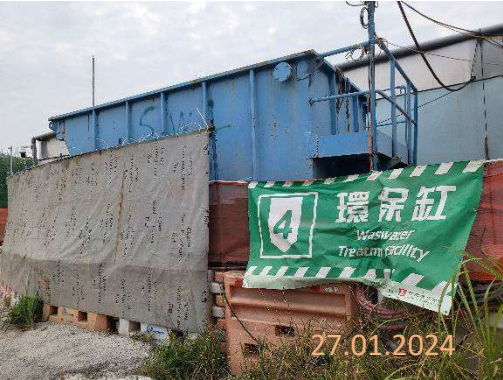
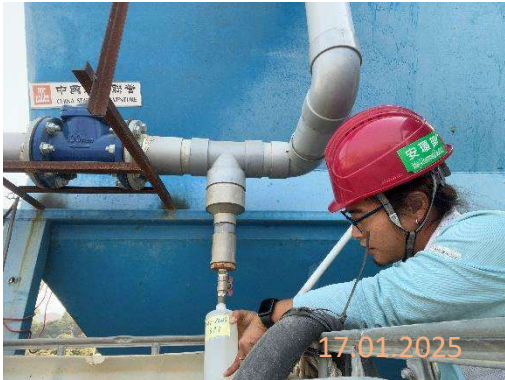
<p>EIA 5.6.1.2 and EM&A Log 4.2</p>			<p>Water Quality</p>	<ul style="list-style-type: none"> • Cover exposed slopes with impervious sheets or cement grout. • Wastewater pumped out of the excavation areas shall be treated to remove suspended solid prior to discharge. • Provide desilting/ sedimentation devices for wastewater treatment prior to discharge. • Provide drip tray to prevent spillage of fuels

<p>By main contractor at KNP site</p>

<p>By main contractor at KNP site</p>
---	--	--	----------------------	---	---

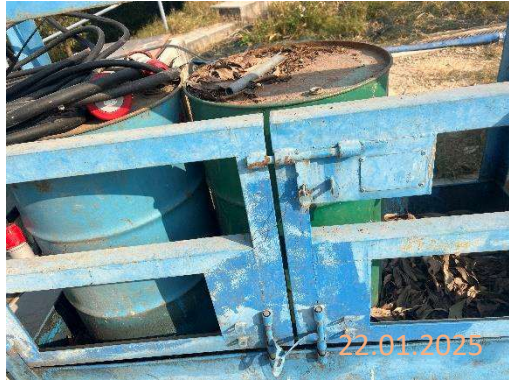
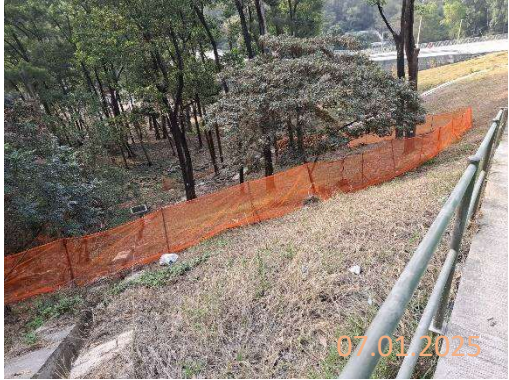
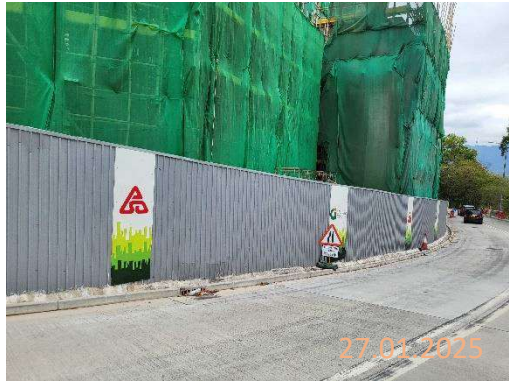
<p data-bbox="1541 639 1939 667">By main contractor at KNP site</p>
<p data-bbox="203 735 376 911">EIA Table 10.11; EM&A Table 9.1</p>			<p data-bbox="889 735 1111 815">Landscape and Visual Impact</p>	<ul data-bbox="1137 735 1518 1294" style="list-style-type: none"> <li data-bbox="1137 735 1518 1102">• Preservation of existing trees will be undertaken in accordance with DEVB TC(W) 7/2015 and Guidelines for Tree Risk Assessment and Management Arrangement <li data-bbox="1137 1118 1518 1294">• Implement temporary traffic arrangement which control construction area to

<p>minimize landscape and visual impacts</p> <ul style="list-style-type: none">• Minimize visual impact during construction stage. Site office not visually prominent from public room and surrounding• Planting will take place as soon the planting area is installed with subsoil drainage• Decorative hoarding is provided (Refer to photo).

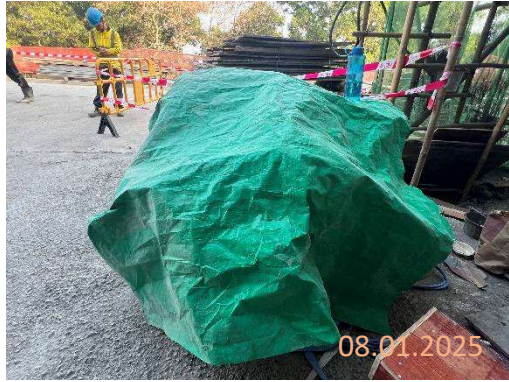
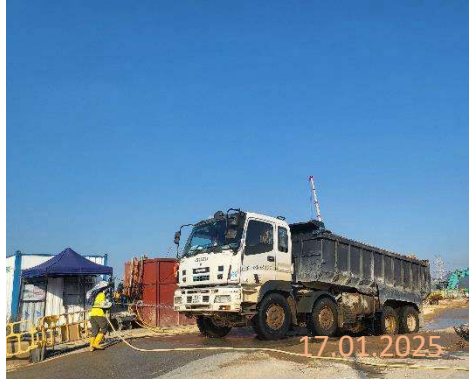
<p>EIA 3.9.1; EM&A Log 2.2</p>	<p>Construction of footings, substructure and superstructure</p>	<p>Kong Nga Po Site</p>	<p>Air</p>	<ul style="list-style-type: none"> • Cover dusty materials with impervious sheets • Exposed slopes covered with waterproof layers such as tarpaulin sheets or grout to reduce the potential for sediment laden runoff entering the drainage system. • Provide wheel washing facility at site entrance

<p>By main contractor at KNP site</p>

<p>By subcontractor at KNP site</p>
--	--	-------------------------	------------	--	--

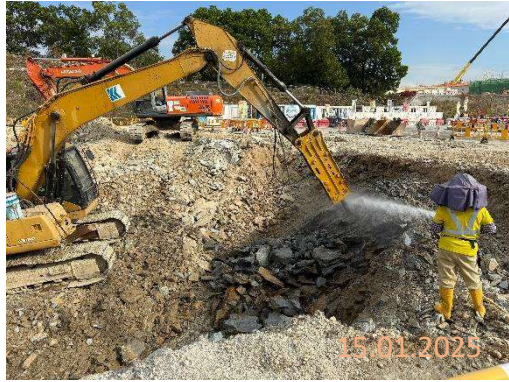
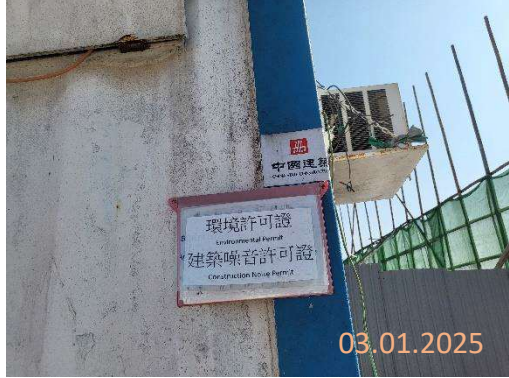
<p data-bbox="1541 639 1912 671">By subcontractor at KNP site</p>
<p data-bbox="203 687 376 815">EIA 4.4.6; EM&A Log 3.2</p>			<p data-bbox="887 687 965 719">Noise</p>	<ul data-bbox="1137 687 1518 863" style="list-style-type: none"> <li data-bbox="1137 687 1518 863">Valid construction noise permit should be obtained and displayed on site

<p data-bbox="1541 1074 1939 1106">By main contractor at KNP site</p>

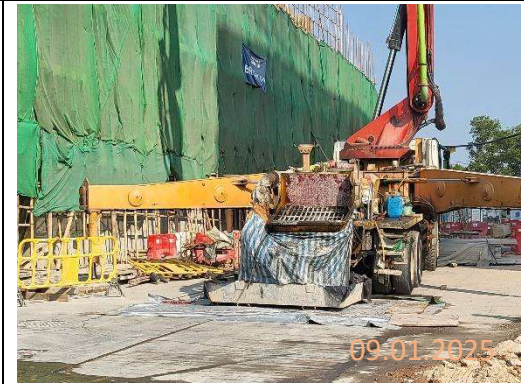
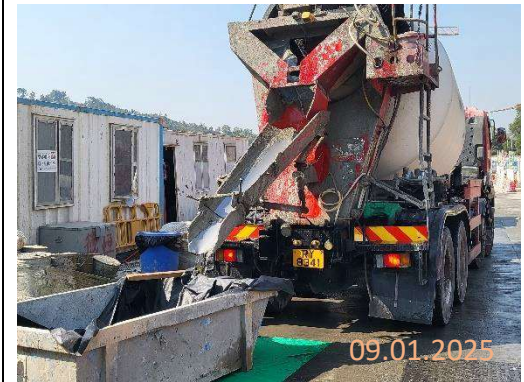
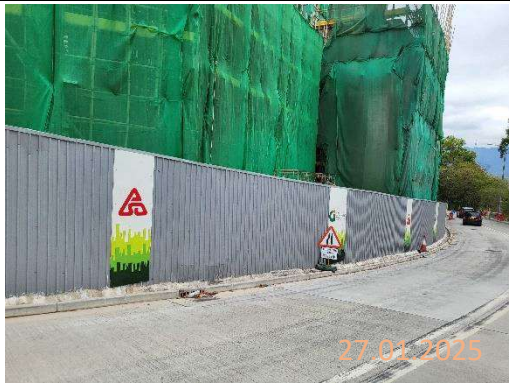
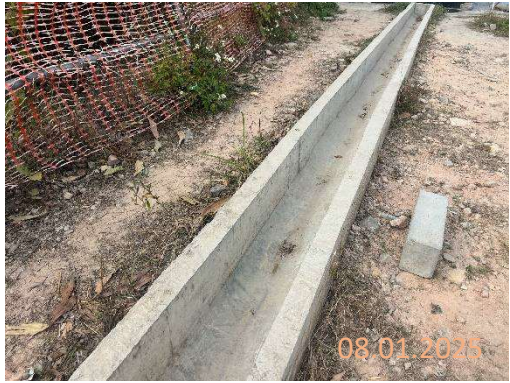
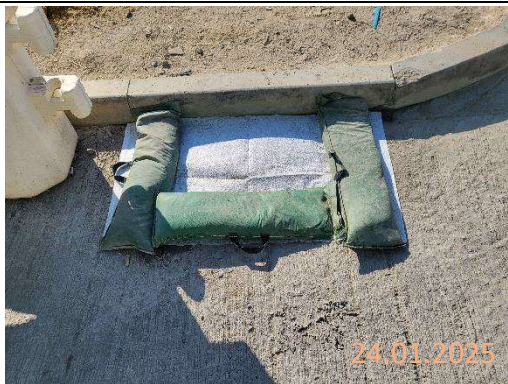
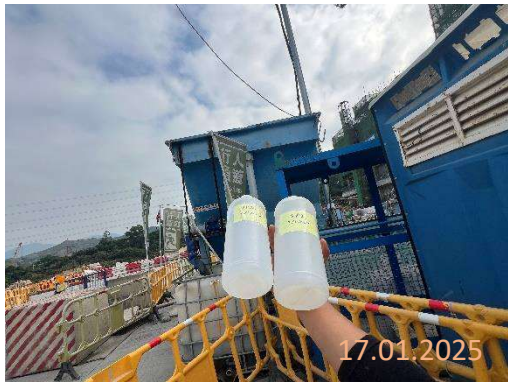
EIA 5.6.1.3
and EM&A
Log 4.2

Water Quality

- Surface water from concrete batching areas and the rest of the site should be separated as far as possible.
- Temporary drainage is free of obstruction.
- Gullies are sealed to prevent silt or debris from entering the drainage system.

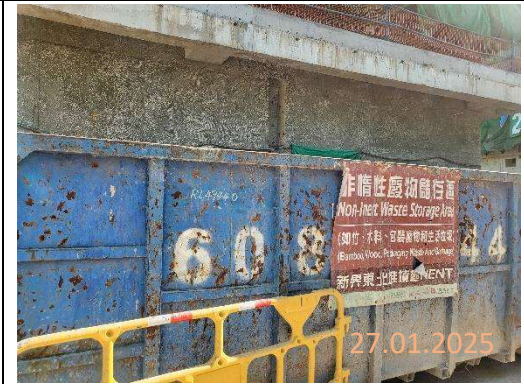
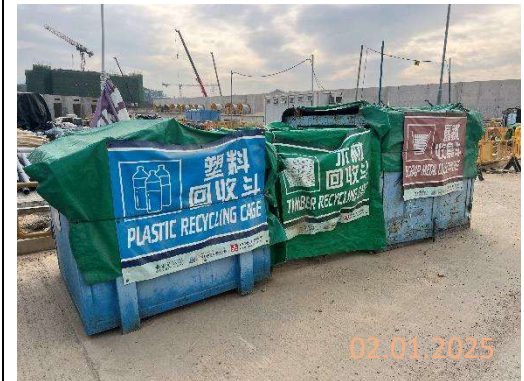
EIA 7.5.1.2
and EM&A
Log 6.2

Waste
Management

- Segregation and storage of different types of waste in different containers or skips or stockpiles to enhance reuse or recycling of materials and their proper disposal
- Sort non-inert C&D materials to recover any recyclable portions

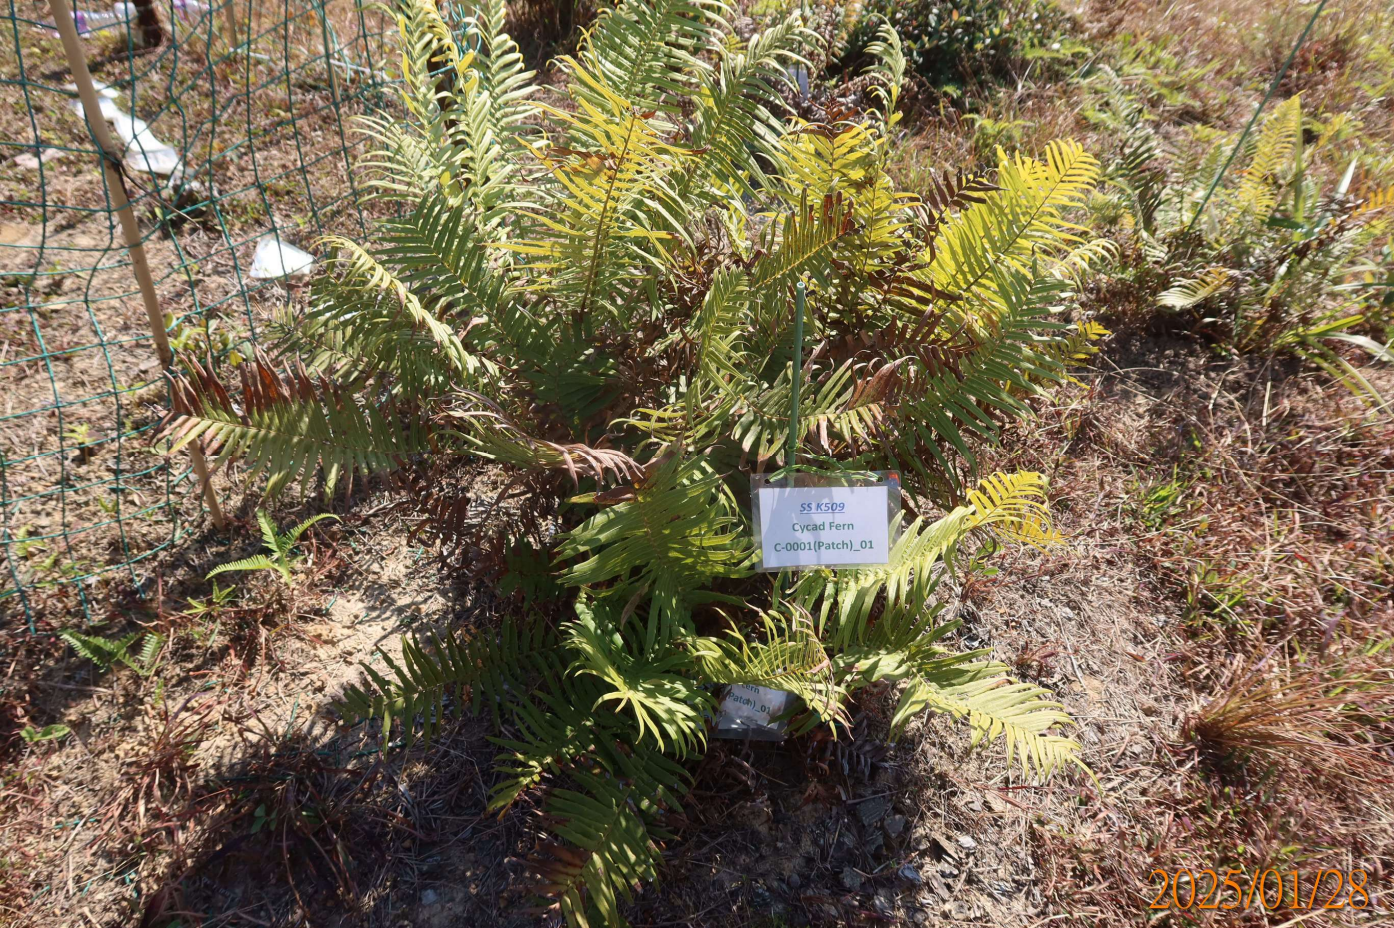
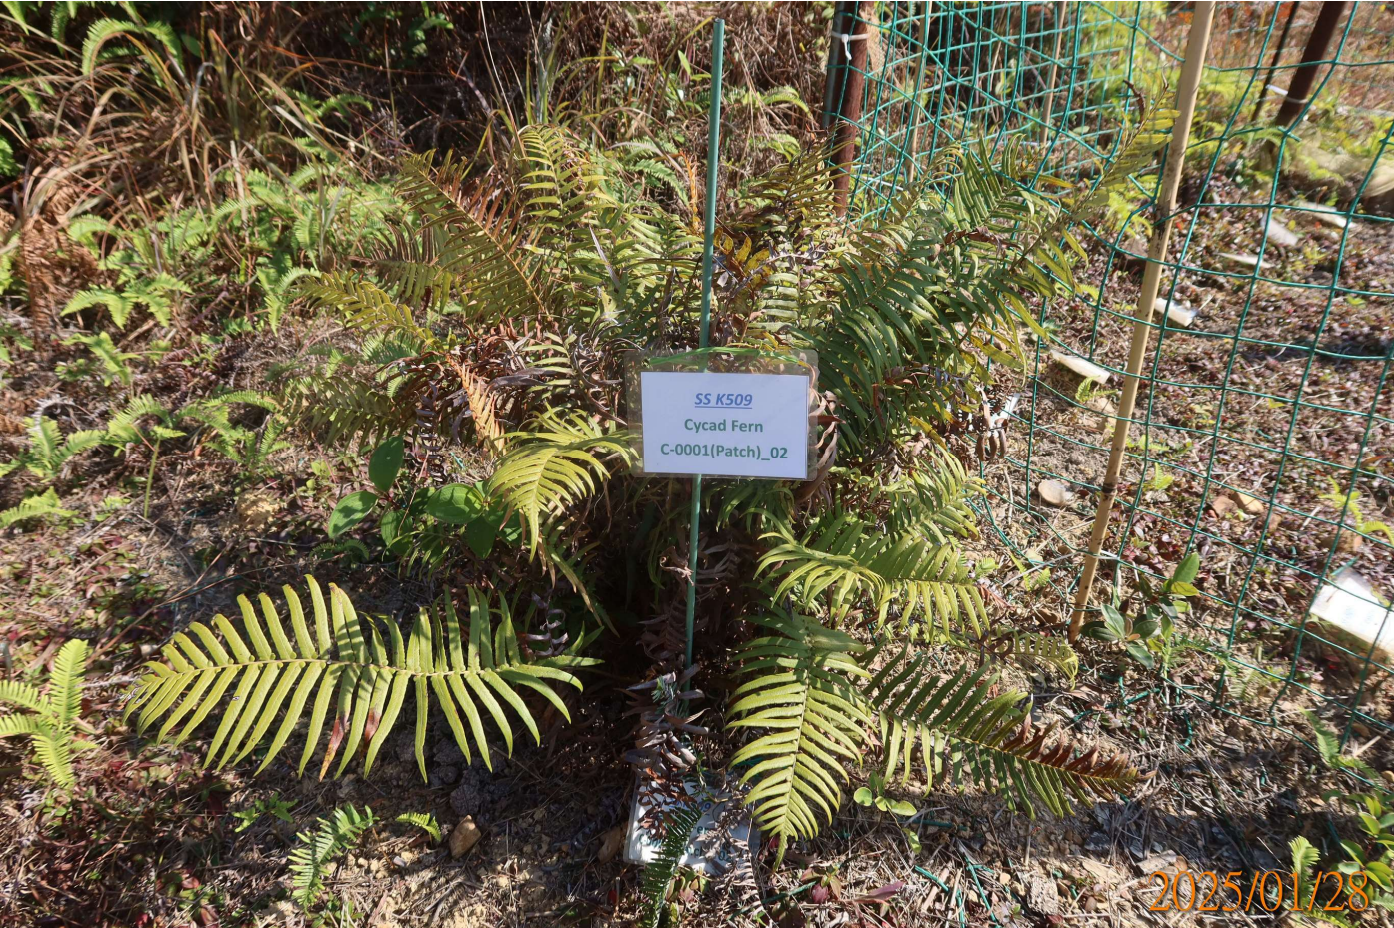
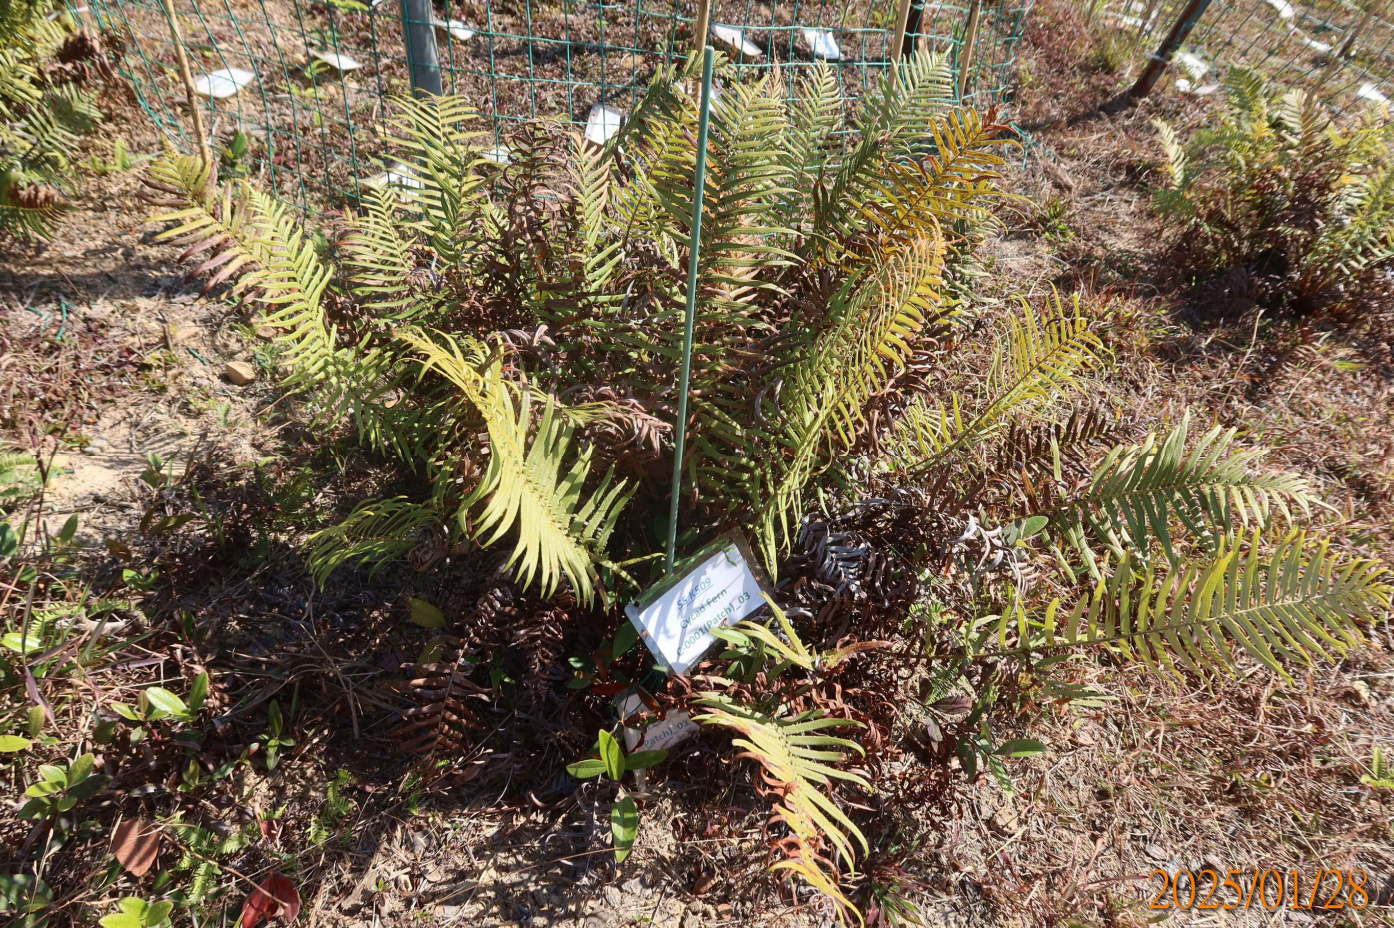
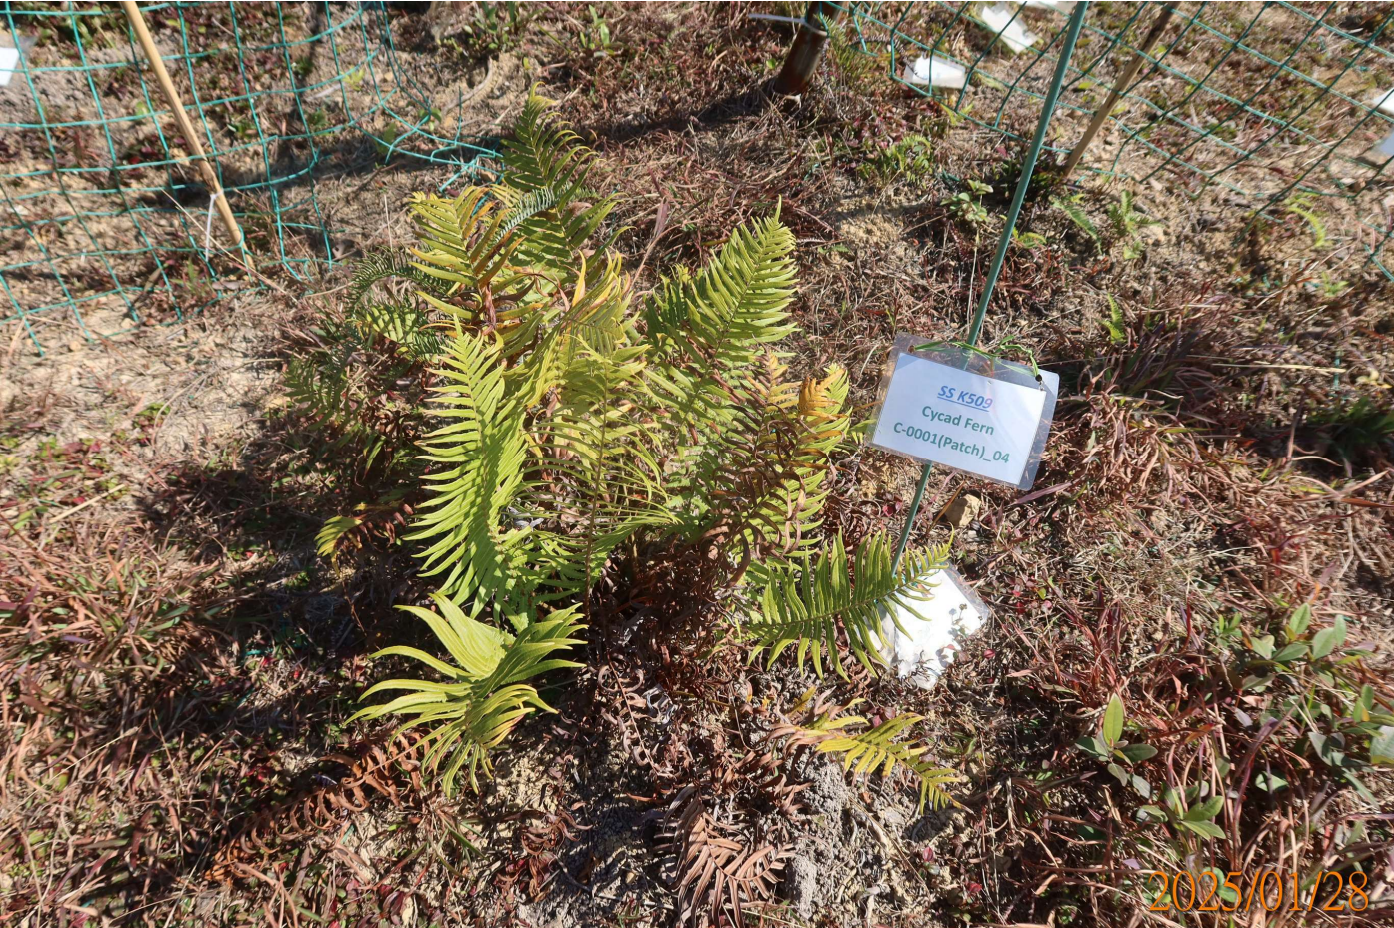
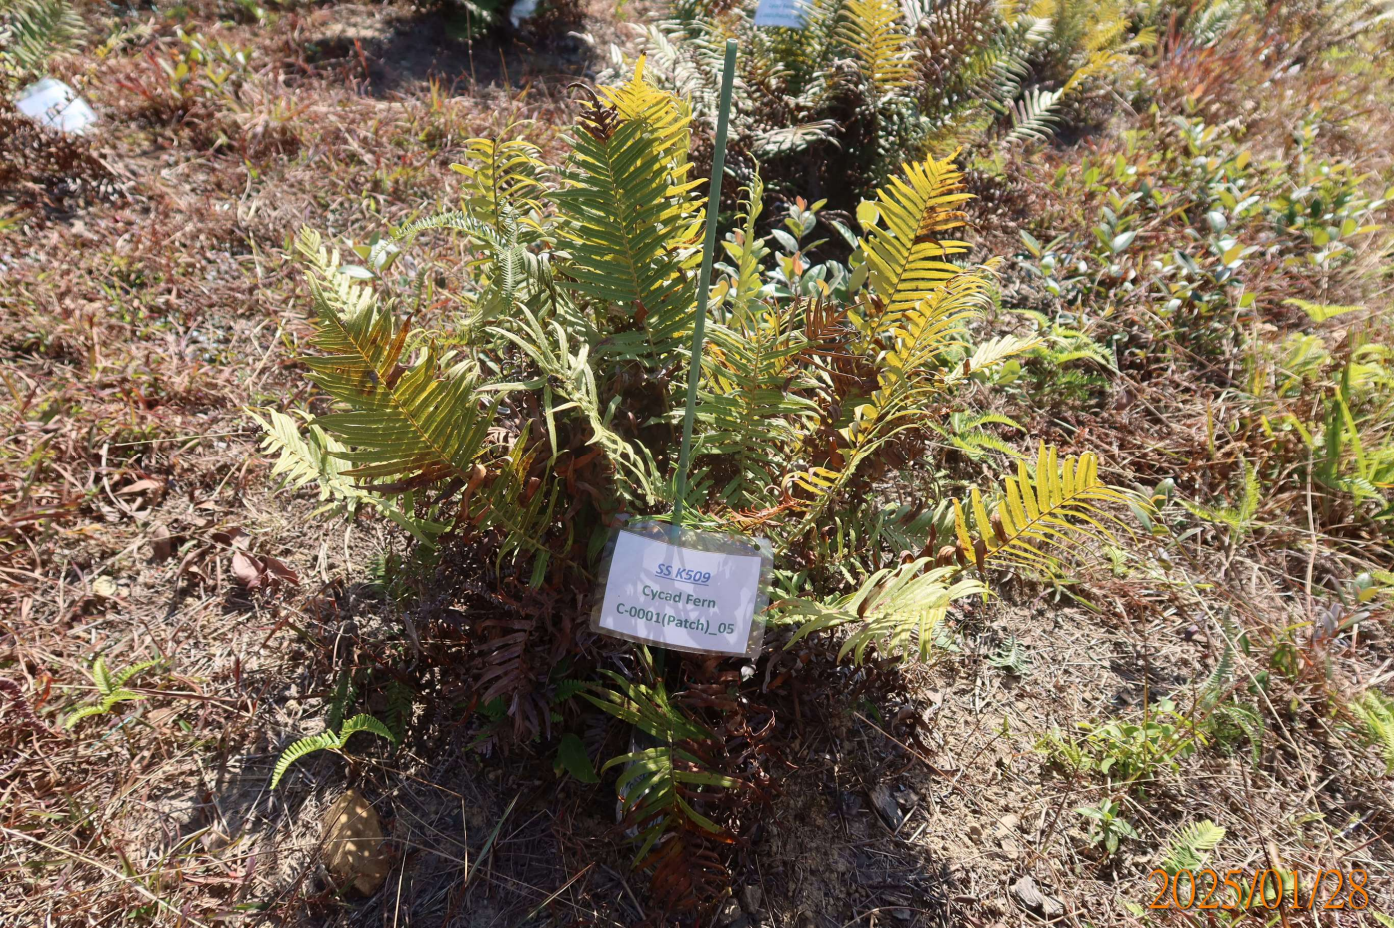
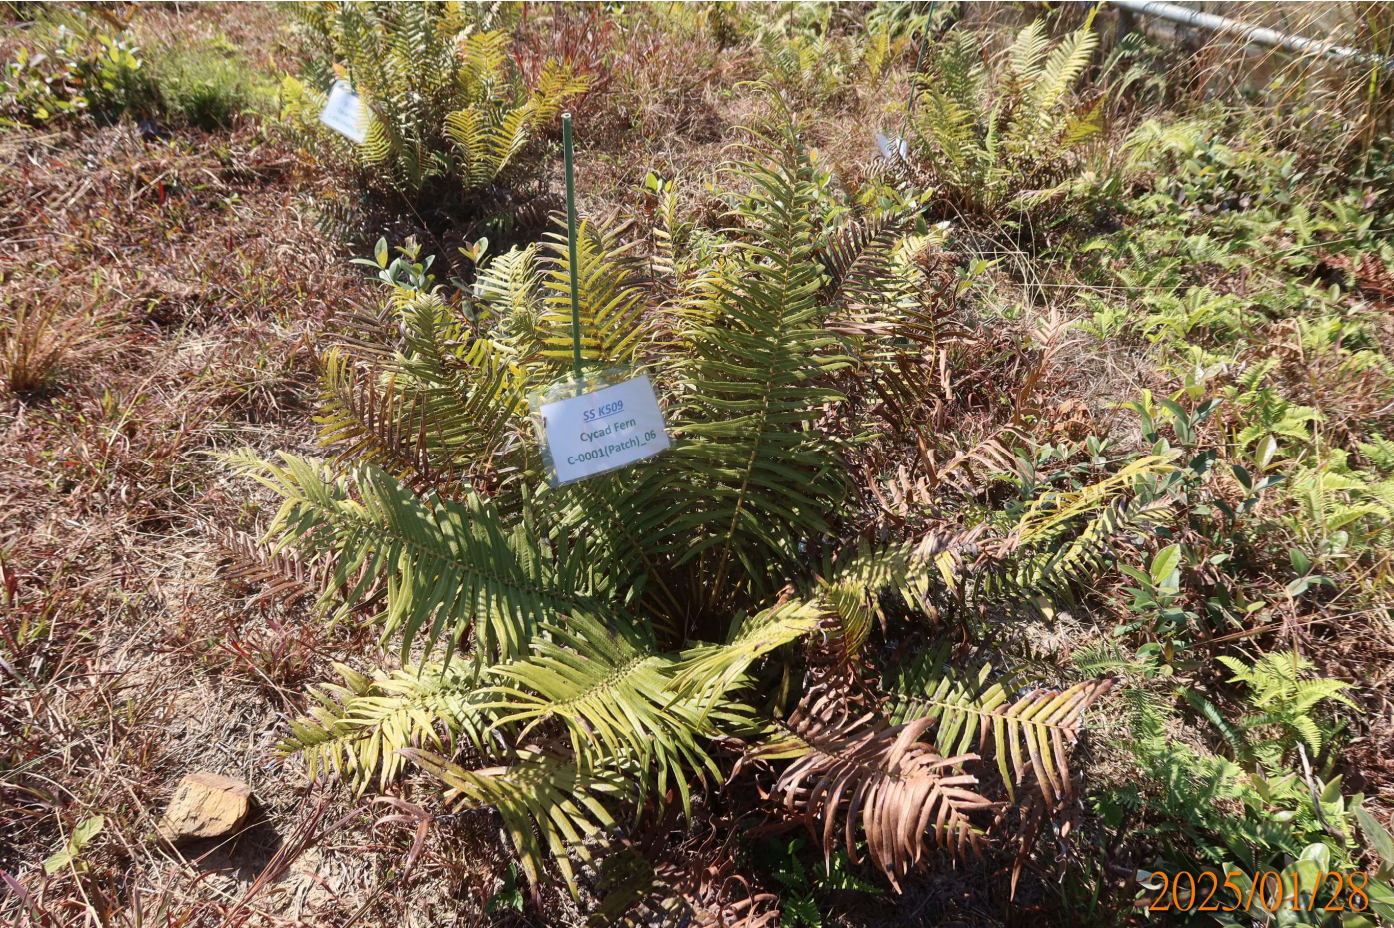
Tree/Plant/ Colony No.	Number of Individuals	Species Name	Form (Good/Fair/Poor)	Health (Good/Fair/Poor)	Remark
C-0001	01	<i>Brainea insignis</i>	F	F	Young leaves observed
	02	<i>Brainea insignis</i>	F	F	Young leaves observed
	03	<i>Brainea insignis</i>	F	F	Young leaves observed
	04	<i>Brainea insignis</i>	F	F	Young leaves observed
	05	<i>Brainea insignis</i>	F	F	Young leaves observed
	06	<i>Brainea insignis</i>	F	F	Young leaves observed
	07	<i>Brainea insignis</i>	F	F	Young leaves observed
	08	<i>Brainea insignis</i>	F	F	Young leaves observed
C-0002	01	<i>Brainea insignis</i>	F	F	Young leaves observed
	02	<i>Brainea insignis</i>	F	F	Young leaves observed
	03	<i>Brainea insignis</i>	F	P	Young leaves observed
	04	<i>Brainea insignis</i>	F	P	Young leaves observed
	05	<i>Brainea insignis</i>	F	F	Young leaves observed
	06	<i>Brainea insignis</i>	F	F	Young leaves observed
	07	<i>Brainea insignis</i>	F	F	Young leaves observed

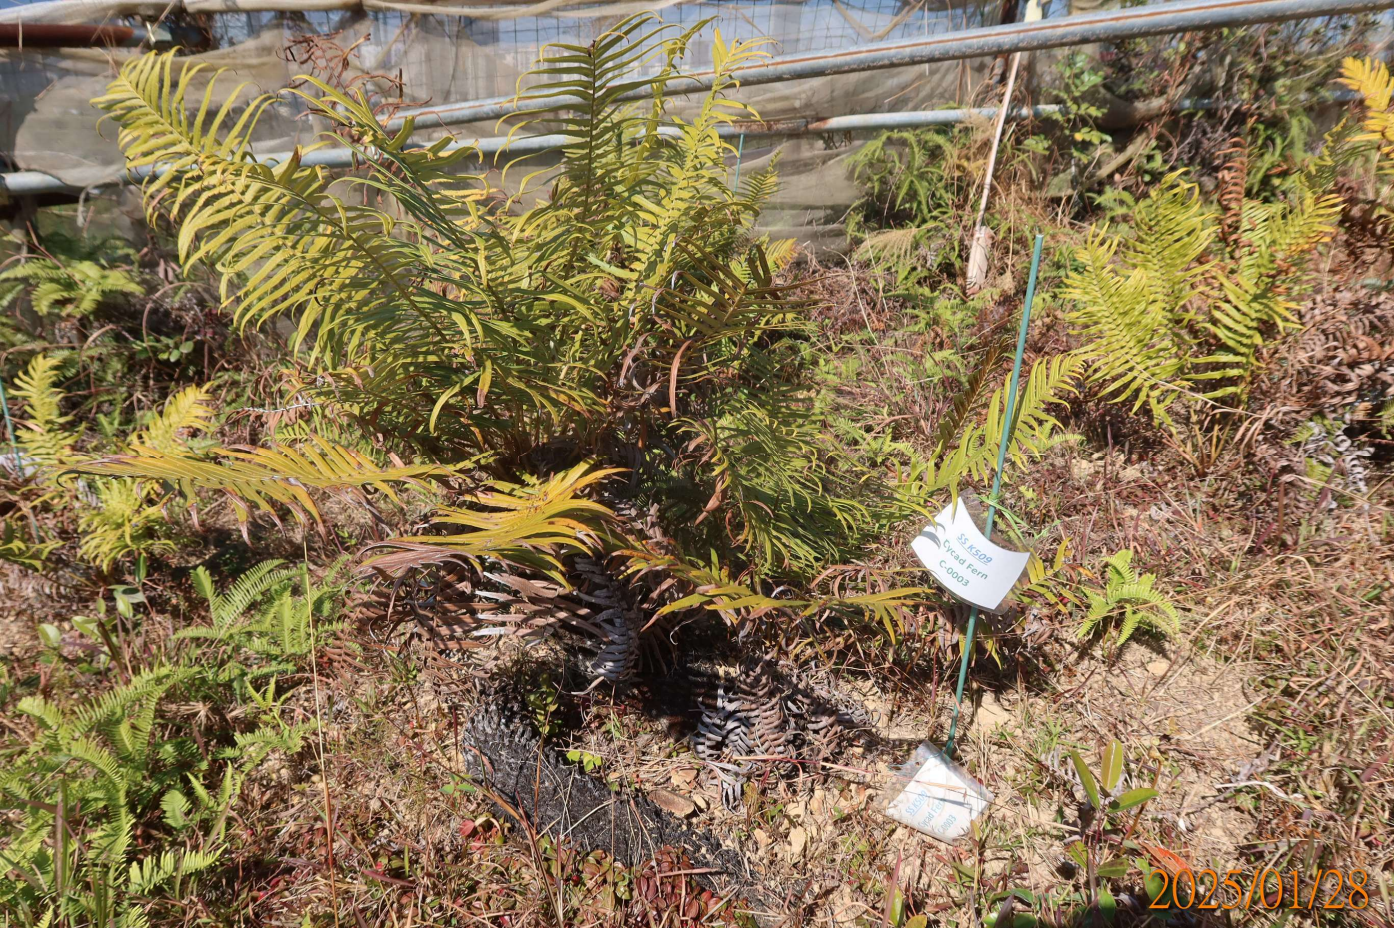
08	<i>Brainea insignis</i>	F	F	Young leaves observed
C-0003	01	<i>Brainea insignis</i>	F	F	Young leaves observed
C-0004	01	<i>Brainea insignis</i>	P	P	Young leaves at base; Dry out caused by bushfire initially outside site boundary and high temperature on 2 Feb 2021
	02	<i>Brainea insignis</i>	F	F	Young leaves observed
	03	<i>Brainea insignis</i>	F	F	Young leaves observed
	04	<i>Brainea insignis</i>	F	F	Young leaves observed
	05	<i>Brainea insignis</i>	F	F	Young leaves observed
	06	<i>Brainea insignis</i>	F	F	Young leaves observed
	07	<i>Brainea insignis</i>	F	F	Young leaves observed
	08	<i>Brainea insignis</i>	F	F	Young leaves observed
	09	<i>Brainea insignis</i>	P	P	Dry out caused by bushfire initially outside site boundary and high temperature on 2 Feb 2021
	10	<i>Brainea insignis</i>	F	P	Young leaves at base
	11	<i>Brainea insignis</i>	F	F	Young leaves observed
	12	<i>Brainea insignis</i>	F	P	Young leaves observed

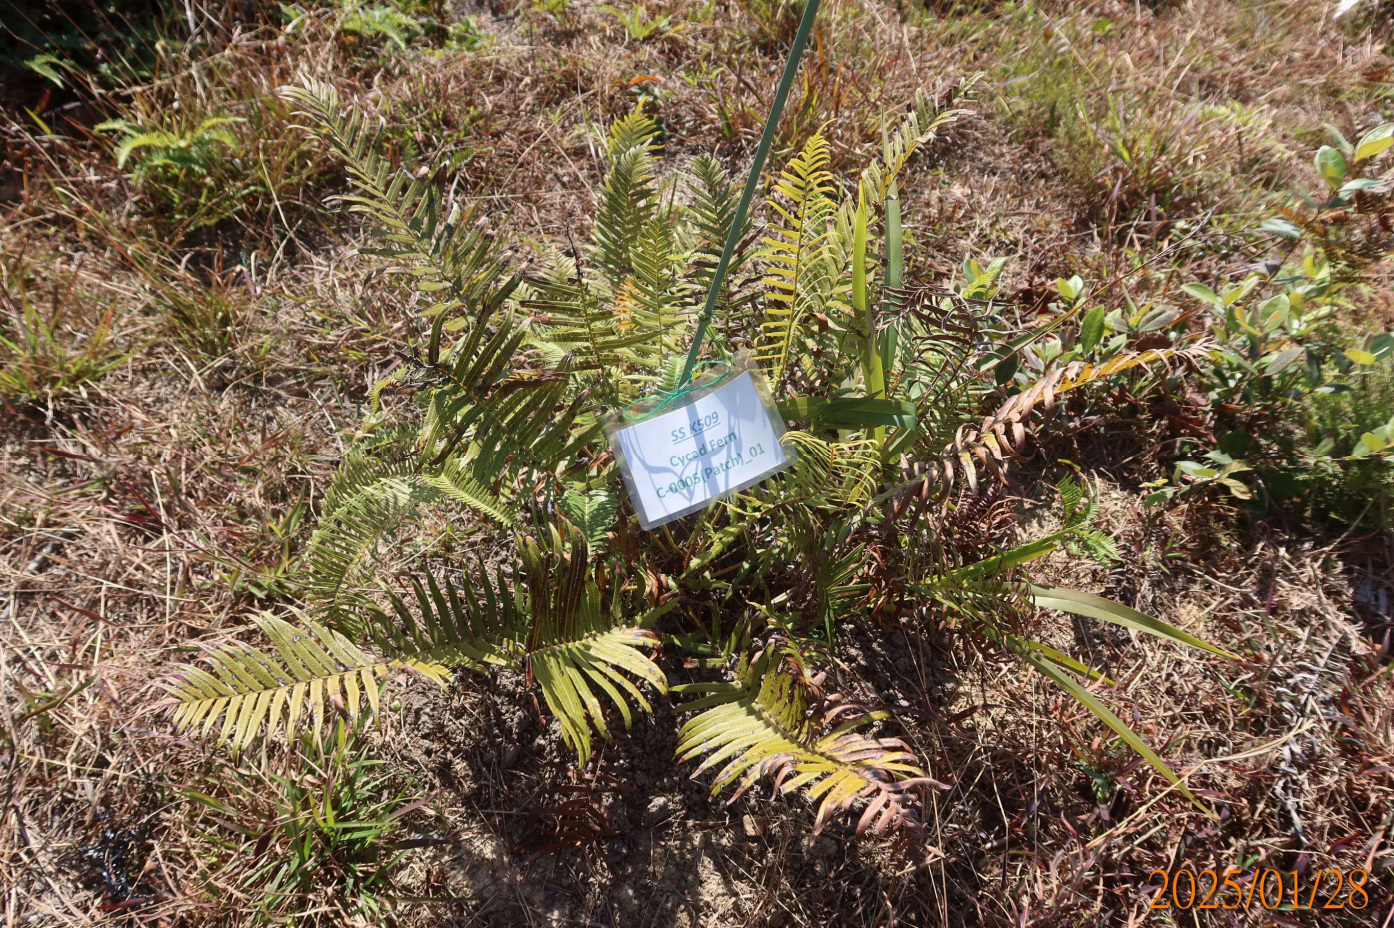
C-0005(Patch)_01

Tree/Plant/ Colony No.	Number of Individuals	Species Name	Form (Good/Fair/Poor)	Health (Good/Fair/Poor)	Remark
C-0005	01	<i>Brainea insignis</i>	F	F	Young leaves observed
	02	<i>Brainea insignis</i>	F	F	Young leaves observed
	03	<i>Brainea insignis</i>	F	F	Young leaves observed
	04	<i>Brainea insignis</i>	F	F	Young leaves observed
	05	<i>Brainea insignis</i>	F	P	Young leaves observed
	06	<i>Brainea insignis</i>	F	F	Young leaves observed
	07	<i>Brainea insignis</i>	F	F	Young leaves observed
C-0006	01	<i>Brainea insignis</i>	F	F	Young leaves observed
C-0007	01	<i>Brainea insignis</i>	F	F	Young leaves observed
	02	<i>Brainea insignis</i>	F	P	-
C-0008	01	<i>Brainea insignis</i>	F	F	Young leaves observed
	02	<i>Brainea insignis</i>	F	F	Young leaves observed
	03	<i>Brainea insignis</i>	P	P	Young leaves observed
	04	<i>Brainea insignis</i>	F	F	Young leaves observed
	05	<i>Brainea insignis</i>	F	F	Young leaves observed

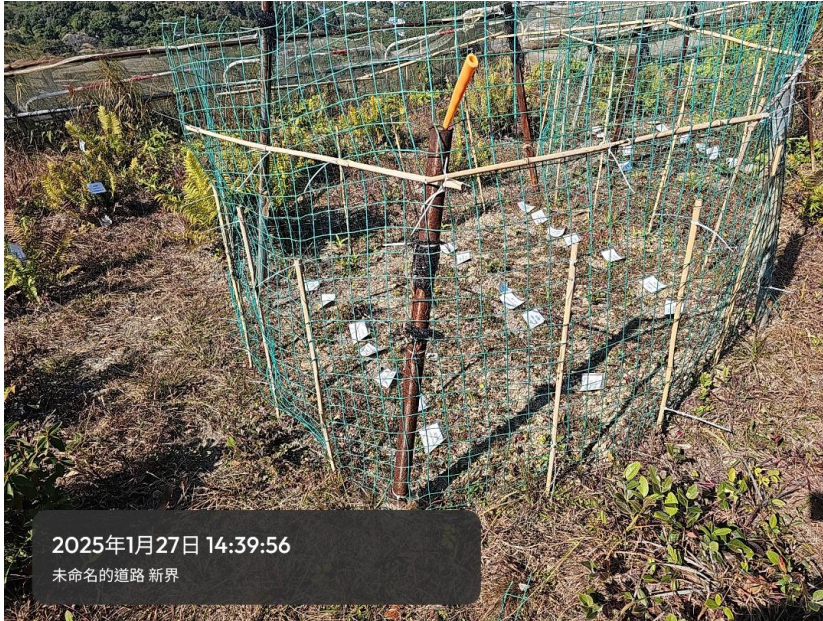
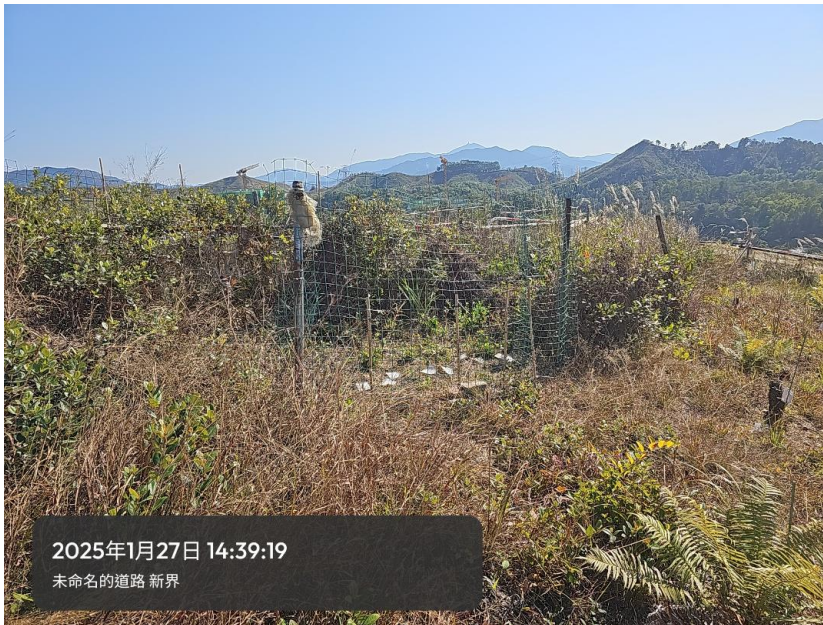
- 1) Please refer to the guidelines on soil improvement issued by the Greening, Landscape and Tree Management Section (GLTMS) of the development bureau (2022) to apply to monitoring and maintenance of transplanted flora species.
- 2) Daily watering frequency is needed to keep the soil moist.
- 3) Installation of a shaded net is provided below.
- 4) The wild plants that are growing in undesirable areas should be removed.
- 5) The Black Shade Net should be installed.

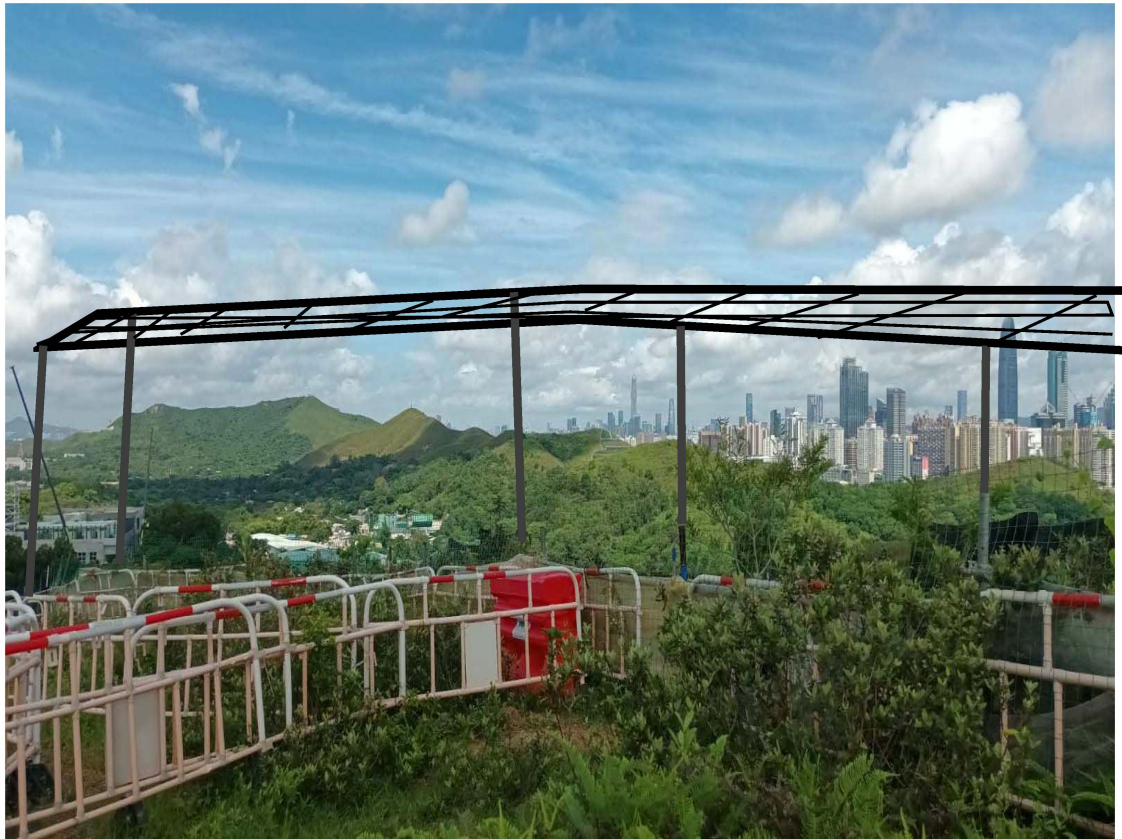
The installation of a shaded net

Remark: Non scale & Conceptual drawing
