**EP-510/2016 – Police Facilities in Kong Nga Po**

**Service Contract No. NDO 07/2019  
Environmental Team for Site Formation and  
Infrastructure Works for Police Facilities in  
Kong Nga Po**

**Monthly Environmental Monitoring and  
Audit Report for January 2025  
(Version 1.0)**

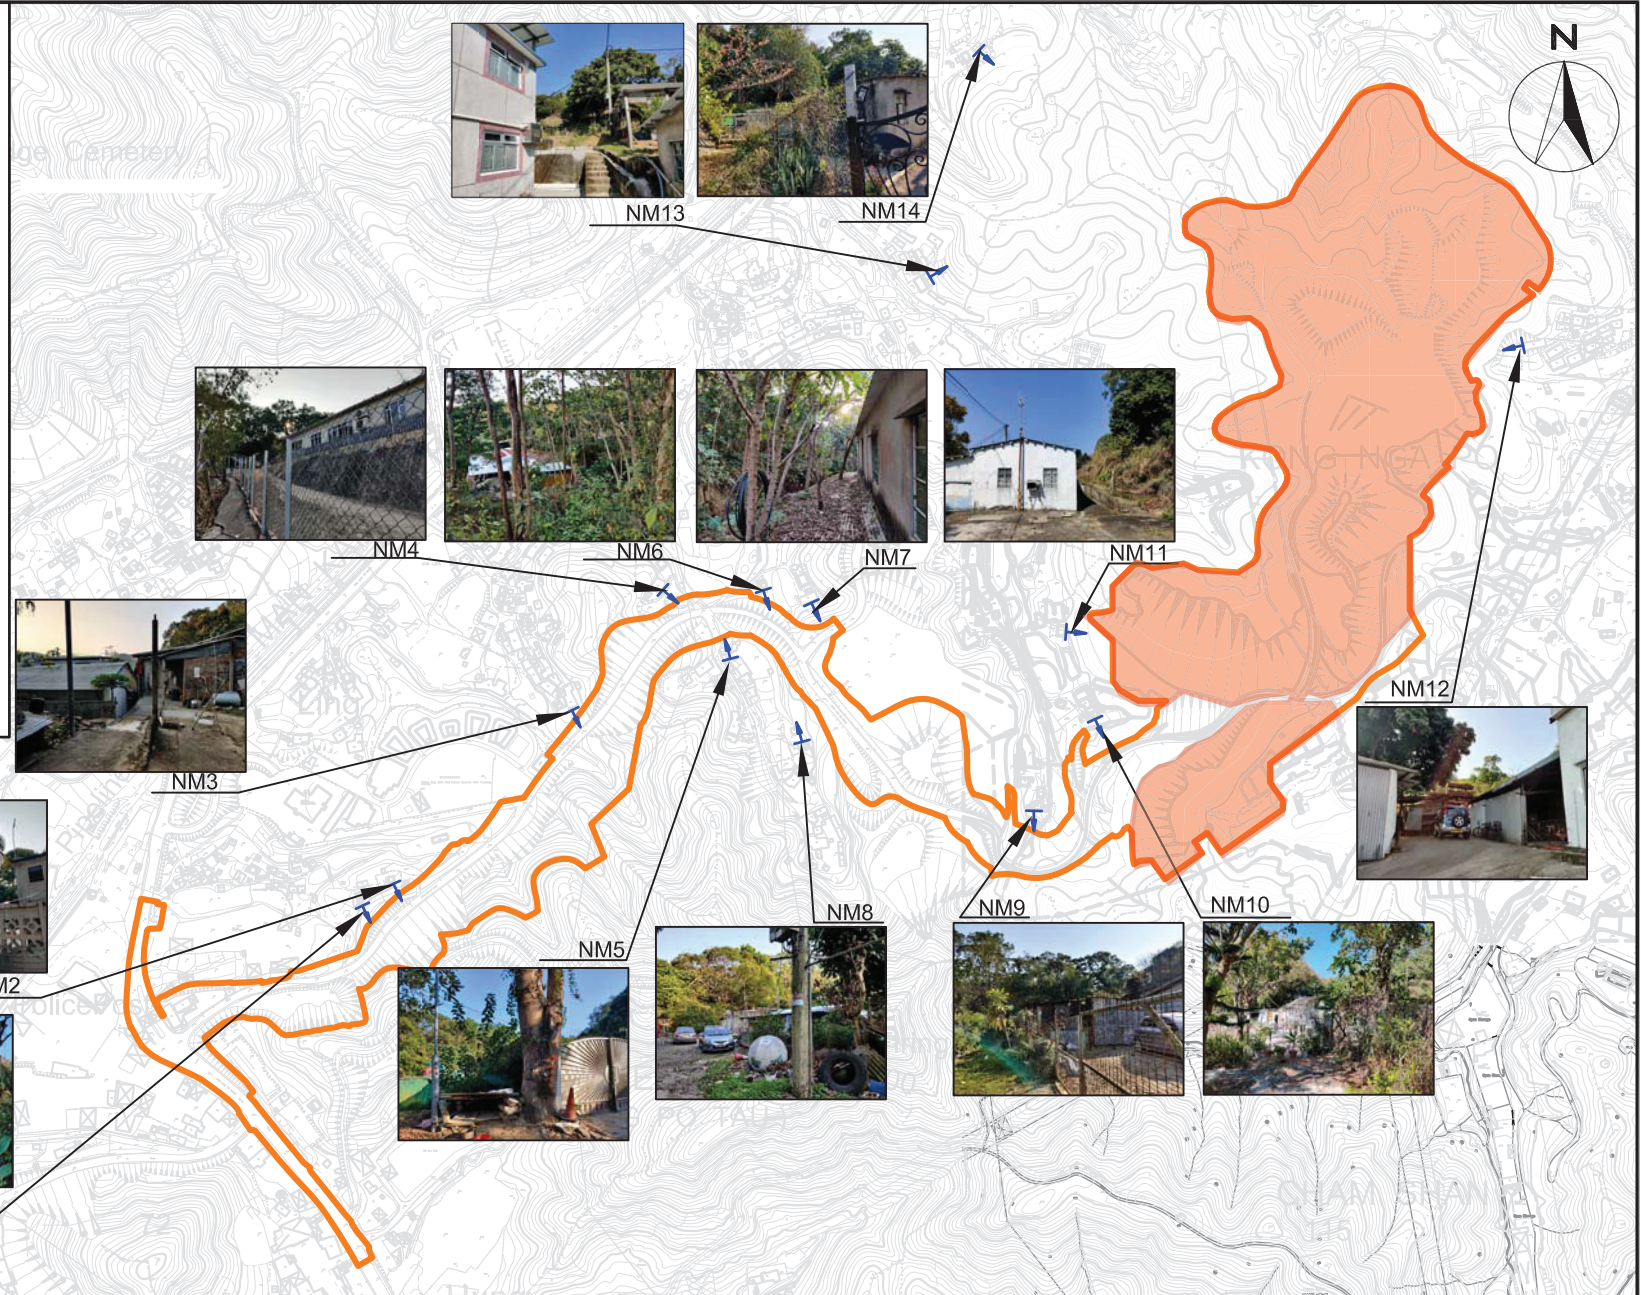
**Noise Monitoring Stations**

Noise Monitoring Stations	
ID	Description
NM1	Village House, Sha Ling
NM2	Village House, Sha Ling
NM3	Village House No. 248, Sha Ling
NM4	Village House, Sha Ling
NM5	Village House No. 270, Sha Ling
NM6	Village House, Sha Ling
NM7	Village House, Sha Ling
NM8	Village House, Sha Ling
NM9	Village House, Kong Nga Po
NM10	Village House, Kong Nga Po
NM11	Village House, Kong Nga Po
NM12	Village House, Kong Nga Po
NM13	Village House, Kong Nga Po
NM14	Village House, near Man Kam To Road

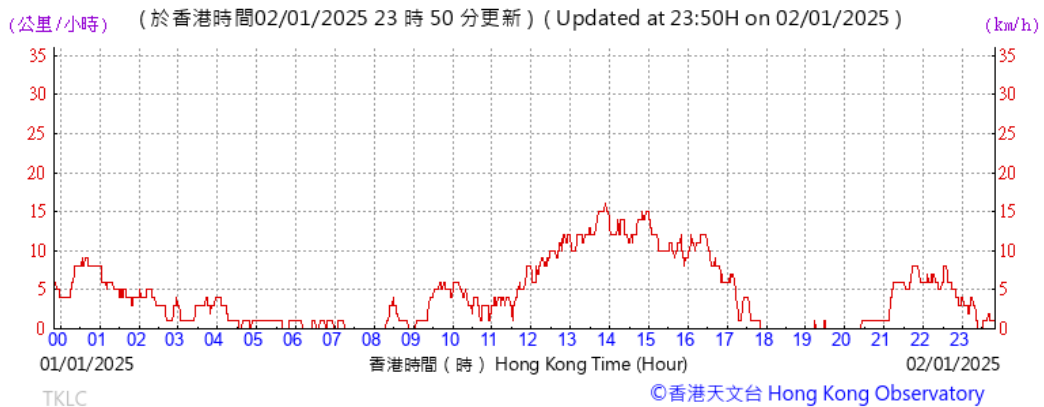
## 2 January 2025

Title Service Contract No. NDO 07/2019 Environmental Team for Site Formation and Infrastructure Works for Police Facilities in Kong Nga Po  Meteorological Data at Ta Kwu Ling Weather Station	Scale N.T.S	Project No. WMA20001	consulting . testing . research
	Date Jan 25	Appendix G

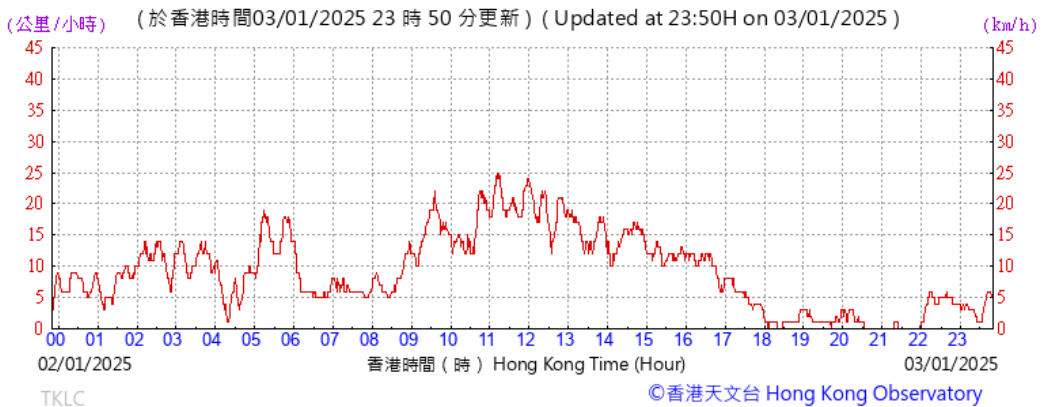
### 3 January 2025

Title	Service Contract No. NDO 07/2019	Scale	Project No. WMA20001	
	Environmental Team for Site Formation and Infrastructure Works for Police Facilities in Kong Nga Po	N.T.S	Appendix	
Meteorological Data at Ta Kwu Ling Weather Station		Date	G	
		Jan 25

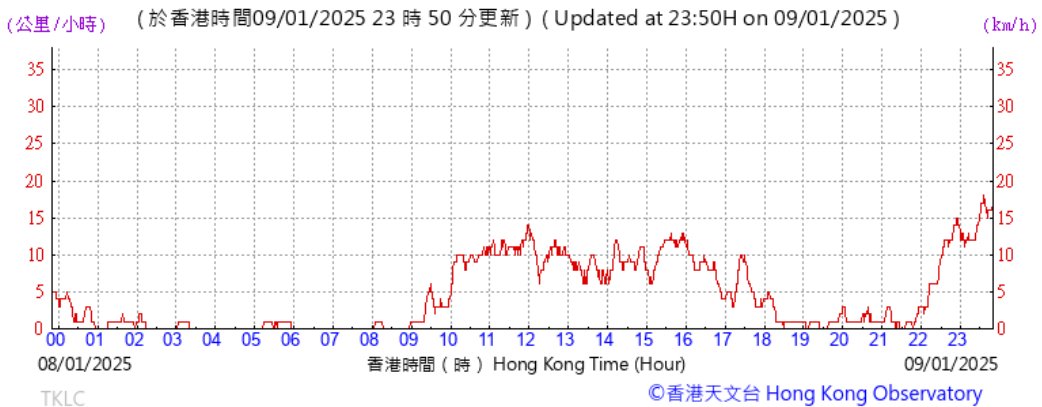
# 9 January 2025

Title	Service Contract No. NDO 07/2019	Scale	Project No. WMA20001	
	Environmental Team for Site Formation and Infrastructure Works for Police Facilities in Kong Nga Po	N.T.S	Appendix	
Meteorological Data at Ta Kwu Ling Weather Station		Date	G	
		Jan 25

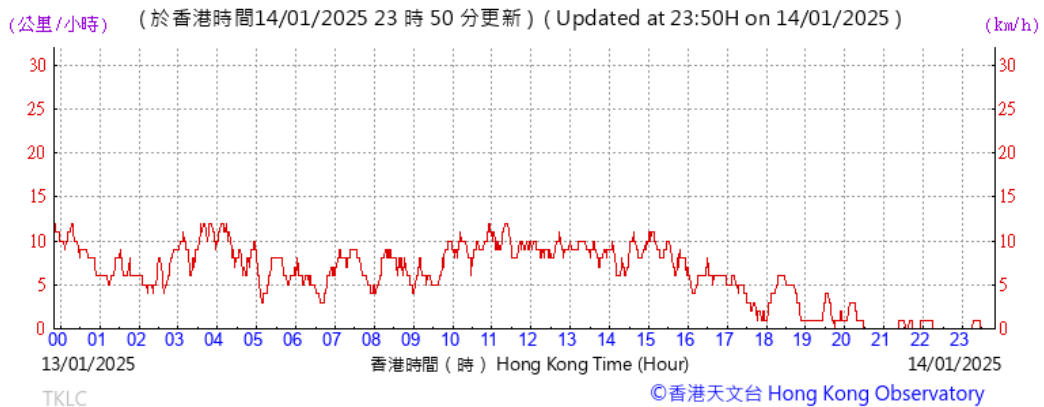
# 14 January 2025

Title	Service Contract No. NDO 07/2019	Scale	Project No. WMA20001	
	Environmental Team for Site Formation and Infrastructure Works for Police Facilities in Kong Nga Po	N.T.S	Appendix	
Meteorological Data at Ta Kwu Ling Weather Station		Date	G	
		Jan 25

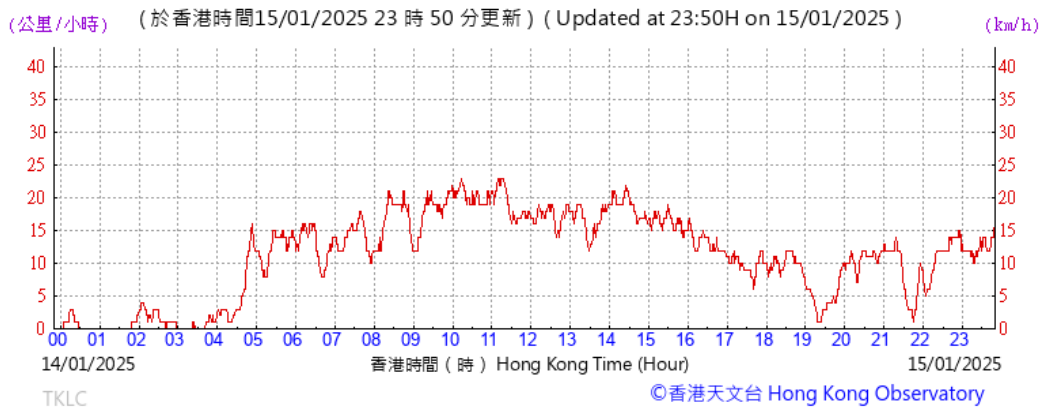
# 15 January 2025

Title	Service Contract No. NDO 07/2019	Scale	Project	
	Environmental Team for Site Formation and Infrastructure Works for Police Facilities in Kong Nga Po	N.T.S	No. WMA20001	
Meteorological Data at Ta Kwu Ling Weather Station		Date	Appendix	
		Jan 25	G

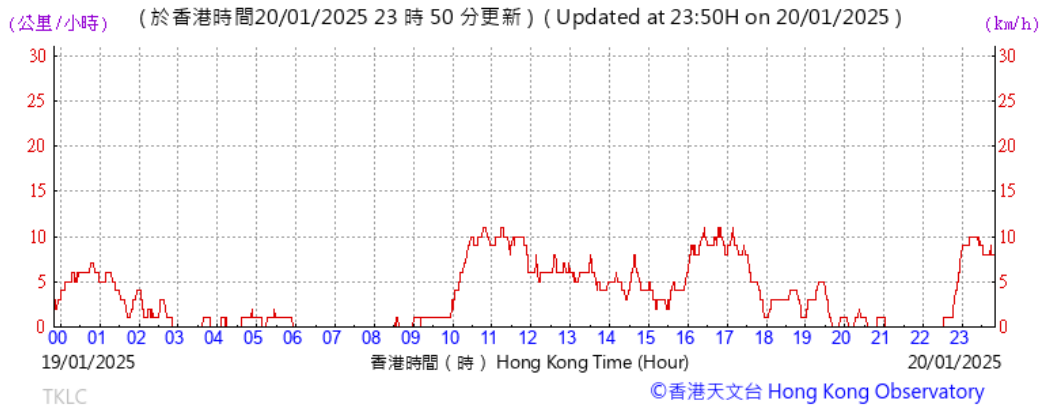
## 20 January 2025

Title Service Contract No. NDO 07/2019 Environmental Team for Site Formation and Infrastructure Works for Police Facilities in Kong Nga Po  Meteorological Data at Ta Kwu Ling Weather Station	Scale N.T.S	Project No. WMA20001	
	Date Jan 25	Appendix G

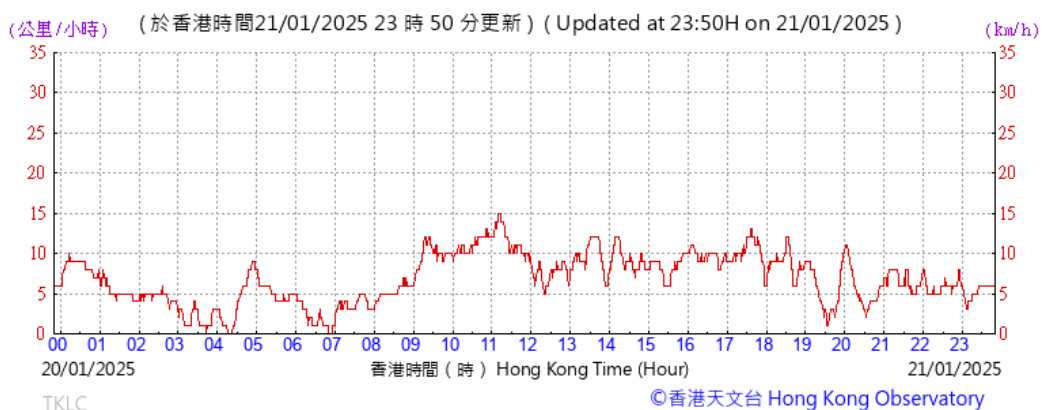
## 21 January 2025

Title Service Contract No. NDO 07/2019 Environmental Team for Site Formation and Infrastructure Works for Police Facilities in Kong Nga Po  Meteorological Data at Ta Kwu Ling Weather Station	Scale N.T.S	Project No. WMA20001	consulting . testing . research
	Date Jan 25	Appendix G

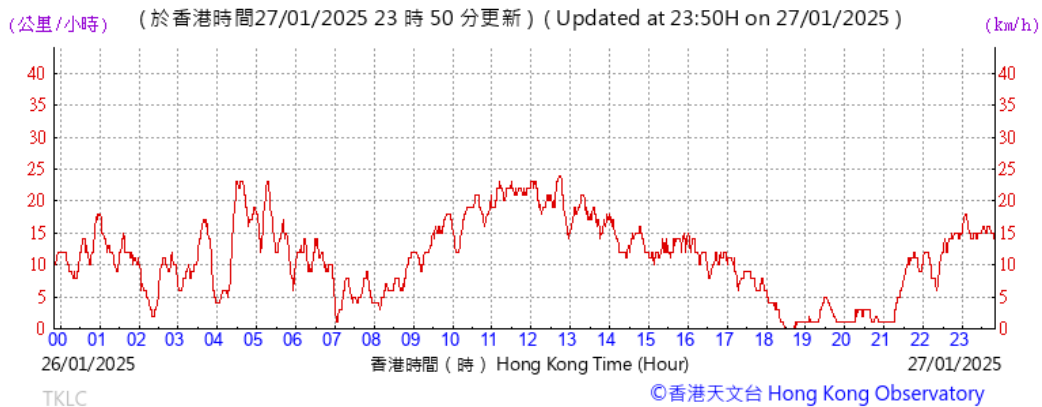
## 27 January 2025

Title Service Contract No. NDO 07/2019 Environmental Team for Site Formation and Infrastructure Works for Police Facilities in Kong Nga Po  Meteorological Data at Ta Kwu Ling Weather Station	Scale N.T.S	Project No. WMA20001	consulting . testing . research
	Date Jan 25	Appendix G

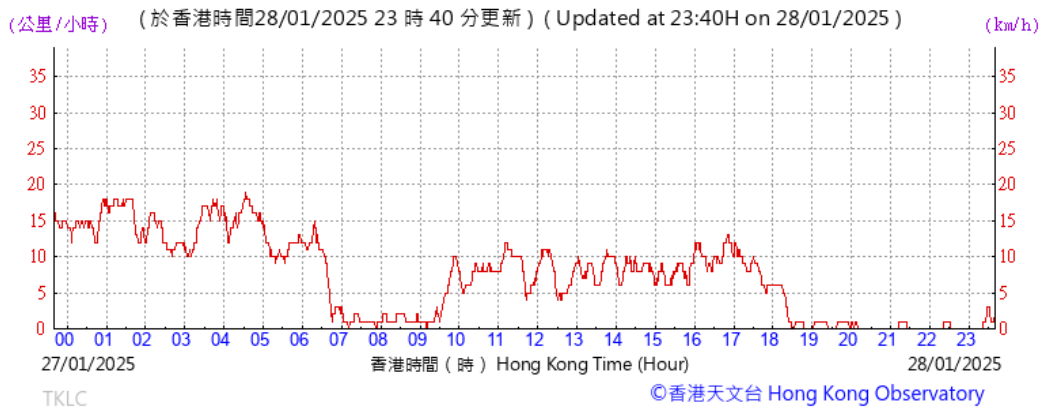
## 28 January 2025

Title Service Contract No. NDO 07/2019 Environmental Team for Site Formation and Infrastructure Works for Police Facilities in Kong Nga Po  Meteorological Data at Ta Kwu Ling Weather Station	Scale N.T.S	Project No. WMA20001	
	Date Jan 25	Appendix G
