EP-510/2016 – Police Facilities in Kong Nga Po

**Service Contract No. NDO 07/2019
Environmental Team for Site Formation and
Infrastructure Works for Police Facilities in
Kong Nga Po**

**Monthly Environmental Monitoring and
Audit Report for March 2025
(Version 1.0)**

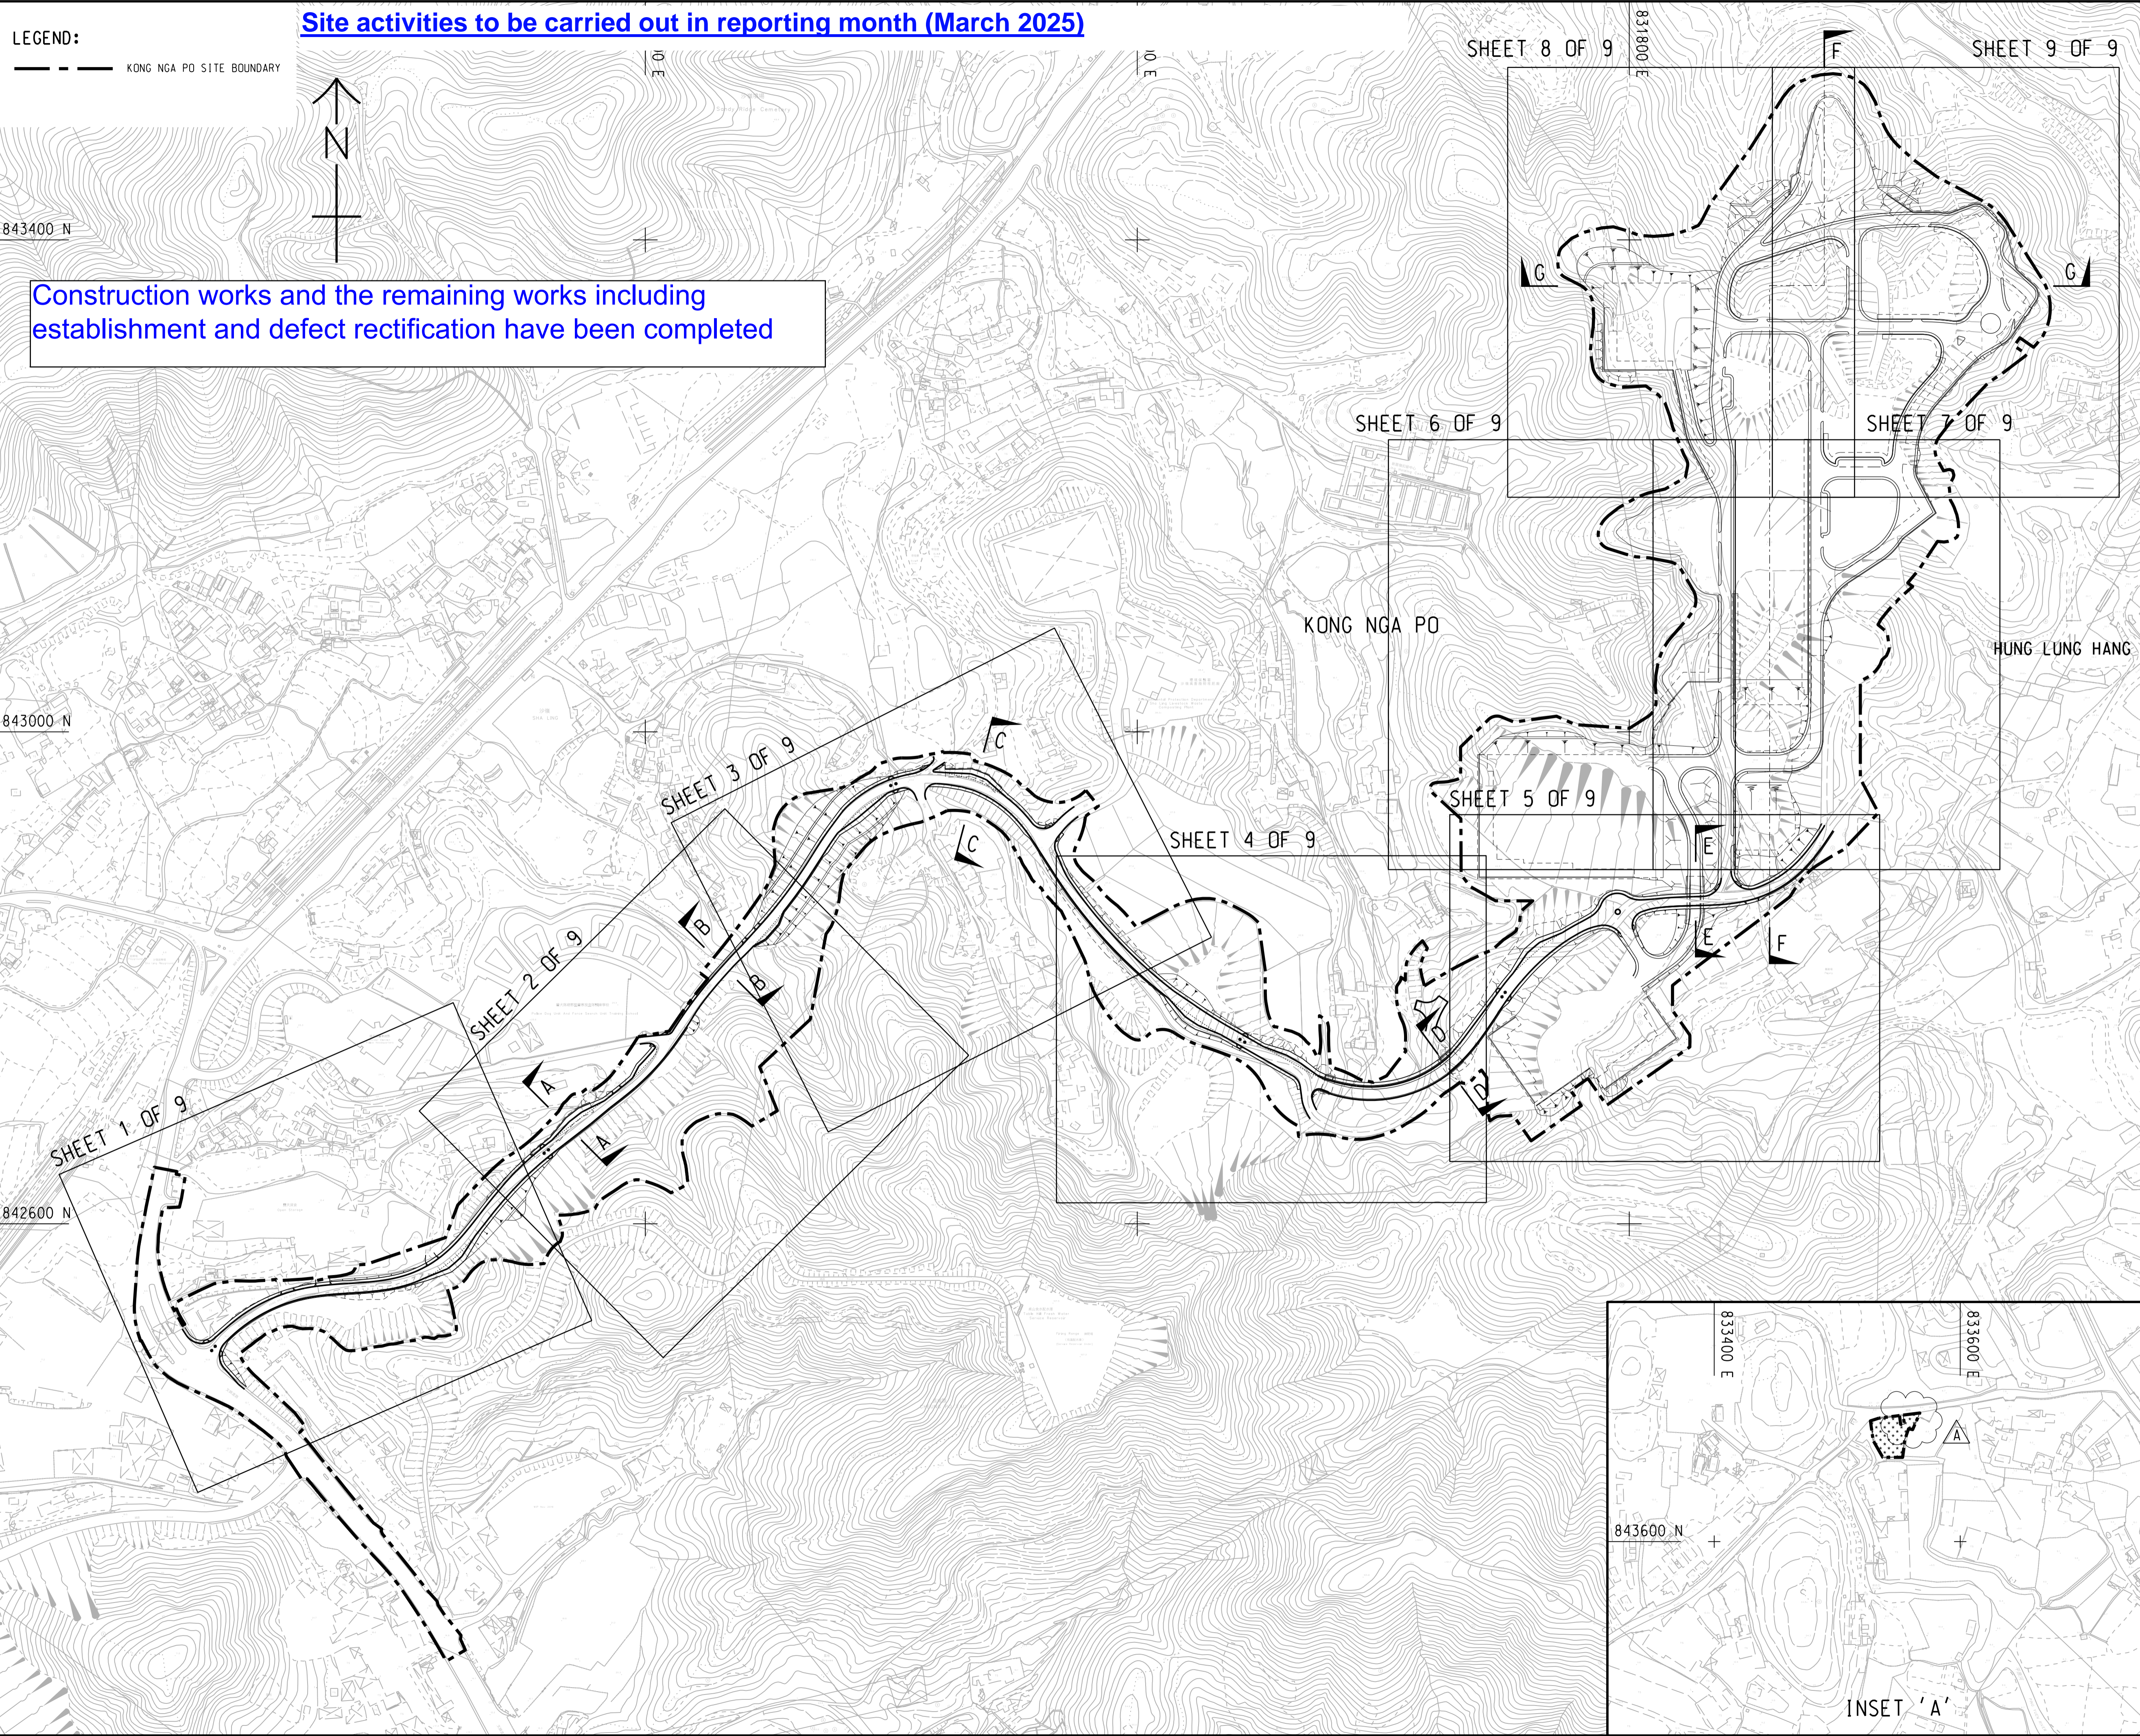
Site activities to be carried out in reporting month (March 2025)

Construction works and the remaining works including establishment and defect rectification have been completed

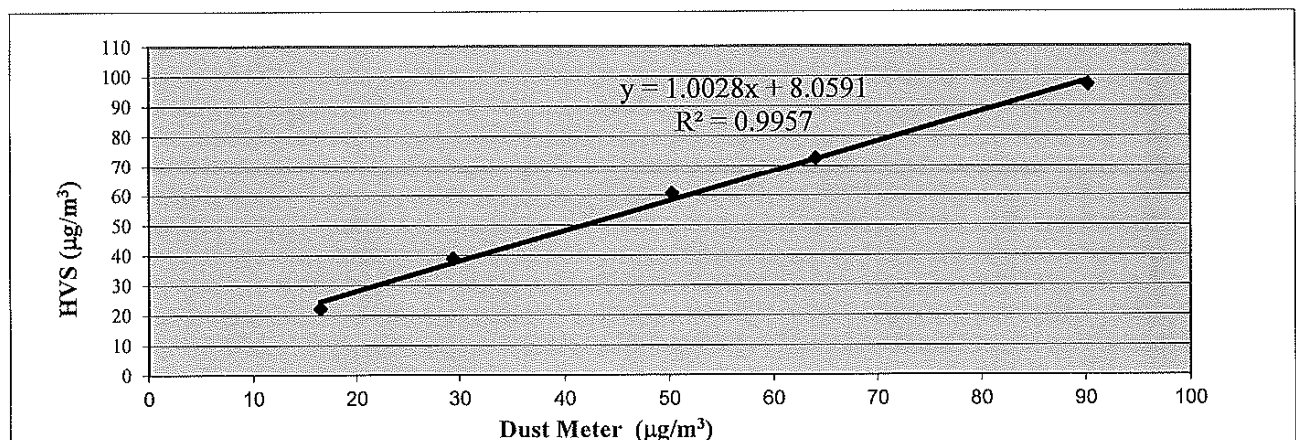
Set Correlation Factor	
Particulate Concentration by High Volume Sampler ($\mu\text{g}/\text{m}^3$)	58.3
Particulate Concentration by Dust Meter ($\mu\text{g}/\text{m}^3$)	50.1
Measuring time, (min)	60

Set Correlation Factor , SCF
 $\text{SCF} = |K = \text{High Volume Sampler} / \text{Dust Meter, } (\mu\text{g}/\text{m}^3) |$ 1.164

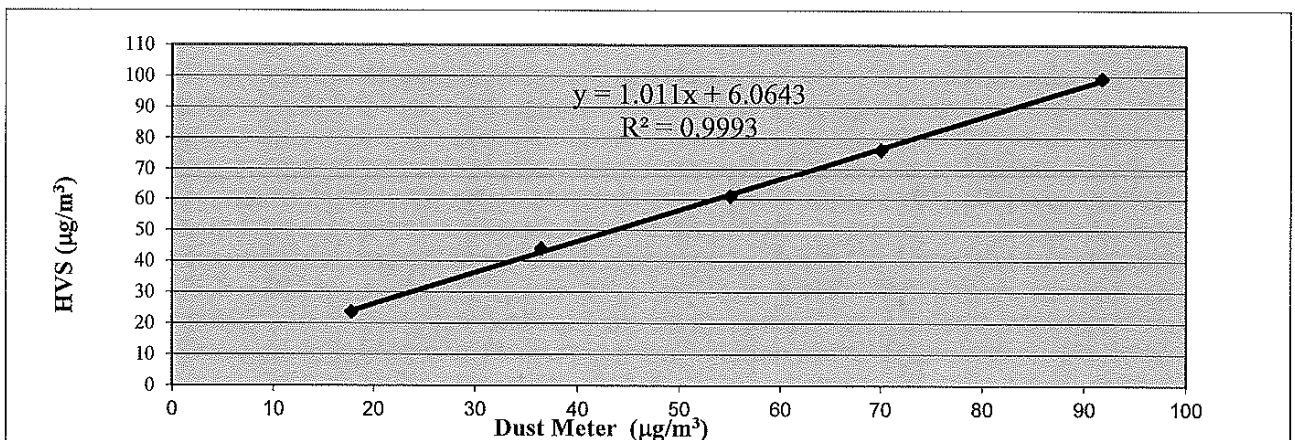
Set Correlation Factor	
Particulate Concentration by High Volume Sampler ($\mu\text{g}/\text{m}^3$)	60.9
Particulate Concentration by Dust Meter ($\mu\text{g}/\text{m}^3$)	54.3
Measuring time, (min)	60

Set Correlation Factor , SCF
 SCF = [K=High Volume Sampler / Dust Meter, ($\mu\text{g}/\text{m}^3$)] 1.123

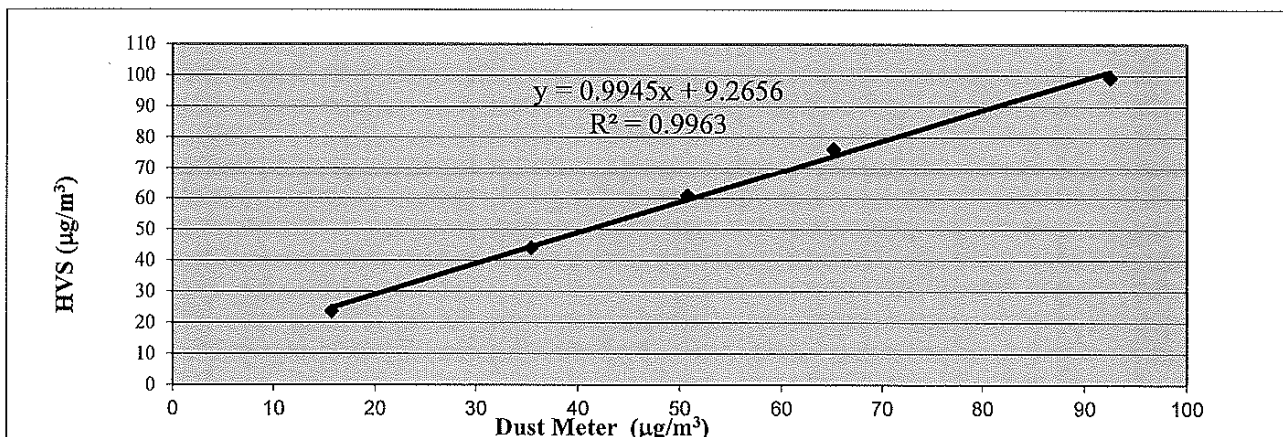
Set Correlation Factor	
Particulate Concentration by High Volume Sampler ($\mu\text{g}/\text{m}^3$)	60.9
Particulate Concentration by Dust Meter ($\mu\text{g}/\text{m}^3$)	51.9
Measuring time, (min)	60

Set Correlation Factor, SCF
 $\text{SCF} = | \text{K} = \text{High Volume Sampler} / \text{Dust Meter, } (\mu\text{g}/\text{m}^3) |$ 1.173

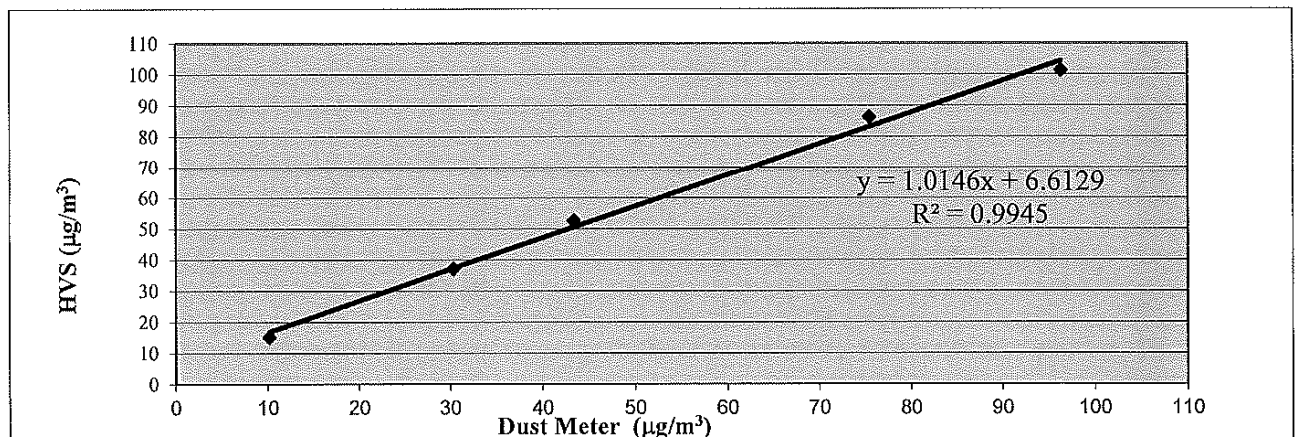
Set Correlation Factor, SCF

SCF = [$K = \text{High Volume Sampler} / \text{Dust Meter}, (\mu\text{g}/\text{m}^3)$] 1.144

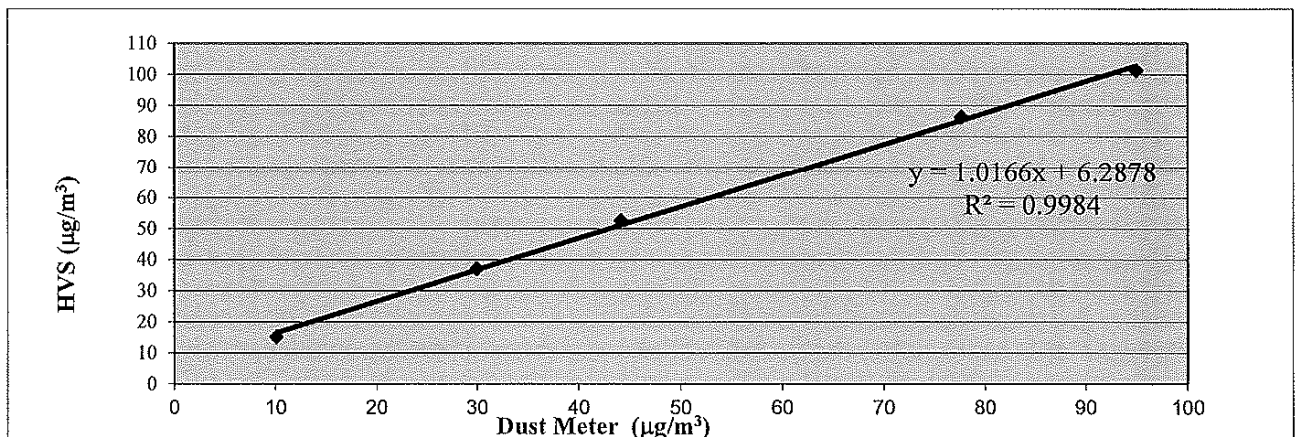
Set Correlation Factor, SCF

SCF = [K=High Volume Sampler / Dust Meter, ($\mu\text{g}/\text{m}^3$)] 1.139

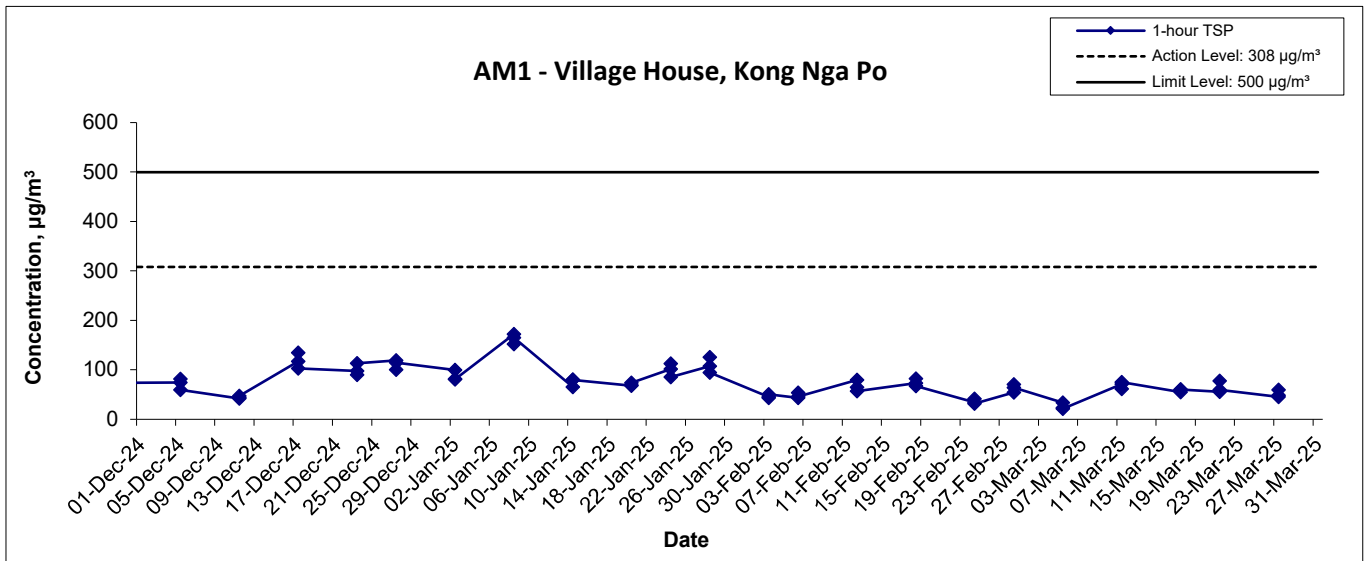
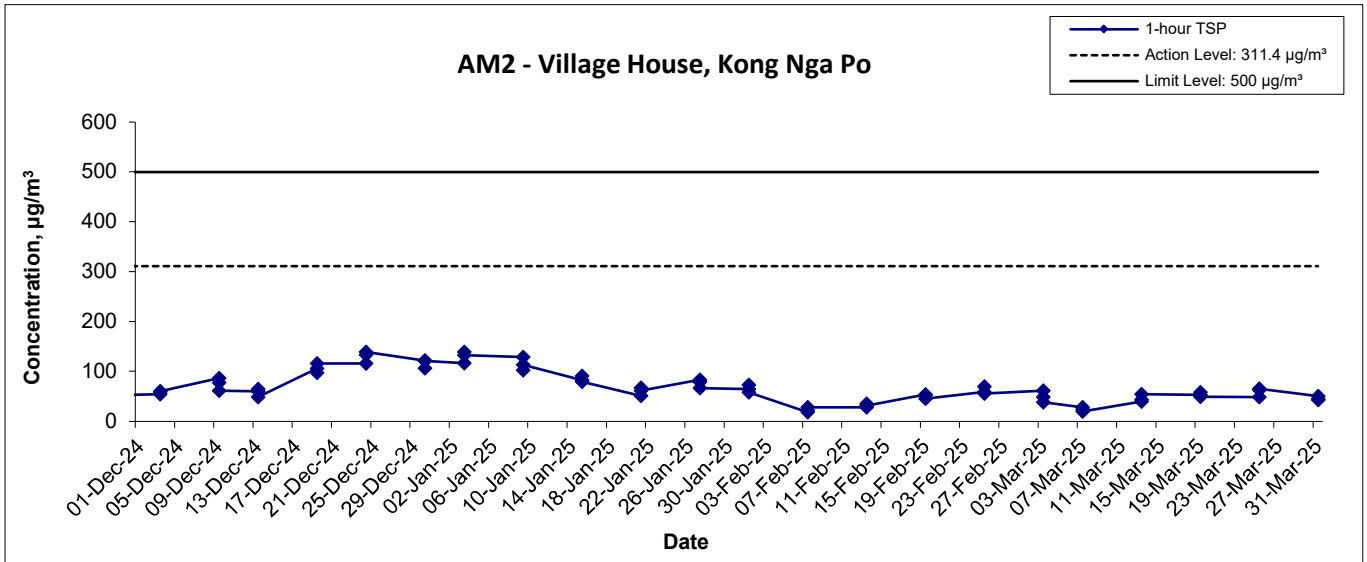
1-hr TSP Concentration Levels

Location AM2 - Village House, Kong Nga Po			
Date	Time	Weather	Particulate Concentration ($\mu\text{g}/\text{m}^3$)
3-Mar-25	13:10	Cloudy	61.4
3-Mar-25	14:10	Cloudy	48.5
3-Mar-25	15:10	Cloudy	38.2
7-Mar-25	13:00	Cloudy	27.8
7-Mar-25	14:00	Cloudy	23.5
7-Mar-25	15:00	Cloudy	19.7
13-Mar-25	13:00	Sunny	39.4
13-Mar-25	14:00	Sunny	43.1
13-Mar-25	15:00	Sunny	53.9
19-Mar-25	9:00	Sunny	52.9
19-Mar-25	10:00	Sunny	57.6
19-Mar-25	11:00	Sunny	49.0
25-Mar-25	13:00	Sunny	48.1
25-Mar-25	14:00	Sunny	62.4
25-Mar-25	15:00	Sunny	64.7
31-Mar-25	9:00	Cloudy	50.3
31-Mar-25	10:00	Cloudy	42.2
31-Mar-25	11:00	Cloudy	44.2
		Minimum	19.7
		Maximum	64.7
		Average	45.9

Title Service Contract No. NDO 07/2019 Environmental Team for Site Formation and Infrastructure Works for Police Facilities in Kong Nga Po Graphical Presentation of 1-hour TSP Monitoring Results	Scale N.T.S	Project No. WMA20001

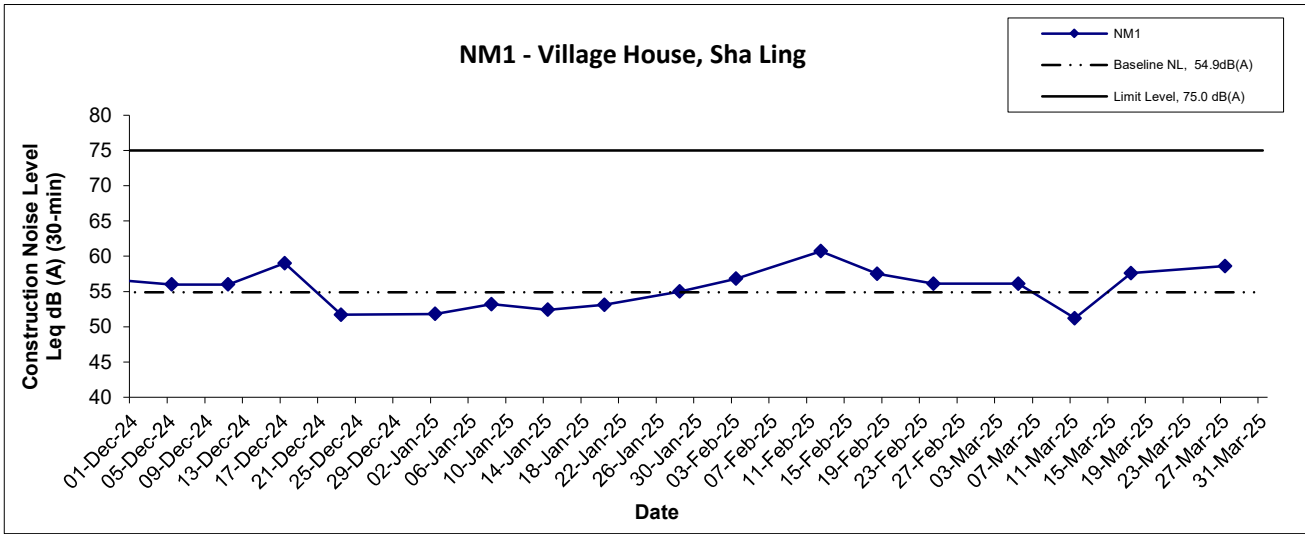
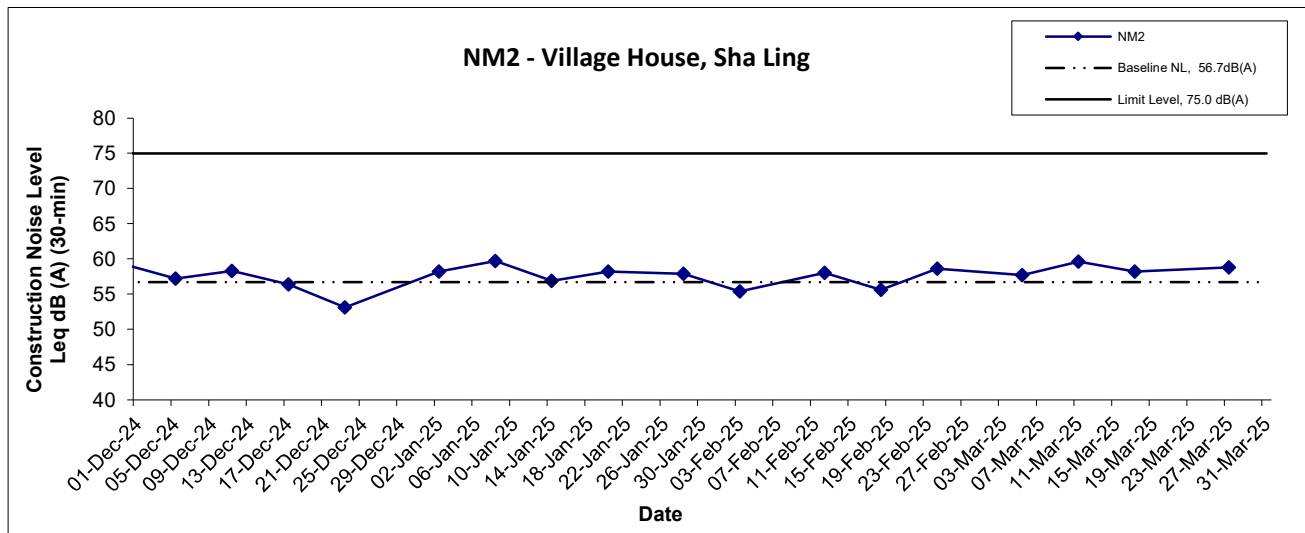
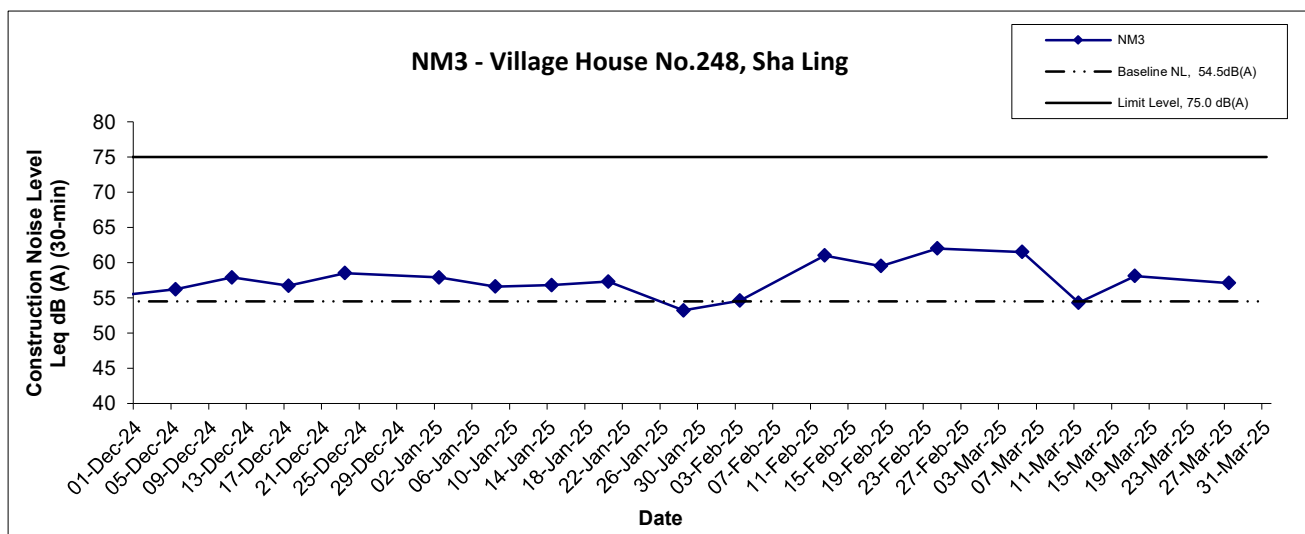
Noise Levels

Title Service Contract No. NDO 07/2019 Environmental Team for Site Formation and Infrastructure Works for Police Facilities in Kong Nga Po Graphical Presentation of Construction Noise Monitoring Results	Scale	Project No.	consulting . testing . research
	N.T.S	WMA20001	
Date	Mar 25	Appendix	F

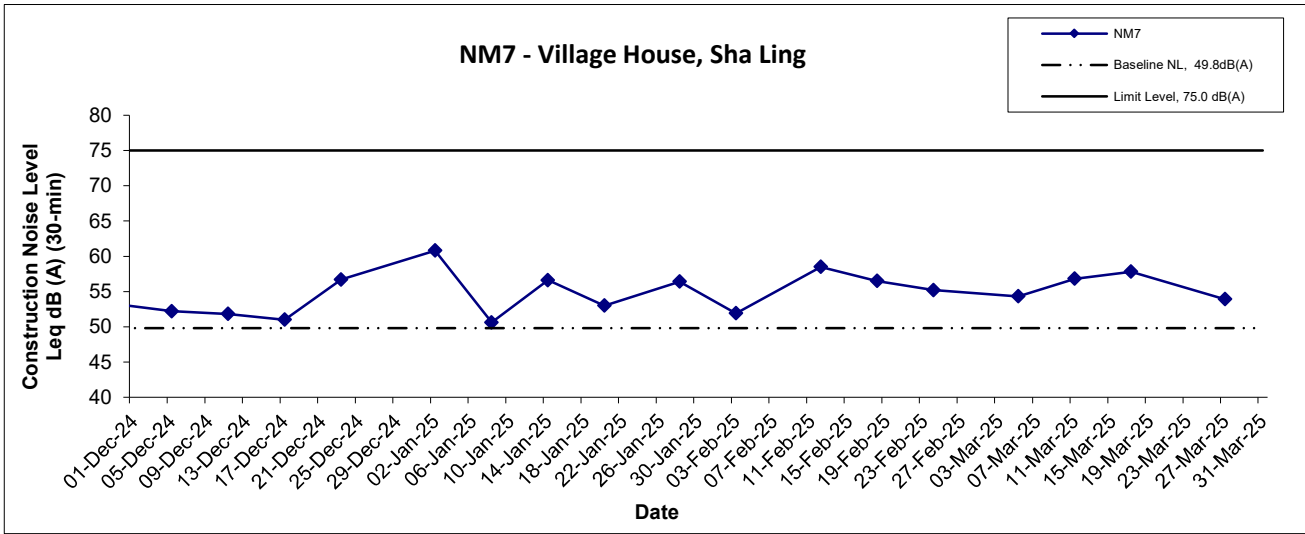
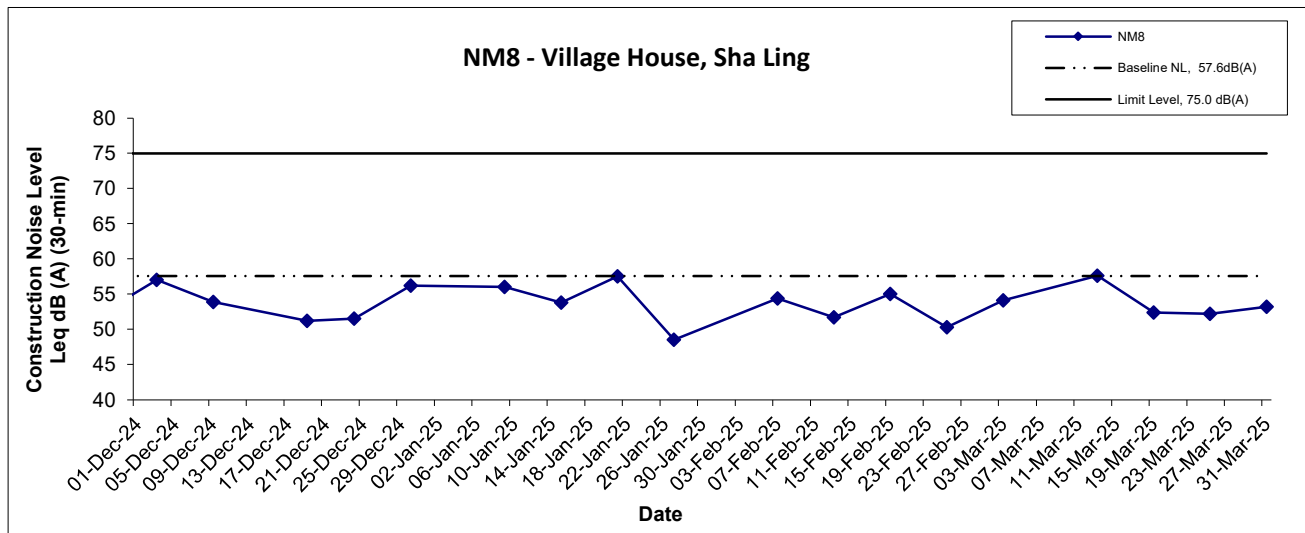
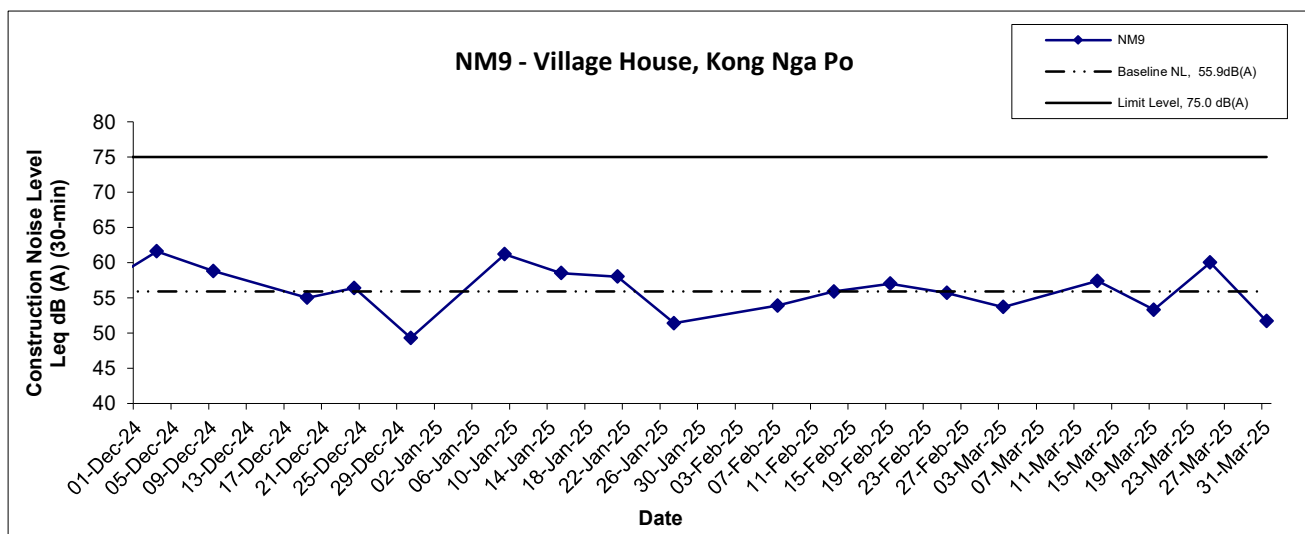
Noise Levels

Title Service Contract No. NDO 07/2019 Environmental Team for Site Formation and Infrastructure Works for Police Facilities in Kong Nga Po Graphical Presentation of Construction Noise Monitoring Results	Scale	Project No.	consulting . testing . research
	N.T.S	WMA20001	
	Date	Appendix	
	Mar 25	F

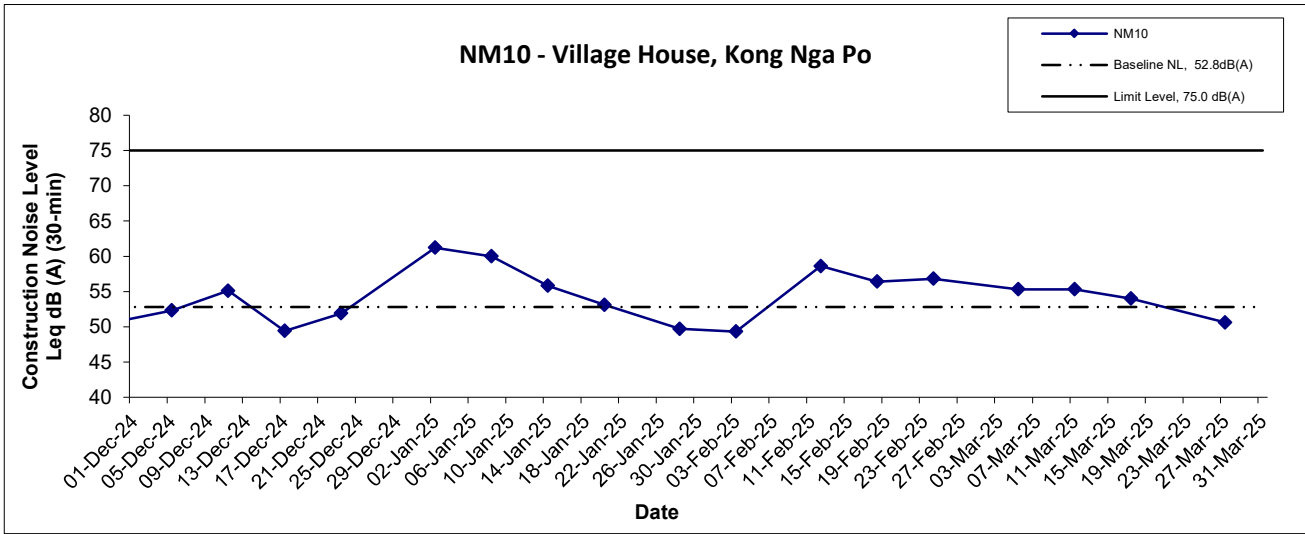
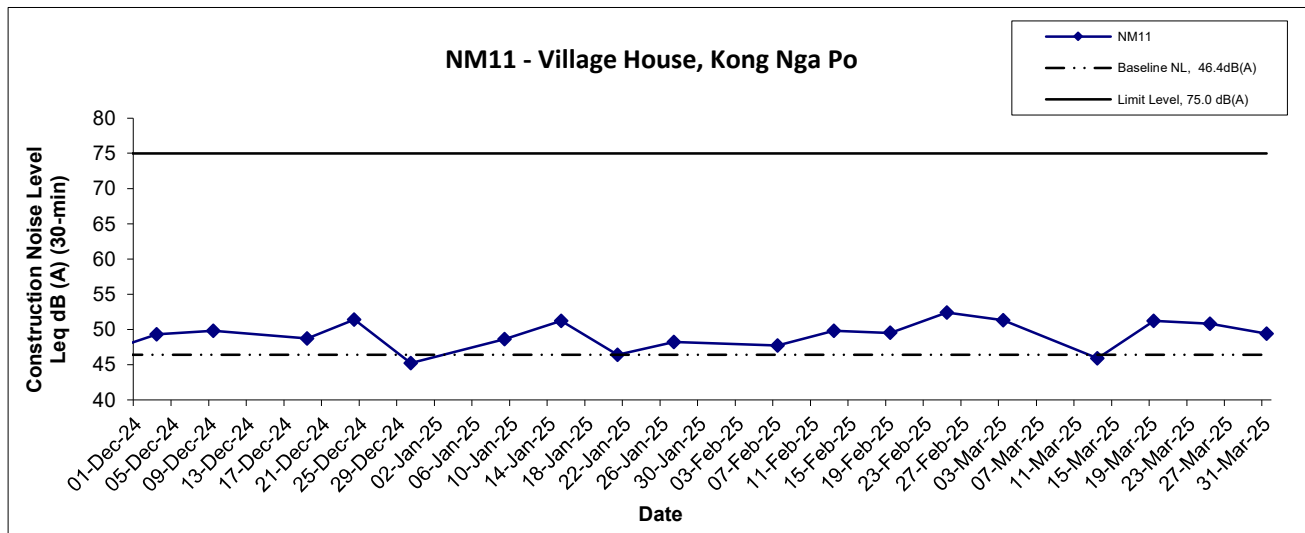
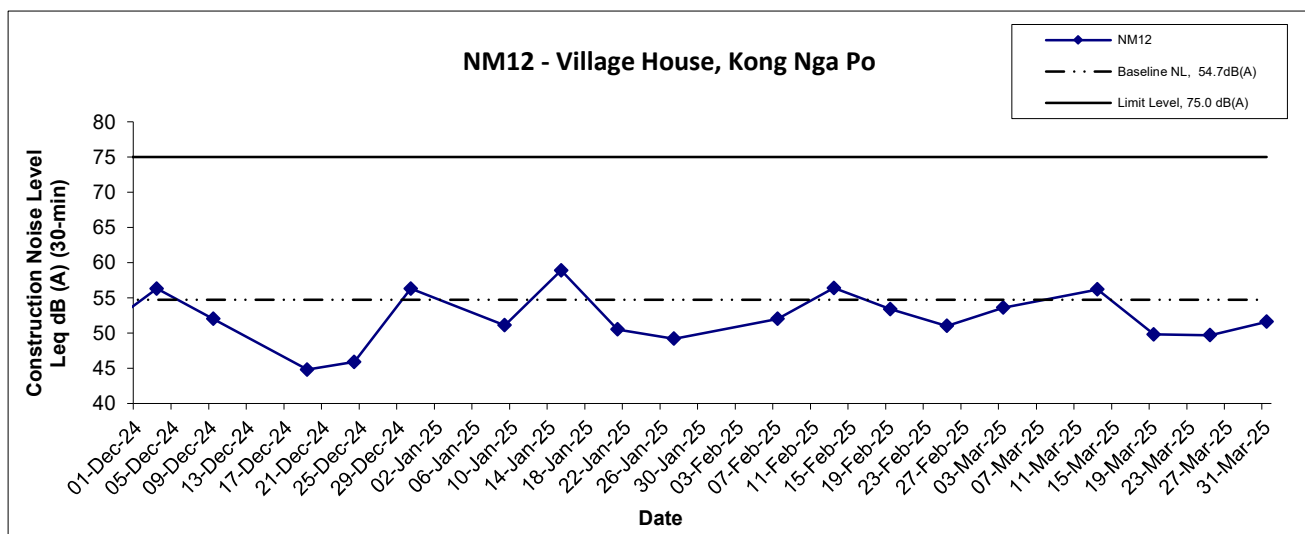
Noise Levels

Title Service Contract No. NDO 07/2019 Environmental Team for Site Formation and Infrastructure Works for Police Facilities in Kong Nga Po Graphical Presentation of Construction Noise Monitoring Results	Scale	Project No.	consulting . testing . research
	N.T.S	WMA20001	
Date	Mar 25	Appendix	F

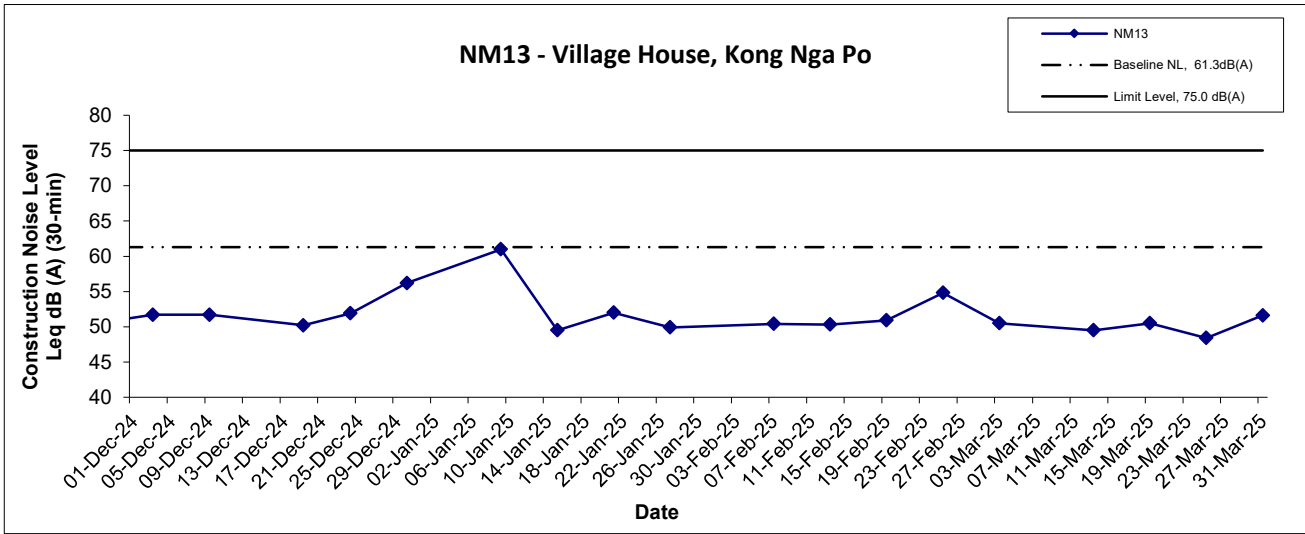
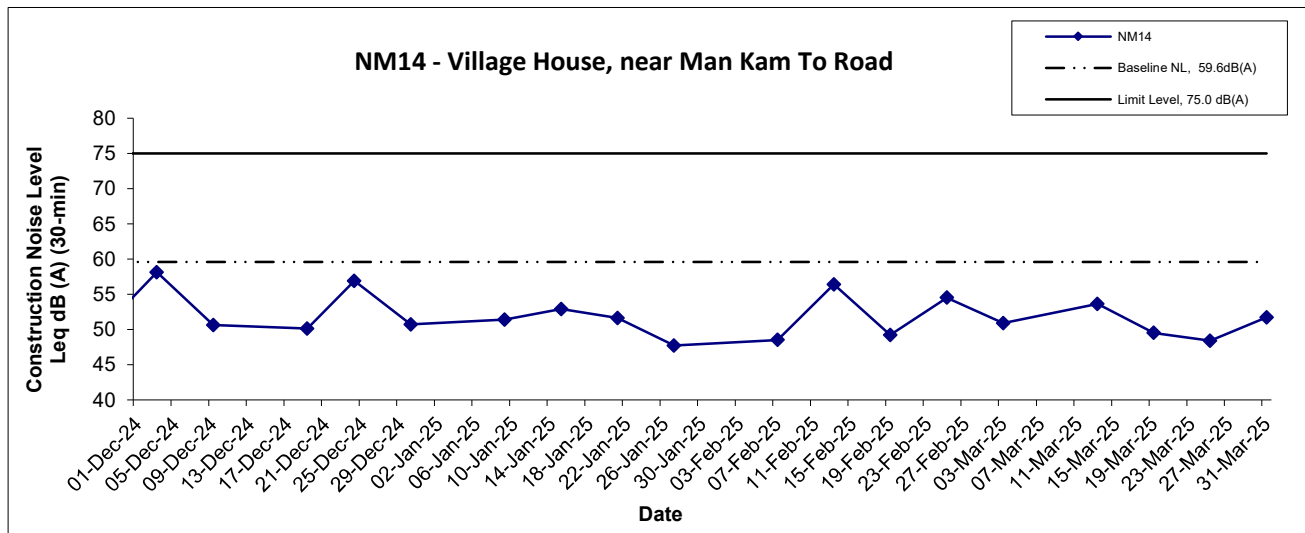
Noise Levels

Title Service Contract No. NDO 07/2019 Environmental Team for Site Formation and Infrastructure Works for Police Facilities in Kong Nga Po Graphical Presentation of Construction Noise Monitoring Results	Scale	Project No.	consulting . testing . research
	N.T.S	WMA20001	
Date	Mar 25	Appendix	F

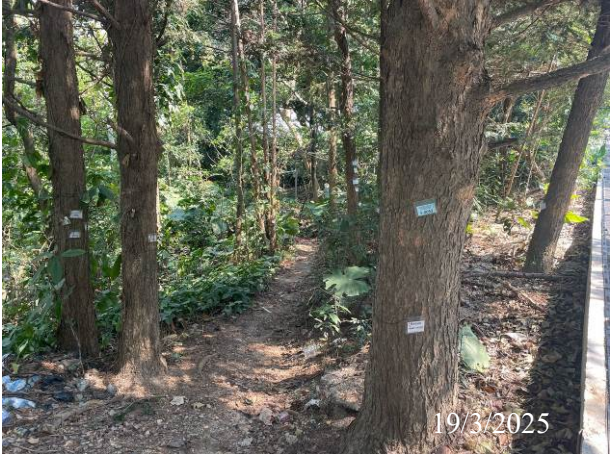
<p>Photo 5</p>

<p>Description: Construction works next to undersized seedling of <i>Aquilaria sinensis</i> have been completed, protective fence for undersized seedling of <i>Aquilaria sinensis</i> is no longer required and has been removed.</p>	<p>Photo 6</p>

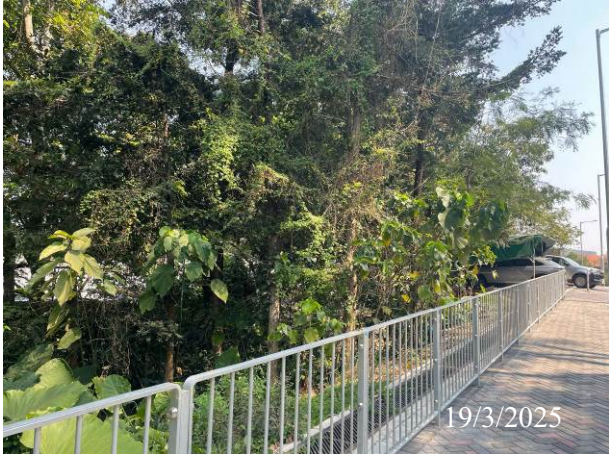
<p>Description: Construction works next to the undersized seedling of <i>Aquilaria sinensis</i> have been completed and permanent fencing has been properly erected along the pedestrian walkway.</p>
<p>Photo 7</p>

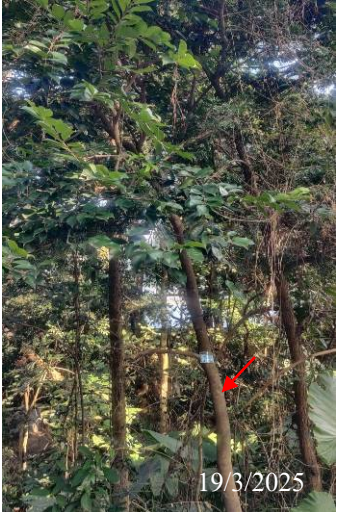
<p>Description: General view of undersized seedling of <i>Aquilaria sinensis</i></p>
