**EP-510/2016 – Police Facilities in Kong Nga Po**

**Service Contract No. NDO 07/2019  
Environmental Team for Site Formation and  
Infrastructure Works for Police Facilities in  
Kong Nga Po**

**Quarterly Environmental Monitoring and  
Audit Report for October to December 2024  
(Version 1.0)**

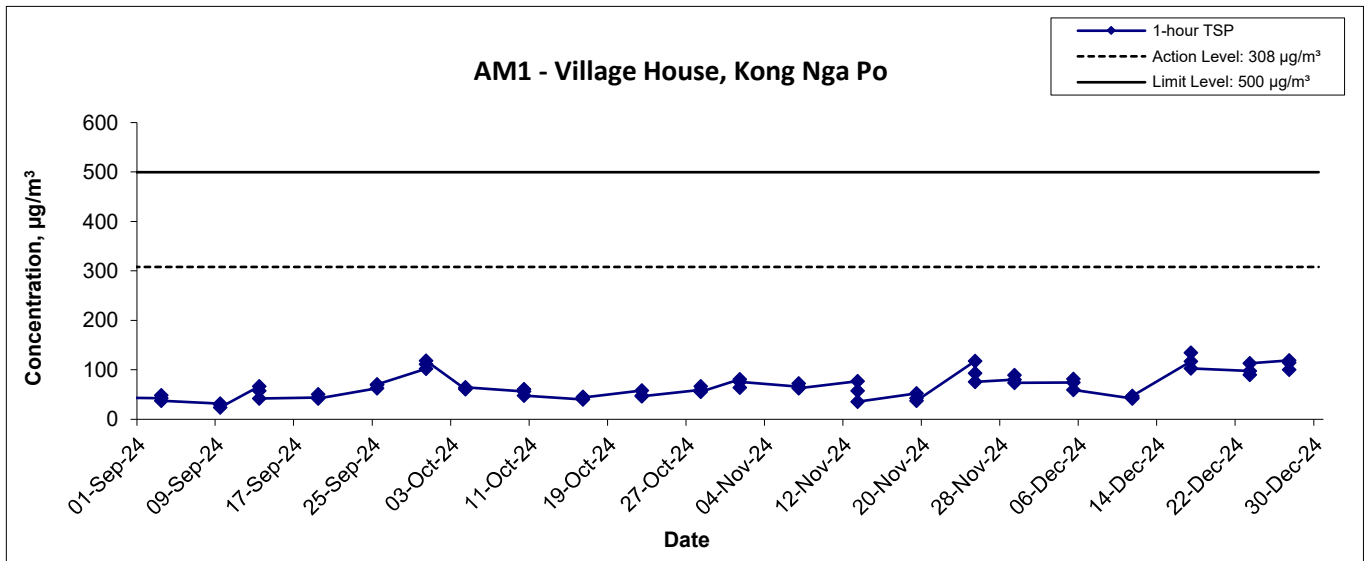
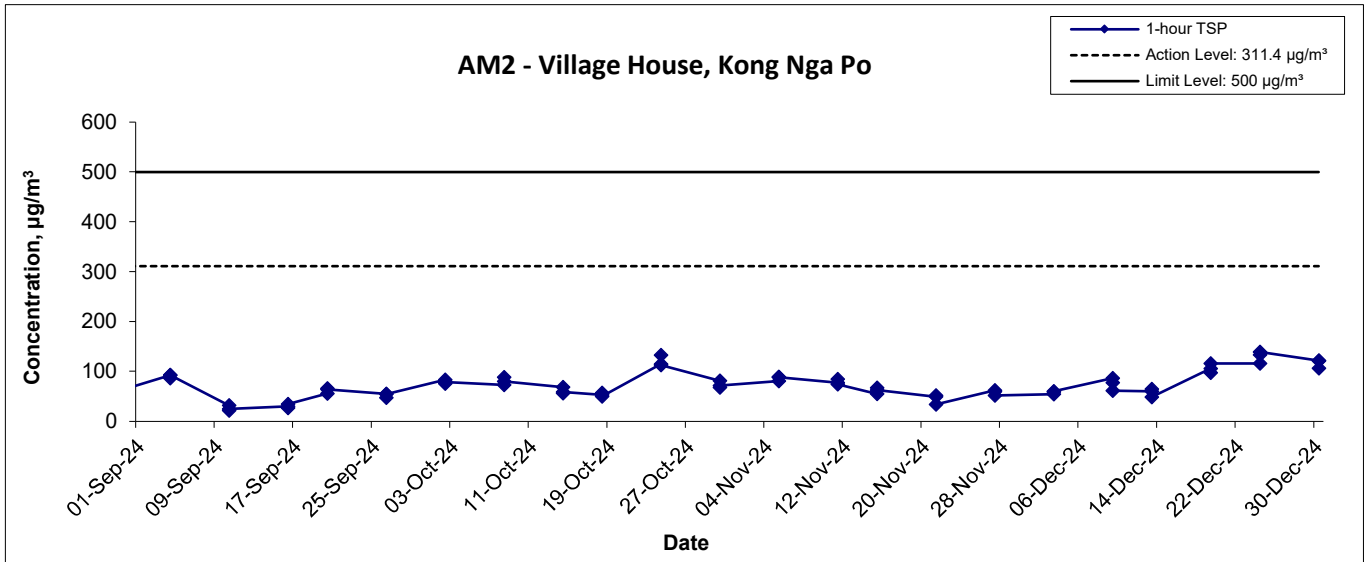
### 1-hr TSP Concentration Levels

Title Service Contract No. NDO 07/2019 Environmental Team for Site Formation and Infrastructure Works for Police Facilities in Kong Nga Po Graphical Presentation of 1-hour TSP Monitoring Results	Scale N.T.S	Project No. WMA20001

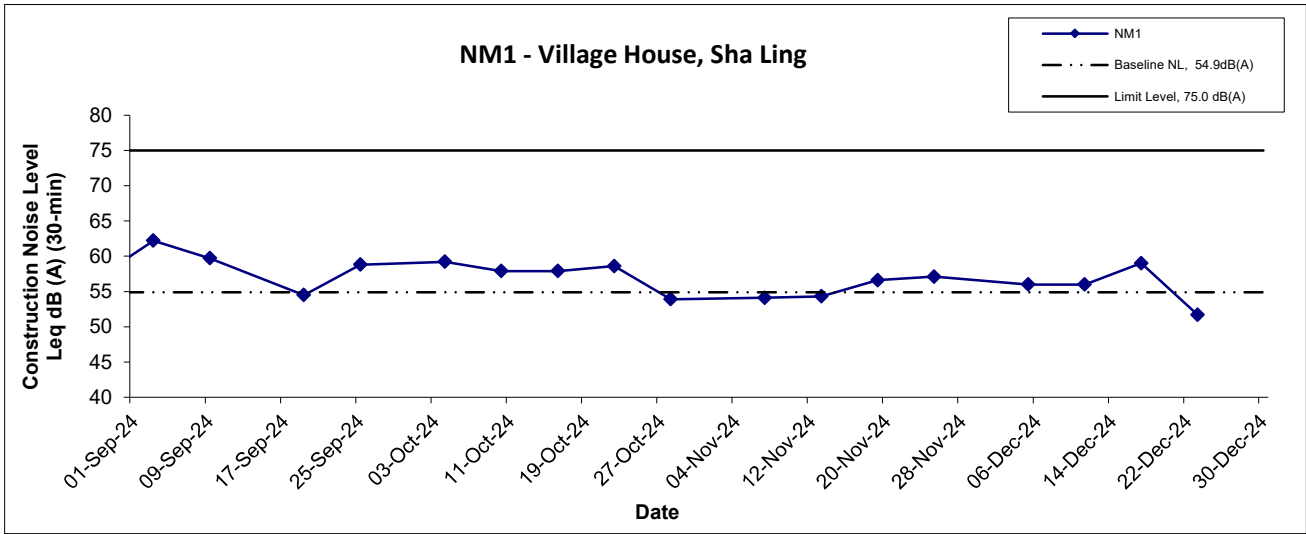
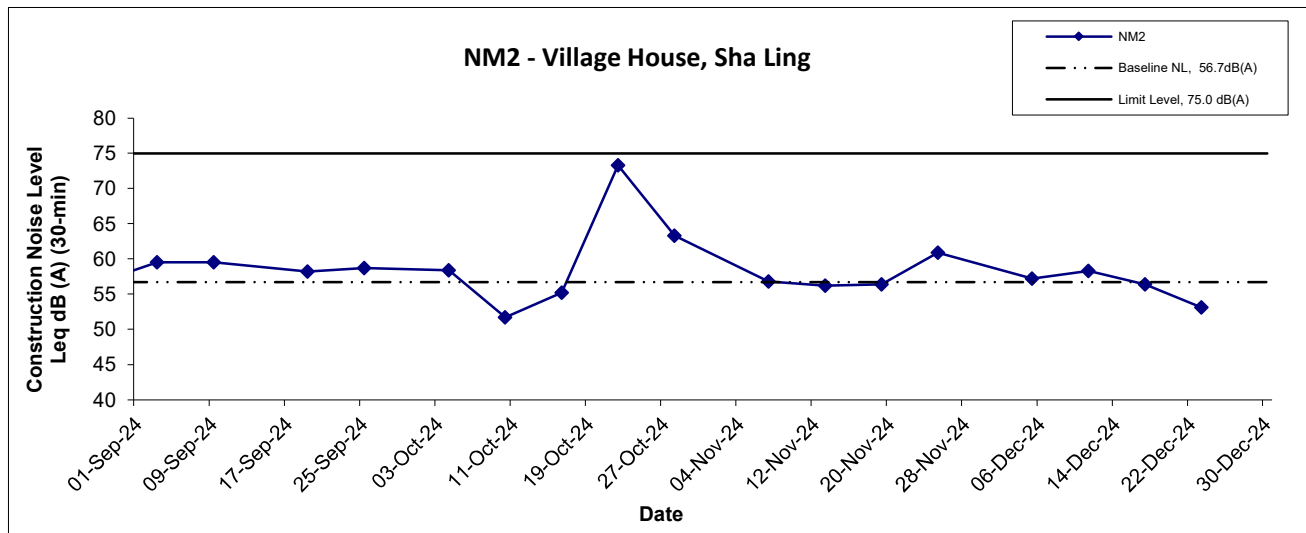
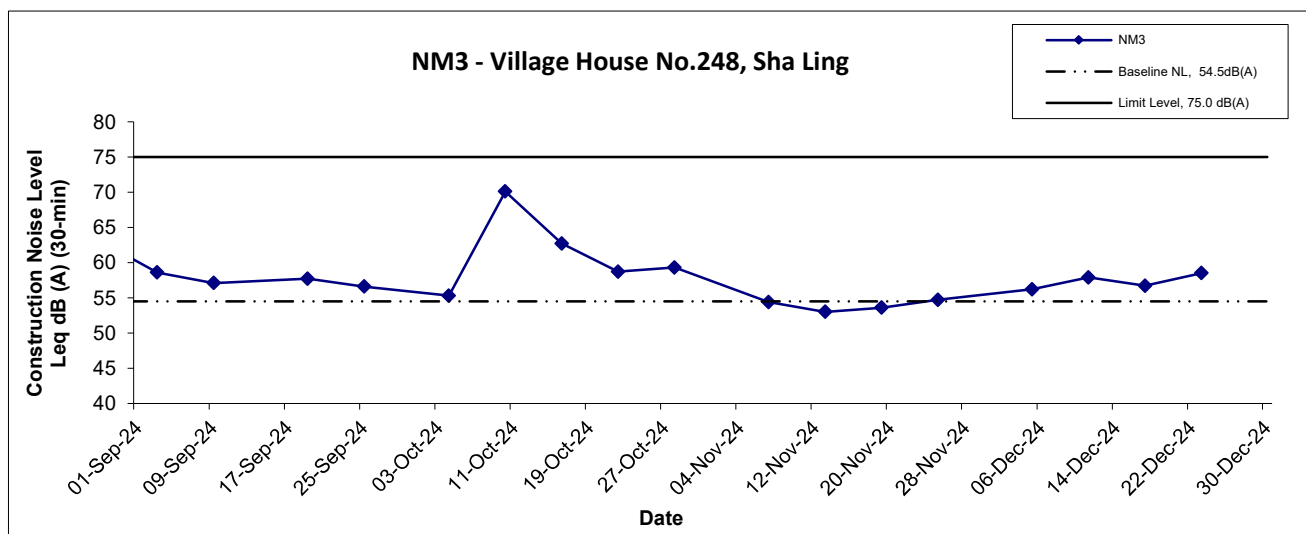
## Noise Levels

Title Service Contract No. NDO 07/2019 Environmental Team for Site Formation and Infrastructure Works for Police Facilities in Kong Nga Po Graphical Presentation of Construction Noise Monitoring Results	Scale	Project No.	consulting . testing . research
	N.T.S	WMA20001	
Date	Dec 24	Appendix	C

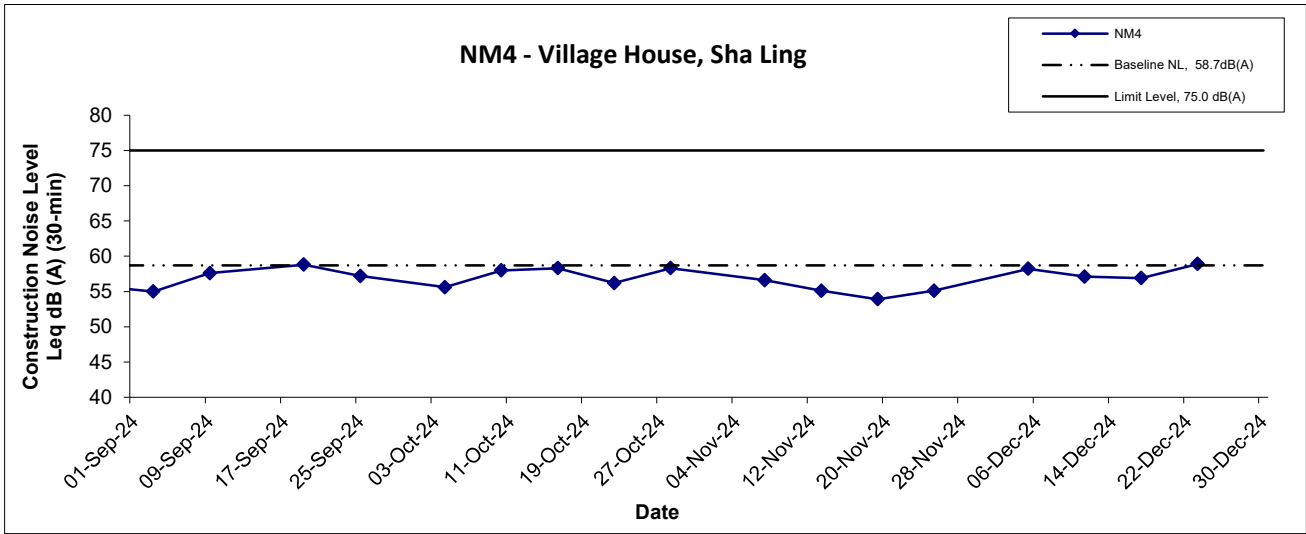
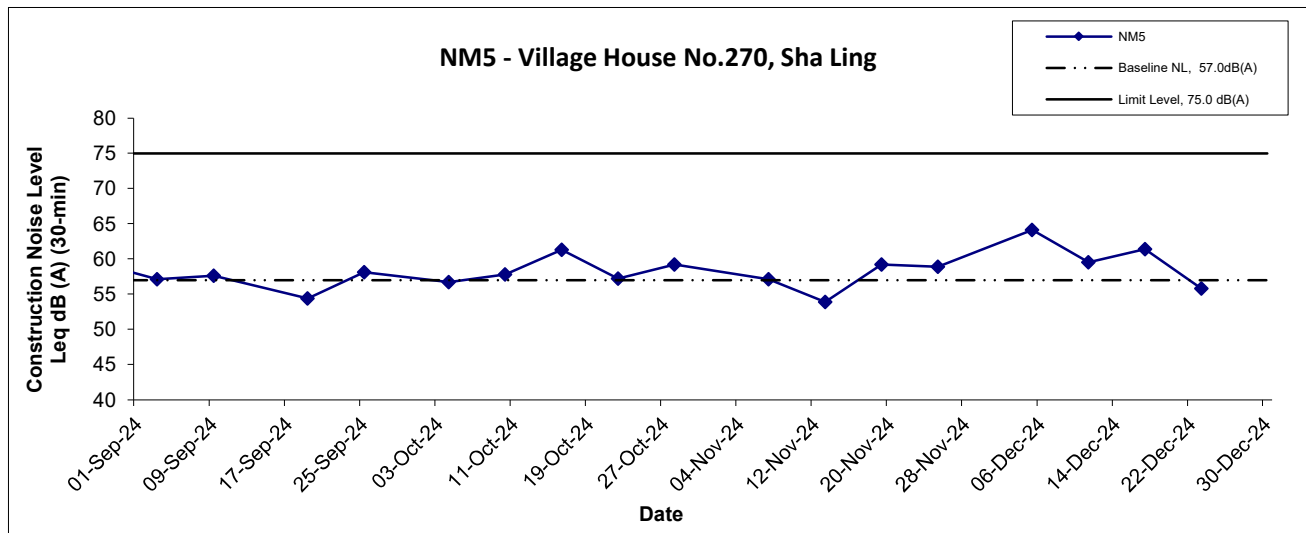
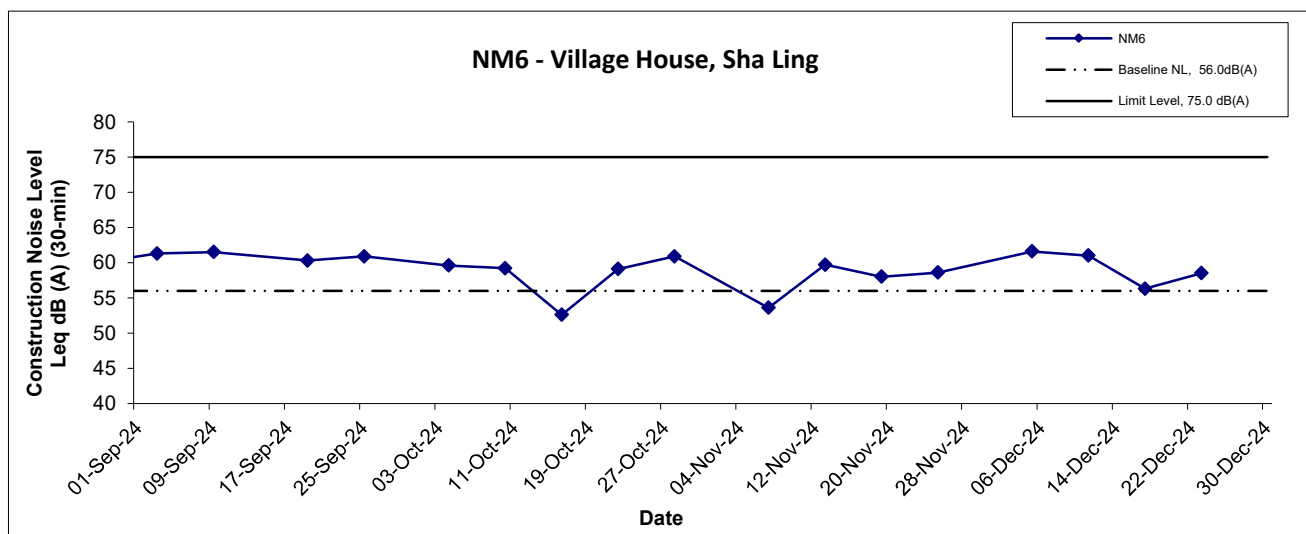
## Noise Levels

Title Service Contract No. NDO 07/2019 Environmental Team for Site Formation and Infrastructure Works for Police Facilities in Kong Nga Po Graphical Presentation of Construction Noise Monitoring Results	Scale	N.T.S	Project No.	WMA20001
	Date	Dec 24	Appendix	C

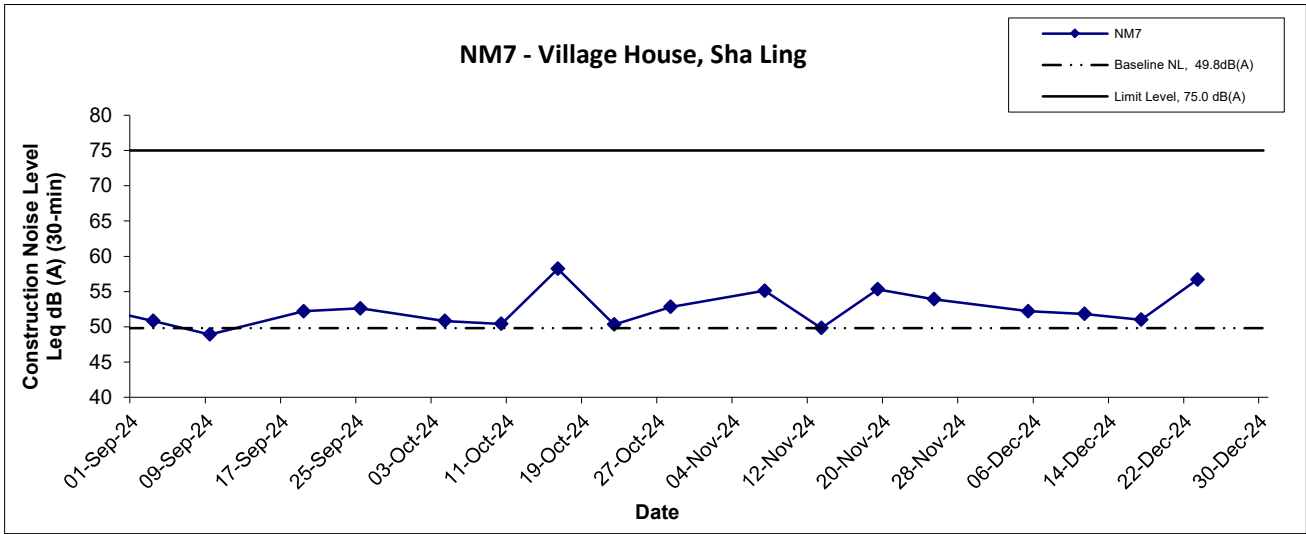
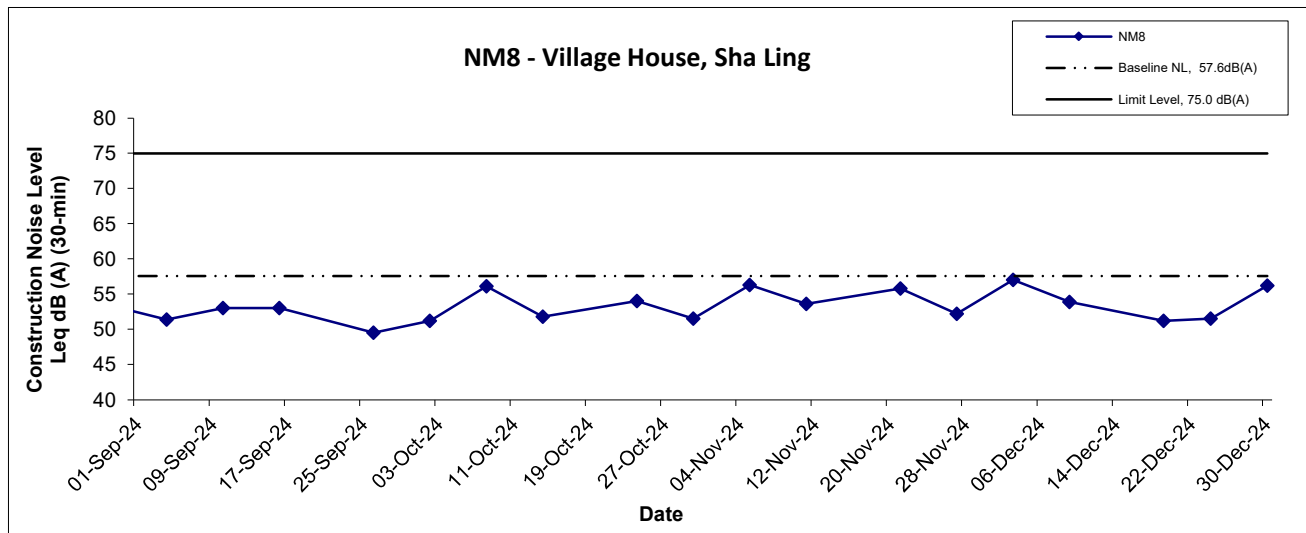
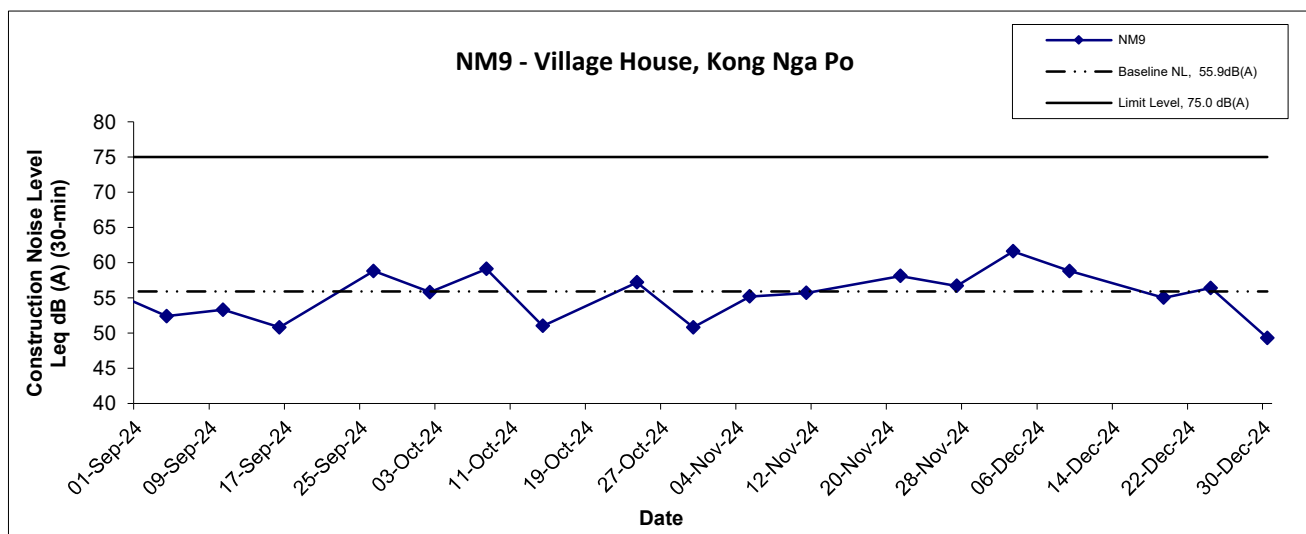
## Noise Levels

Title Service Contract No. NDO 07/2019 Environmental Team for Site Formation and Infrastructure Works for Police Facilities in Kong Nga Po Graphical Presentation of Construction Noise Monitoring Results	Scale N.T.S	Project No. WMA20001	consulting . testing . research
	Date Dec 24	Appendix C

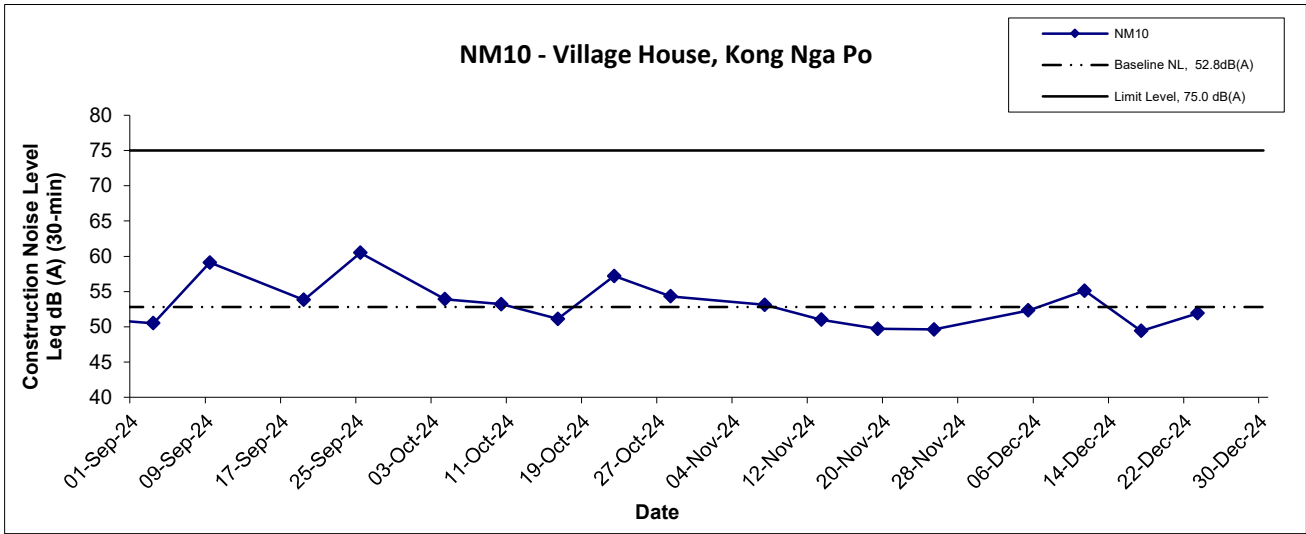
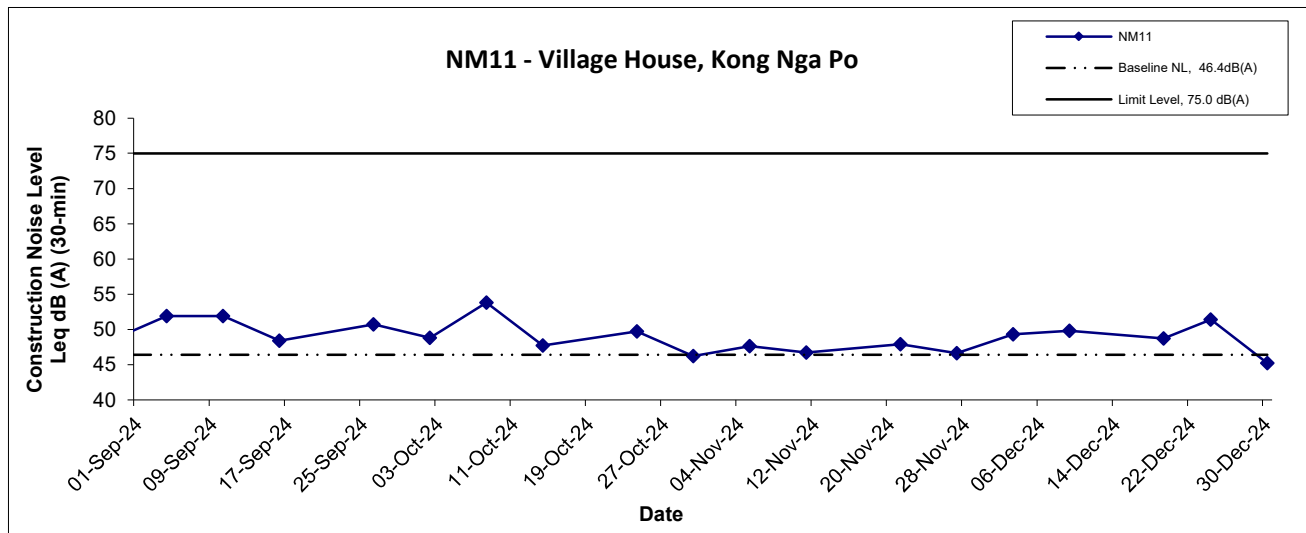
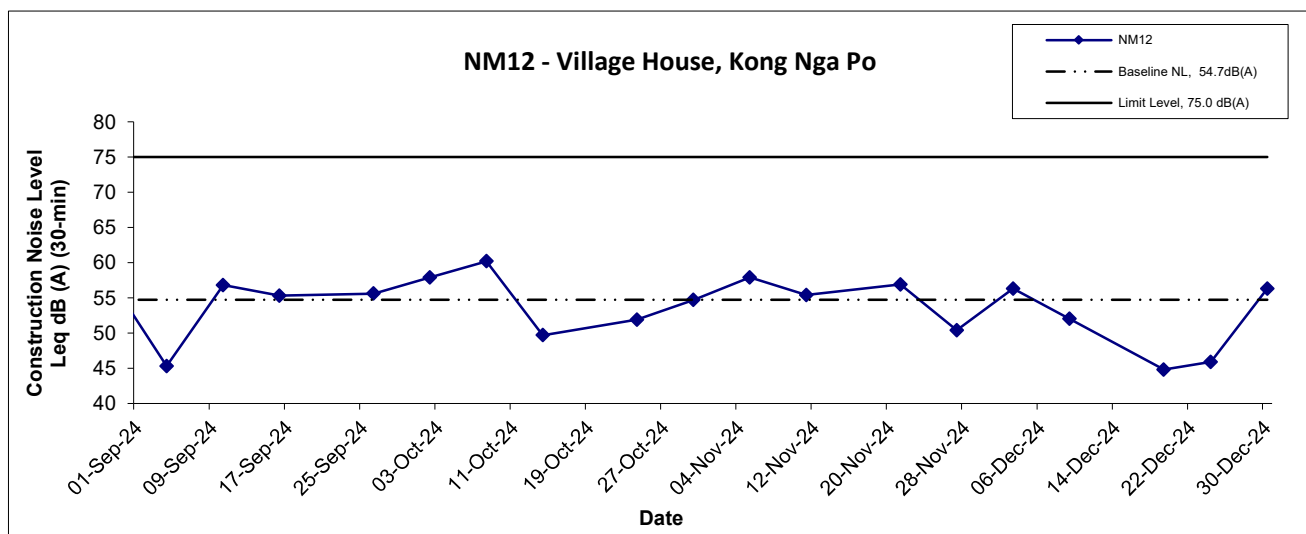
## Noise Levels

Title Service Contract No. NDO 07/2019 Environmental Team for Site Formation and Infrastructure Works for Police Facilities in Kong Nga Po Graphical Presentation of Construction Noise Monitoring Results	Scale N.T.S	Project No. WMA20001	consulting . testing . research
	Date Dec 24	Appendix C

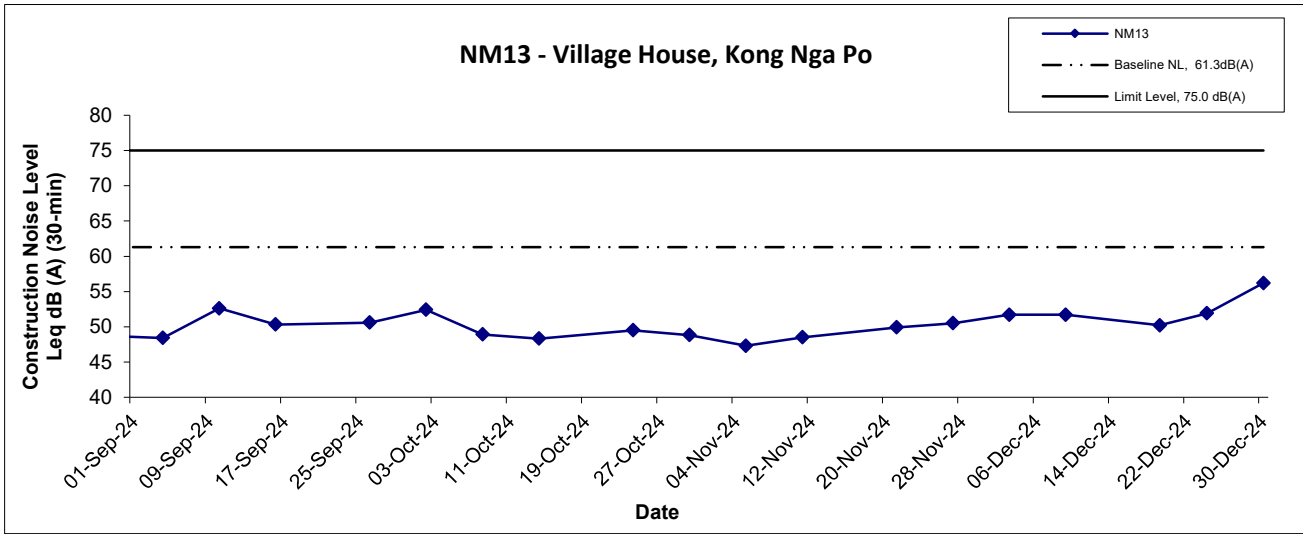
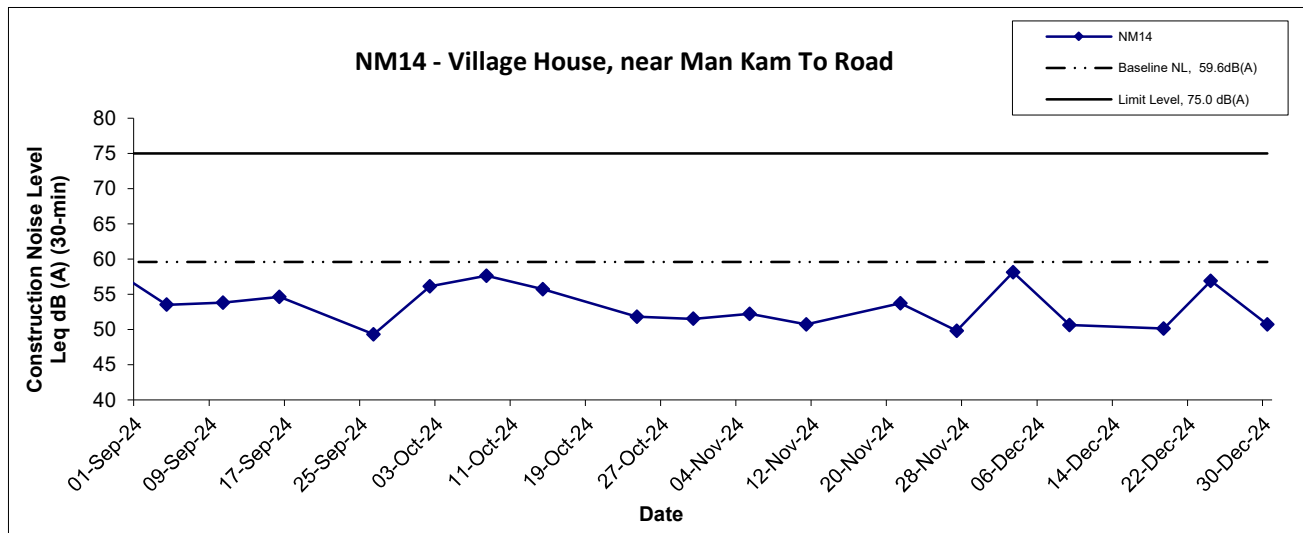
## Noise Levels

Title Service Contract No. NDO 07/2019 Environmental Team for Site Formation and Infrastructure Works for Police Facilities in Kong Nga Po Graphical Presentation of Construction Noise Monitoring Results	Scale N.T.S	Project No. WMA20001	consulting . testing . research
	Date Dec 24	Appendix C
