**EP-510/2016 – Police Facilities in Kong Nga Po**

**Service Contract No. NDO 07/2019  
Environmental Team for Site Formation and  
Infrastructure Works for Police Facilities in  
Kong Nga Po**

**Quarterly Environmental Monitoring and  
Audit Report for January to March 2025  
(Version 1.0)**

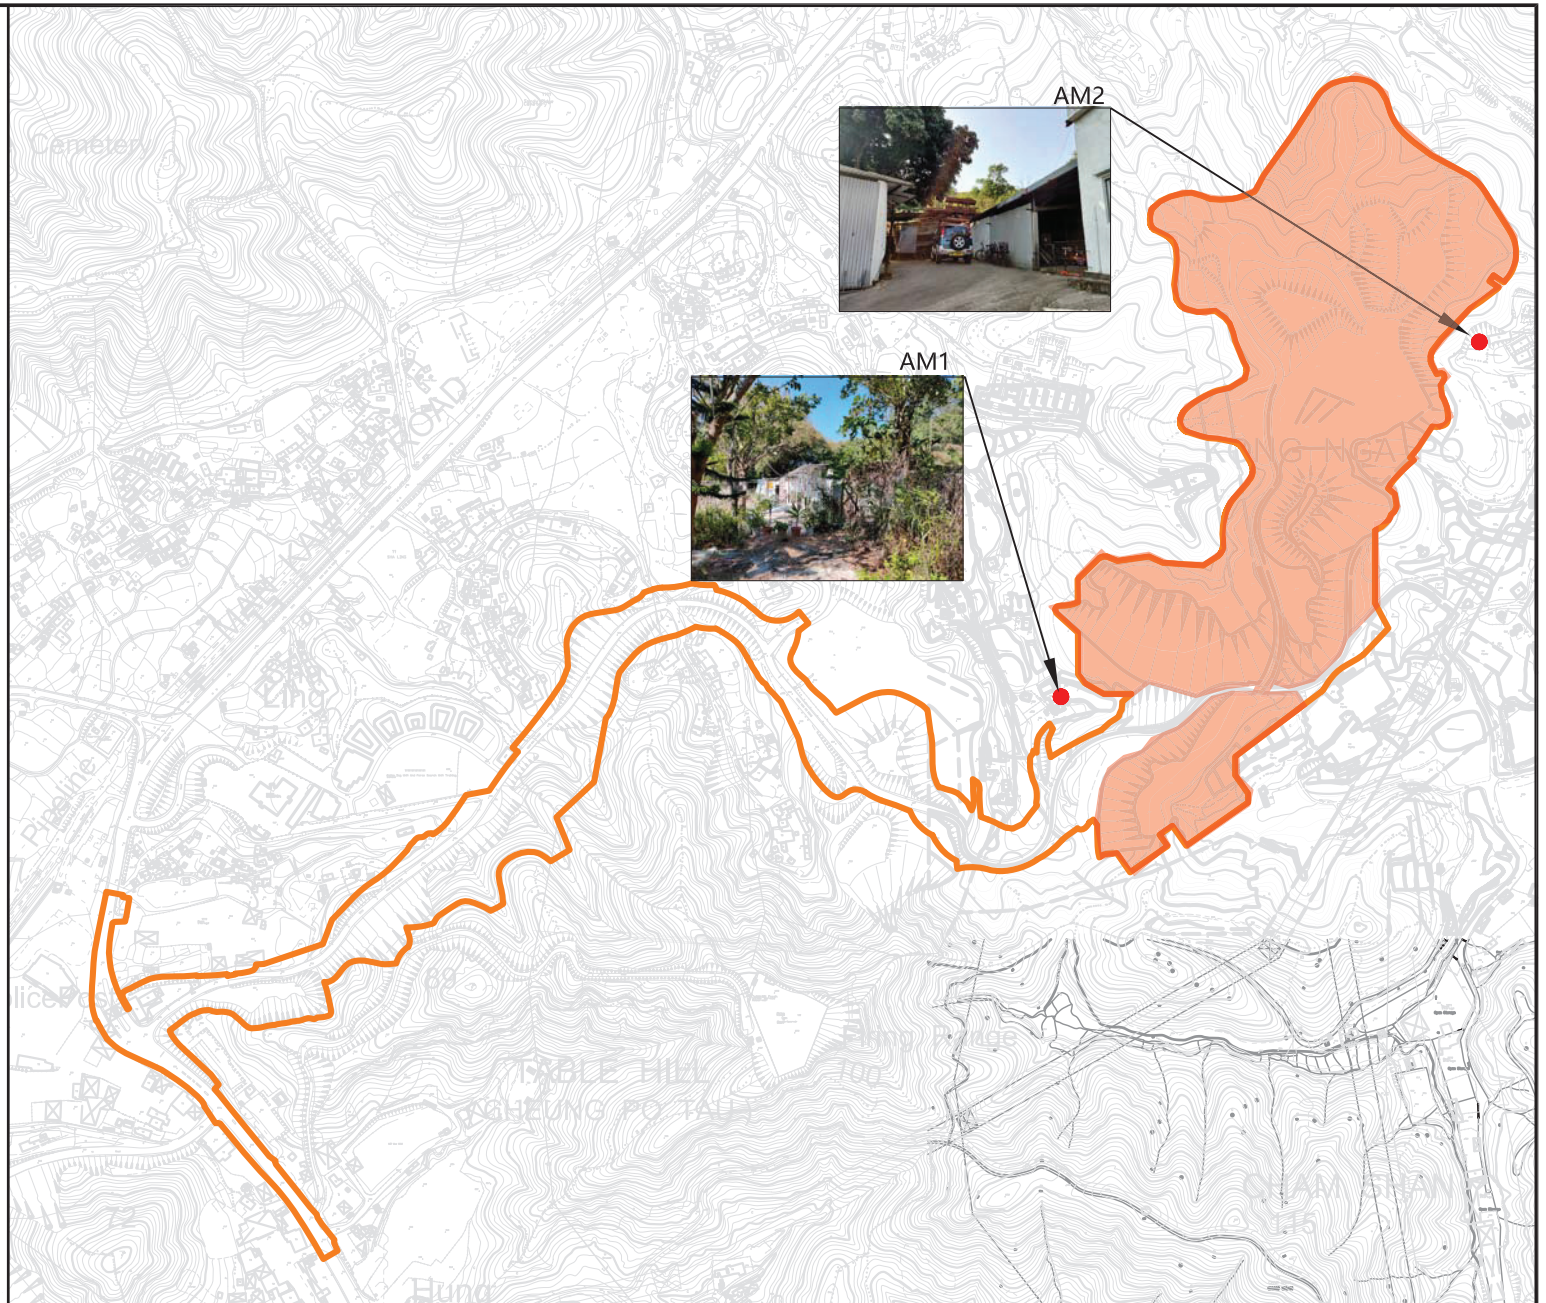
**Air Quality Monitoring Stations**

Air Quality Monitoring Stations	
ID	Description
AM1	Village House, Kong Nga Po
AM2	Village House, Kong Nga Po

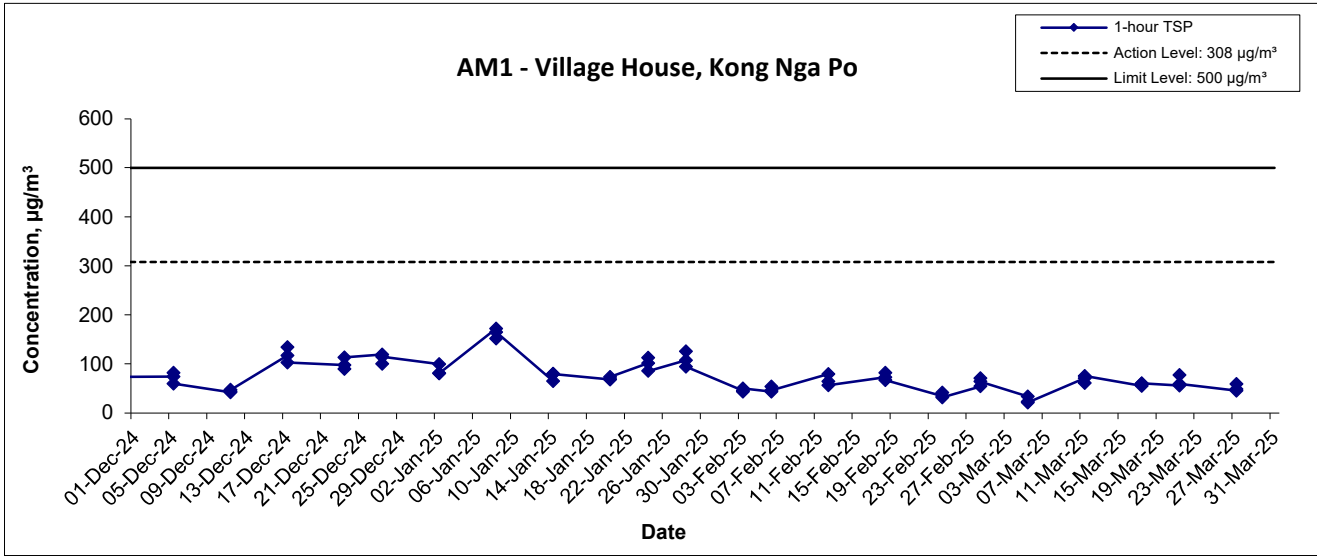
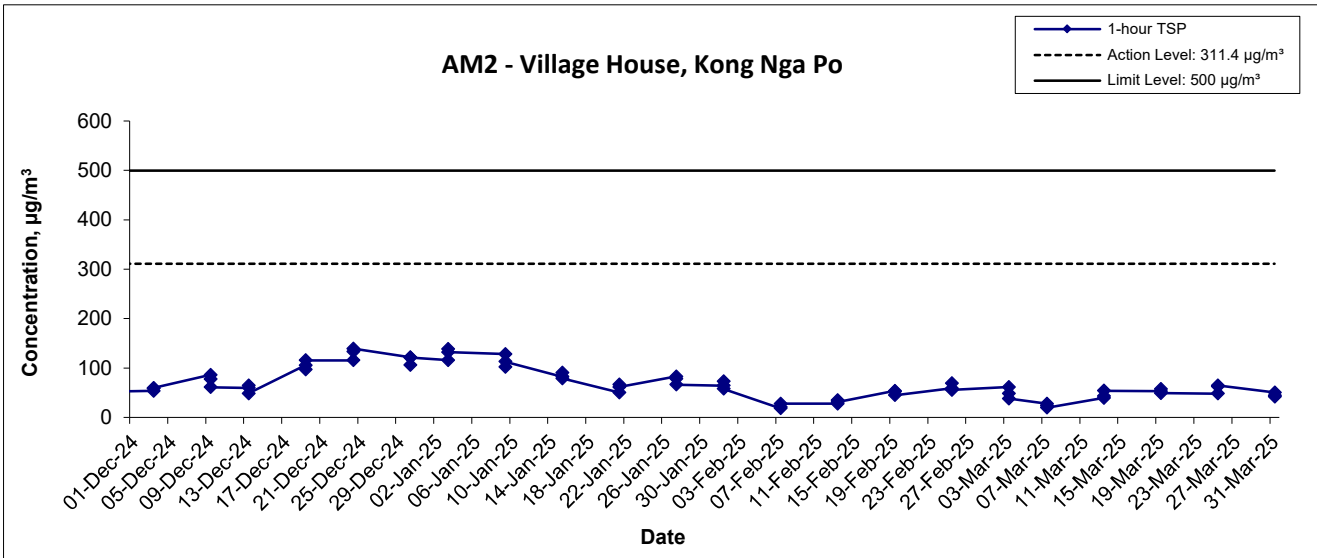
### 1-hr TSP Concentration Levels

Title Service Contract No. NDO 07/2019 Environmental Team for Site Formation and Infrastructure Works for Police Facilities in Kong Nga Po  Graphical Presentation of 1-hour TSP Monitoring Results	Scale N.T.S	Project No. WMA20001	consulting . testing . research
	Date Mar 25	Appendix B

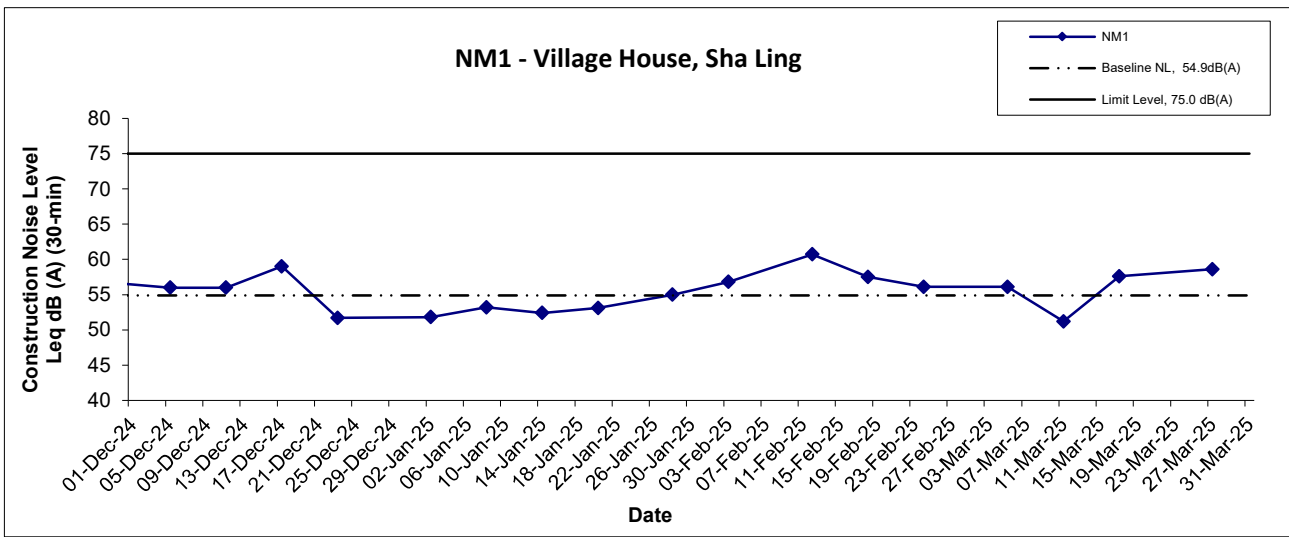
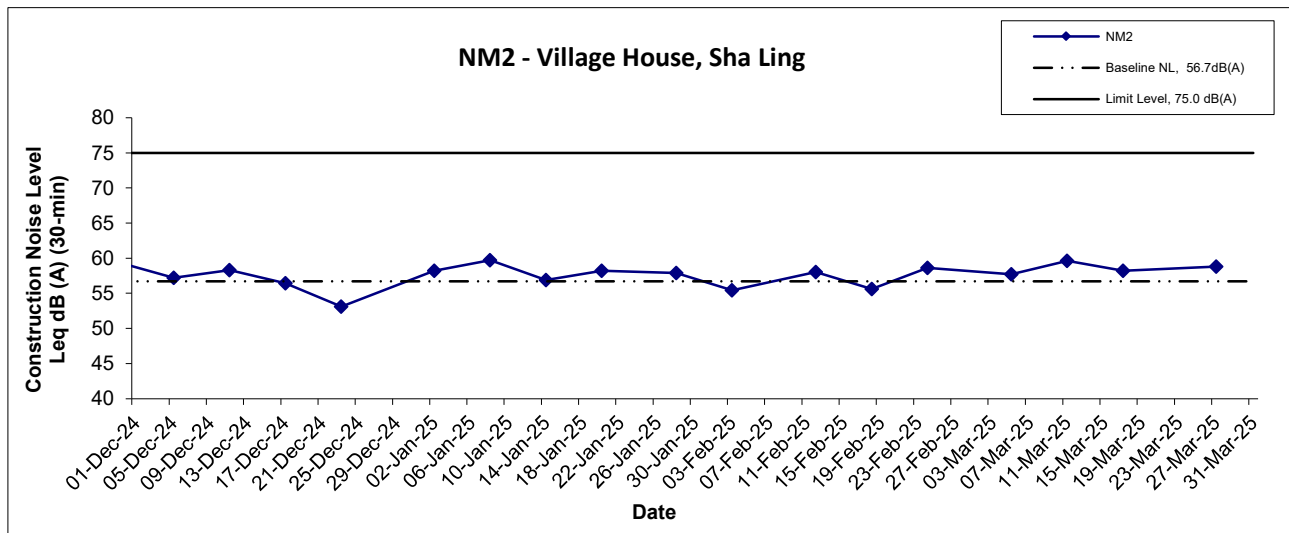
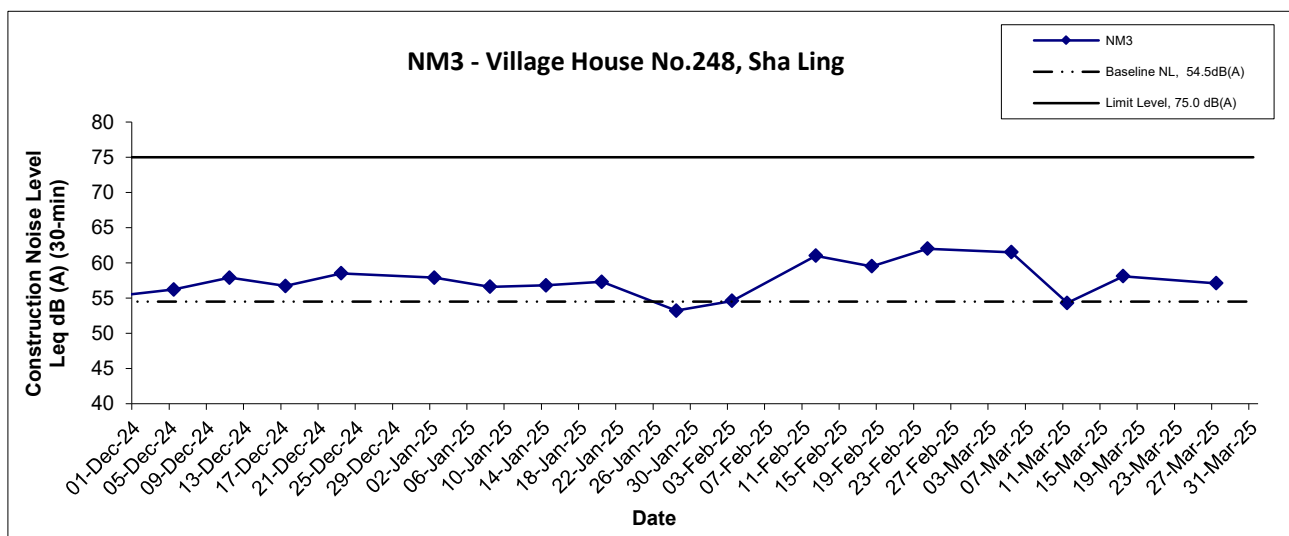
## Noise Levels

Title Service Contract No. NDO 07/2019 Environmental Team for Site Formation and Infrastructure Works for Police Facilities in Kong Nga Po Graphical Presentation of Construction Noise Monitoring Results	Scale N.T.S	Project No. WMA20001	consulting . testing . research
	Date Mar 25	Appendix C

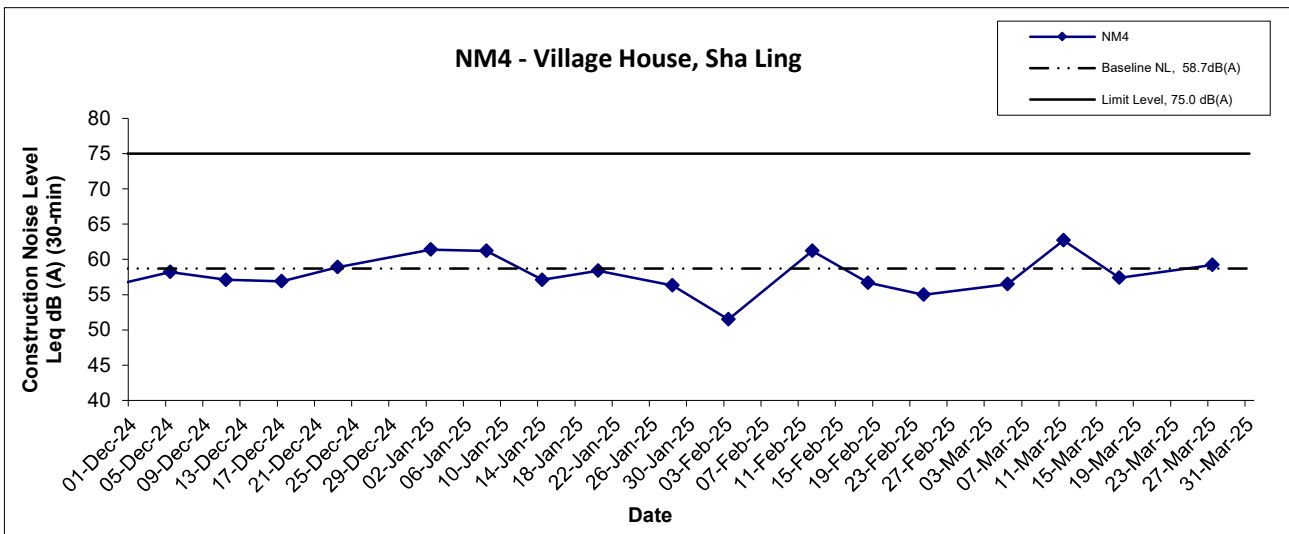
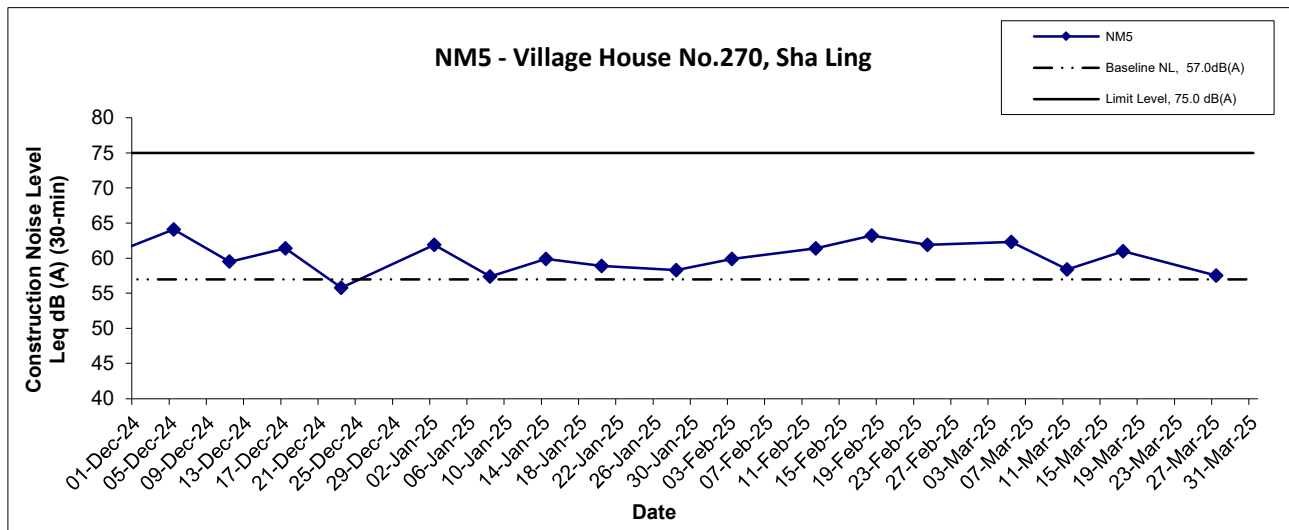
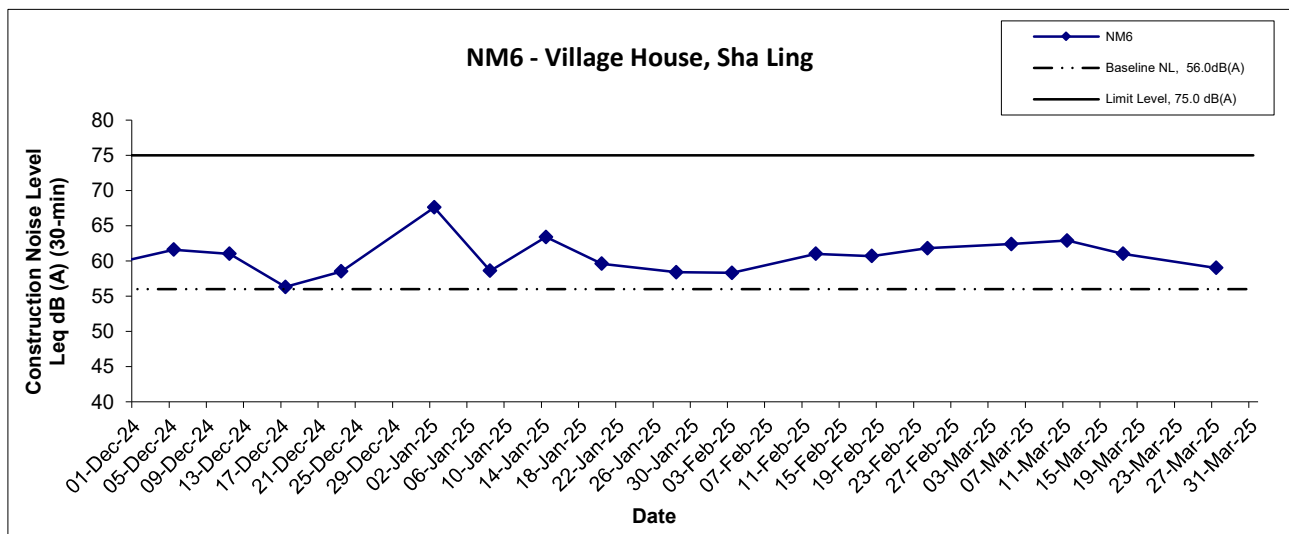
## Noise Levels

Title Service Contract No. NDO 07/2019 Environmental Team for Site Formation and Infrastructure Works for Police Facilities in Kong Nga Po Graphical Presentation of Construction Noise Monitoring Results	Scale N.T.S	Project No. WMA20001	 consulting . testing . research
	Date Mar 25	Appendix C

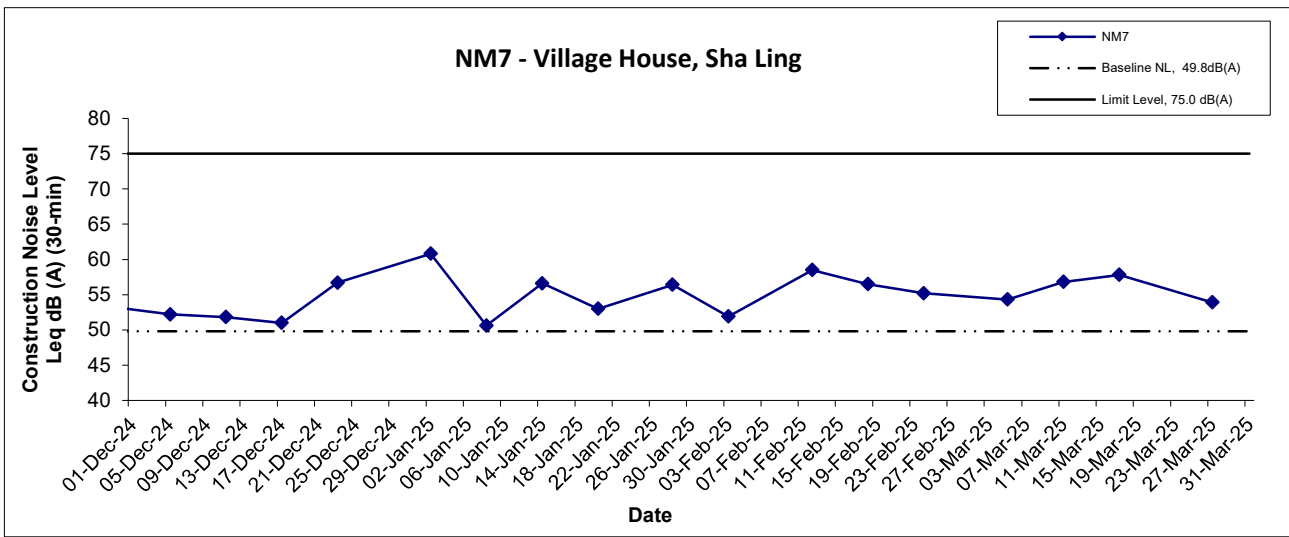
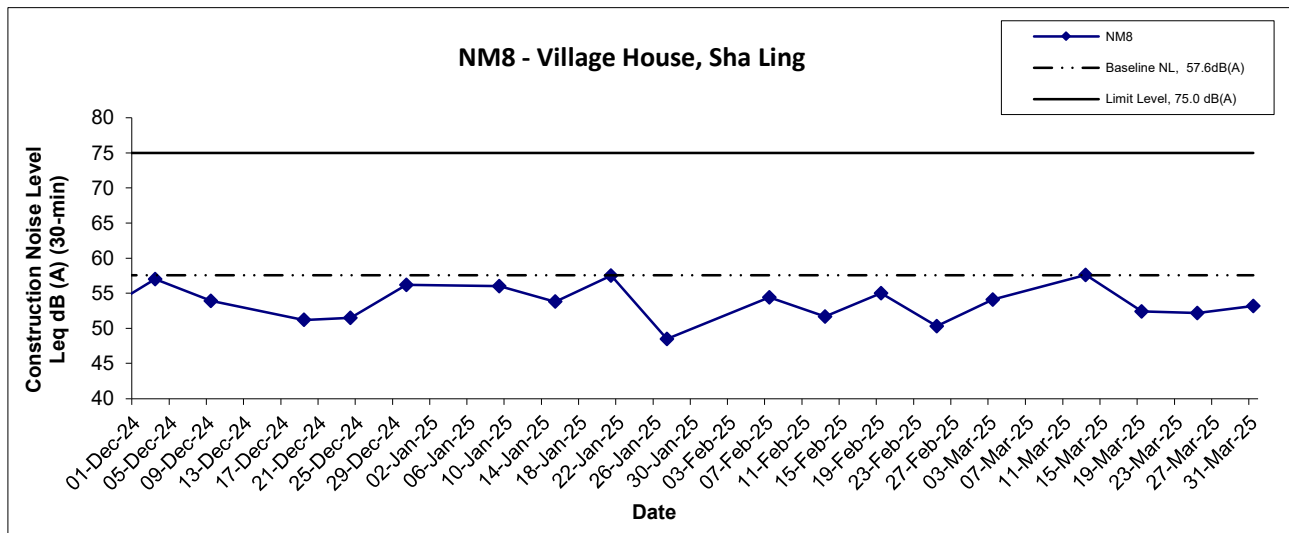
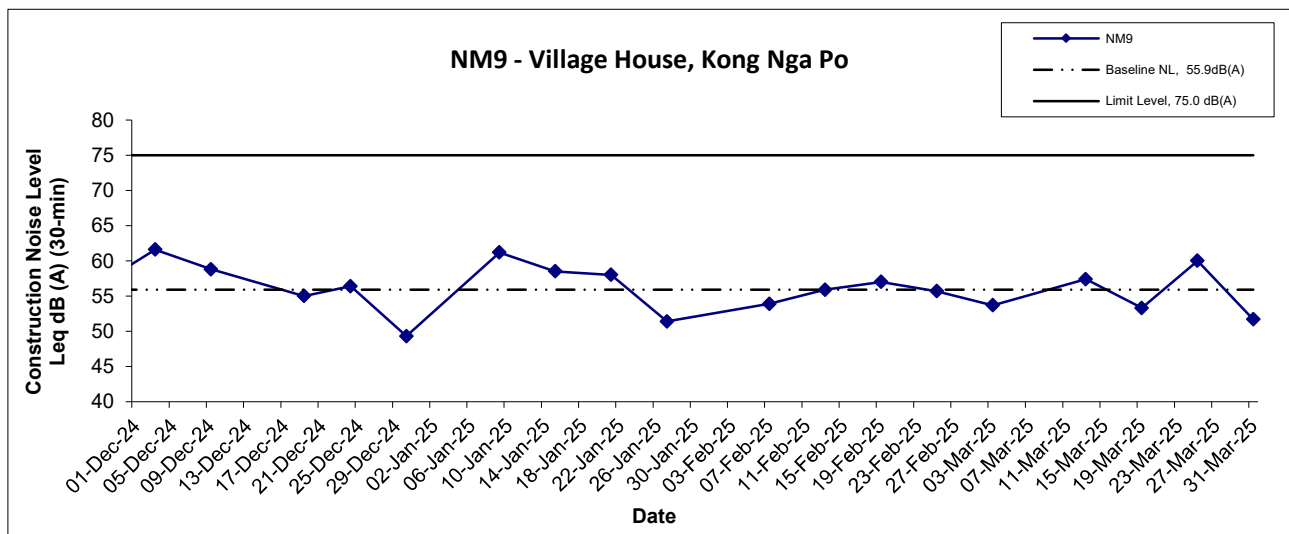
## Noise Levels

Title Service Contract No. NDO 07/2019 Environmental Team for Site Formation and Infrastructure Works for Police Facilities in Kong Nga Po Graphical Presentation of Construction Noise Monitoring Results	Scale N.T.S	Project No. WMA20001	consulting . testing . research
	Date Mar 25	Appendix C

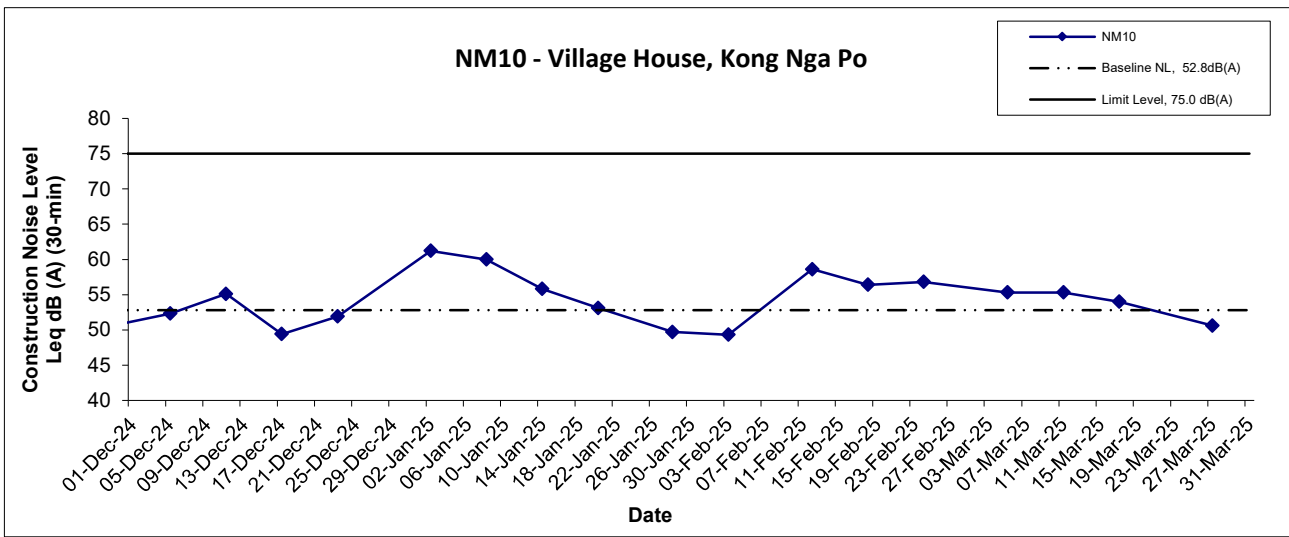
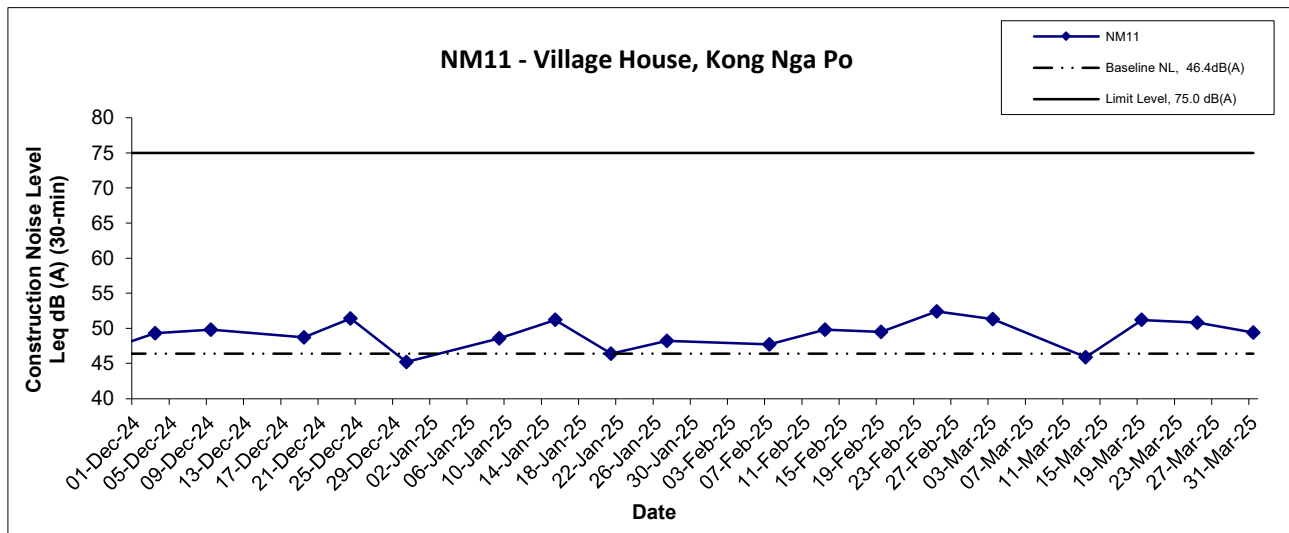
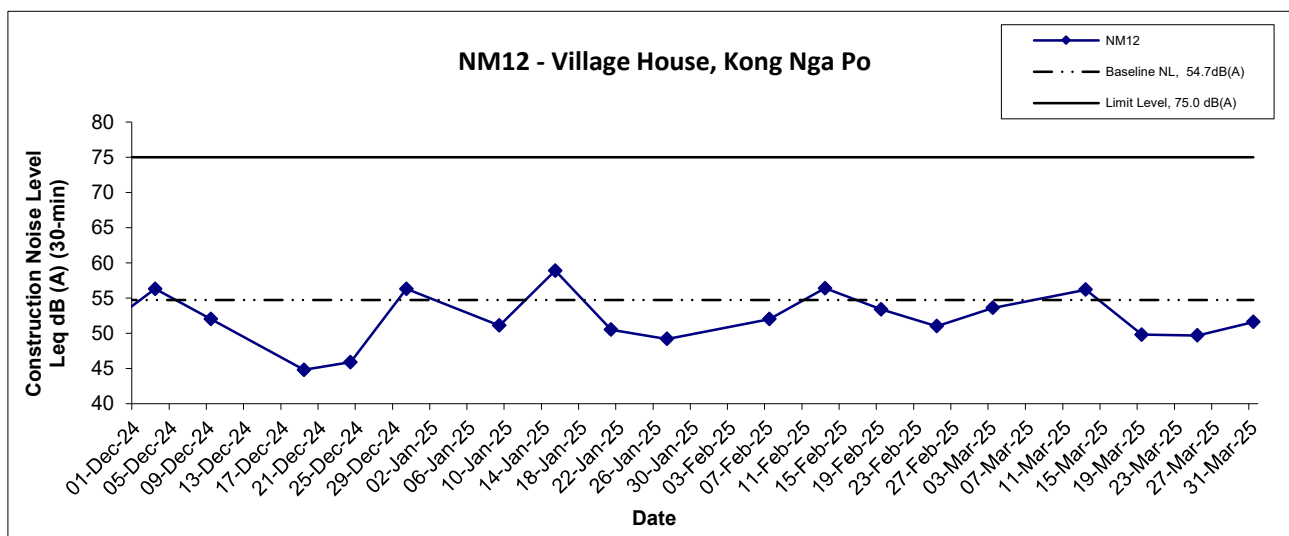
## Noise Levels

Title Service Contract No. NDO 07/2019 Environmental Team for Site Formation and Infrastructure Works for Police Facilities in Kong Nga Po Graphical Presentation of Construction Noise Monitoring Results	Scale N.T.S	Project No. WMA20001	consulting . testing . research
	Date Mar 25	Appendix C

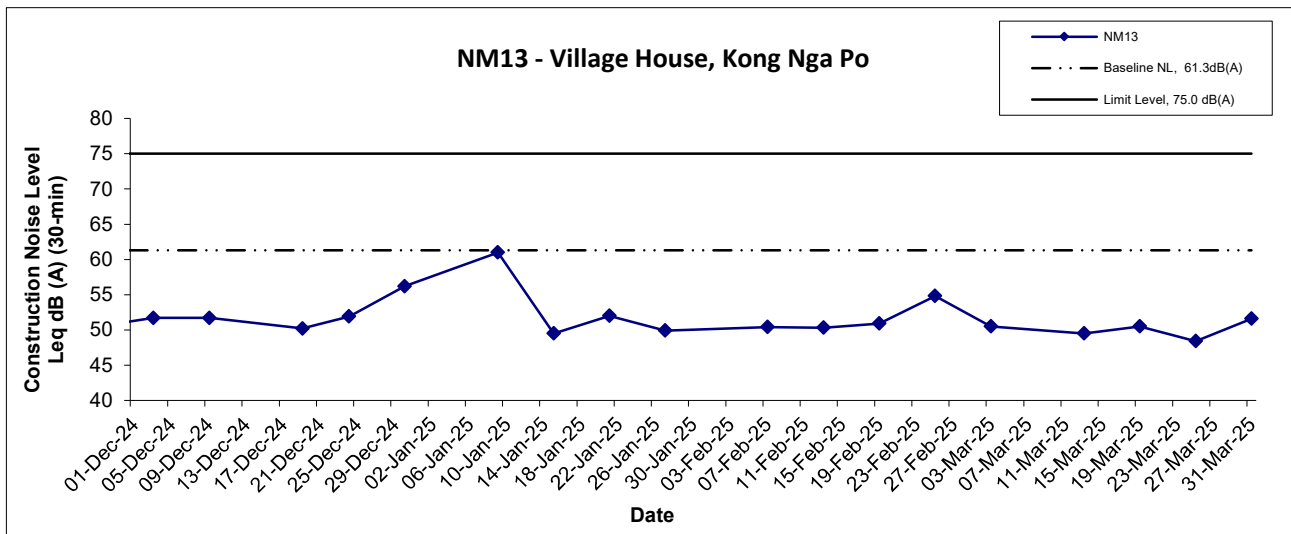
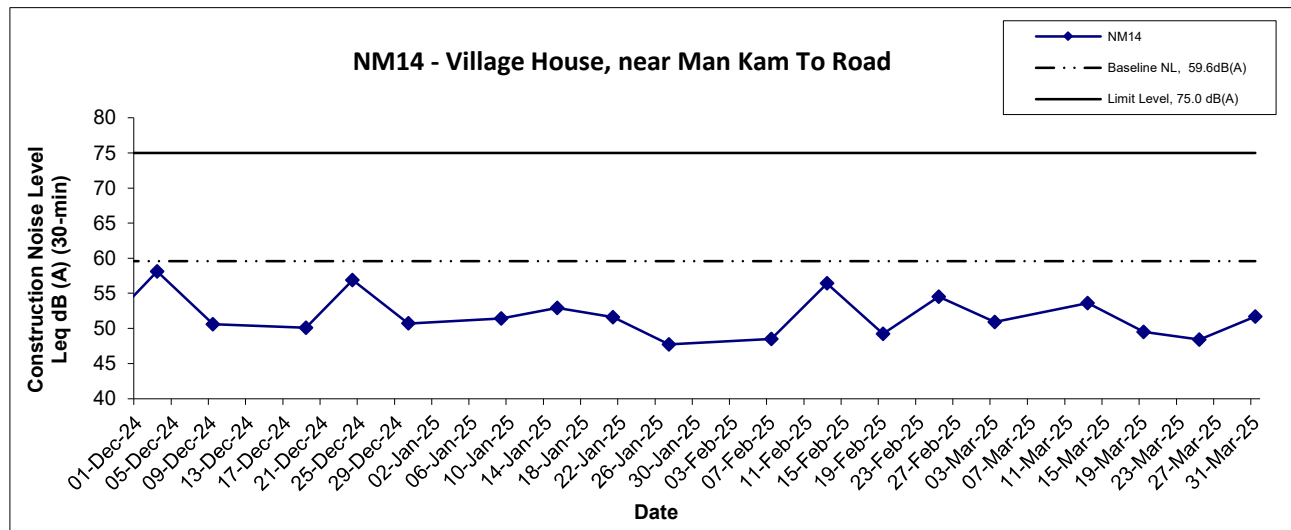
## Noise Levels

Title Service Contract No. NDO 07/2019 Environmental Team for Site Formation and Infrastructure Works for Police Facilities in Kong Nga Po Graphical Presentation of Construction Noise Monitoring Results	Scale	N.T.S	Project No.	WMA20001	consulting . testing . research
	Date	Mar 25	Appendix	C
