EP-510/2016 – Police Facilities in Kong Nga Po

**Service Contract No. NDO 07/2019
Environmental Team for Site Formation and
Infrastructure Works for Police Facilities in
Kong Nga Po**

**Monthly Environmental Monitoring and
Audit Report for June 2025
(Version 1.0)**

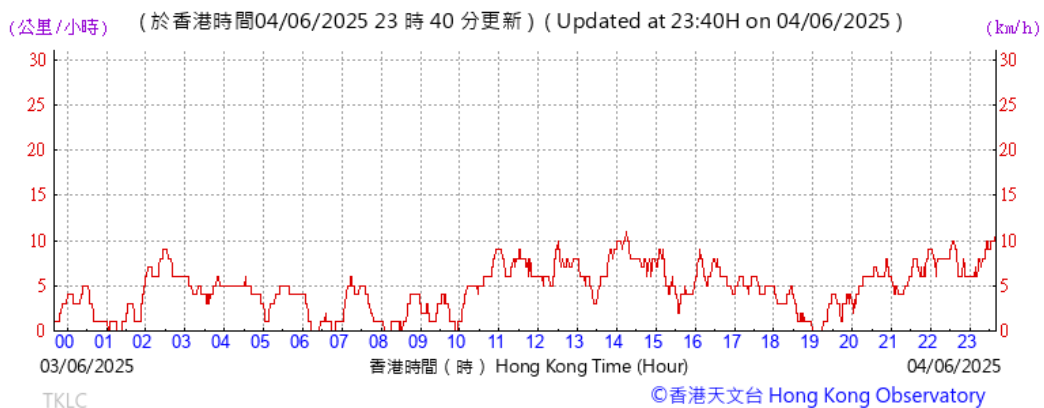
4 June 2025

Title Service Contract No. NDO 07/2019 Environmental Team for Site Formation and Infrastructure Works for Police Facilities in Kong Nga Po Meteorological Data at Ta Kwu Ling Weather Station	Scale N.T.S	Project No. WMA20001	
	Date Jun 25	Appendix G

- 3.6 Meteorological information was extracted from “Hong Kong Observatory - Ta Kwu Ling Weather Station” as the alternative method to obtain representative wind data. For Ta Kwu Ling Weather Station, it is located nearby the Project site and situated at approximately 15m above mean sea level. The station’s wind data monitoring equipment is set above the existing ground ten meters in compliance with the general setting up requirement. Furthermore, this station also provides other meteorological information, such as the humidity, rainfall, air pressure and temperature etc. The general meteorological conditions and the meteorological data at Ta Kwu Ling Weather Station are presented in **Appendix G**.
