EP-510/2016 – Police Facilities in Kong Nga Po

**Service Contract No. NDO 07/2019
Environmental Team for Site Formation and
Infrastructure Works for Police Facilities in
Kong Nga Po**

**Monthly Environmental Monitoring and
Audit Report for July 2025
(Version 1.0)**

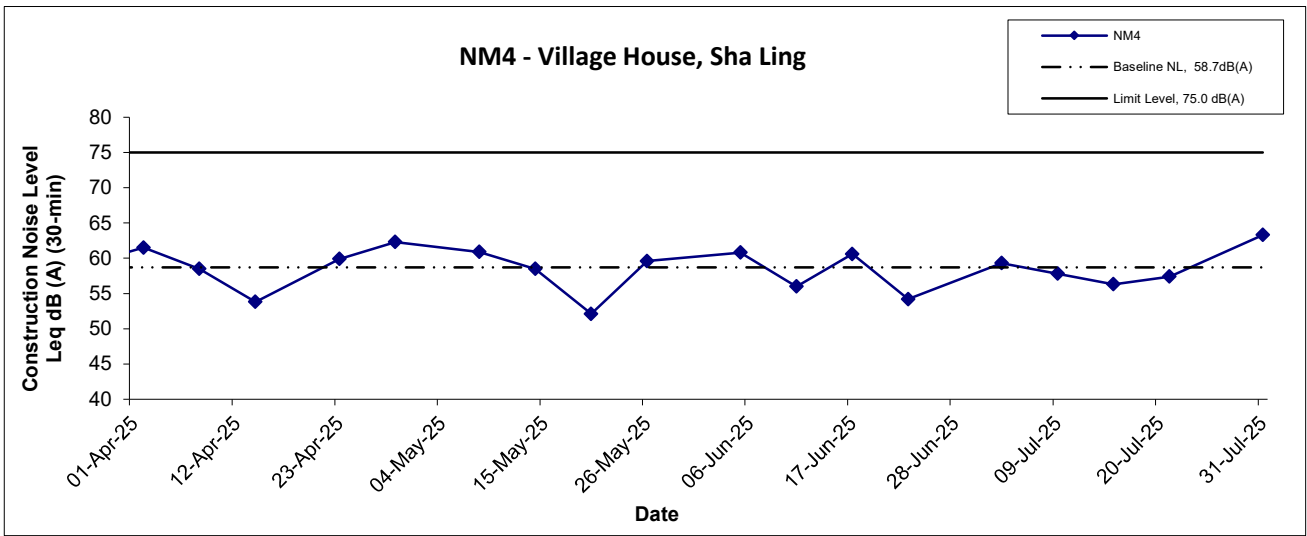
Noise Levels

Title Service Contract No. NDO 07/2019 Environmental Team for Site Formation and Infrastructure Works for Police Facilities in Kong Nga Po Graphical Presentation of Construction Noise Monitoring Results	Scale N.T.S	Project No. WMA20001	consulting . testing . research
	Date Jul 25	Appendix F
