**EP-510/2016 – Police Facilities in Kong Nga Po**

**Service Contract No. NDO 07/2019  
Environmental Team for Site Formation and  
Infrastructure Works for Police Facilities in  
Kong Nga Po**

**Monthly Environmental Monitoring and  
Audit Report for September 2025  
(Version 1.0)**

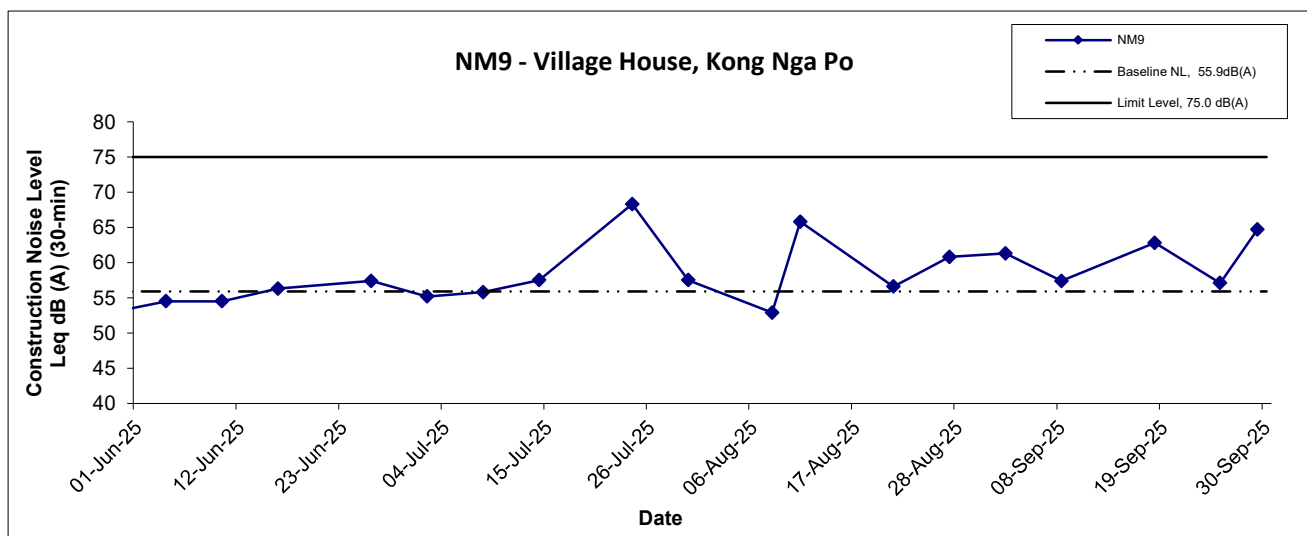
## Noise Levels

Title Service Contract No. NDO 07/2019 Environmental Team for Site Formation and Infrastructure Works for Police Facilities in Kong Nga Po Graphical Presentation of Construction Noise Monitoring Results	Scale	N.T.S	Project No.	WMA20001
	Date	Sept 25	Appendix	F
