# Civil Engineering and Development Department

## Service Contract No. NDO 07/2019 Environmental Team for Site Formation and Infrastructure Works for Police Facilities in Kong Nga Po

### Detailed Vegetation Survey Report (Version 3.0)

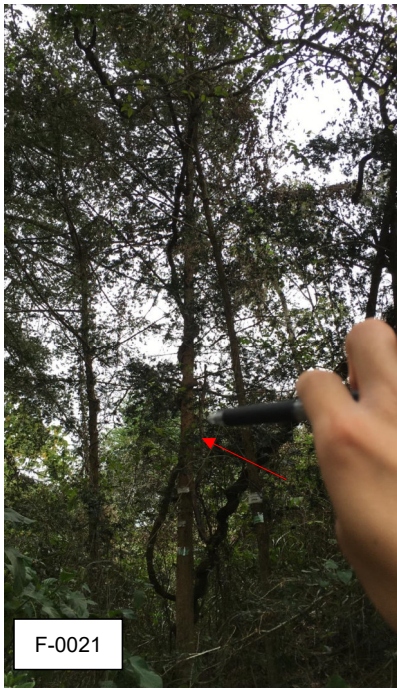
F-0010	1	<i>Keteleeria fortunei</i>	油杉	9	220	4	F	P	M	F	L	B	Retain	2	-
F-0011	1	<i>Keteleeria fortunei</i>	油杉	3	60	2	F	P	L	F	L	B	Retain	2	Broken branches
F-0012	1	<i>Keteleeria fortunei</i>	油杉	4	120	2	F	F	M	F	L	B	Retain	2	-
F-0013	1	<i>Keteleeria fortunei</i>	油杉	5	150	3	F	F	M	F	L	B	Retain	2	-
F-0014	1	<i>Keteleeria fortunei</i>	油杉	5	140	3	F	F	L	F	L	B	Retain	2	Broken branches
F-0015	1	<i>Keteleeria fortunei</i>	油杉	3	92	-	P	P	L	P	L	B	Retain	2	Leaning
F-0016	1	<i>Keteleeria fortunei</i>	油杉	2	41	1	P	P	L	P	L	B	Retain	2	Leaning
F-0017	1	<i>Keteleeria fortunei</i>	油杉	4	108	2	P	P	L	P	L	B	Fell	3	Broken branches, Leaning, Dead
F-0018	1	<i>Keteleeria fortunei</i>	油杉	2	89	1.5	P	P	L	P	L	B	Retain	2	Broken branches
F-0019	1	<i>Keteleeria fortunei</i>	油杉	4	86	2	P	P	L	P	L	B	Retain	2	Broken branches, Leaning
F-0020	1	<i>Keteleeria fortunei</i>	油杉	5	86	1.5	F	F	M	F	L	B	Retain	2	-
F-0021	1	<i>Keteleeria fortunei</i>	油杉	7	152	3	P	P	M	P	L	B	Retain	2	-

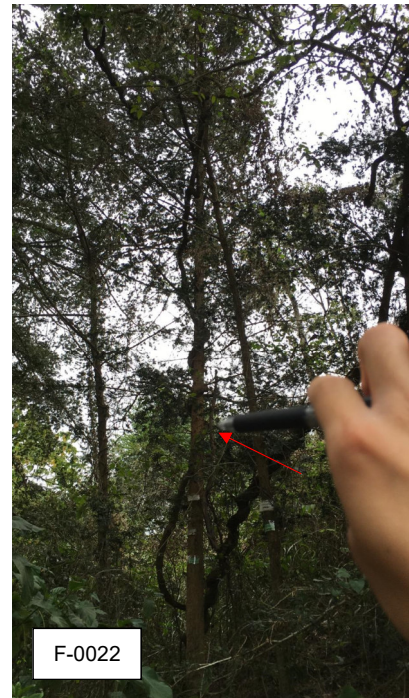
F-0022	1	<i>Keteleeria fortunei</i>	油杉	5	76	2	F	F	L	F	L	B	Retain	2	-
F-0023	1	<i>Keteleeria fortunei</i>	油杉	8	181	4	F	F	M	F	L	B	Retain	2	-
F-0024	1	<i>Keteleeria fortunei</i>	油杉	8	296	6	F	F	M	F	L	B	Retain	2	-
F-0025	1	<i>Keteleeria fortunei</i>	油杉	4	124	4	F	F	M	F	L	B	Retain	2	Pollarded
F-0027	1	<i>Keteleeria fortunei</i>	油杉	2.5	-	2	F	F	L	F	L	B	Retain	2	Pollarded
F-0028	1	<i>Keteleeria fortunei</i>	油杉	3	80	2	F	F	L	F	L	B	Retain	2	Broken branches, Leaning
F-0029	1	<i>Keteleeria fortunei</i>	油杉	7	190	3	F	F	M	F	L	B	Retain	2	-
F-0030	1	<i>Keteleeria fortunei</i>	油杉	7	203	5	F	F	M	F	L	B	Retain	2	-
F-0031	1	<i>Keteleeria fortunei</i>	油杉	3	76	1.5	F	F	L	F	L	B	Retain	2	-
F-0032	1	<i>Keteleeria fortunei</i>	油杉	7	140	3	F	F	L	F	L	B	Retain	2	-
F-0034	1	<i>Keteleeria fortunei</i>	油杉	13	430	6	F	F	M	F	L	B	Retain	2	-
F-0035	1	<i>Keteleeria fortunei</i>	油杉	5	105	1.5	P	P	L	P	L	B	Retain	2	Leaning
F-0036	1	<i>Keteleeria fortunei</i>	油杉	7	162	4	F	F	M	F	L	B	Retain	2	-
