EP-510/2016 – Police Facilities in Kong Nga Po

**Service Contract No. NDO 07/2019
Environmental Team for Site Formation and
Infrastructure Works for Police Facilities in
Kong Nga Po**

**Monthly Environmental Monitoring and
Audit Report for September 2020
(Version 1.0)**

**Site Formation and Infrastructure Works for Police Facilities in Kong Nga Po
Monthly Environmental Monitoring and Audit Report for September 2020**

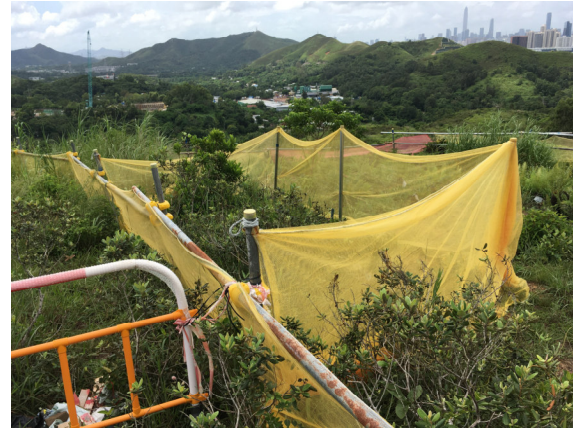
Photo 8

Description: Protective fence for transplanted *Spiranthes sinensis* are properly erected.

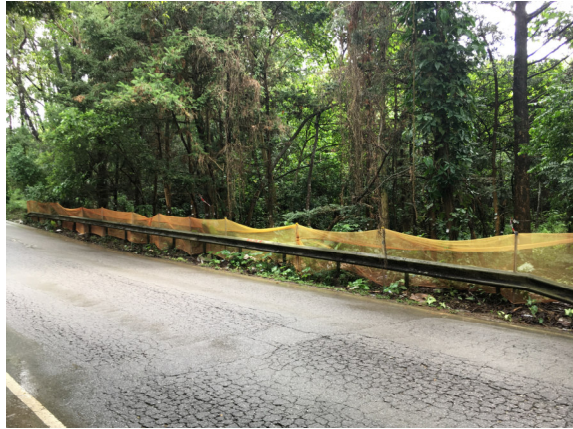
Photo 9

Description: Protective fence for *Keteleeria fortunei* are properly erected.

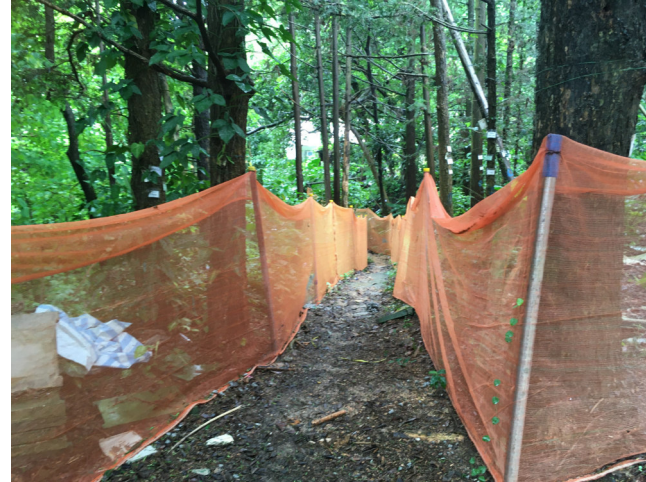
Photo 16

Description: Protective fence for undersized seedling of *Aquilaria sinensis* are properly erected.
