**EP-510/2016 – Police Facilities in Kong Nga Po**

**Service Contract No. NDO 07/2019  
Environmental Team for Site Formation and  
Infrastructure Works for Police Facilities in  
Kong Nga Po**

**Monthly Environmental Monitoring and  
Audit Report for January 2021  
(Version 1.0)**

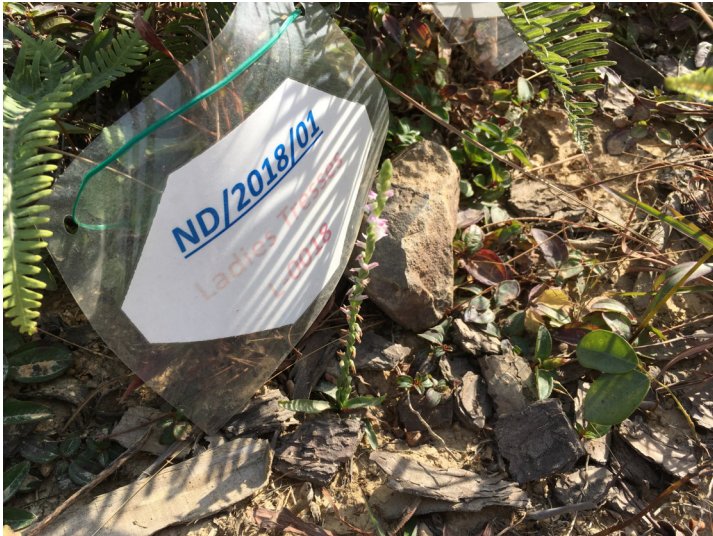
Photo 9

Description: Flowering was observed in one of the *Spiranthes sinensis*.

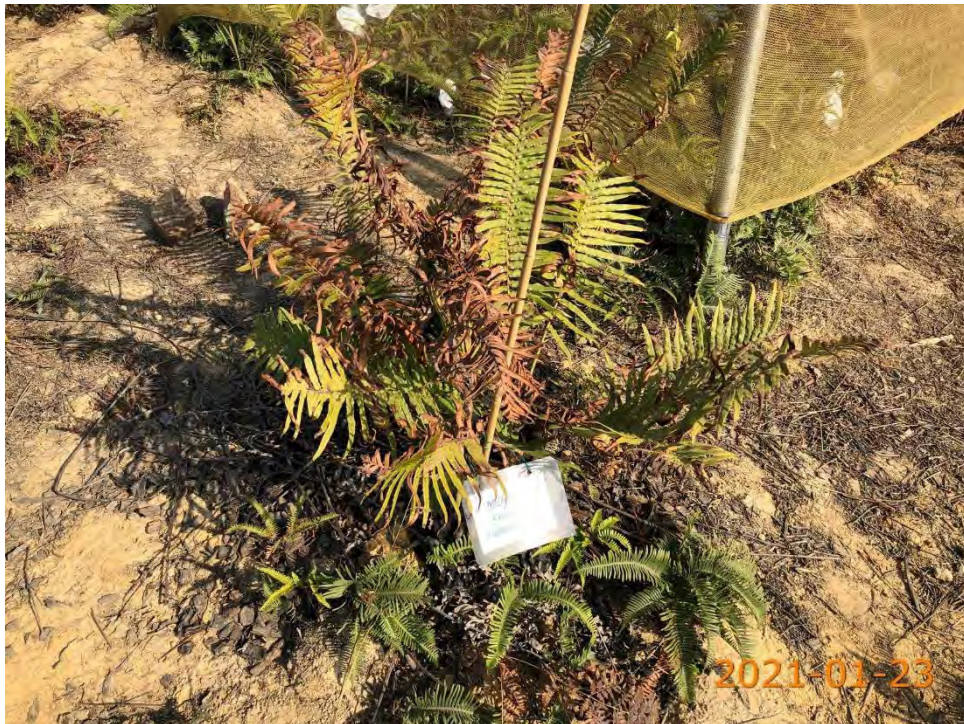
C-0001(Patch)\_01

07	<i>Brainea insignis</i>	P	P	Dropping terminal crown, young fronds observed
	08	<i>Brainea insignis</i>	F	F	
	09	<i>Brainea insignis</i>	F	F	Withered fronds observed
	10	<i>Brainea insignis</i>	F	F	
	11	<i>Brainea insignis</i>	F	F	
	12	<i>Brainea insignis</i>	F	F	
	13	<i>Brainea insignis</i>	F	F

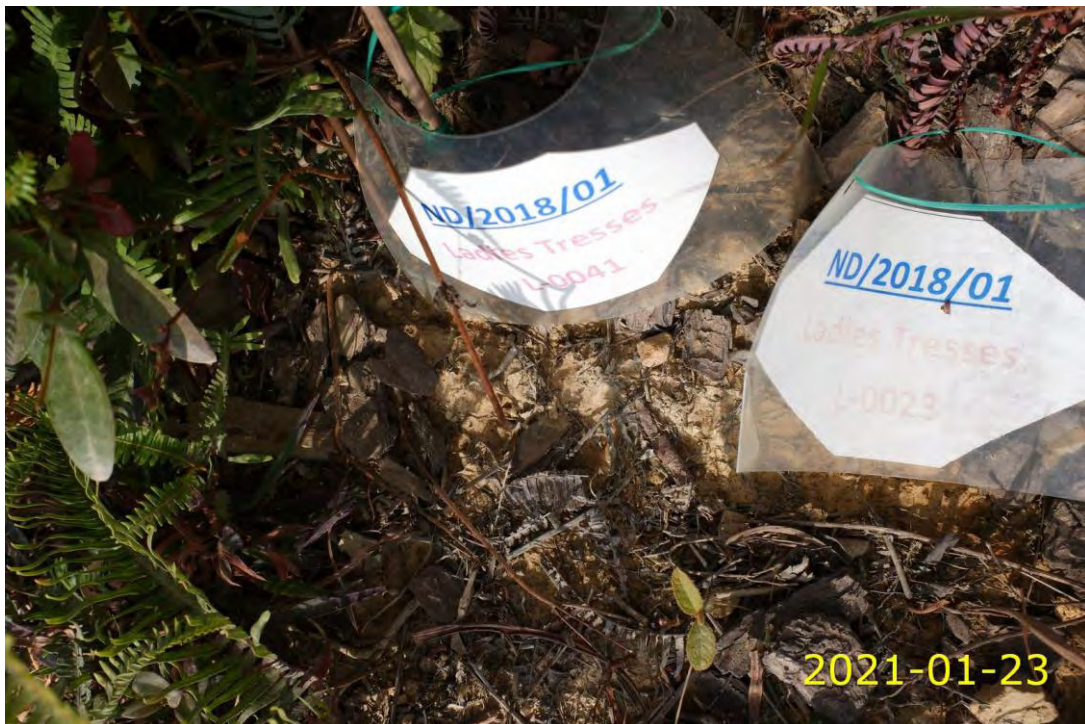
L-0040	<i>Spiranthes sinensis</i>	F	F	
L-0041	<i>Spiranthes sinensis</i>	-	-	No sprout observed
L-0042	<i>Spiranthes sinensis</i>	F	F	No sprout observed
