EP-510/2016 – Police Facilities in Kong Nga Po

**Service Contract No. NDO 07/2019
Environmental Team for Site Formation and
Infrastructure Works for Police Facilities in
Kong Nga Po**

**Monthly Environmental Monitoring and
Audit Report for February 2021
(Version 1.0)**

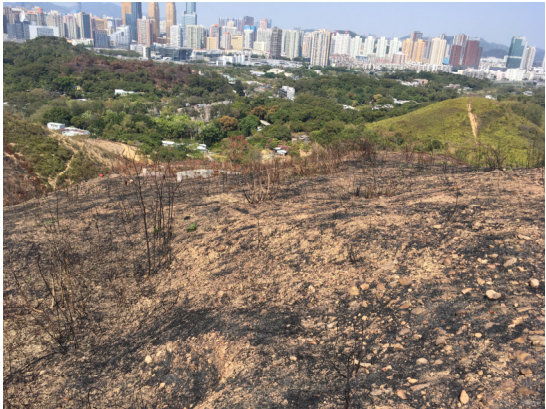
<p>Photo 1</p>

<p>Description: Bushfire near Kong Nga Po main site was recorded on 2nd February 2021 and affected the vegetation area near receptor site for <i>Brainea insignis</i>.</p>	<p>Photo 2</p>   <p>Description: Damaged protective fence are replaced and properly erected for transplanted <i>Brainea insignis</i>.</p>
<p>Photo 3</p>   <p>Description: Damaged protective fence are replaced and properly erected for transplanted <i>Brainea insignis</i>.</p>	<p>Photo 4</p>   <p>Description: Three transplanted <i>Brainea insignis</i> were affected by the bushfire and condition of the individuals are closely monitored by the Contractor.</p>

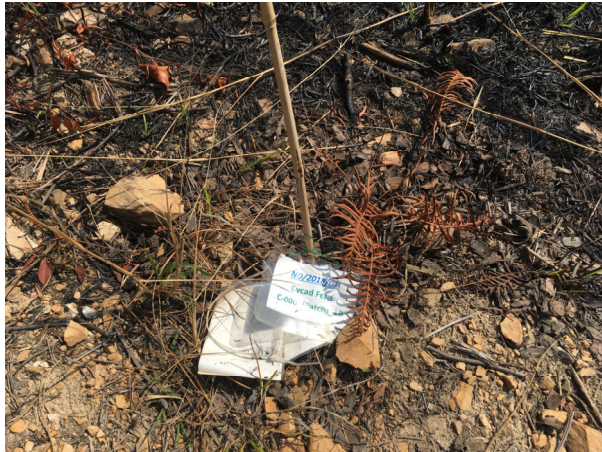
Photo 5

Description: Three transplanted *Brainea insignis* were affected by the bushfire and condition of the individuals are closely monitored by the Contractor.

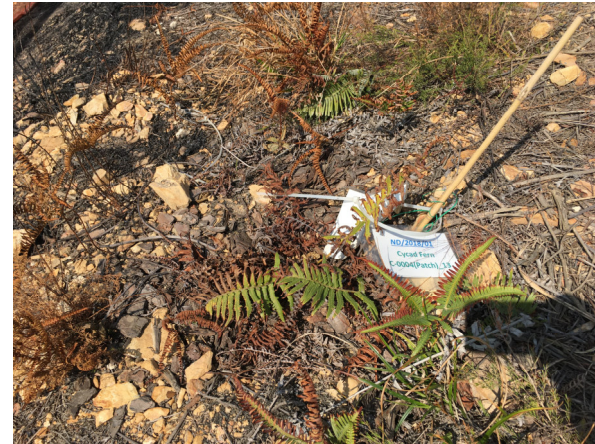
Photo 6

Description: Three transplanted *Brainea insignis* were affected by the bushfire and condition of the individuals are closely monitored by the Contractor.

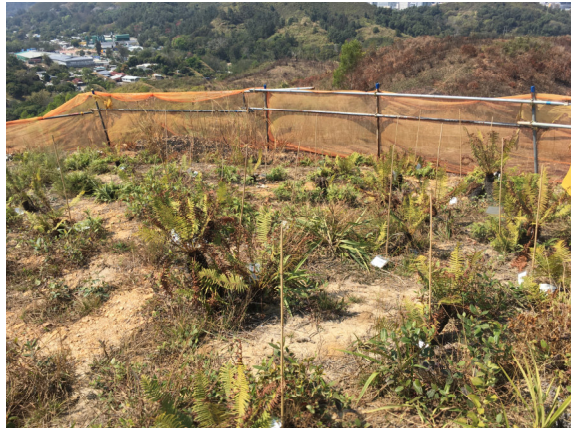
Photo 7

Description: Close monitoring is conducted by the Contractor for the transplanted *Brainea insignis* that may be potentially affected by the bushfire.

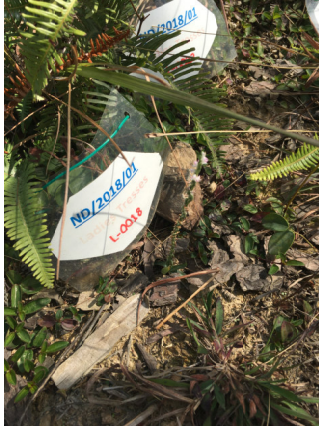
Photo 15

Description: Flowering and flower buds of *Spiranthes sinensis* are observed.

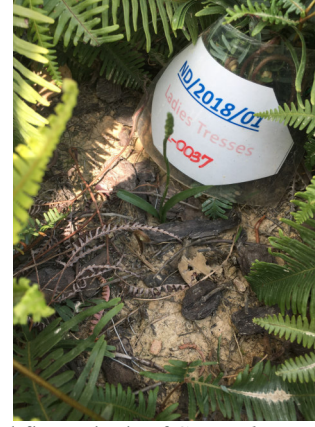
Photo 16

Description: Flowering and flower buds of *Spiranthes sinensis* are observed.

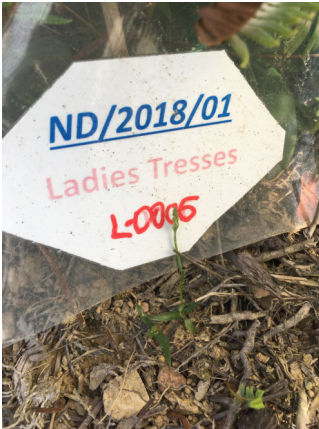
Photo 17

Description: Flowering and flower buds of *Spiranthes sinensis* are observed.

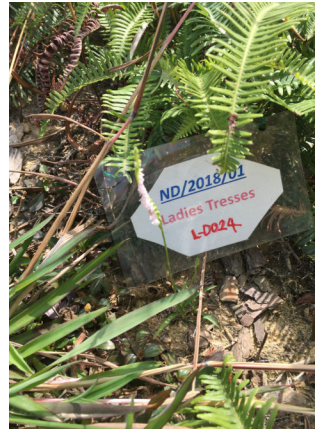
Photo 18

Description: Flowering and flower buds of *Spiranthes sinensis* are observed.

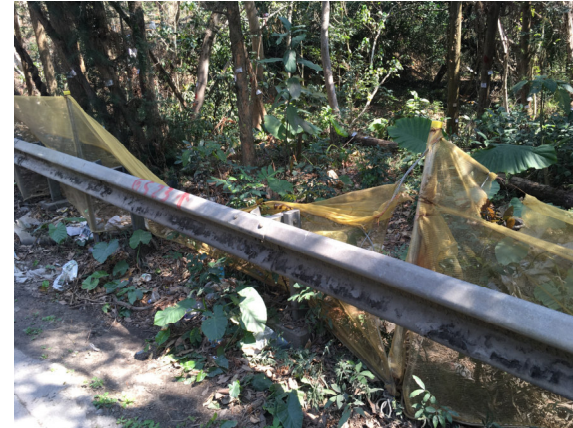
Photo 22

Description: Contractor was reminded to keep maintain the protective fencing properly and replace the loosing fencing for *Keteleeria fortunei*.

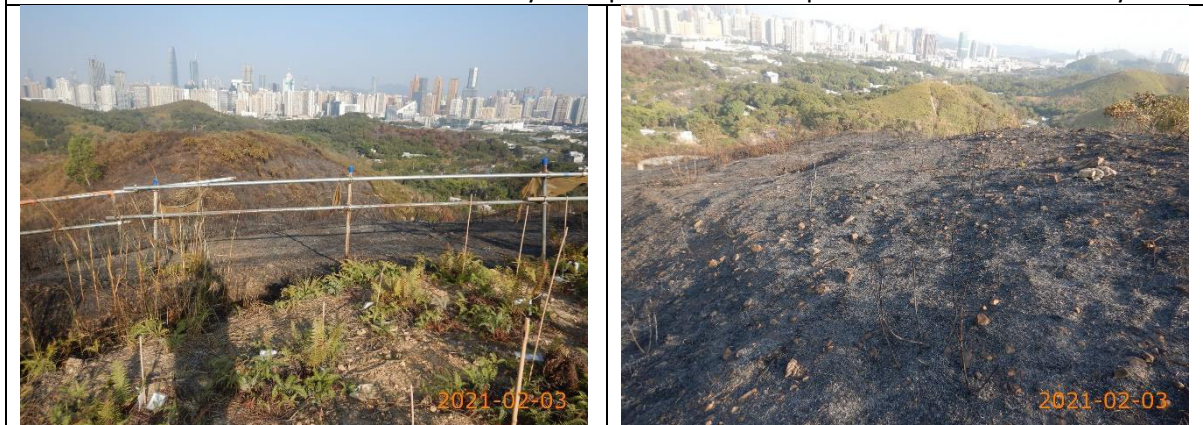
The Contractor had conducted inspection with landscaping specialist on the conservative species on the next day (3 February 2021). No Ladies Tresses was affected by the bushfire however Cycad fern was damaged and summarized as below:

Colony Number	Condition
C-0004(Patch)_01	Dry out caused by bushfire
C-0004(Patch)_09	Burned by bushfire
C-0004(Patch)_13	Burned by bushfire
C-0004(Patch)_15	Dry out caused by bushfire
C-0004(Patch)_16	Dry out caused by bushfire
C-0004(Patch)_18	Burned by bushfire
C-0011(Patch)_01	Dry out caused by bushfire

Inspection of conservative species on the next day (3 February 2021)

Suggested Measures
