EP-510/2016 – Police Facilities in Kong Nga Po

**Service Contract No. NDO 07/2019
Environmental Team for Site Formation and
Infrastructure Works for Police Facilities in
Kong Nga Po**

**Monthly Environmental Monitoring and
Audit Report for March 2021
(Version 1.0)**

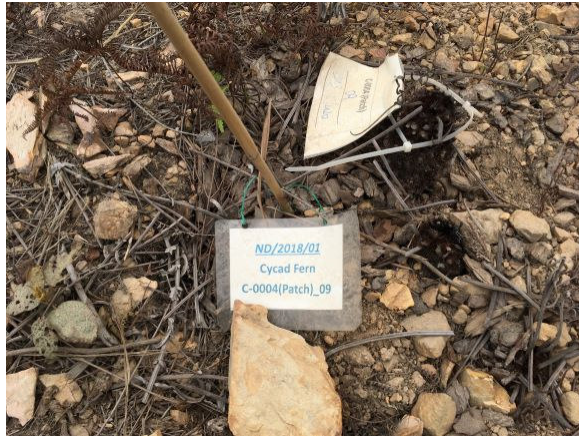
Photo 5

Description: Condition of transplanted *Brainea insignis* affected by bushfire are closely monitored by the Contractor.

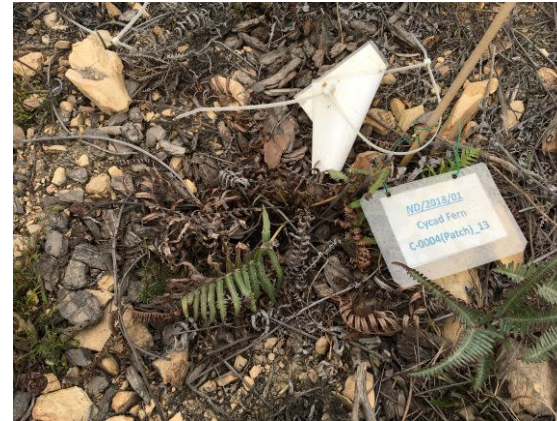
Photo 6

Description: Condition of transplanted *Brainea insignis* affected by bushfire are closely monitored by the Contractor.

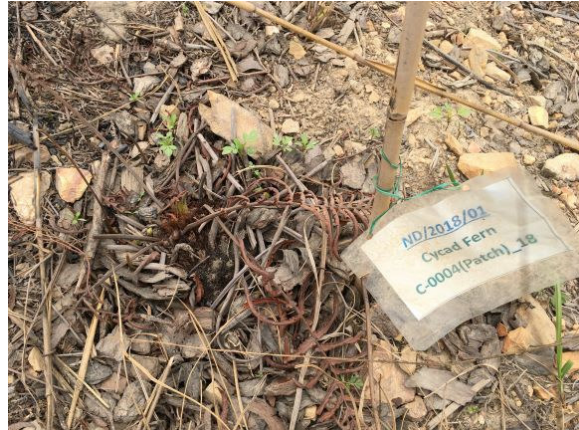
Photo 7

Description: Condition of transplanted *Brainea insignis* affected by bushfire are closely monitored by the Contractor.

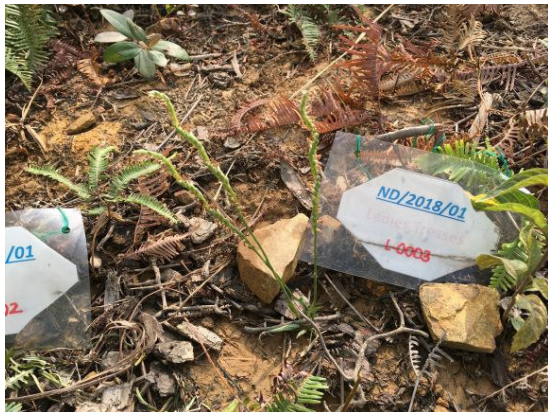
Photo 12

Description: Flowering and flower buds of *Spiranthes sinensis* are observed.

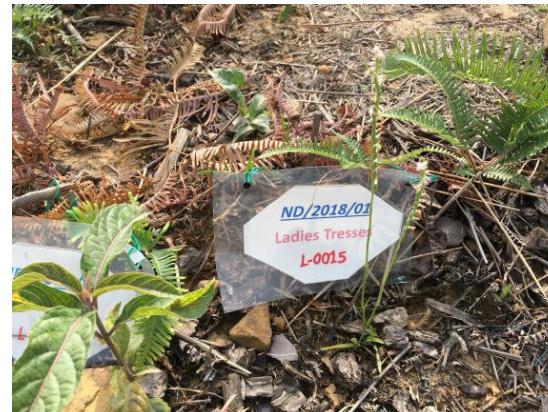
Photo 13

Description: Flowering and flower buds of *Spiranthes sinensis* are observed.

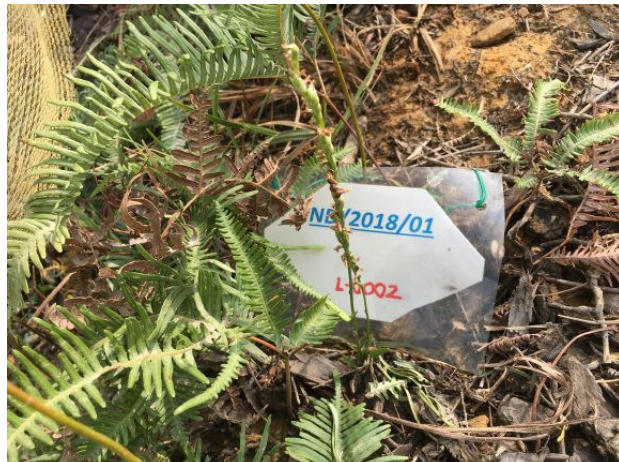
Photo 14

Description: Flowering and flower buds of *Spiranthes sinensis* are observed.

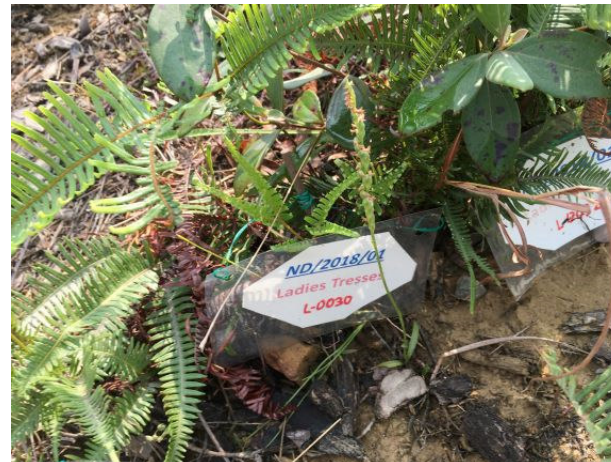
Photo 15

Description: Flowering and flower buds of *Spiranthes sinensis* are observed.
