EP-510/2016 – Police Facilities in Kong Nga Po

**Service Contract No. NDO 07/2019
Environmental Team for Site Formation and
Infrastructure Works for Police Facilities in
Kong Nga Po**

**Monthly Environmental Monitoring and
Audit Report for August 2021
(Version 1.0)**

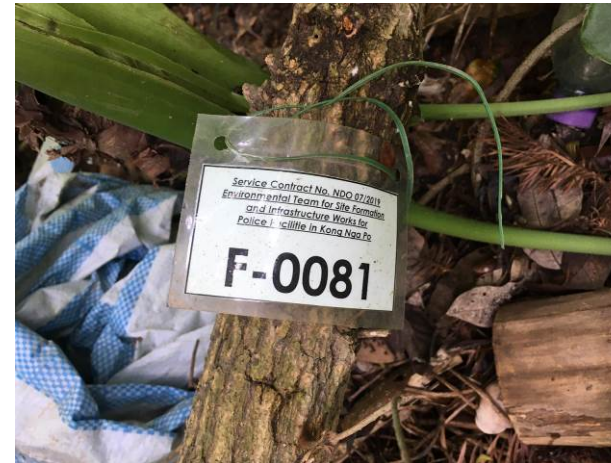
Photo 12

Description: An undersized seedling of *Keteleeria fortunei* (F-0081) was found collapsed due to internal decay.

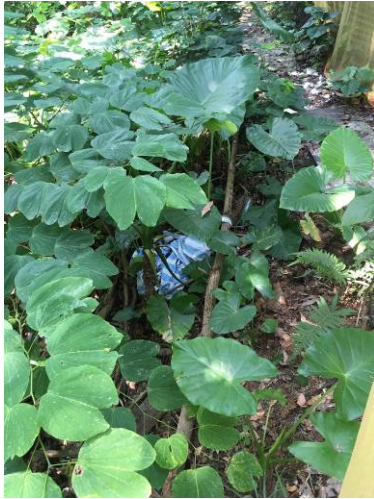
Photo 13

Description: An undersized seedling of *Keteleeria fortunei* (F-0081) was found collapsed due to internal decay. No construction activity was observed at the location of *Keteleeria fortunei*.

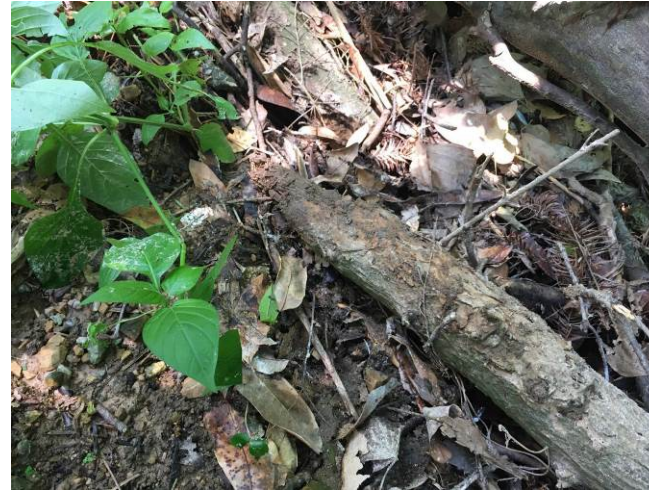
Photo 14

Description: An undersized seedling of *Keteleeria fortunei* (F-0081) was found collapsed due to internal decay.

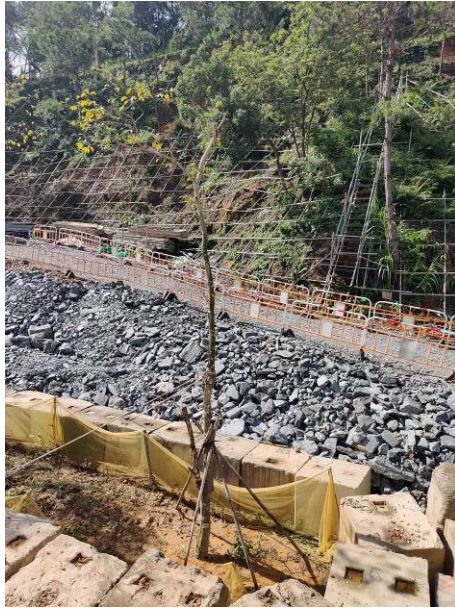
Photo 17

- 5.10 During monthly monitoring, poor health condition of *Aquilaria sinensis* A-0009 and A-0010 were found. The Contractor was reminded to improve the drainage system and soil condition at the receptor site as soon as possible. No construction activity and equipment storage was observed within the receptor site. Temporary protective fence were properly erected and maintained for the transplanted species.

Description: Poor health condition of *Aquilaria sinensis* A-0010 was found. The Contractor was reminded to improve the drainage system and soil condition at the receptor site as soon as possible.

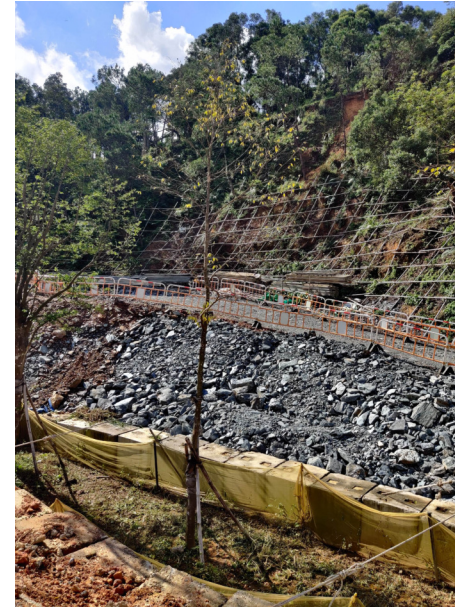
Photo 18

Description: Poor health condition of *Aquilaria sinensis* A-0009 was found. The Contractor was reminded to improve the drainage system and soil condition at the receptor site as soon as possible.
