EP-510/2016 – Police Facilities in Kong Nga Po

**Service Contract No. NDO 07/2019
Environmental Team for Site Formation and
Infrastructure Works for Police Facilities in
Kong Nga Po**

**Quarterly Environmental Monitoring and
Audit Report for July to September 2021
(Version 1.0)**

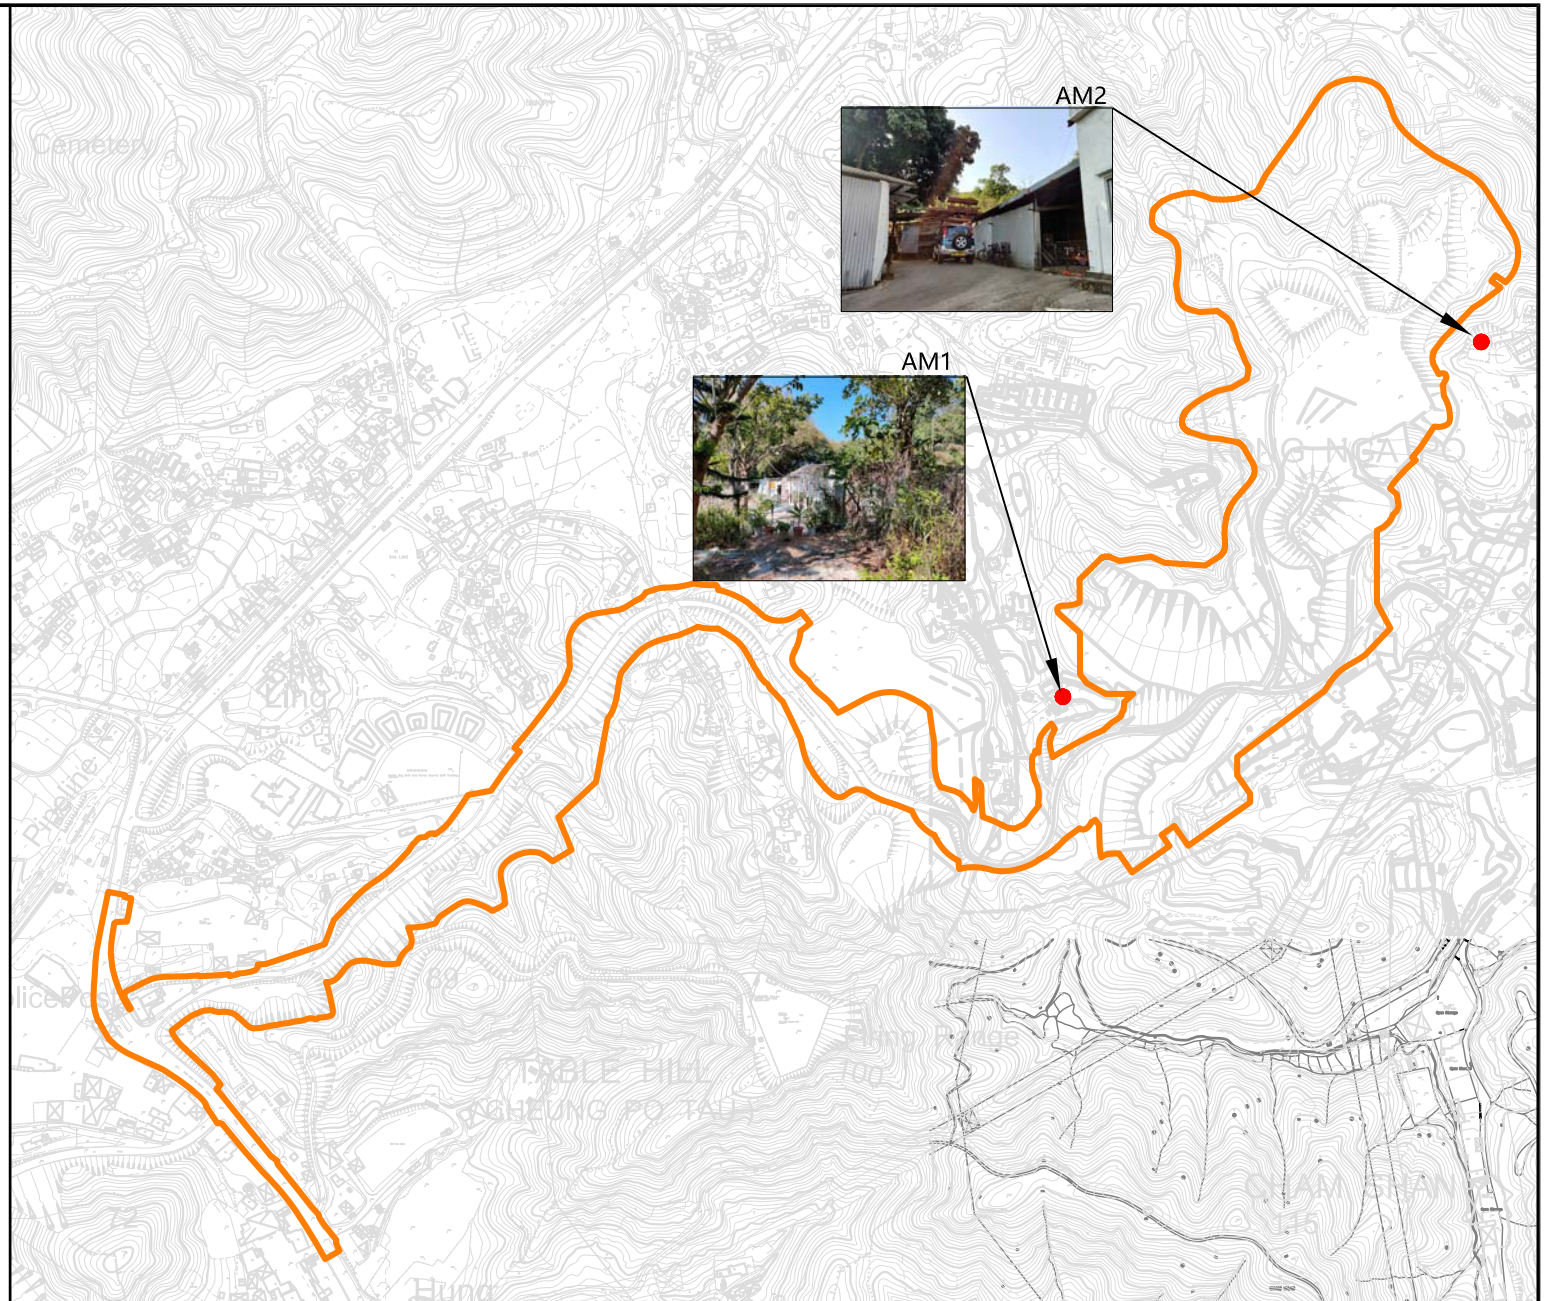
Air Quality Monitoring Stations

AIR QUALITY MONITORING STATIONS	
I.D	Description
AM1	Village House, Kong Nga Po
AM2	Village House, Kong Nga Po

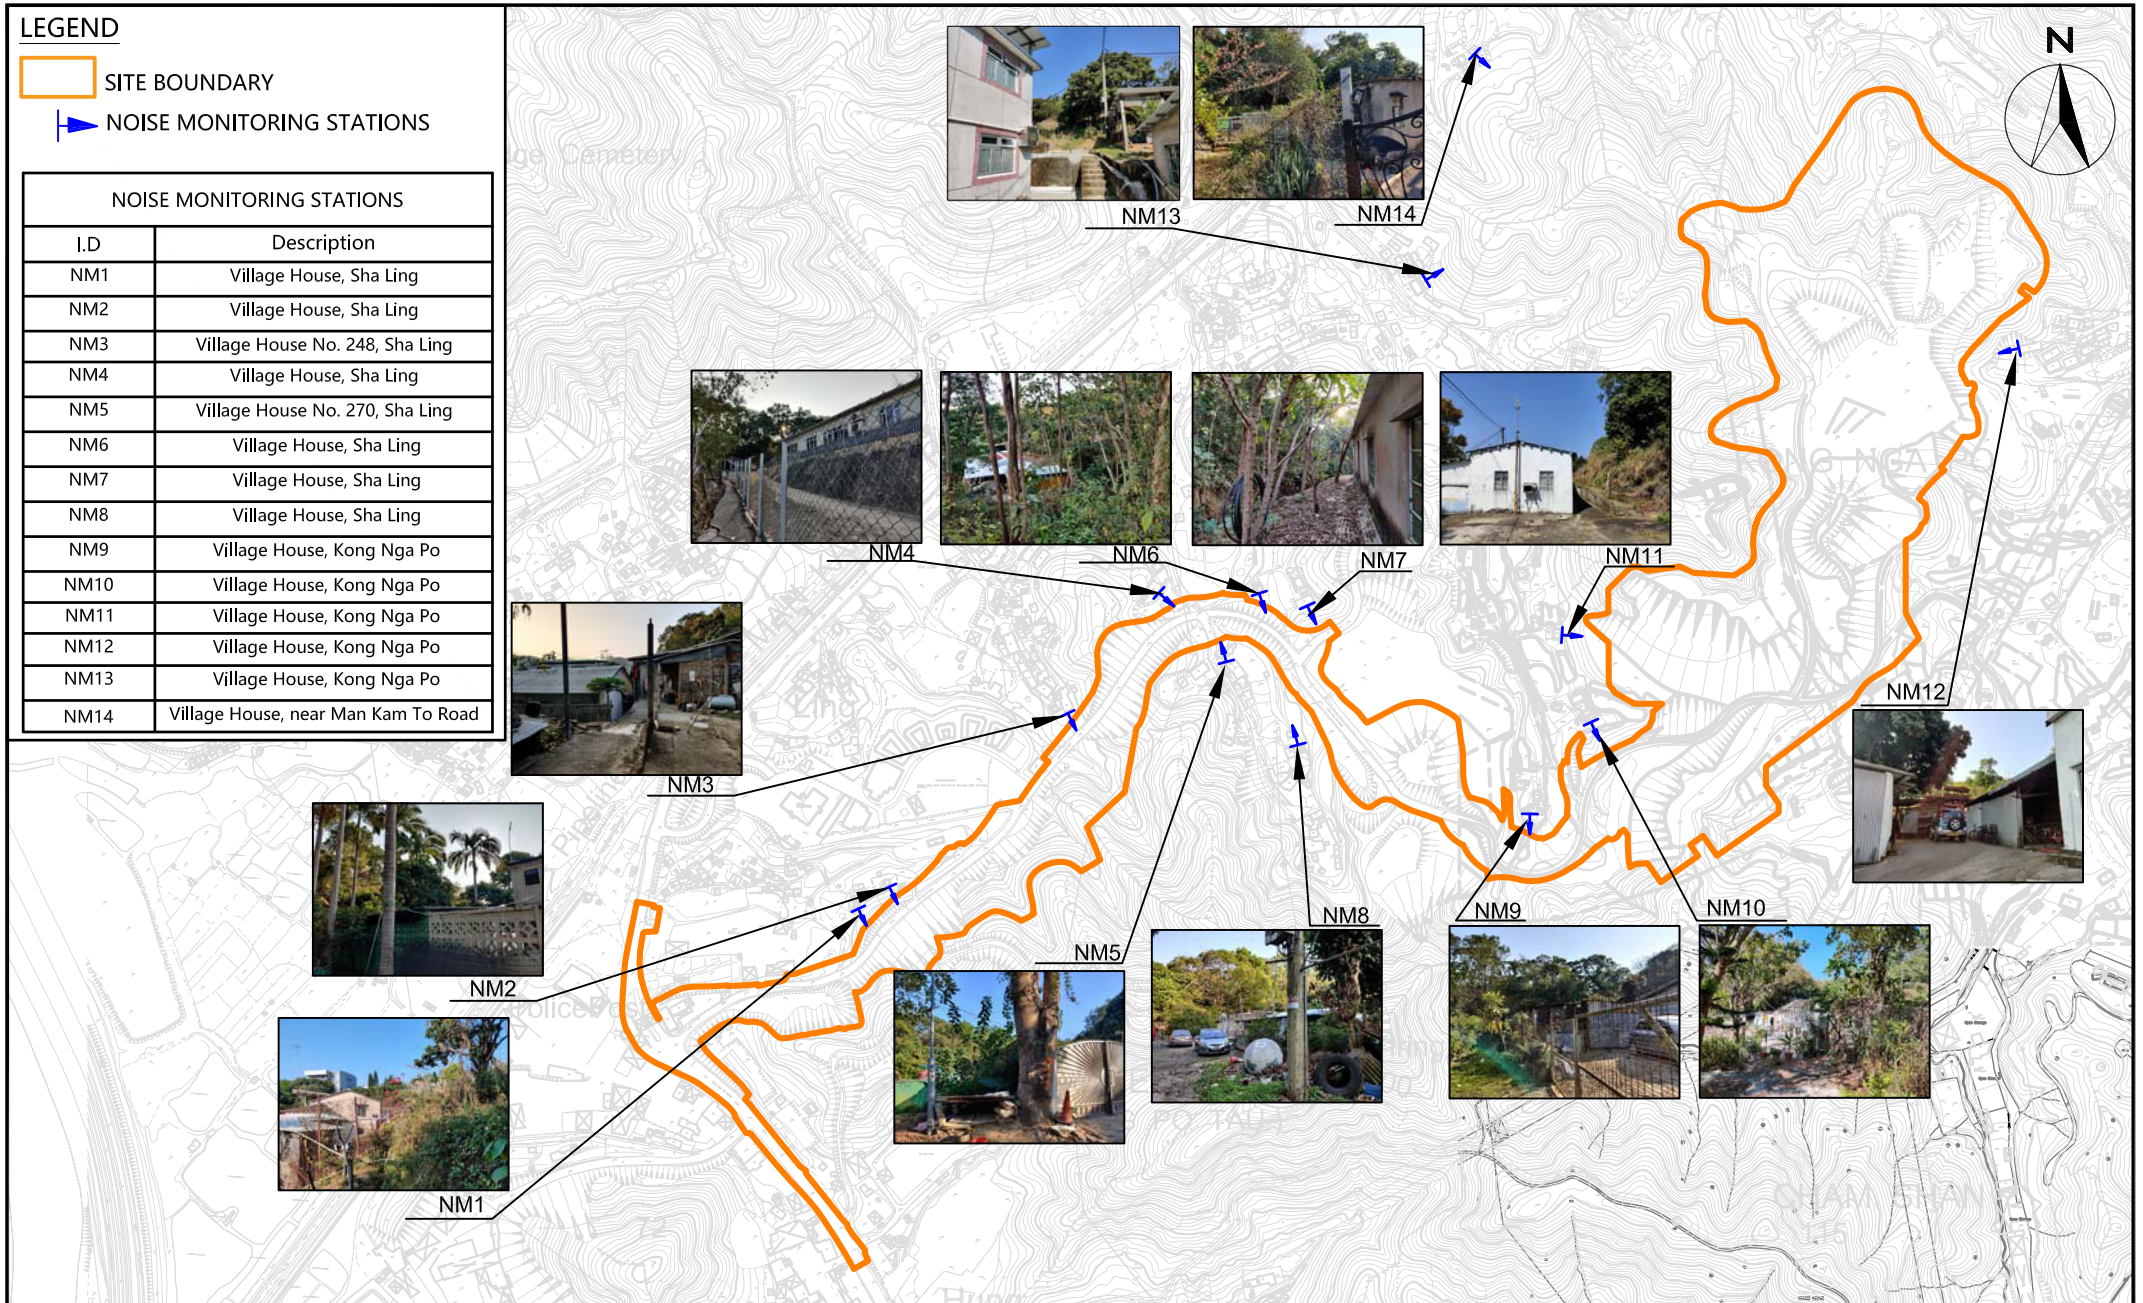
SCALE	A4 @ 1:50000	DATE	JUL 2020	
CHECK	IT	DRAWN	NL	
JOB No.	WMA20001	FIGURE NO.	3	REV —

NOISE MONITORING STATIONS	
I.D	Description
NM1	Village House, Sha Ling
NM2	Village House, Sha Ling
NM3	Village House No. 248, Sha Ling
NM4	Village House, Sha Ling
NM5	Village House No. 270, Sha Ling
NM6	Village House, Sha Ling
NM7	Village House, Sha Ling
NM8	Village House, Sha Ling
NM9	Village House, Kong Nga Po
NM10	Village House, Kong Nga Po
NM11	Village House, Kong Nga Po
NM12	Village House, Kong Nga Po
NM13	Village House, Kong Nga Po
NM14	Village House, near Man Kam To Road

Service Contract No. NDO 07/2019
 Environmental Team for Site Formation and Infrastructure Works for Police Facilities in Kong Nga Po
Noise Monitoring Stations

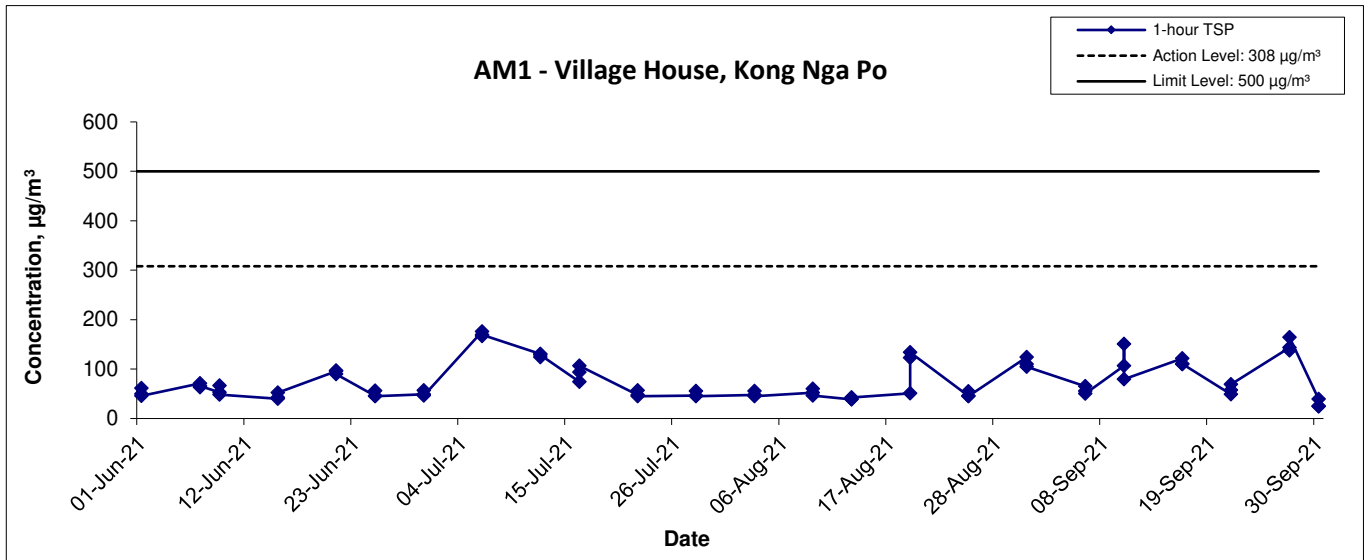
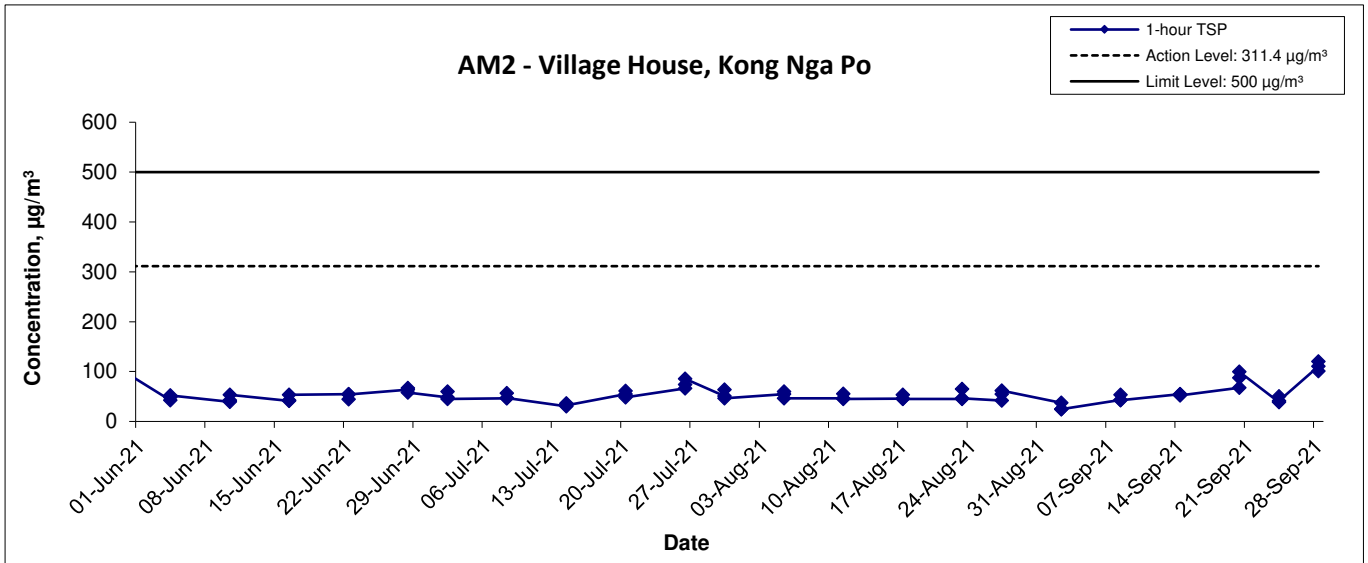
1-hr TSP Concentration Levels

Title Service Contract No. NDO 07/2019 Environmental Team for Site Formation and Infrastructure Works for Police Facilities in Kong Nga Po Graphical Presentation of 1-hour TSP Monitoring Results	Scale N.T.S	Project No. WMA20001

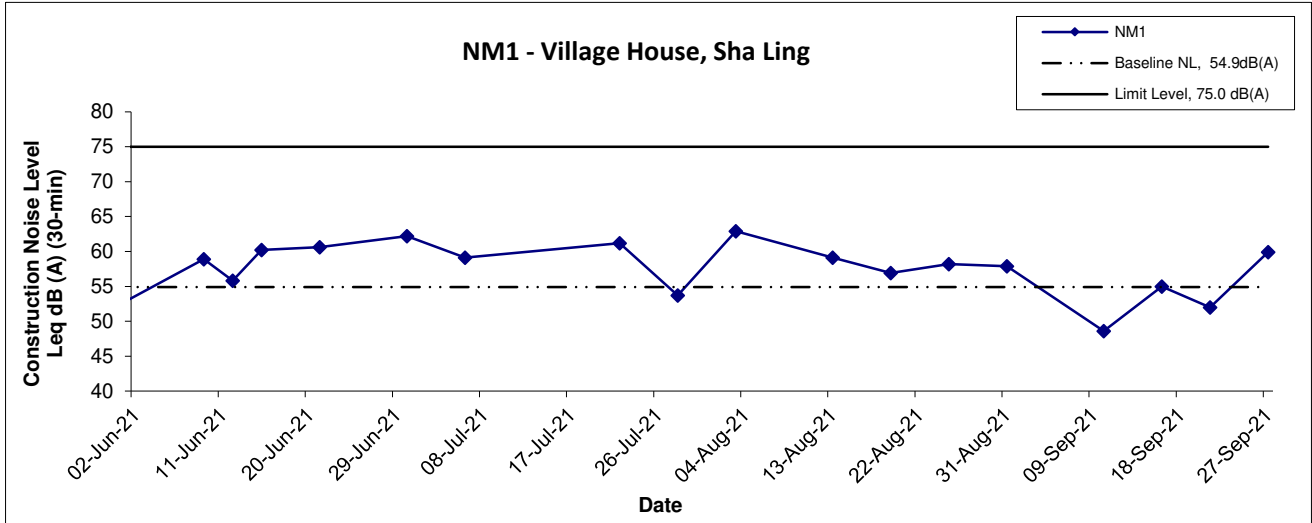
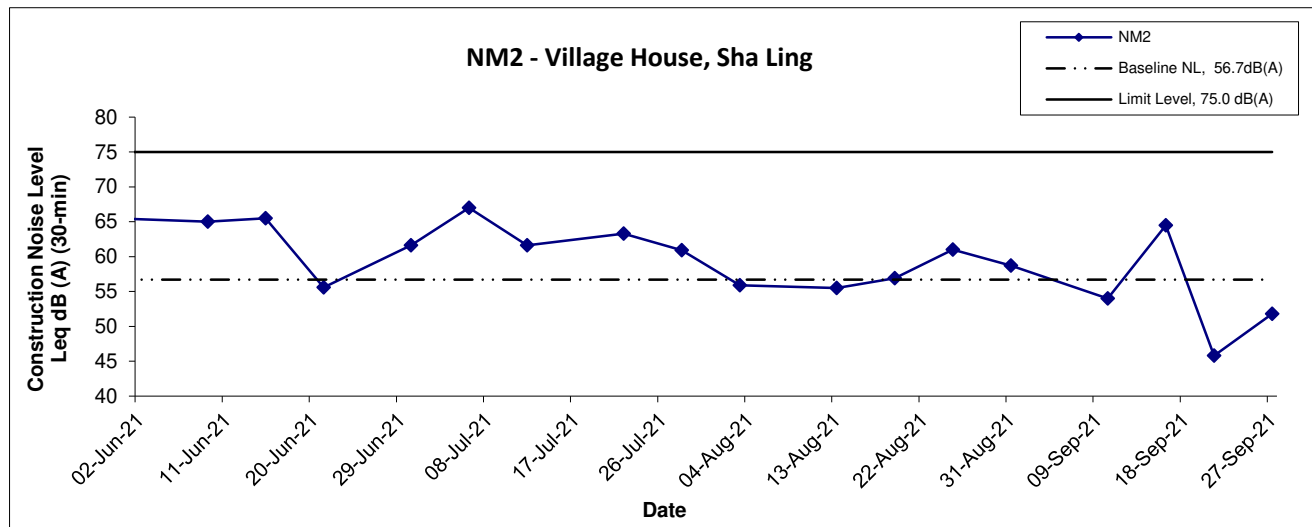
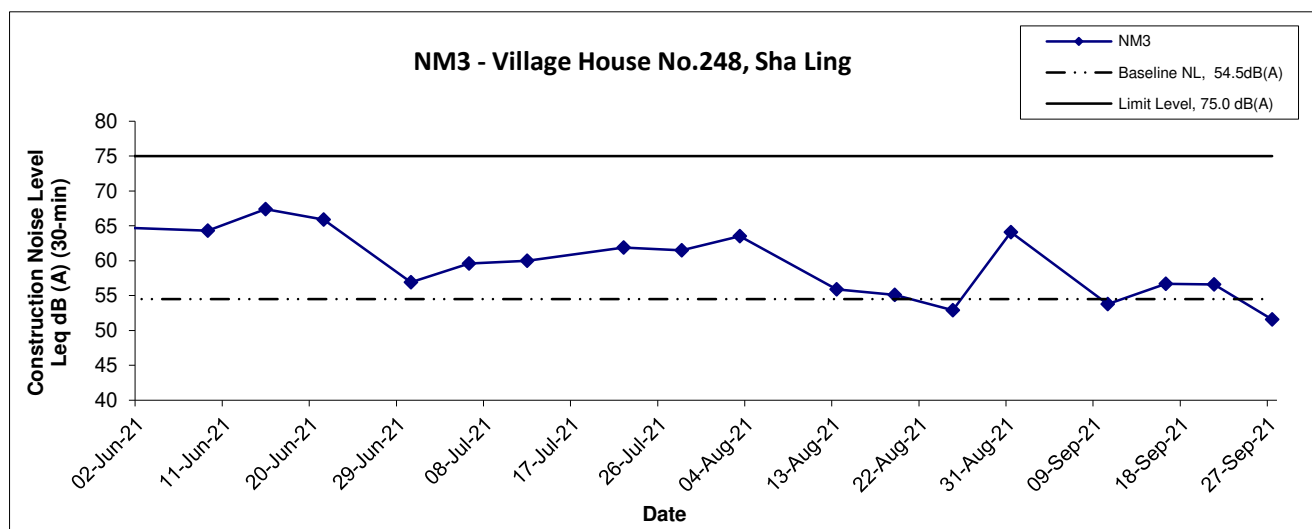
Noise Levels

Title Service Contract No. NDO 07/2019 Environmental Team for Site Formation and Infrastructure Works for Police Facilities in Kong Nga Po Graphical Presentation of Construction Noise Monitoring Results	Scale N.T.S	Project No. WMA20001	匯力 consulting · testing · research
	Date Sept 21	Appendix C

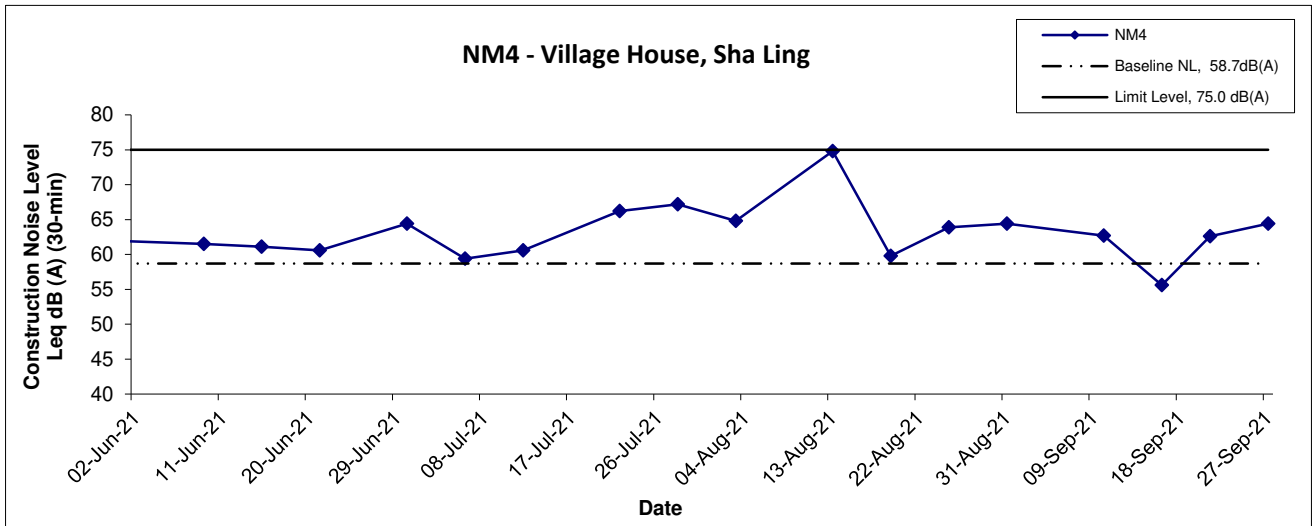
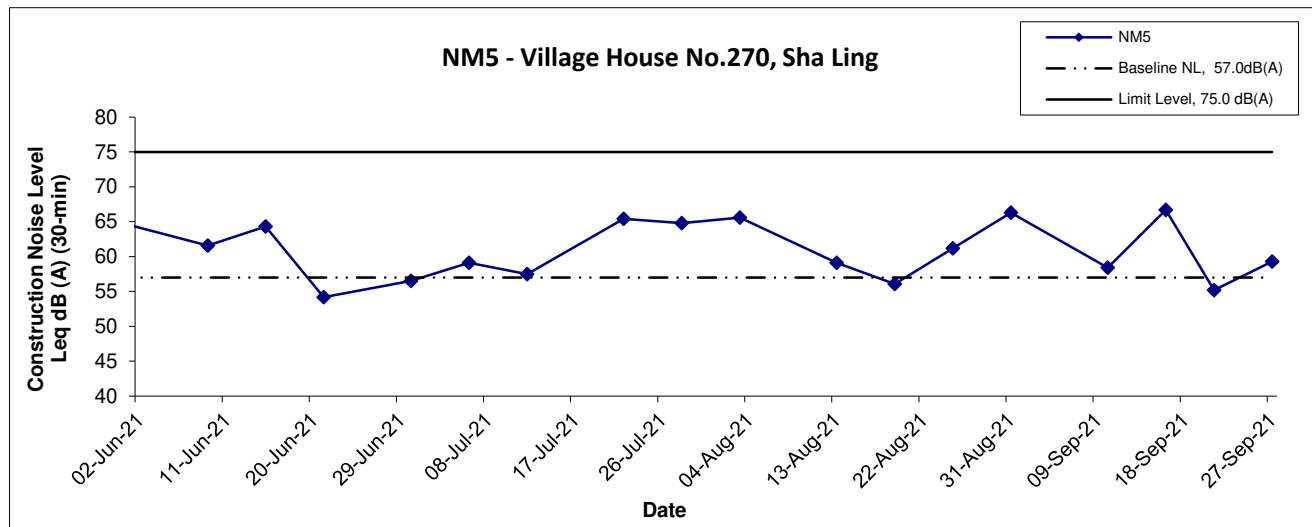
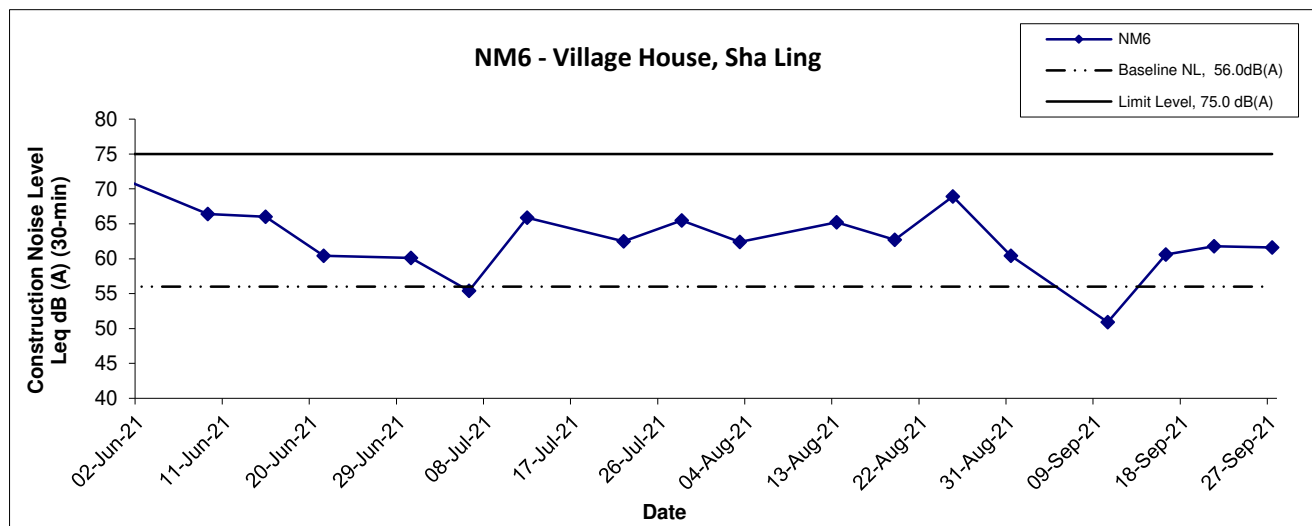
Noise Levels

Title Service Contract No. NDO 07/2019 Environmental Team for Site Formation and Infrastructure Works for Police Facilities in Kong Nga Po Graphical Presentation of Construction Noise Monitoring Results	Scale N.T.S	Project No. WMA20001	匯力 consulting · testing · research
	Date Sept 21	Appendix C

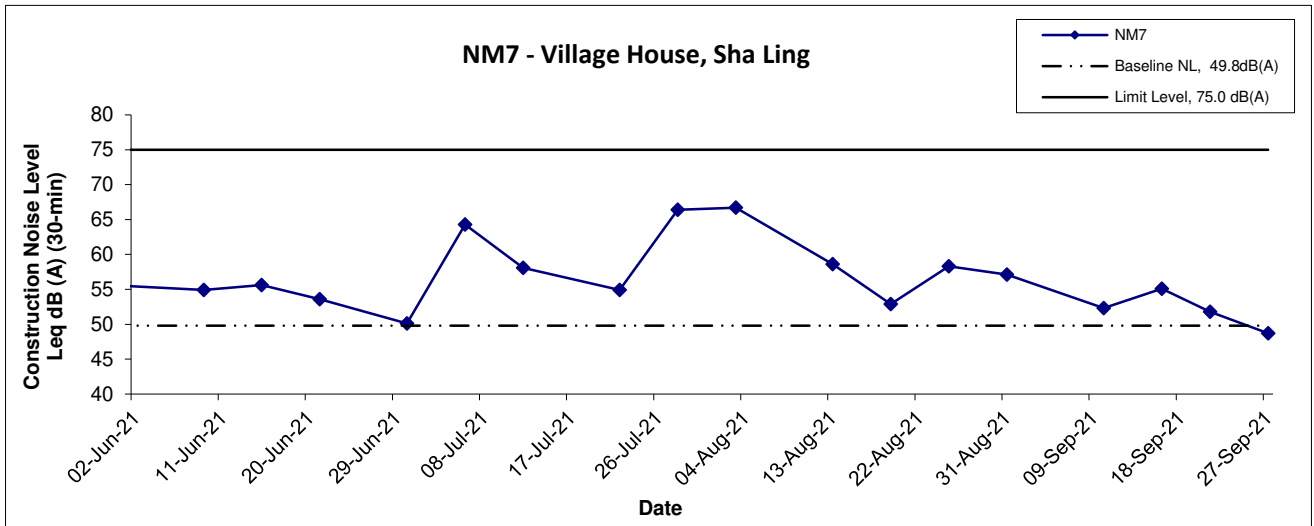
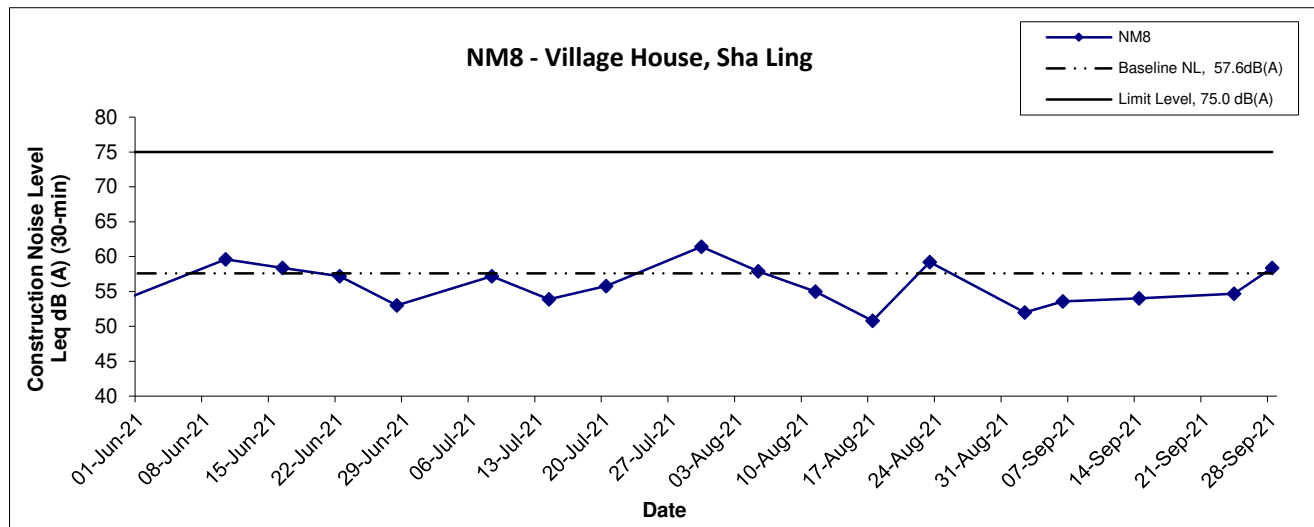
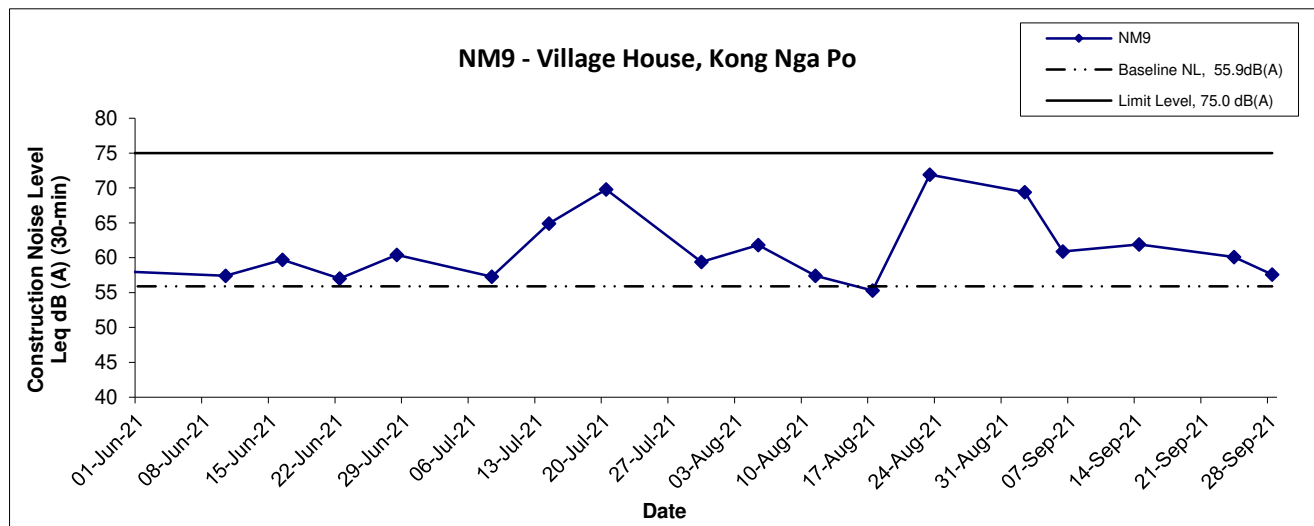
Noise Levels

Title Service Contract No. NDO 07/2019 Environmental Team for Site Formation and Infrastructure Works for Police Facilities in Kong Nga Po Graphical Presentation of Construction Noise Monitoring Results	Scale N.T.S	Project No. WMA20001	匯力 consulting · testing · research
	Date Sept 21	Appendix C

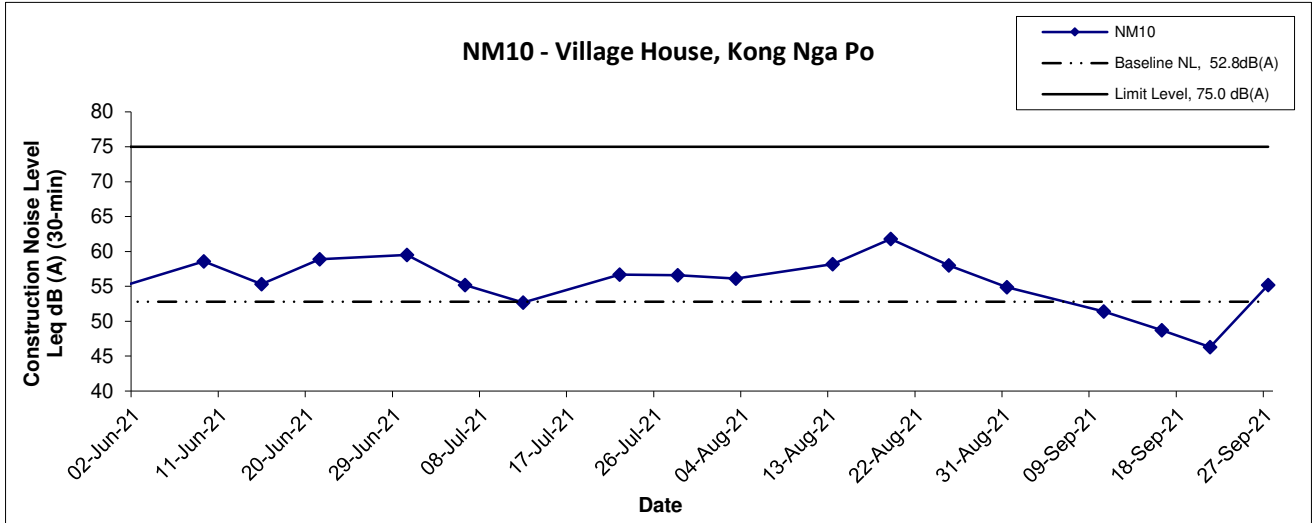
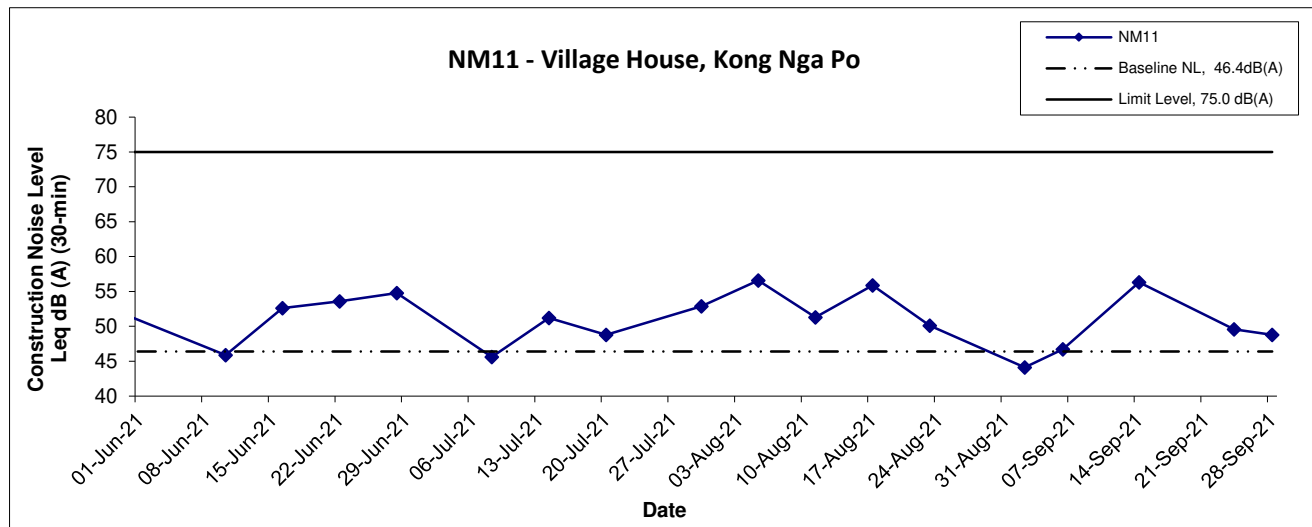
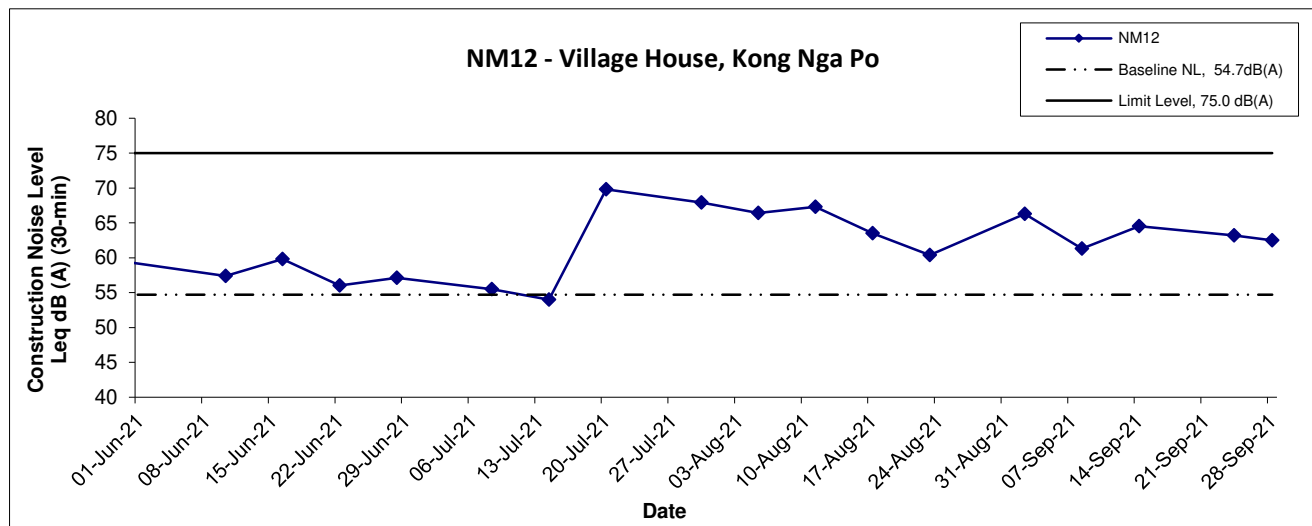
Noise Levels

Title Service Contract No. NDO 07/2019 Environmental Team for Site Formation and Infrastructure Works for Police Facilities in Kong Nga Po Graphical Presentation of Construction Noise Monitoring Results	Scale N.T.S	Project No. WMA20001	consulting · testing · research
	Date Sept 21	Appendix C

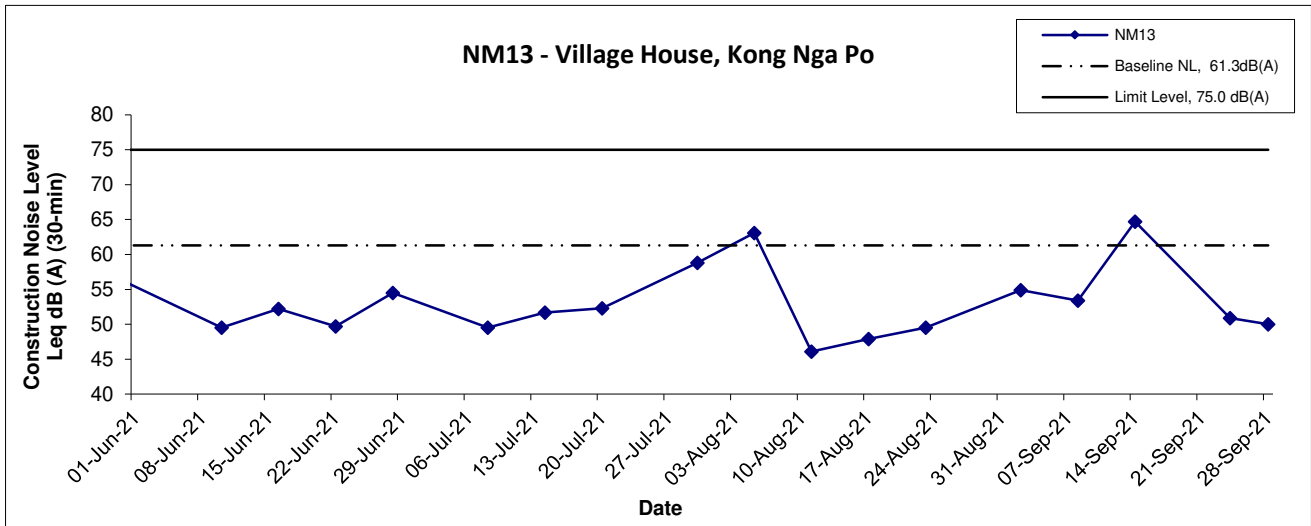
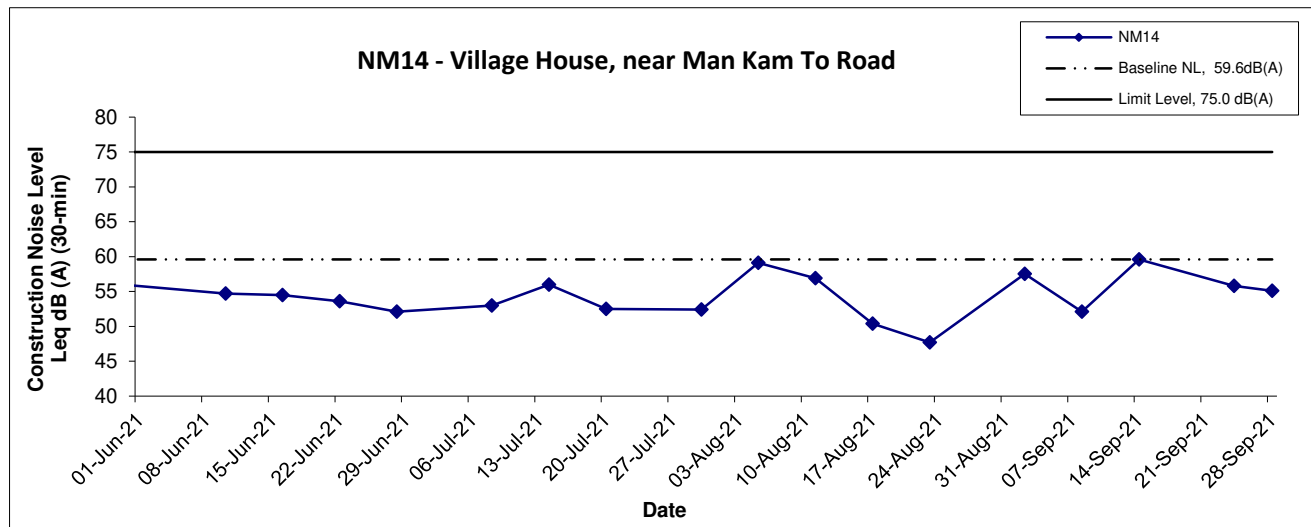
Noise Levels

Title Service Contract No. NDO 07/2019 Environmental Team for Site Formation and Infrastructure Works for Police Facilities in Kong Nga Po Graphical Presentation of Construction Noise Monitoring Results	Scale N.T.S	Project No. WMA20001	consulting · testing · research
	Date Sept 21	Appendix C
