**EP-510/2016 – Police Facilities in Kong Nga Po**

**Service Contract No. NDO 07/2019  
Environmental Team for Site Formation and  
Infrastructure Works for Police Facilities in  
Kong Nga Po**

**Monthly Environmental Monitoring and  
Audit Report for December 2021  
(Version 1.0)**

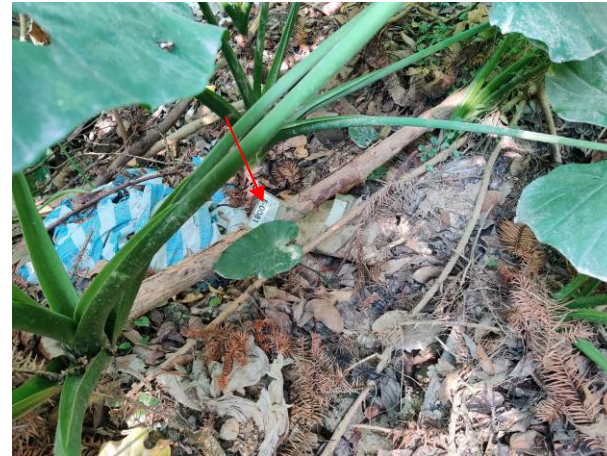
Photo 12

Description: An undersized seedling of *Keteleeria fortunei* (F-0081) was found collapsed due to internal decay.

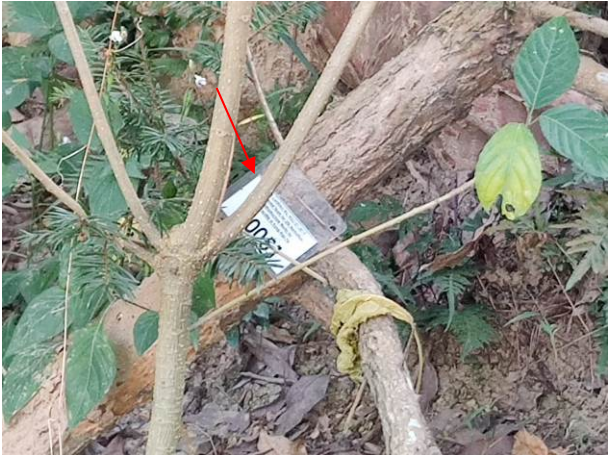
Photo 13

Description: An undersized seedling of *Keteleeria fortunei* (F-0051) was found uprooted by the nearby fallen tree.

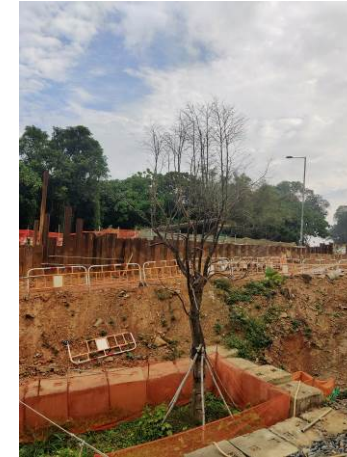
Photo 15

Description: Poor health condition of *Aquilaria sinensis* A-008 (defoliation, dead branches, dieback twigs on tree crown etc.) was found. The Contractor was reminded to take appropriate and prompt action (e.g. pruning, mulching etc.) according to the tree conditions to rescue the tree.

- 5.10 During monthly monitoring, poor health condition of *Aquilaria sinensis* A-008, A-0009 and A-0010 (defoliation, dead branches, dieback twigs on tree crown etc.) were found. The Contractor was reminded to closely monitor and take appropriate and prompt action (e.g. pruning, mulching etc.) according to the tree conditions to rescue the trees with reference to the approved transplantation proposal. No construction activity and equipment storage were observed within the receptor site. Temporary protective fence was properly erected and maintained for the transplanted species.

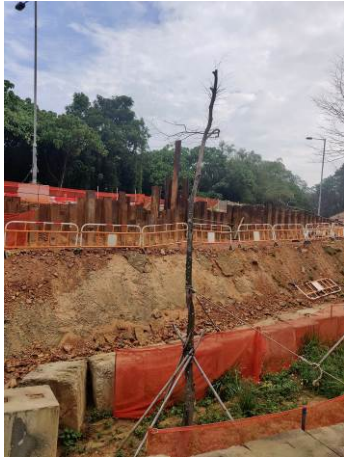
Photo 16

Description: Poor health condition of *Aquilaria sinensis* A-0010 (defoliation, dead branches, dieback twigs on tree crown etc.) was found. The Contractor was reminded to take appropriate and prompt action (e.g. pruning, mulching etc.) according to the tree conditions to rescue the tree.

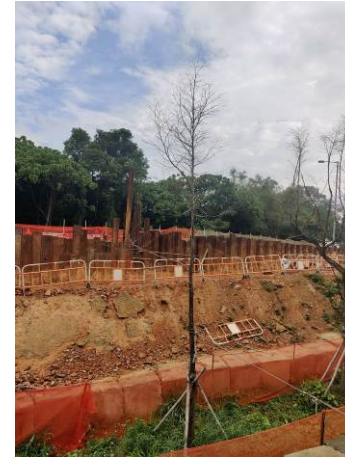
Photo 17

Description: Poor health condition of *Aquilaria sinensis* A-0009 (defoliation, dead branches, dieback twigs on tree crown etc.) was found. The Contractor was reminded to take appropriate and prompt action (e.g. pruning, mulching etc.) according to the tree conditions to rescue the tree.
