EP-510/2016 – Police Facilities in Kong Nga Po

**Service Contract No. NDO 07/2019
Environmental Team for Site Formation and
Infrastructure Works for Police Facilities in
Kong Nga Po**

**Monthly Environmental Monitoring and
Audit Report for February 2022
(Version 1.0)**

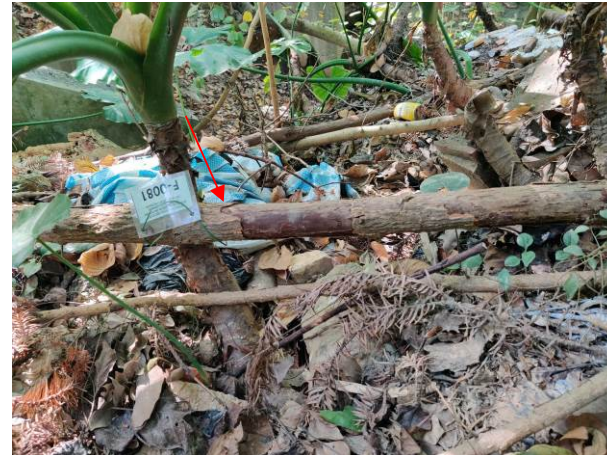
Photo 13

Description: An undersized seedling of *Keteleeria fortunei* (F-0081) was found collapsed due to internal decay.

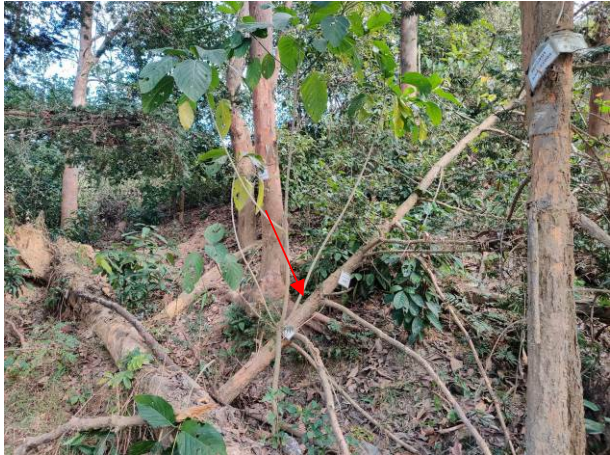
Photographic Records for Monthly Monitoring of Flora Species of Conservation Interest on 28th February 2022

Description: An undersized seedling of *Keteleeria fortunei* (F-0051) was found uprooted by the nearby fallen tree.

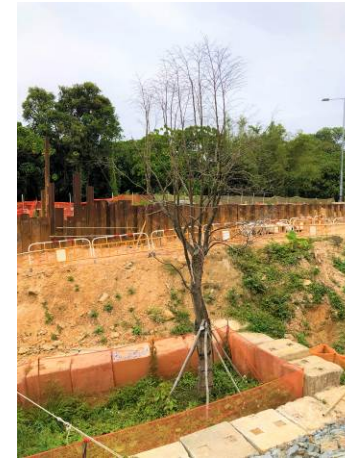
Photo 16

Description: Poor health condition of *Aquilaria sinensis* A-008 (defoliation, dead branches, dieback twigs on tree crown etc.) was found. The Contractor was reminded to closely monitor and take appropriate and prompt action according to the tree conditions to rescue the tree.

- 5.10 During monthly monitoring, poor health condition of *Aquilaria sinensis* A-008, A-0009 and A-0010 (dead branches, dieback twigs etc.) were still found. The Contractor was reminded to closely monitor and take appropriate and prompt action according to the tree conditions to rescue the trees with reference to the approved transplantation proposal. No construction activity and equipment storage were observed within the receptor site. Temporary protective fence was properly erected and maintained for the transplanted species. The Contractor was also recommended to check any influencing factors outside the receptor sites which are likely affected, directly or indirectly to the transplanted individuals.

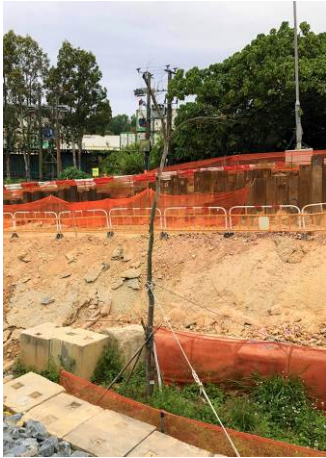
Photo 17

Description: Poor health condition of *Aquilaria sinensis* A-0010 (defoliation, dead branches, dieback twigs on tree crown etc.) was found. The Contractor was reminded to closely monitor and take appropriate and prompt action according to the tree conditions to rescue the tree.

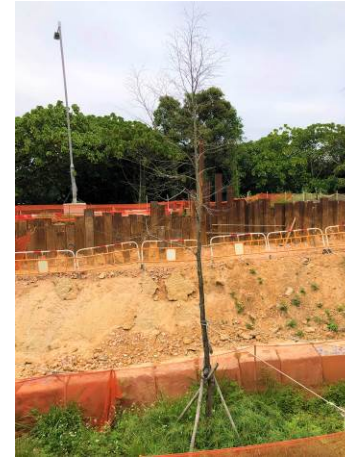
Photographic Records for Monthly Monitoring of Flora Species of Conservation Interest on 28th February 2022

Description: Poor health condition of *Aquilaria sinensis* A-0009 (defoliation, dead branches, dieback twigs on tree crown etc.) was found. The Contractor was reminded to closely monitor and take appropriate and prompt action according to the tree conditions to rescue the tree.

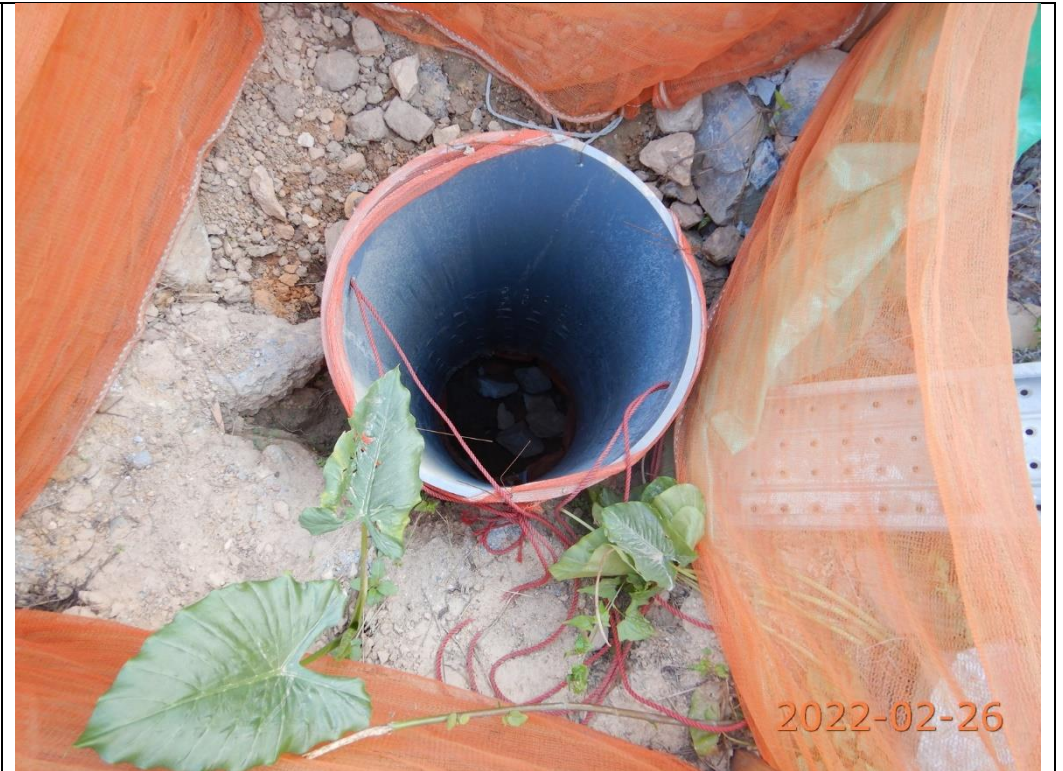
Formation of ditch to guide surface runoff to water pumping location

Provision of de-watering well and conduct de-watering during rainy days

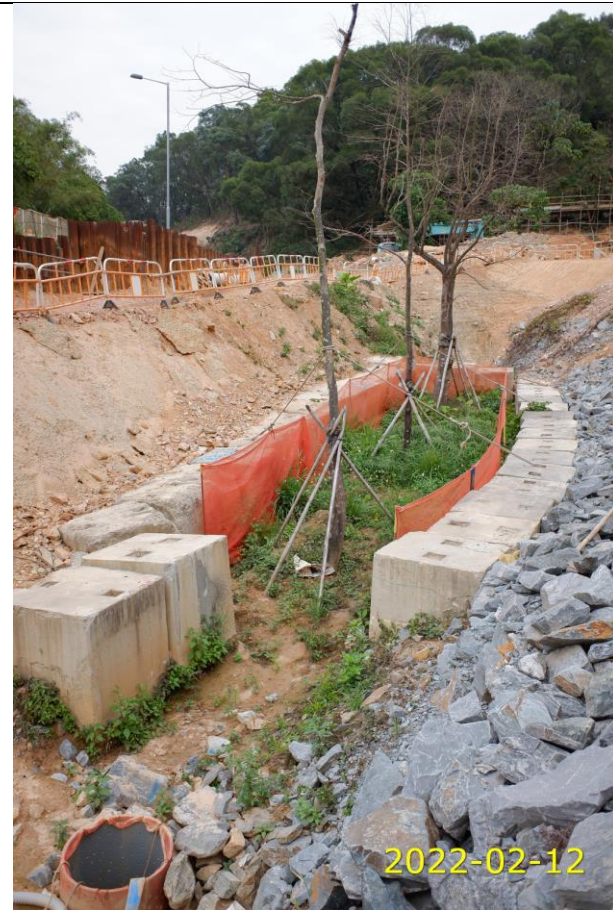
Formation of ditch to guide surface runoff to water pumping location, moist soil surface observed

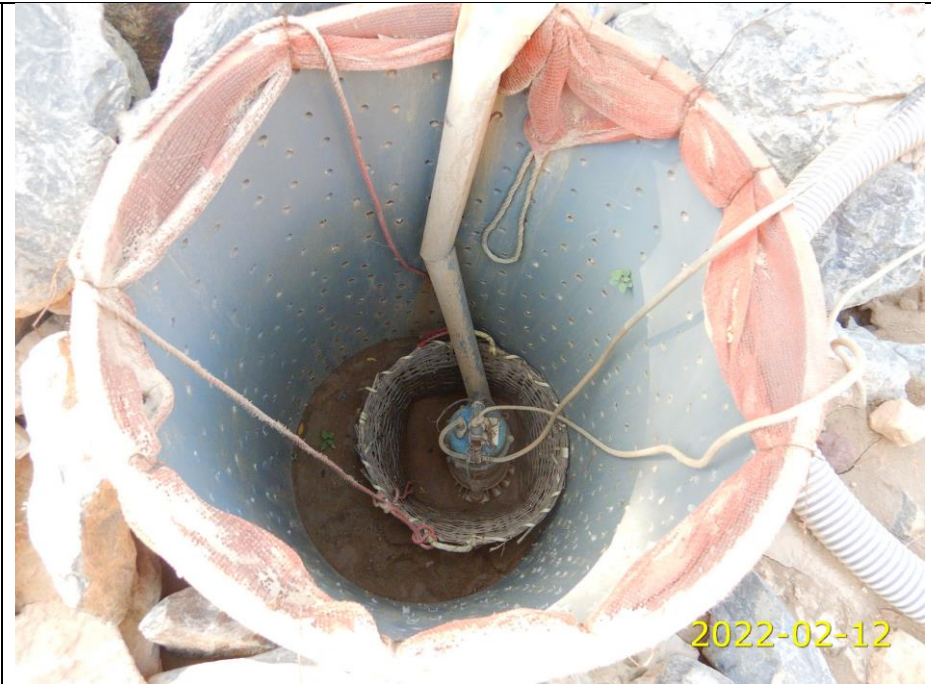
Submersible pump standby
